## Some Notes on the Construction of Christos Ho Pantepoptes (Eski Imaret Camii) in Istanbul

Robert OUSTERHOUT

Δελτίον ΧΑΕ 16 (1991-1992), Περίοδος Δ'. Στη μνήμη του  
André Grabar (1896-1990) • Σελ. 47-56

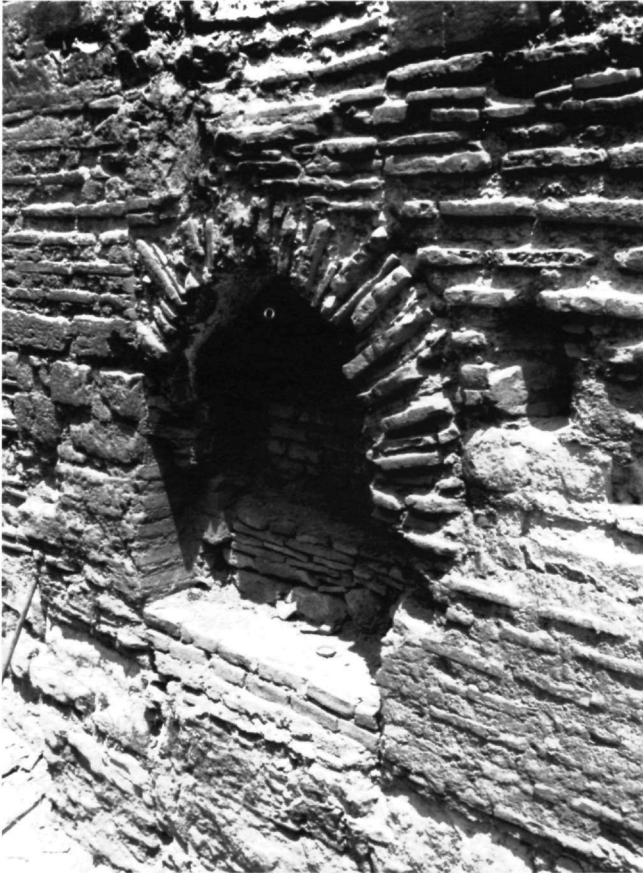
Fig. 9. Istanbul, *Christos ho Pantepoptes*. South façade, detail of niche.
