# Accessibility of Shared Space by Visually Challenged People

## ABSTRACT

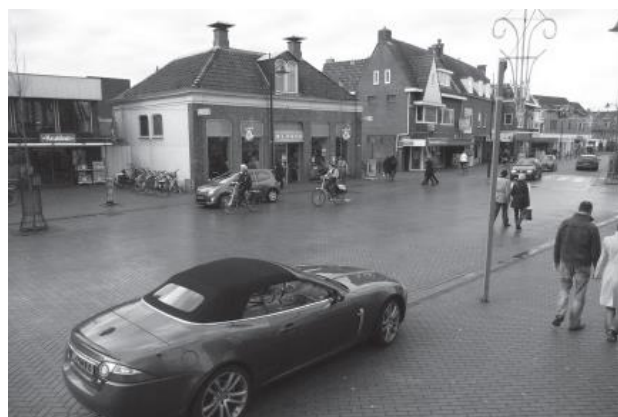
**Figure 1.** Example of Shared Space in the Netherlands. All traffic flows (e.g. cars, bicycles and pedestrians) mingle.

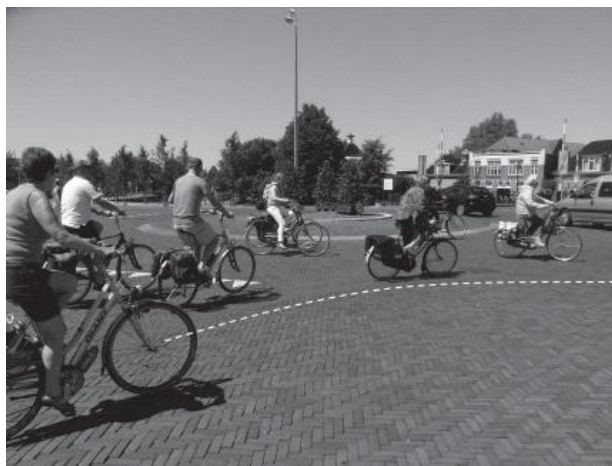
**Figure 2.** Sneek (Prins Hendrikkade). A dotted line indicates the position of a grey surface line between dark red bricks, forming the suggested, unofficial separation with the carriageway. The cyclist on the left is riding in a zone where pedestrians are also expected to walk.

Demarcations between different parts of the street were realized at eight out of the ten locations, using different colours of paving material. The brightness contrast between the carriageway and what could be considered pavement or a walking route was not sufficient at any of these locations: i.e. differences in reflectance factor were below the prescribed minimum of 0.3 [11]. Special zones were realized for pedestrians around a square or roundabout at two locations. These zones were marked with differently coloured paving or by an upstanding edge. At only three locations the walking route was completely free of obstacles, such as bicycle racks, shop displays, terraces, etc. Obstacles on walking routes were never marked with warning signs. Eight locations included areas where cyclists could be expected to ride in the same area that was used by pedestrians (e.g. Figure 2).

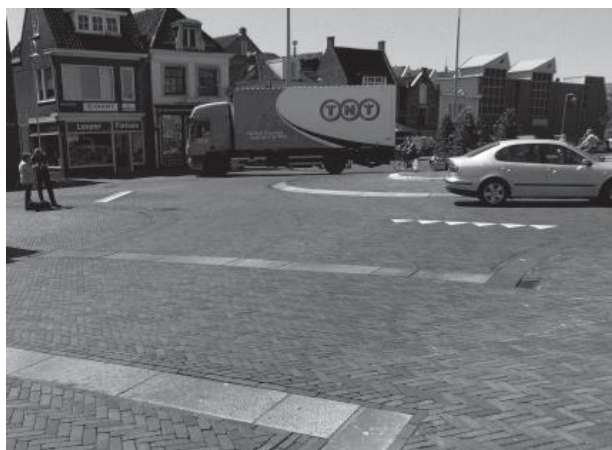
**Figure 3.** Sneek (Prins Hendrikkade). In the front there is a crossing suggestion, marked by grey stones amongst dark red paving.

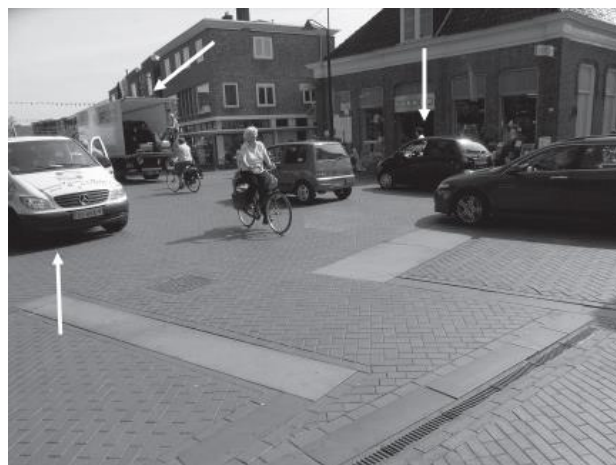
**Figure 4.** Haren (Rijksstraatweg). Three parked cars, indicated by white arrows, lead to a chaotic situation.

When drivers are free to park their car anywhere unpredictable and chaotic situations can arise (Figure 4). While parked cars as such are not a problem for visually impaired persons, predictability and structure are very important for them to maintain orientation. Therefore a clear parking policy with either carefully designated parking places or a no-parking zone should be part of the Shared-Space design [15, 16].
