## Accessibility of Shared Space by Visually Challenged People

"Enabling Access for Persons with Visual Impairment" : Proceedings of the International Conference ICEAPVI Athens, Greece, February 12-14, 2015

# Accessibility of Shared Space by Visually Challenged People

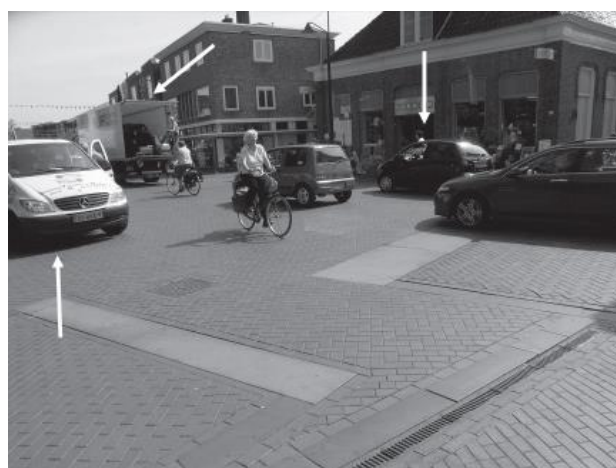
When drivers are free to park their car anywhere unpredictable and chaotic situations can arise (Figure 4). While parked cars as such are not a problem for visually impaired persons, predictability and structure are very important for them to maintain orientation. Therefore a clear parking policy with either carefully designated parking places or a no-parking zone should be part of the Shared-Space design [15, 16].

**Figure 4.** Haren (Rijksstraatweg). Three parked cars, indicated by white arrows, lead to a chaotic situation.
