GFRP anchoring systems for soft-rock geostructures with high cultural and environmental value

Geotechnical Engineering for the Preservation of Monuments and Historic Sites III

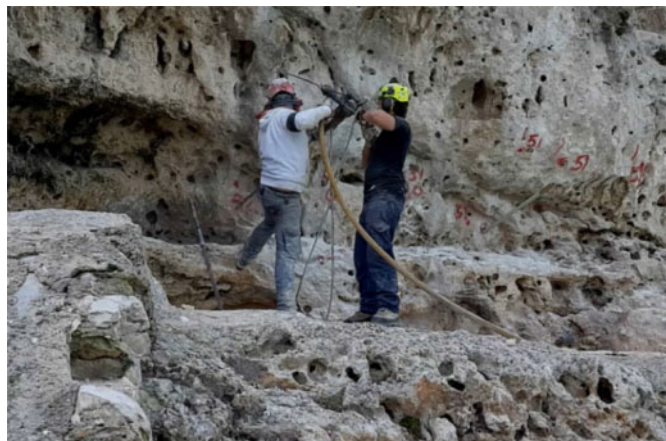
Figure 6. Favellato SPA technician preparing the holes in the limestone.

The choice of the diameter of the holes was made in relation to the diameters of the bars used. For, 32 mm holes were drilled while for both the Ø25 and Ø32 bars a 51 mm hole was used (Figure 6). All the bar (D) and hole (D_h) diameters are reported in Table 3. All anchoring lengths were fixed to one meter.

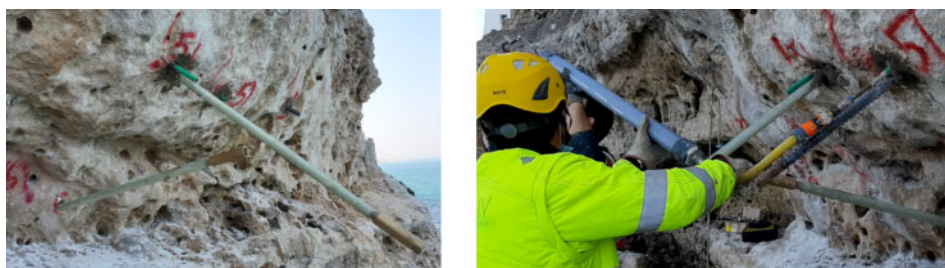
Figure 7. a) VTR bars blocked by *Lampocem* before injection; b) injection of *MasterEmaco 222* through injection tube in CG.

In FT1 12 bars were installed (4 in CG and 8 in CB limestone) and pulled to failure or to the maximum capacity of the jacking system (100 Tons). Of the 4 bars installed in the calcarenite, 2 were Ø32 GFRP hollow tubular bars and 2 were 26, 5 Ø DYWIDAG bar. The holes in zone 2 in Figure 3 (in CG calcarenite) with an upward inclination of approximately 45° were filled using a bespoke injection system (Figures 7a and 7b). First the bars were inserted into the holes for a length of 1 m with a tube for the injection of the consolidating material. Both the bar and the tube were fixed to the rock face using an ultra-fast cement mortar (*Lampocem* from Mapei) that helped to seal the hole preventing the consolidants to leak out during the injection. Once cured a very fluid lime-based mortar (*MasterInject 222* – Pozzolanic lime grout, cement-free) was injected through the preinstalled tube.

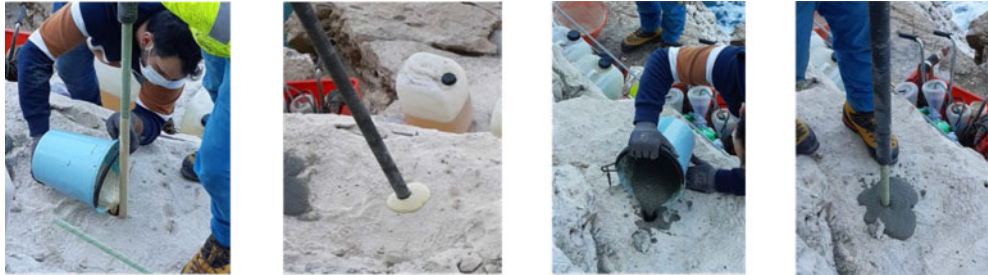
Figure 8. Pouring to two different materials.

A few meters below the above described calcarenite anchors a bank of CB limestone was chosen (Zone 1 in Figure 3) and injected, by pour (see Figure 8). 4 different bars with different diameters, for a total of 8 holes were filled with either an organomineral resin (*MasterRoc RBA 380*) or a quick-setting cement mortar (*MasterEmaco T 1200 PG*).

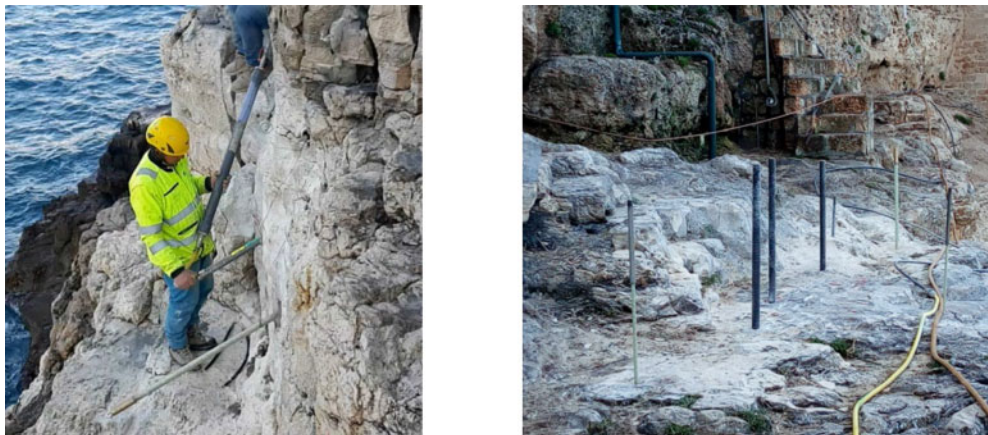
Figure 9. a) Technician during injection *MasterEmaco A 60* in CB1/2; b) anchor in FT2 zone 1.

In FT2, 12 anchors were installed (all in CB limestone), with 8 different types of consolidating materials. Except for the CB1/2 and CB2/2 bars (Zone 2), where the consolidant material was injected with the same bespoke method used in FT1 and described above (Figure 9a), all the other bars were grouted by casting the chosen material (Figure 9b).

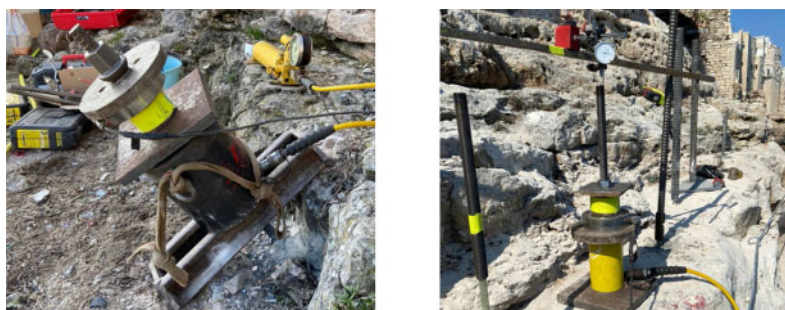
Figure 11. a) Pull test with 1000 kN capacity Hallow piston; b) pull test with 300 kN capacity hallow piston.

All the pull-out tests were performed using Hallow piston Hydraulic cylinder Jack brought under pressure by a manual pump, connected to a load cell to measure the applied tensile force. Depending on the estimated capacity the 100ton capacity or 30ton capacity hallow piston was used. Data acquisition was carried out digitally, using 3 digital displacement transducers connected to a data logger to which a connection to the pump was also added to also view the applied force. By connecting the data logger to a portable PC, it was possible to view and record in real time the displacement and force signals of the transducers. The results of the pull test of the CB8/2 and CB11/2 anchors are reported in Figure 11. In the figure the failure loads related to rock-consolidant shear failure, bar consolidant shear failure and yielding of the bar are also reported. For the anchoring length of 1 m and for tests in CB limestone, failure is expected to occur because of the yielding of the bar. The two tests reported in Figure 10 could not reach failure as the maximum load of the piston was reached in both cases. The main difference that clearly visible is the much stiffer response of the DYWIDAG compared to the GFRP one. Because of technical issues related to the data acquisition system it was not possible to perform all test with a digital data acquisition. For these latter, to measure and record displacements an analog displacement transducer was used (Figure 11). The force was also recorded manually. As detailed in Table 3 some tests were performed after 18 hours of curing time. Others were performed after 40 days. The field-testing campaign will be completed by the end of 2022 (about one year after installation) will be performed.
