Williams Honors College, Honors Research
Projects

Electrochemical Chloride Removal

Electrochemical Chloride Removal (ECR) of Reinforced Concrete

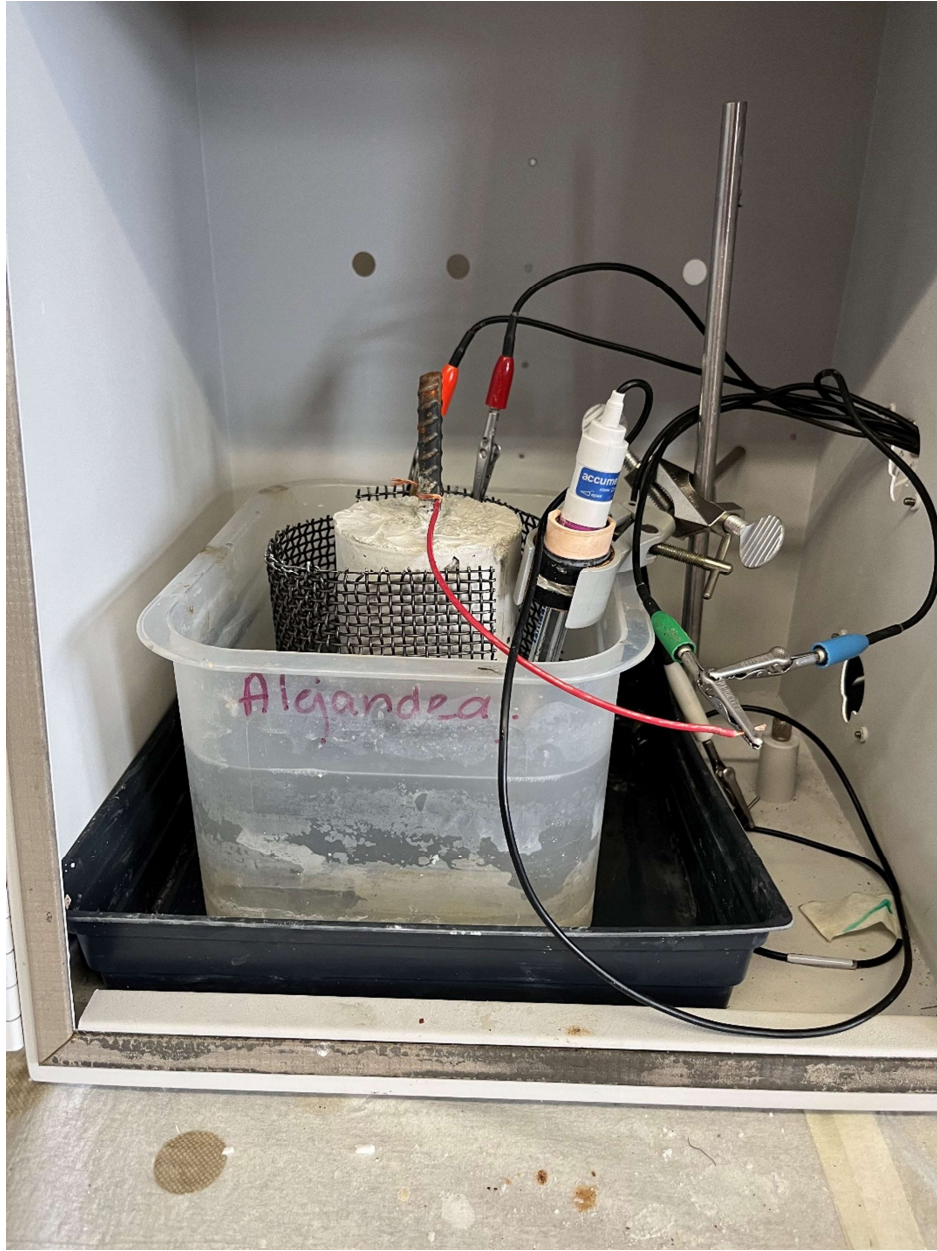
Figure 1: Photograph of the reference cell set-up that was used to gather OCP, EIS, and CPP data.

Once the samples were given adequate time to dry, electrochemical testing began. The solution that this testing occurred in was a 2-gram calcium hydroxide per liter solution. This mixture was made using a magnetic stirrer to ensure adequate and thorough mixing. The solution was poured into this container up to 8.9 cm up the concrete sample. The first test to be run was the OCP, EIS, and CPP testing for the control sample (without chlorides). After this testing was completed, baseline testing was done for a sample with chlorides that had not received the ECR treatment. The testing set-up for this can be seen in **Figure 1**. In this test set-up, a steel mesh, wrapped uniformly around the concrete sample, was used for the counter electrode, a saturated calomel electrode was used for the reference electrode, and the concrete and rebar was the working electrode. These electrodes were then hooked-up to the Gamry potentiostat accordingly.

After the ECR treatment was applied to the rebar, the same electrochemical testing that was done to the reference samples was repeated. The set-up for this testing was the same as that of **Figure 1** except the concrete sample had been treated with ECR.

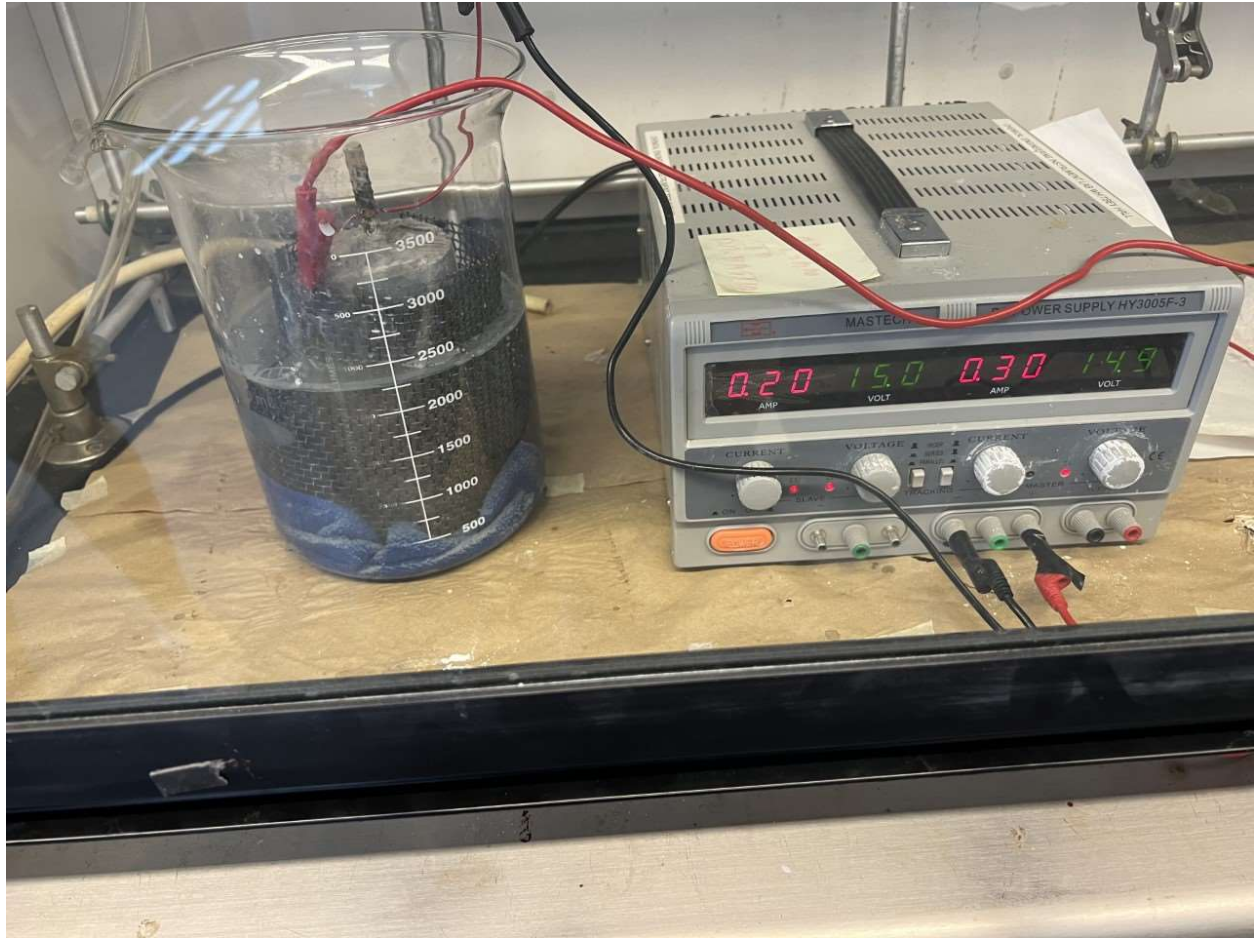
Figure 2: Testing set-up for the electrochemical chloride removal (ECR) set-up shown above. In this image, the positive, red wire, was connected to the steel mesh, and the negative, black wire, was connected to the rebar with the voltage being set at 15 volts.

the solution was poured into the container such that the concrete sample was submerged appropriately, the wrapped steel mesh was placed around the concrete sample. Ensure that this mesh is not in contact with the concrete sample. After the set-up was verified, the ECR treatment set-up was applied. This was applied using a DC power supply with the negative output being connected to the rebar coming out of the concrete and the positive output being connected to the steel mesh. This testing was done at 15 volts for 5 hours. A multimeter can be used to check that the DC power supply is applying the correct voltage to the sample. This set-up can be seen in **Figure 2.**

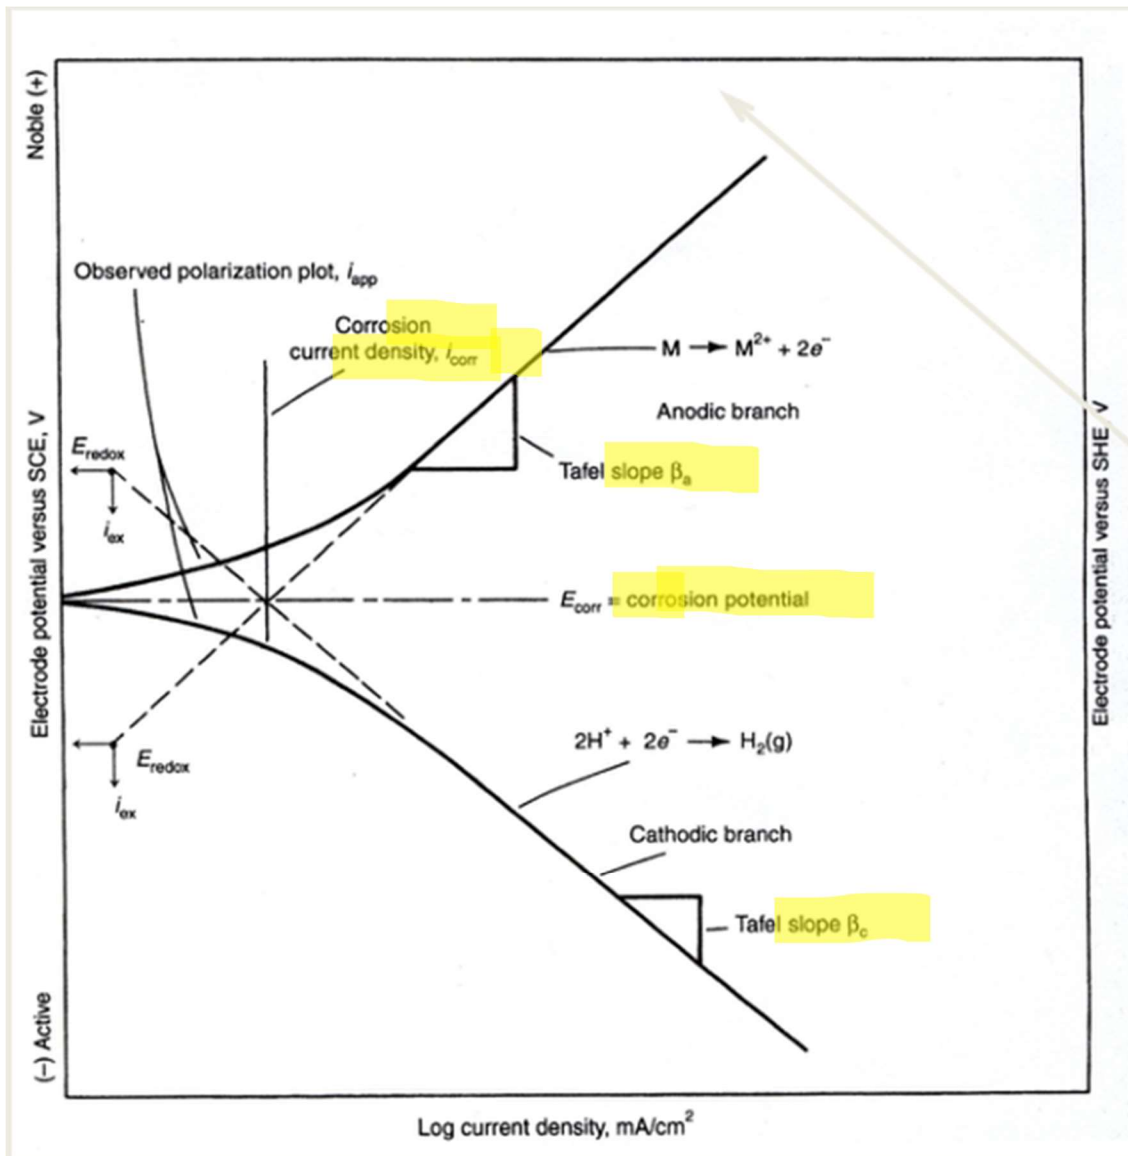
Figure 3: Tafel fit showing where E_{corr} , i_{corr} , β_a and β_c come from.

Throughout this study, there was three separate CPP graphs generated. The first CPP scan was done for the controlled, no chloride environment. The second scan was done for the worst-case scenario with extreme pitting and corrosion. The final scan was done for the sample that had received the ECR treatment. From these graphs, i_{corr} and E_{corr} values were gathered using a Tafel fit. In addition to gathering the corrosion current density and corrosion potential, the anodic and cathodic beta values were able to be gathered in order to better look at the corrosion rates. An example of this Tafel fit is shown in **Figure 3**[9].

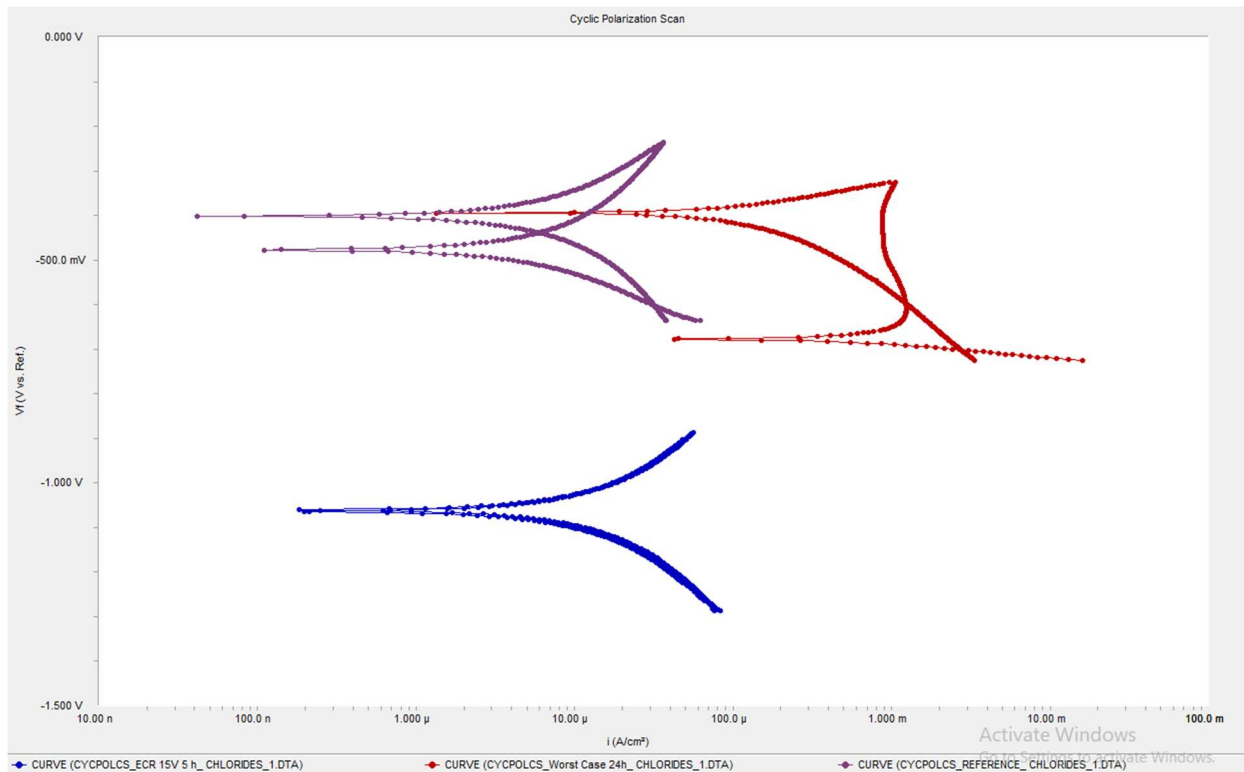
Figure 7: This figure shows the three tests conducted and the CPP scans that were gathered from them. The scan in the top left of the graph, in purple, is that of the reference cell with no chlorides, the scan on the top right of the graph, in red, is that of the worst-case scenario situation, and the scan on the bottom, in blue, is that of the ECR protected sample. As shown here, the icorr values for both the reference and the ECR are like each other, whereas the worst-case scenario has an icorr much greater than the other two.

Three samples were studied using various electrochemical methods. The CPP graphs which contain the Tafel fit data are shown within **Figures 4-7**. These graphs show how rebar reacts both in a non-chloride environment, an aggressive corrosion chloride environment, and a protected chloride contaminated environment. The non-chloride environment performed the best in terms of corrosion resistance with the ECR sample following closely behind. The aggressive environment, which performed the worst, showed signs of extreme pitting and corrosion which lead to an eventual concrete failure as evidenced in **Figures 13-15**.

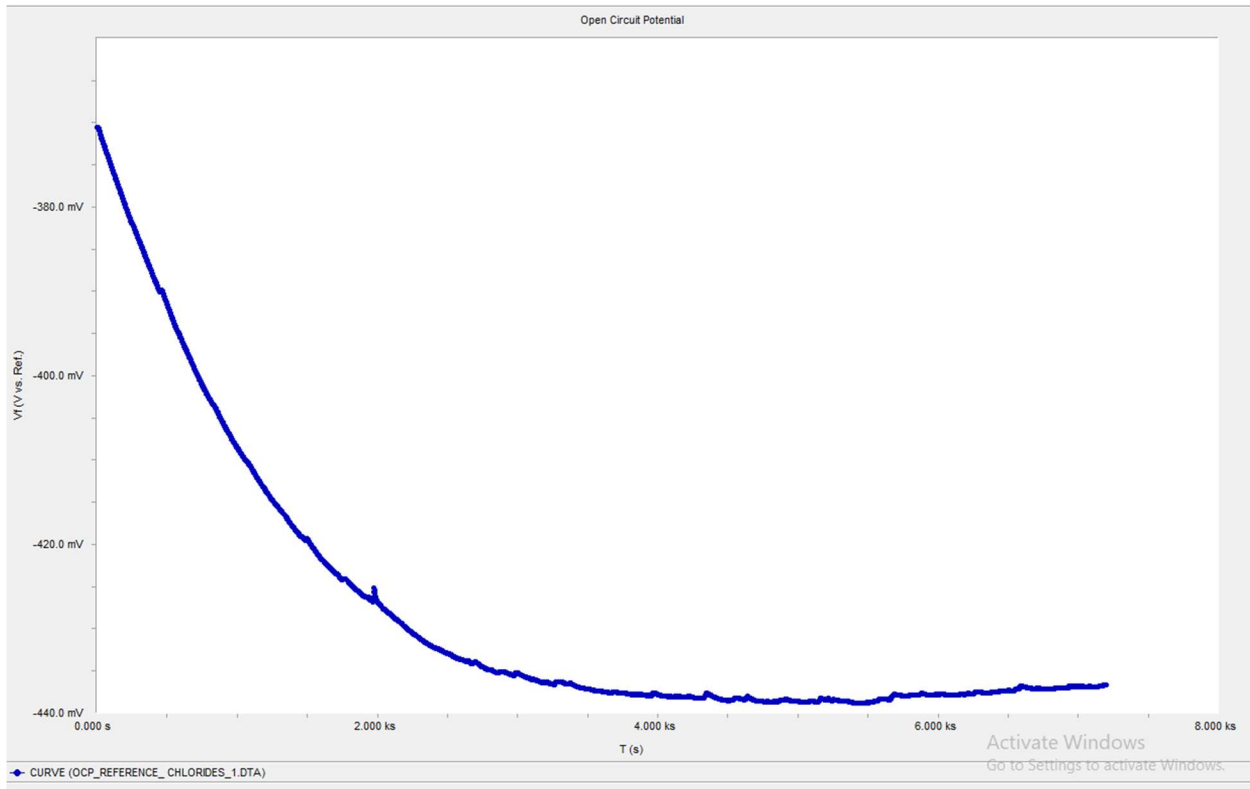
Figure 8: Prior to taking any other measurements or completing any additional tests, OCP testing was conducted on the reference no-chlorides sample. As shown at the end of this curve a semi-steady state was achieved.

Open circuit potential (OCP) values were recorded and graphed to check that the system had reached a stable state. This test was completed prior to both the CPP and EIS testing. Ensuring that there was a stable OCP measurement prior to completing the other tests was crucial to making sure that their values were accurate. An example of what this OCP graph looks like is shown below for the reference, no-chloride environment in **Figure 8**.

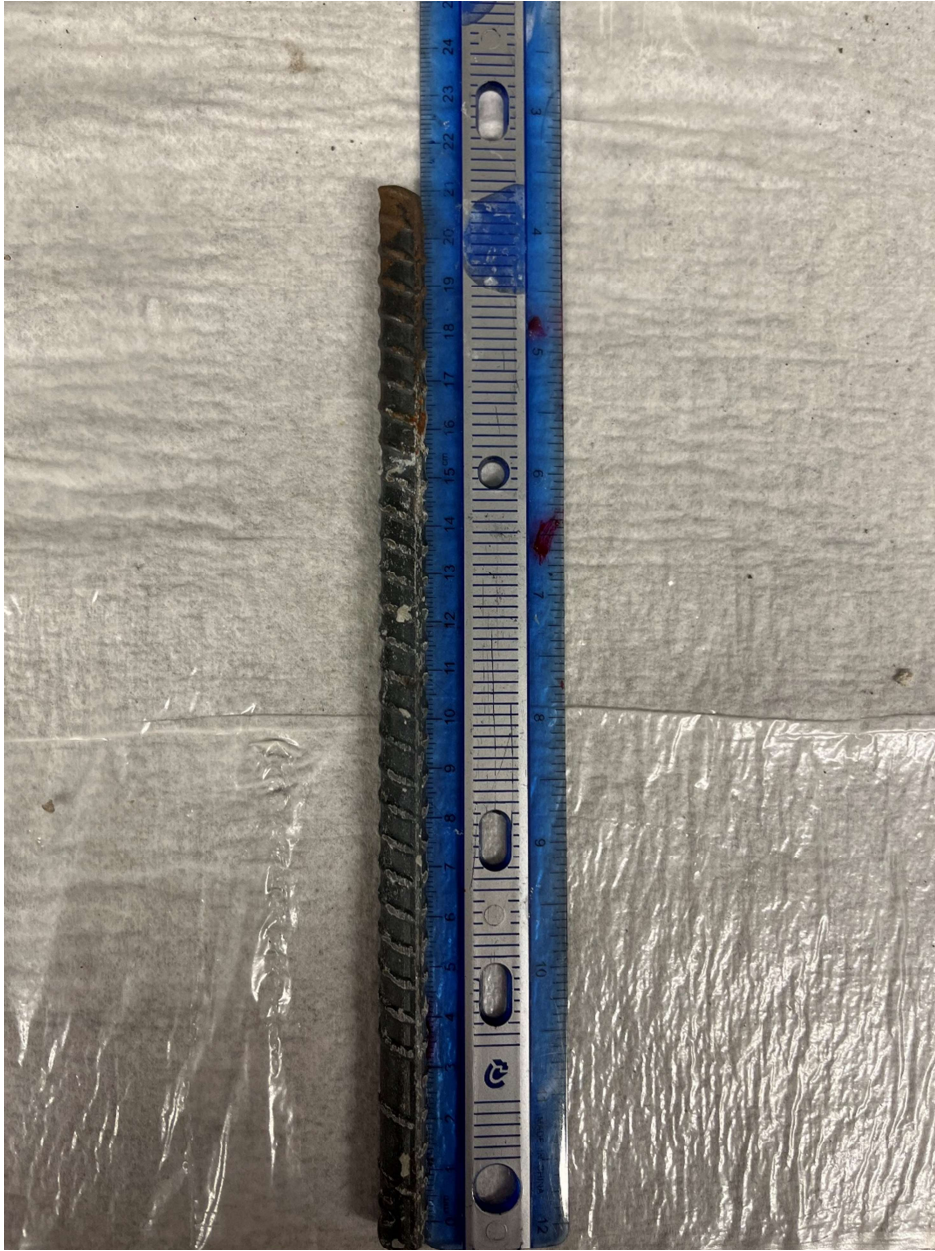
Figure 9: This image shows the rebar sample that was in the concrete mix without any chlorides. This rebar showed no signs of obvious corrosion, both on the bar or on the outside of the concrete.

Visual inspections were done on each sample post-electrochemical testing. These inspections were done by breaking the concrete and releasing the rebar from the middle. Once the rebar was freed, they were cleaned and then inspected to determine if there was any sign of corrosion or pitting. In these examinations, no pitting or extreme corrosion was found on either the reference no-chloride sample, **Figure 9**, or the ECR treated sample, **Figure 13**. Extreme pitting and extreme weight loss was shown in the worst-case scenario sample as shown in **Figures 10-12**.

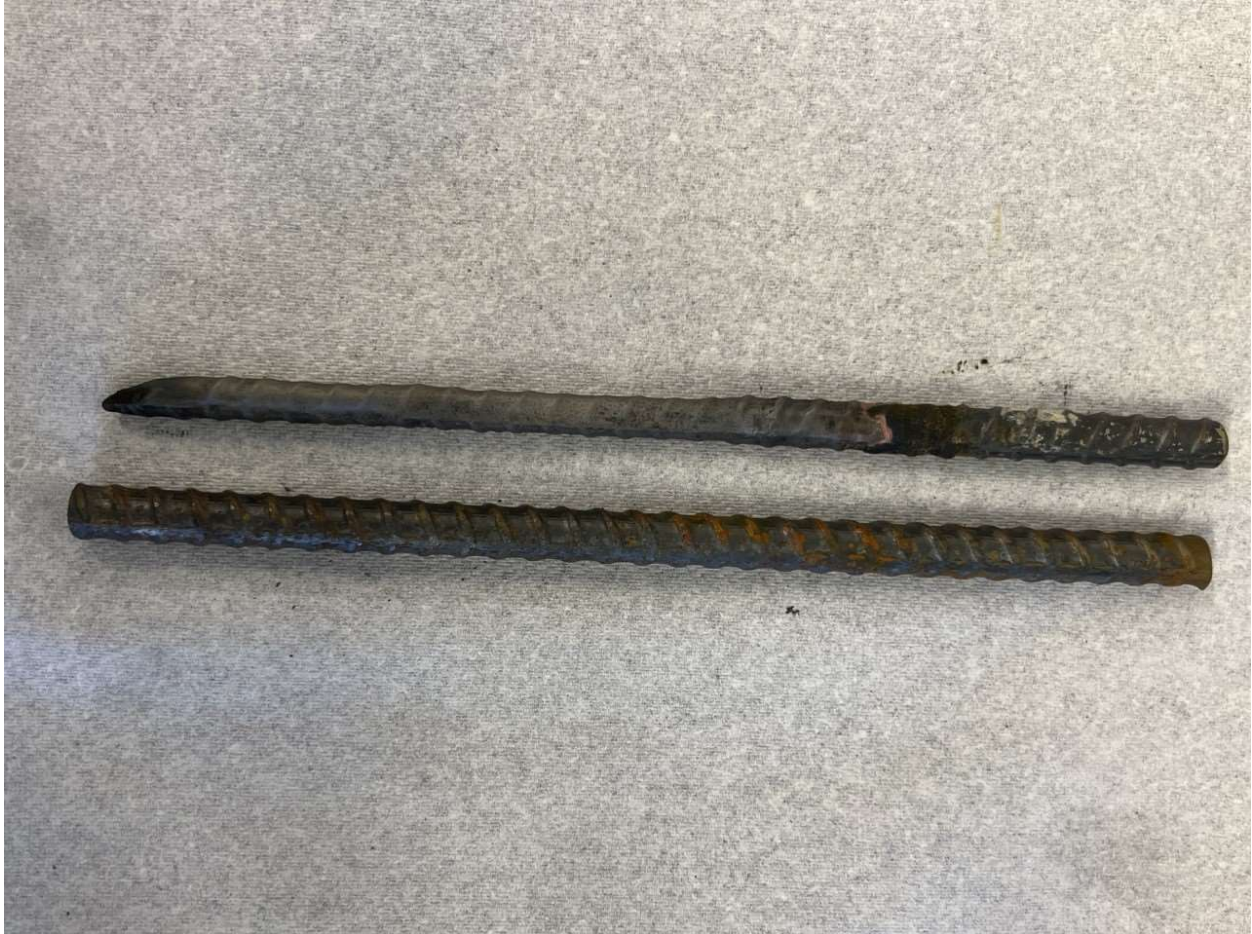
Figure 10: This image shows the extreme corrosion that took place in the worst-case scenario sample (top sample). The rebar on the bottom is the same size as what was initially tested in the worst-case scenario environment. This sample showed extreme mass loss and severe pitting over a 24-hour period.

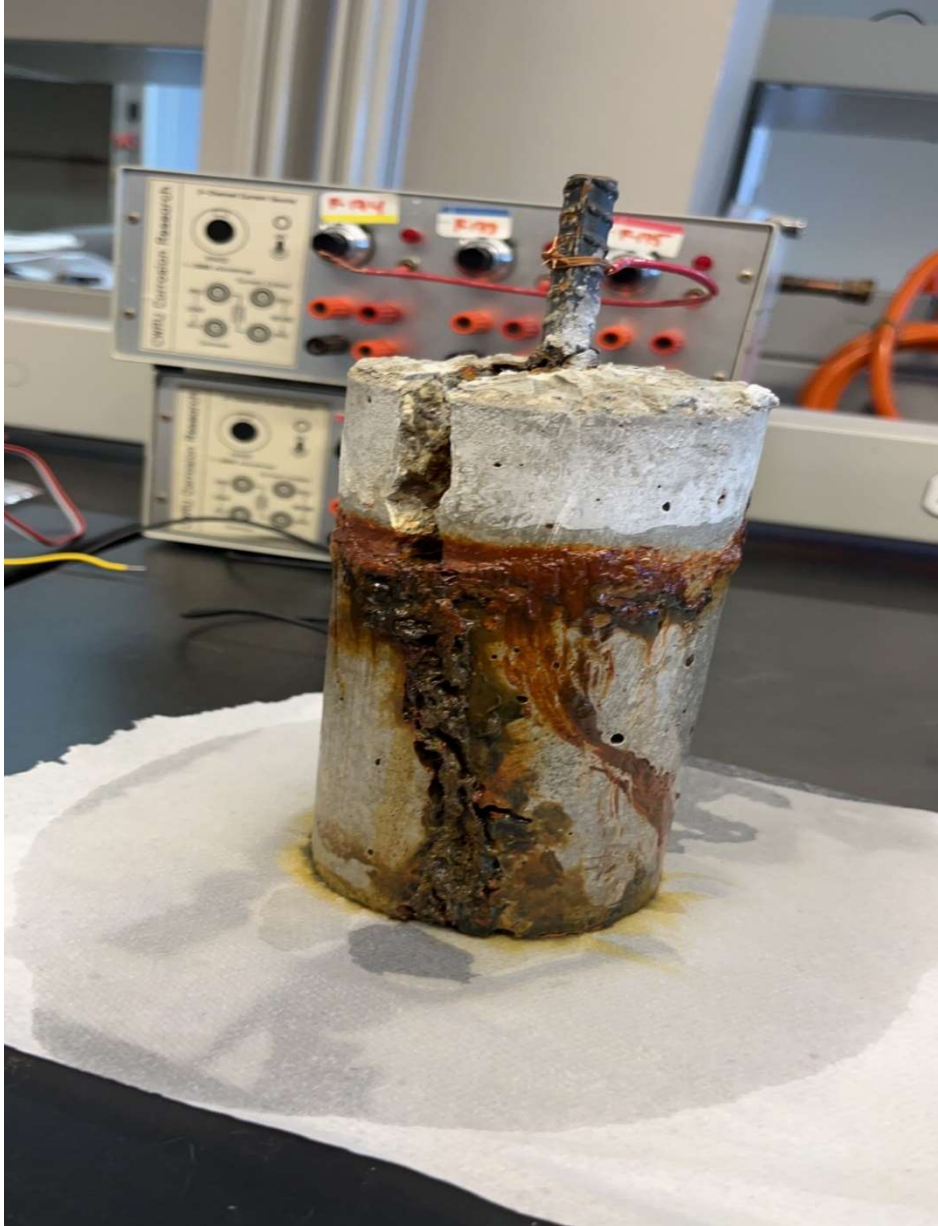
Figure 11: This image shows what the worst-case scenario looked like as soon as it was taken out of the testing environment. A severe crack can be seen in the concrete with corrosion product filling that crack. This observation supports the suggestion that corrosion on rebar within concrete will lead to concrete failure.

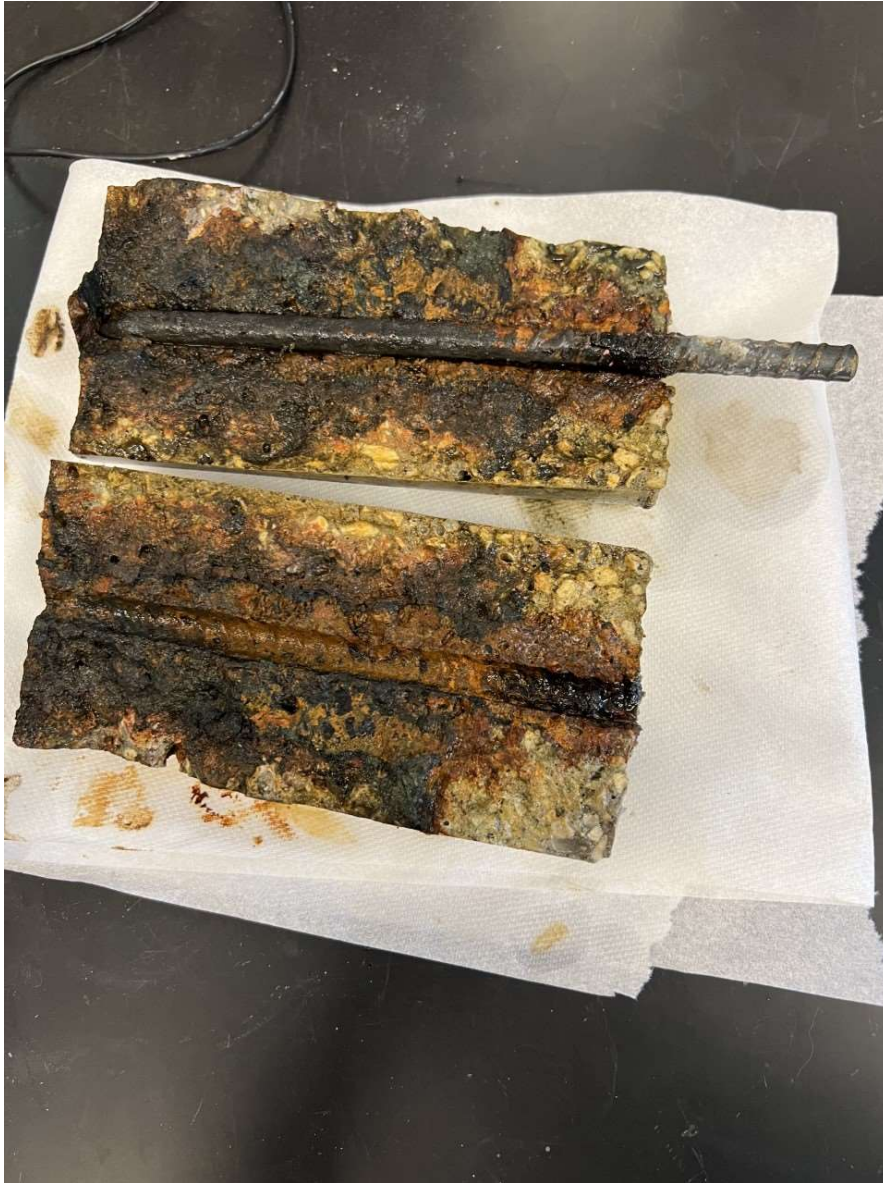
Figure 12: This image was taken shortly after the image from **Figure 12**. When this sample was picked up to be cleaned, a crack that was initially not visible on the backside of this specimen cracked all the way through. This led to the concrete looking like the picture above with two halves of the initial concrete cylinder, both with corrosion product staining inside. This failure supports the idea that extreme corrosion within reinforced concrete will not only lead to failures of the reinforcements, but also total concrete failures leading the structure to collapse under any additional stresses.

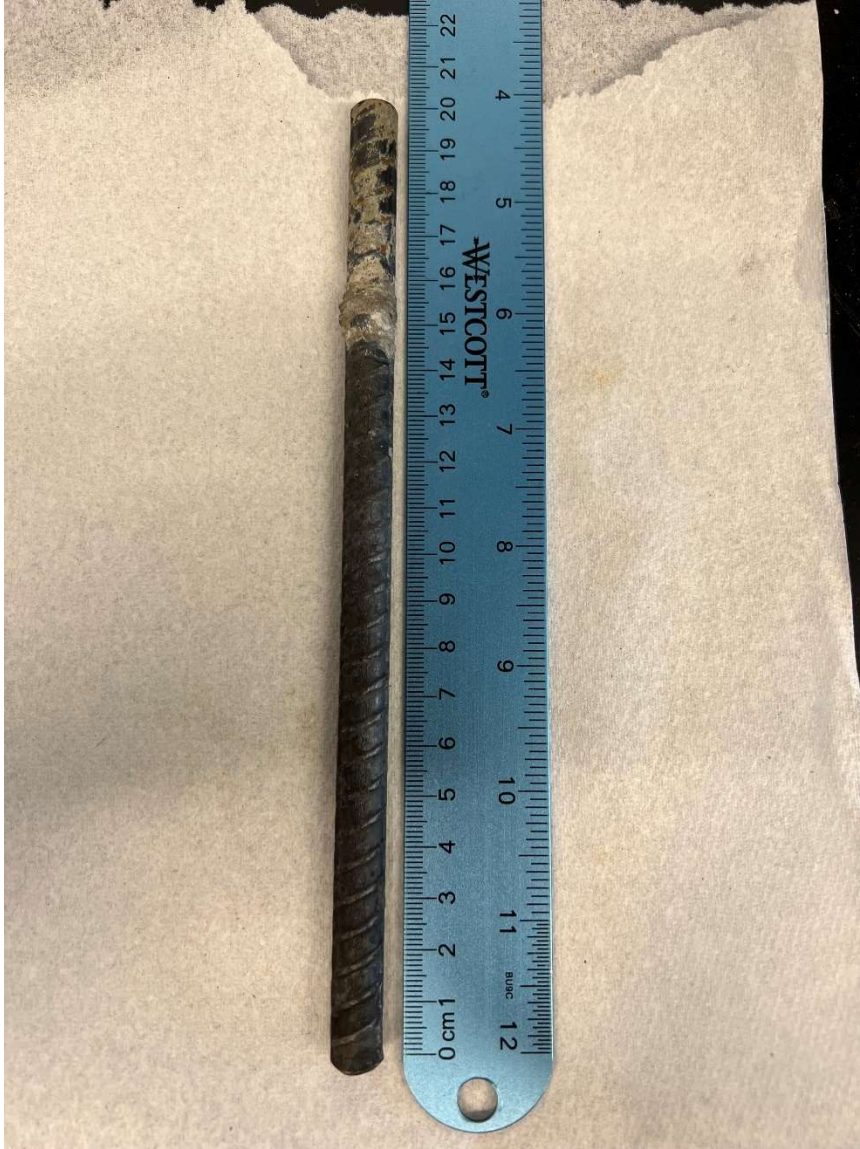
Figure 13: This image shows the rebar that received the ECR treatment. This sample showed no signs of corrosion, both on the concrete and on the rebar itself. This specimen also had chlorides within the concrete which could have caused corrosion, but the ECR treatment prevented this from happening. The concrete encasement of this sample was found to still be very strong with no obvious signs of imminent failure.
