Monitoring of Overhead Polymer Core Composite Conductors Under Excessive Mechanical Loads Using Fiber Bragg Grating Sensors

A Dissertation

Doctor of Philosophy

November 2021

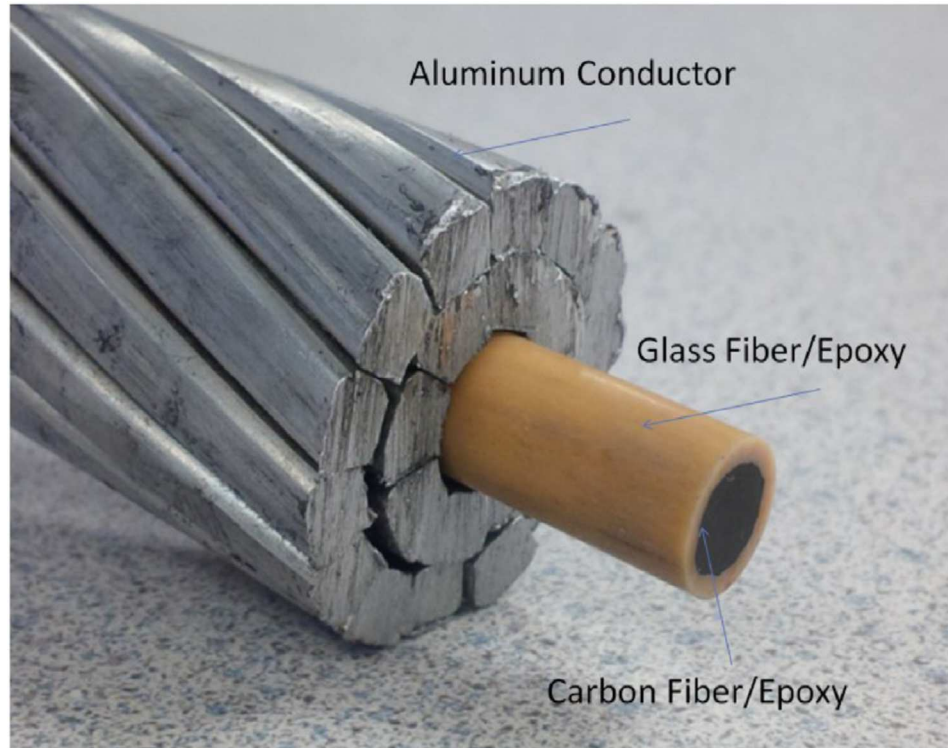
Figure 1-4: Components of ACCC® conductor [10].

ACCC® , shown in Figure 1-4, is manufactured by CTC Global and has a hybrid Polymer Matrix Composite (PMC) core consisting of high strength carbon fibers with a high temperature epoxy resin surrounded by a galvanic corrosion barrier of ECR-glass fibers with the same resin [8]. The conducting strands consist of 1350-O aluminum with a trapezoidal cross-section. The Drake size ACCC® core addressed in this document consists of a nominal diameter of 6.74 mm of unidirectional Carbon Fiber/Epoxy surrounded by an additional layer of unidirectional ECR-Glass/Epoxy to achieve an overall outer diameter of 9.53 mm. This composite core has a rated tensile strength of 2158 MPa with typical installation loads up to 22.2 kN and service loads of 40 kN [9].

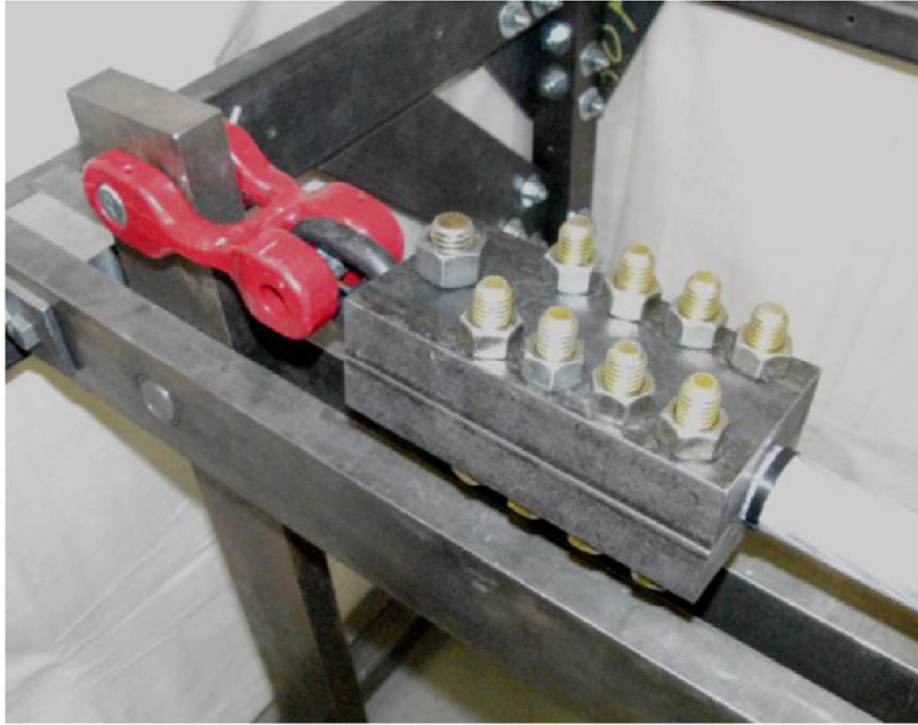
Figure 2-2: Conductor clamp and cable tensioning.

Mechanical AP Dynamometer were used to increase, hold, and measure the tension on the input side of the tensioning lever arms. The measured input tension was then multiplied by the mechanical advantage to calculate the sample tension. Once the desired tension was reached, the dynamometer and chain-hoist were replaced by a turnbuckle-tensioning device to fix the displacement of lever input arms. The calibration of the tensioning method was verified with strain gauges.

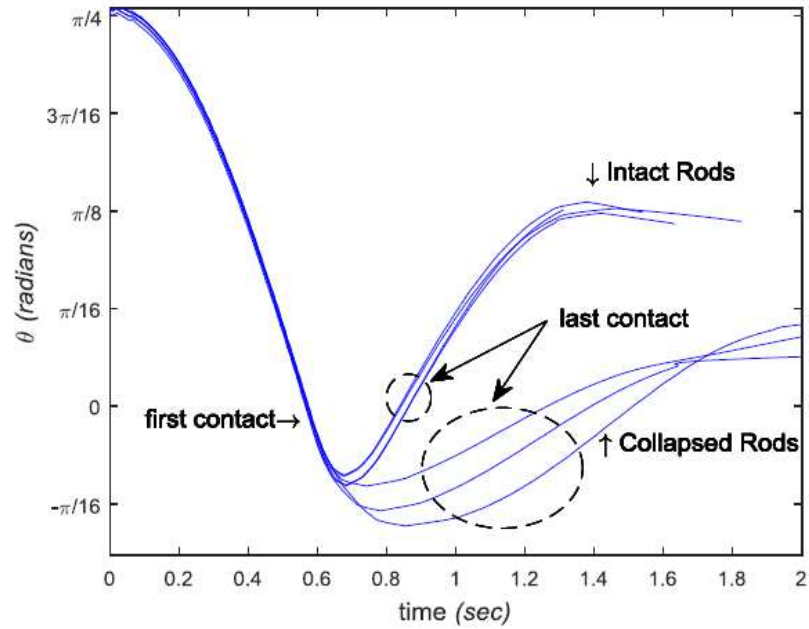
Figure 2-8: Angular positions in 3-point free ends impact experiments resulting in three collapsed core rods and four intact core rods.

The results of both the intact and collapsed rods of Figure 2-8 suggest that the given boundary and loading conditions used in the impact testing determine the transition point of failure. Catastrophic failures of the rods are most likely caused by excessive bending and the kinking type of failure of the carbon fibers on the compressive side of the rod. As mentioned before, this type of catastrophic failure of the ACCC® rods has been previously observed under static conditions by Burks et al in Refs [17] and [18]. When the compressive strength of the carbon fiber composite was not exceeded, the rods did not collapse and the conductors recovered after impact.

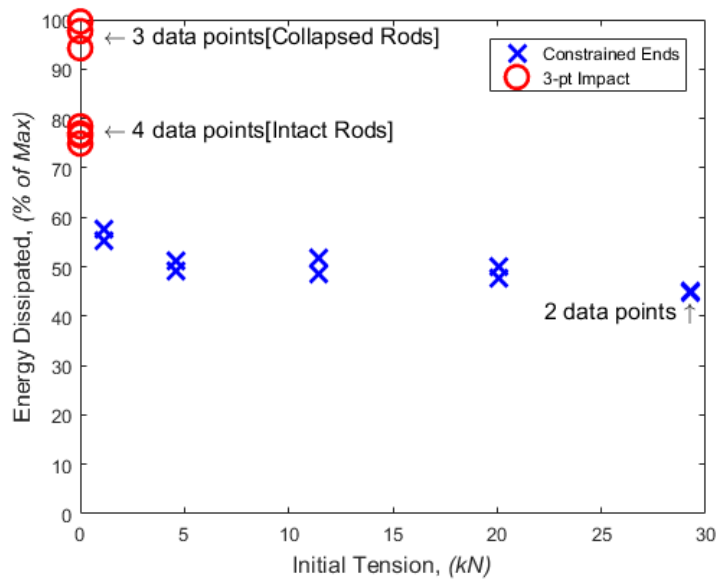
Figure 2-11: Percentage of energy dissipated after impact.

In Figure 2-11 the dissipated energy for each test is plotted as a percentage of the initial kinetic energy in the pendulum with respect to the initial axial tension from all tests. The resulting permanent curvature of the 3-point impact and tensioned conductor samples after removal of conductor clamps is shown in Figure 2-12, with the 3-point impact specimens on the left and applied tension increasing from left to right. The results from each tension test indicate significant repeatability.

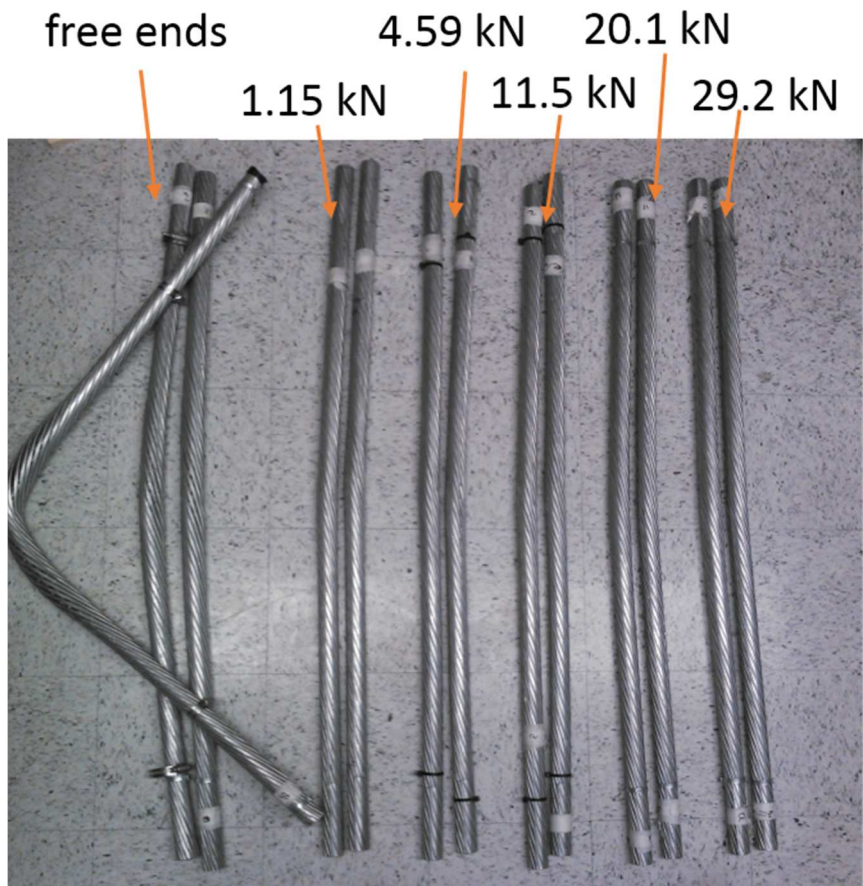
Figure 2-12: Resulting deformation of tested conductors.

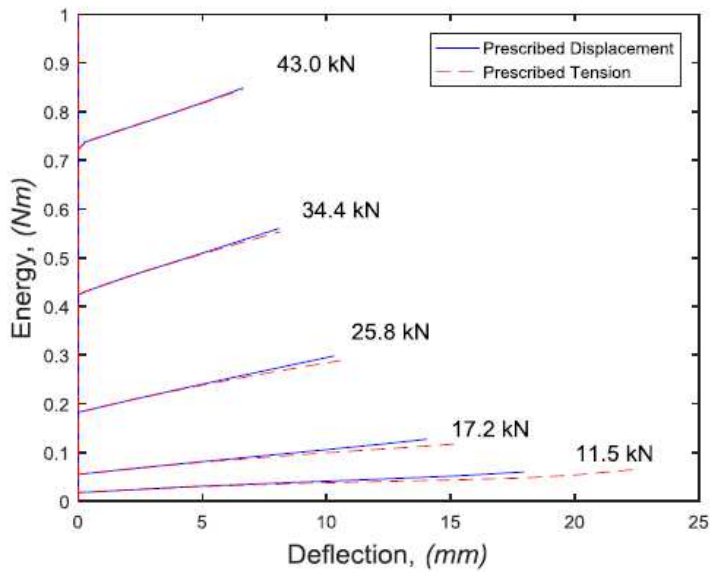
Figure 2-16: Total frictional dissipation energy under transverse loading of 1 kN; static model.

For the prescribed displacement and tension boundary conditions, the total recoverable strain energy, plastic dissipation energy, and frictional dissipation energy from the static model are plotted in Figure 2-14, Figure 2-15, and Figure 2-16, respectively. As the transverse load is applied, the energies increase with deflection until the maximum is attained. For each quantity only small differences in energies are observed between the two boundary conditions. Prescribed tension provides more overall deflection while prescribed displacements result in greater energy values for a given initial axial load. Additionally, as the ratio of transverse load to initial tension decreases, the shift in energies and deflections between the two boundary conditions becomes negligible, suggesting that under relatively large axial to transverse load ratios, either boundary condition can be used to model the conductor response in service. In addition, the relative magnitudes of both the plastic and frictional dissipation energies are significantly smaller than the recoverable (or elastic) energy associated with static loading of the simplistic model considered in this study.

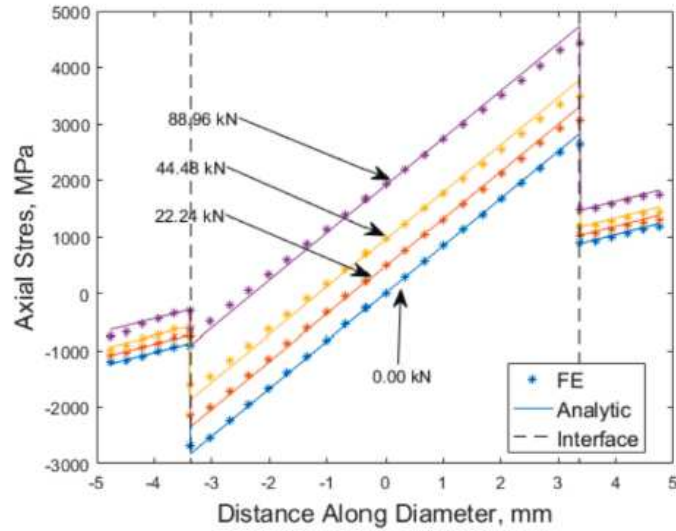
Figure 3-4: σ_{11} along diameter of rod for curvature $1/R = 2.62 \text{ m}^{-1}$ and four different axial loads (indicated by arrows).

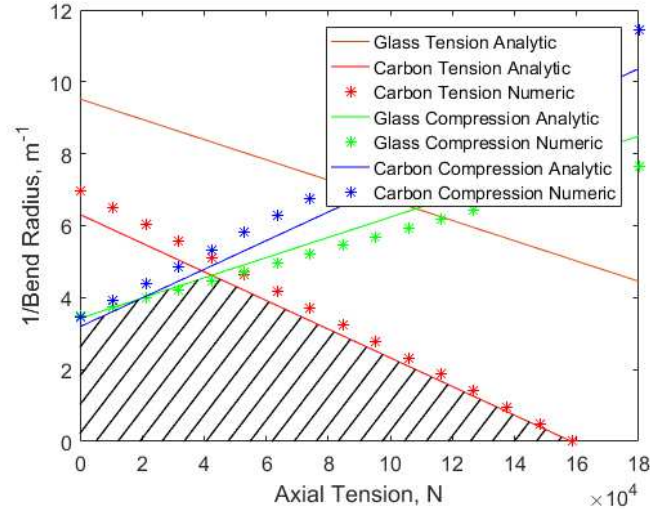
Figure 3-5: Predicted failure as a function of combined bending and tension. Hatch marks indicate safe region.

from four-point bending experiments, bending diameter, $D = 627$ mm compared to $D = 560$ mm (error of 12%).

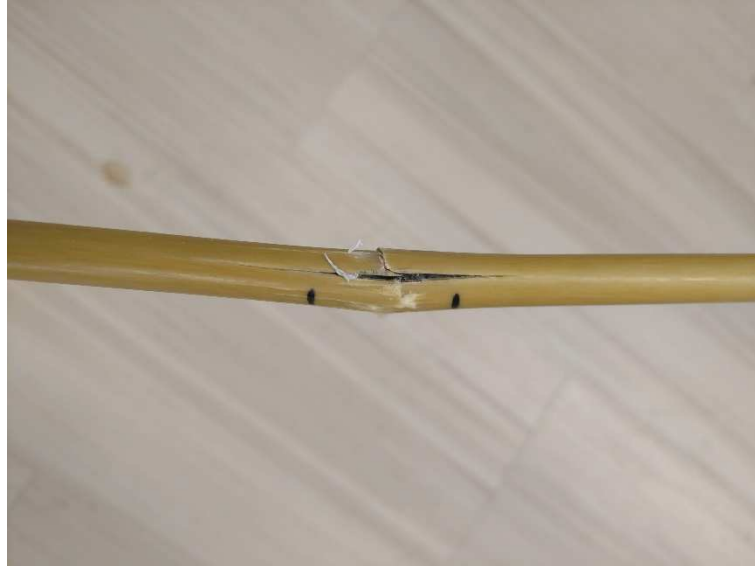
Figure 3-7: Typical example of experimental failure proximal to loading pin in three-point and four-point bend experiments.

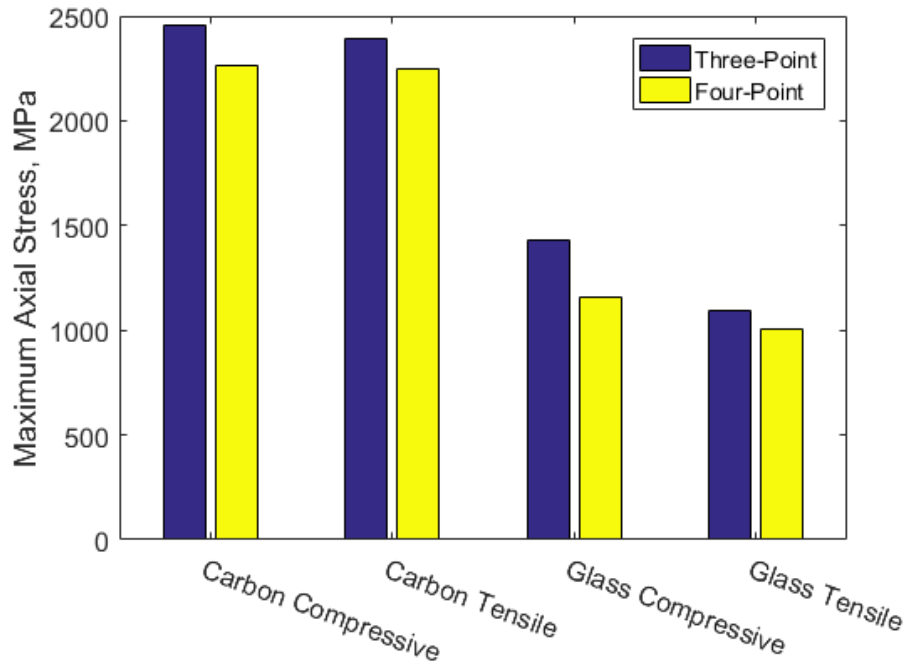
Figure 3-8: Numerically determined maximum axial stresses at experimental failure extension.

The elastic model closely represents the experimental three- and four-point bending results in Figure 3-6a and b, respectively. Specimens with compressive fracture initiation apparent, as in Figure 3-7, were observed to fail in proximity to the loading pins. The applied bending loads are summarized in Table 3.4 with the maximum calculated stresses in the corresponding numerical analyses in Figure 3-8.

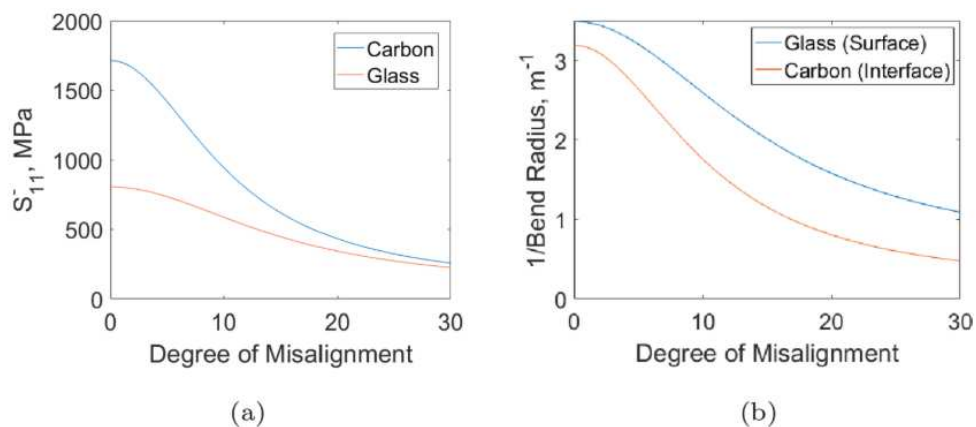
Figure 3-12: Influence of fiber misalignment on (a) composite axial compressive strengths, and (b) damage initiating bend curvature.

This simple case assumes the fibers are parallel and uniformly misaligned across the specimen. Wisnom showed that for variable misalignment over short distances, as found in the hybrid composite rod, the maximum compressive stress to cause micro-buckling is influenced by the average more than the maximum angle of misalignment [33]. Using the compliance transformation relationships to determine the off-axis composite elastic components (ie., an average fiber misalignment), the compressive strengths can be predicted for the misaligned composites by the modified Lo & Chim model [52], [53] in Figure 3-12a. Fiber misalignment has a more profound effect on the compressive strength of the carbon composite as opposed to glass. For example, a 6° misalignment results in a 23% reduction in the theoretical compressive strength of the carbon composite while only a 12% reduction in the glass composite.

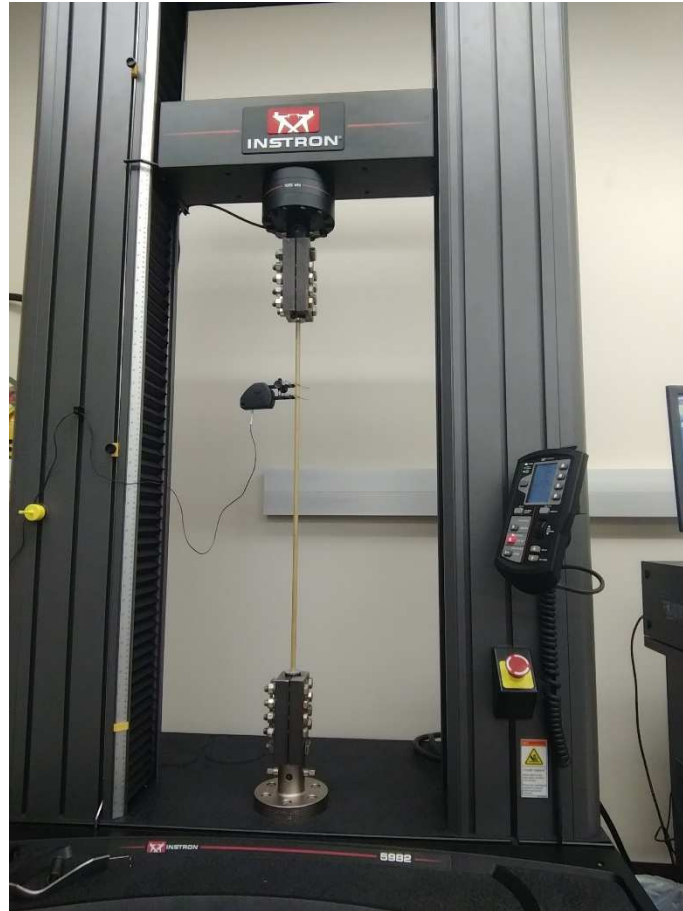
Figure 4-3: Tensile testing of ACCC® rod with FBG array mounted to surface.

Mechanical tests were conducted to evaluate the effect of various simple and multiaxial loads on the response of the FBG sensors. To verify the response of the FBGs to axial loading, the composite rod from the ACCC® conductor with attached sensors and no aluminum strands was tensioned from 0.00 kN to 35.5 kN in the Instron test frame shown in Figure 4-3. Surface strains were recorded independently from the five FBG sensors epoxied to the surface and from an Instron 2630 static clip-on extensometer. Additional axial testing was performed with the sensor mounted rod reinserted into the aluminum stranding to determine the effect of the Al strands on the strain measurements.

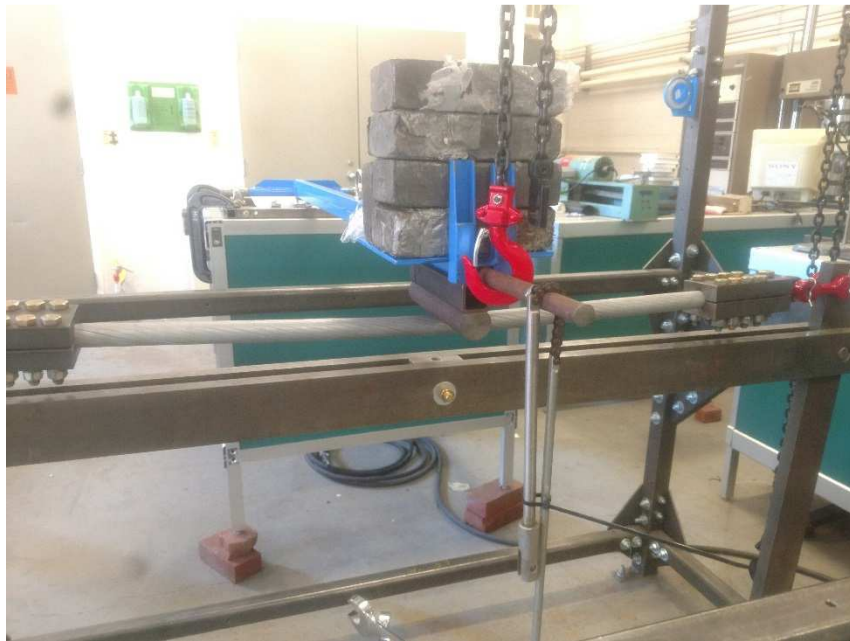
Figure 4-4: Tensioned three point bend setup for ACCC® rod and conductor.

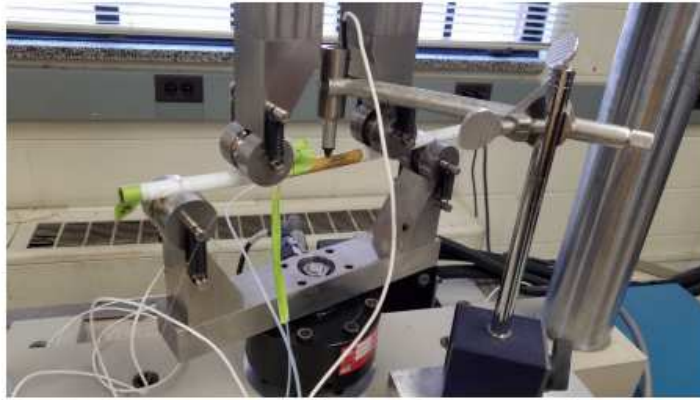
Figure 4-11: Experimental and numerical four-point loading of bare rod.

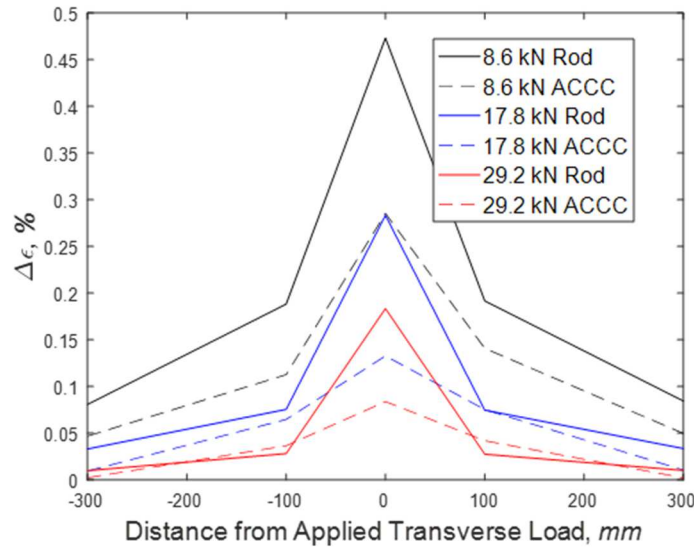
Figure 4-15: FBG strains of composite rod subjected to three-point bending, with and without aluminum stranding.

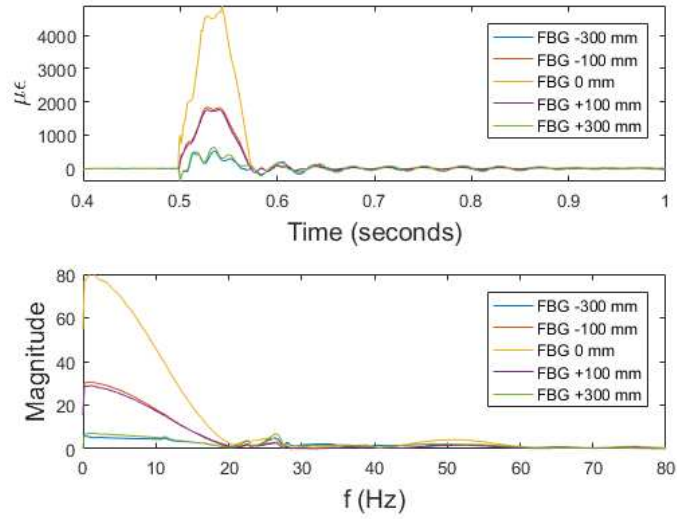
Figure 4-22: Strain response and frequency content for 33.1 J impact.
