Preliminary Report on the 2015 Field Season of the American Excavations at Morgantina: Contrada Agnese Project (CAP)

In its third season, the Contrada Agnese Project (CAP) continued archaeological investigations in the remains of a building, located near the western margins of the ancient urban center of Morgantina. In 2015, excavations opened a larger portion of the so-called Southeast Building, extending from the trenches opened during the 2014 season. These investigations yielded evidence from construction trenches and sub-floor fills that now allow a preliminary dating of the building's phases. The building appears to have had a short life, having been built and abandoned within fewer than 75 years, beginning around the middle of the third century BCE. New architectural features were revealed by the 2015 excavations, including columns composed of terracotta drums and a small oven set in the corner of a central room, indications of monumental decoration and food production, respectively. This combination of monumentality and small-scale production leads excavators to identify the building as a modest house, but further excavations will be needed to fully characterize its form a

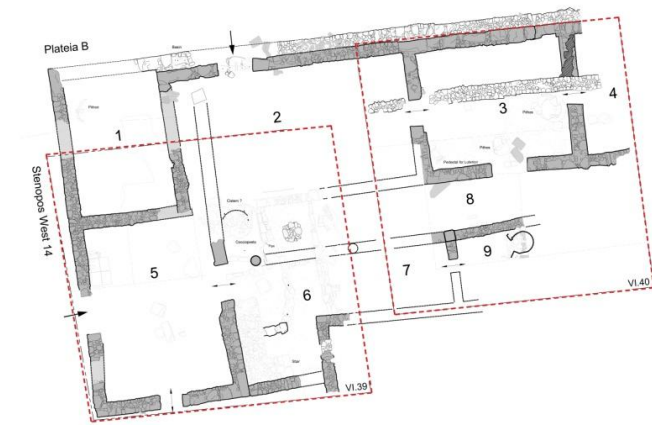
Fig. 1. 2015 State plan of the Southeast Building. Drawing by Giancarlo Filantropi and James Huemoeller.

The 2015 excavations focused largely on the northern rooms of the Southeast Building, expanding the 2014 trenches with the goal of broadening our understanding of the building's function and occupation history. Three trenches were opened in 2015: Trench 39 along the west side of the structure, Trench 40 at the northeast corner, and Trench 41 in the south to locate the boundary of the lot (figs. 1-2). In what follows, we offer a

Trench 40 had three main goals. First, the trench was planned in order to explore further areas originally opened in 2014, but which remained unexcavated. Second, Trench 40 was placed farther to the east than previous CAP trenches, in an attempt to locate the eastern extent of Lot 1 on insula W13/14S. Third, Trench 40 was sited in such a fashion as to help bridge the stratigraphy between that in Room 3, partially excavated in 2014, and that of other rooms in the same building (figs. 1-2).

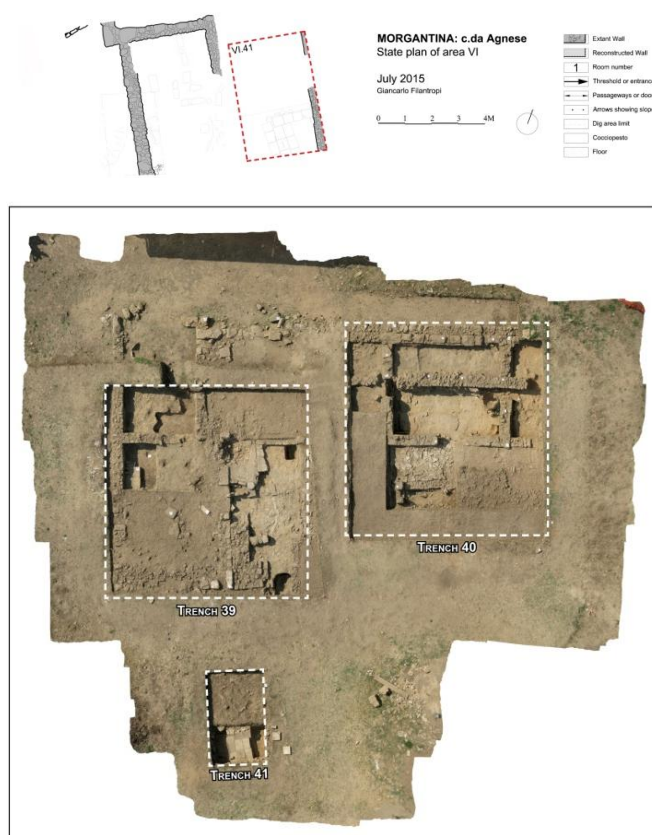
Fig. 2. Aerial orthophoto of 2015 CAP trenches taken on the final day of excavation.

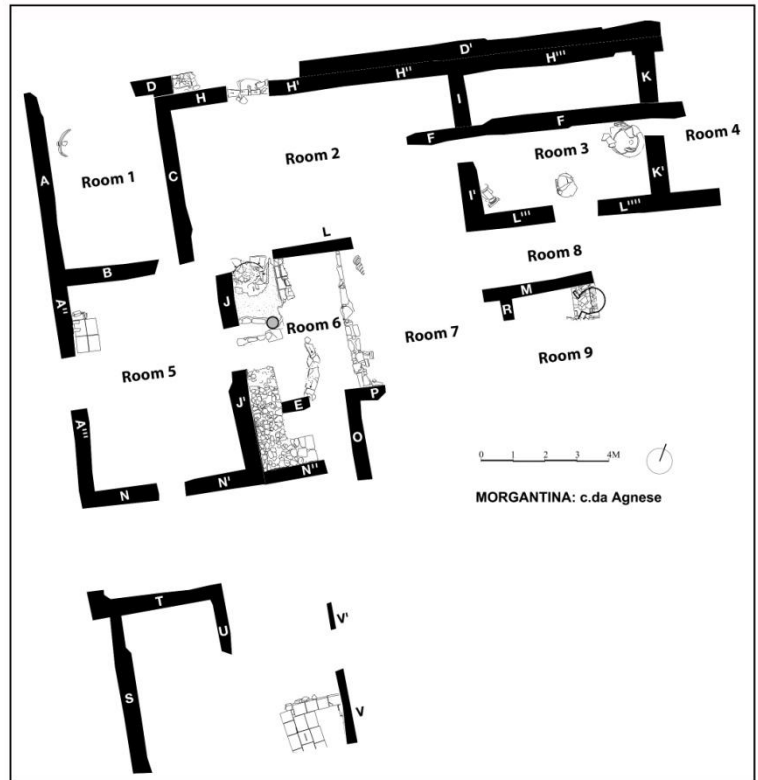
Fig. 3. Plan of Southeast Building with wall labels. Drawing by Giancarlo Filantropi and James Huemoeller.

In the southern part of Room 6, a new wall (Wall E) was laid running East from the L-shaped feature (fig. 3). Wall E was composed of medium-sized blocks infilled with smaller stones, and was preserved only in one course that ran ca. 0.90m east in the direction of Wall O, at the point where Wall O formed a corner with Wall P. Its narrow width, its dry-laid construction technique, and the lack of plaster all suggest that the remains we discovered may not have supported a full-height wall, but perhaps served another, still unknown, purpose.

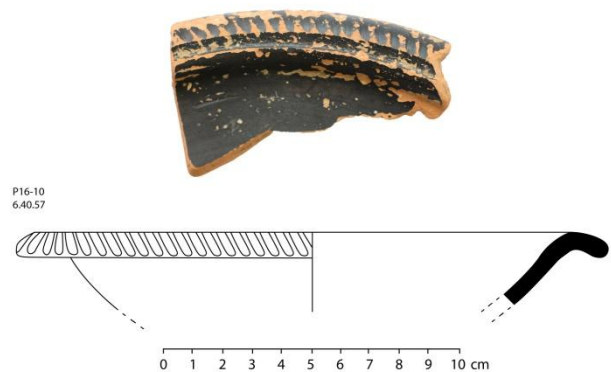
Fig. 4. Rim fragment of a black-gloss, outturned-rim plate or saucer (P16-10) from fill of construction trench for wall K' in Trench 40. Drawing by Mali Skotheim.

⁴ For black-gloss outturned-rim plates or saucers at Morgantina, see *MS VI*: 85-87, nos. 9-10, where Shelly Stone considers production of the shape to fall at the end of the fourth century or in the first half of the third century BCE, based on their presence in fills belonging to the second quarter of the third century.

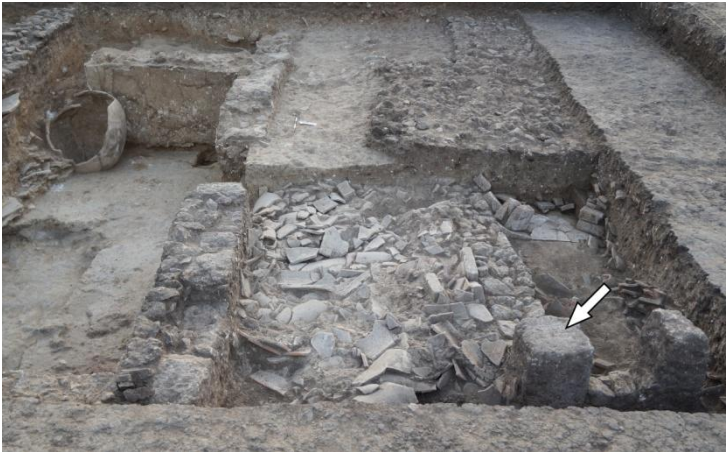
Fig. 5. Stone pier in Trench 40, looking east.

Construction technique cannot in itself provide a precise chronology for wall construction, but it is worth noting that this double-faced technique, using large blocks or dressed stone on an exterior face and rubble on an inner face, was regularly employed in both private and public architecture at Morgantina⁷. A large stone pier, located in Room 8 at the intersection of walls M and R, has been tentatively dated to this phase (fig. 5). It is well-dressed, with four flat vertical faces, one of which preserves a small carved depression of unknown purpose. The corners of the pier are beveled in a similar fashion to the square bricks found throughout the Southeast Building (fig. 6). We suggest that the pier here originally consisted of the large stone as the lowest part, and a superstructure of beveled bricks in the upper part. While we otherwise possess little evidence for the nature of the building during Phase One or for the primary function(s) of its spaces, the presence of the pier suggests that we may have an interior portico of a peristyle or a *pastas* house⁸. The discovery of further piers or column bases is required to confirm this hypothesis.

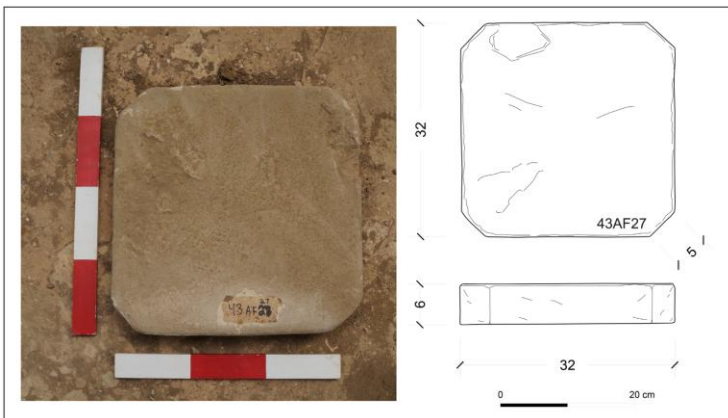
Fig. 6. Terracotta brick with beveled corners from Southeast Building (43AF27). One of many found within the building. Drawing by Giancarlo Filantropi.

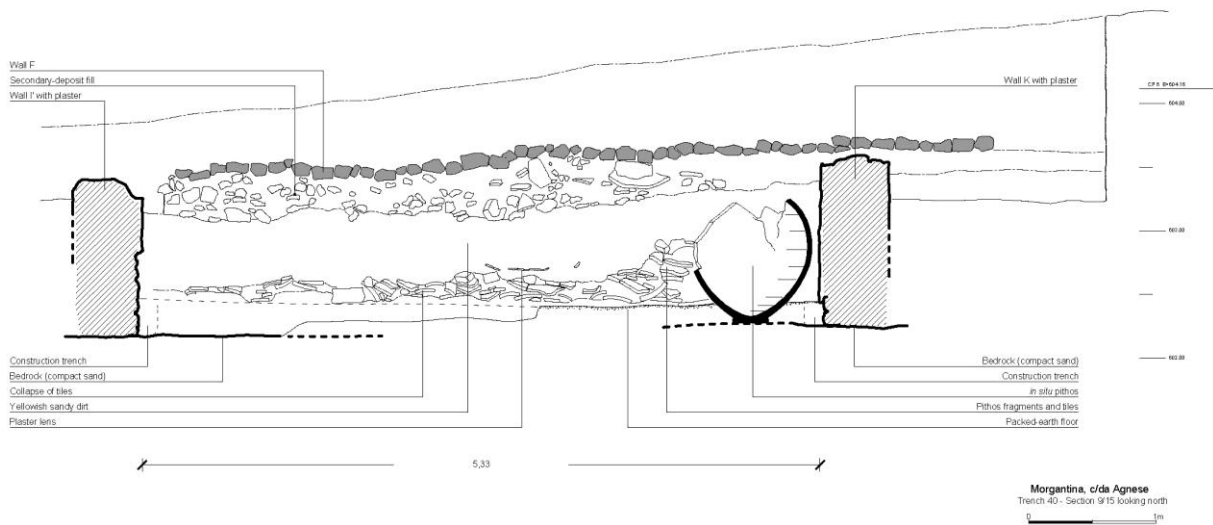
Fig. 9. Section through Trench 40 (Room 3), looking north. Drawing by Giancarlo Filantropi.

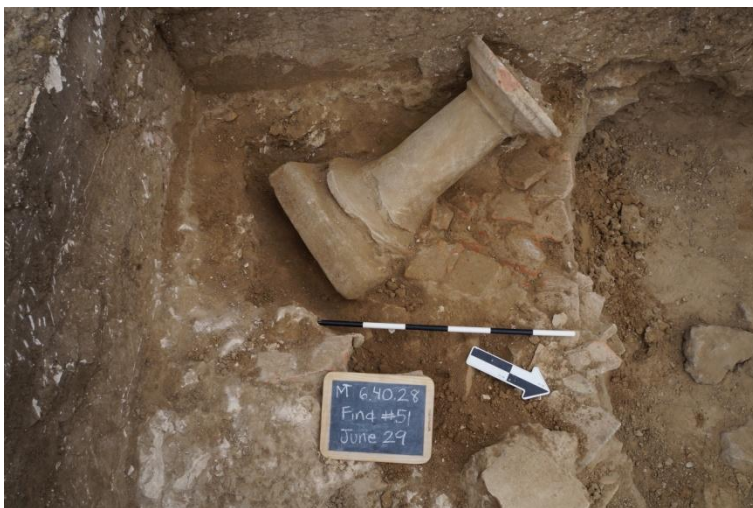
Fig. 10. Louterion base from Trench 40 (Room 3).

Phase Three represents the final period of activity in the building before its abandonment. It is distinguished by the artifacts and the occupation layer which accumulated immediately over the last floor surface of the room. Phase Three ended with the collapse of the roof (Phase Four, below). The objects from this final phase of occupation give some indication as to the nature of activity taking place within the room in the period leading up to its abandonment. The terracotta base of a *louterion* (or *perirrhantion*), was found on the floor in the SW corner leaning against Wall I' (fig. 10). No trace of the dish that once sat on

top of the base was found, leaving it uncertain as to whether the *louterion* was originally a fixture or was placed there later as part of the later, post-abandonment clearing operations that seem to have taken place within the Southeast Building (Phase Five: see below). Perhaps more compelling evidence for the use of Room 3 is the concentration of storage vessels within it, represented not only by the two largely complete vessels, but also by fragments of several more, scattered throughout and mixed in with the layer of roof tile collapse¹¹. Despite this apparent abundance of storage vessels, neither the arrangement of doorways in Room 3 nor the current location of the standing pithos (partially blocking the doorway leading to the east) suggests the space was originally intended for long-term storage. One possible explanation for the present situation is that Room 3 was

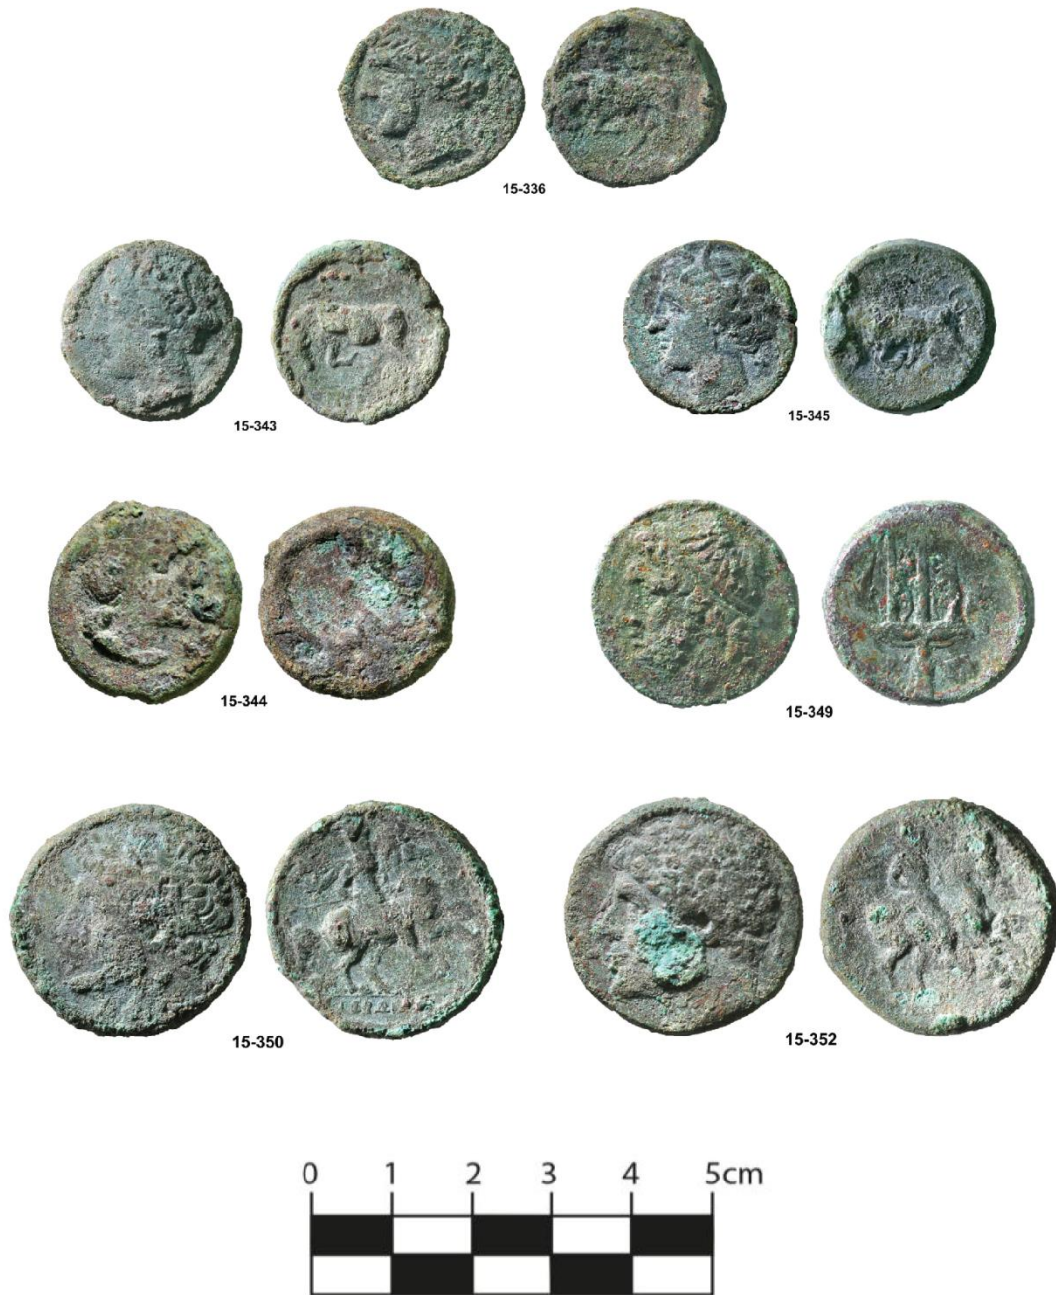
Fig. 11. Coin hoard from Trench 40 (Room 3).

Twenty-one bronze coins were recovered in 2015 from occupation contexts in Room 3¹³. Included in this number are those belonging to a small hoard, containing seven Syracusan coins, that was found buried against the west face of Wall K' (fig. 11). Since they were found adjacent to the wall and not underneath it, they were likely deposited after the the wall was already standing, during a period when the room was in use. The

latest coins in the hoard are part of the prolific bronze issues struck at Syracuse during the first three decades of Hieron II's reign (ca. 269–241 BCE). The hoard's composition, in which coin types from the later decades of Hieron's reign (ca. 240–215 BCE) are notably absent, points to a date of deposition in the second or third quarter of the third century, decades before the abandonment of the building¹⁴. Two Roman coins (fig. 12) found in the soil layer overlying the floor surface are the latest datable objects from below the tile fall. As such, they help to establish a *terminus post quem* for the collapse of the roof at 211 BCE¹⁵. The absence of ceramic and numismatic materials datable to the second century BCE from the contexts that comprise Phase Three leads us to suggest tentatively that occupation in Room 3 took ended before the final decade of the third century.

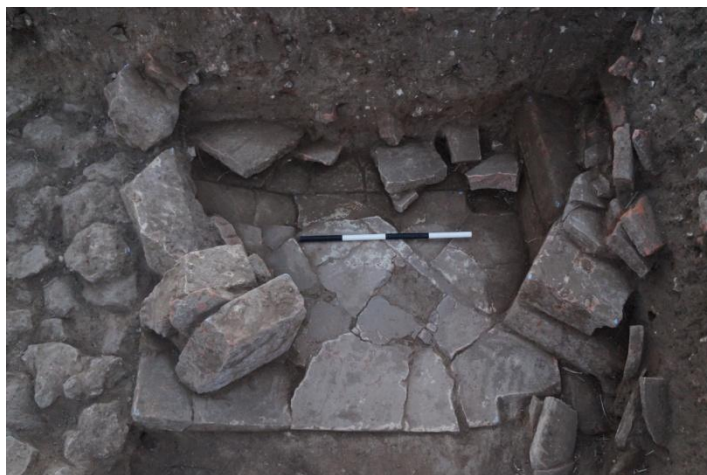
Fig. 13. Remains of an oven in Trench 40 (Room 9), looking east.

Finally, we also provisionally assign a small oven, built in Room 9 against the south face of Wall M, to Phase Three (fig. 13). The oven consists of at least one large flat pantile set on soil, with a dome built of brick and tile fragments. It was only partially exposed in 2015 due to concerns for its preservation. The fact that the pantile rests on soil and cannot yet be associated with a defined floor level makes us hesitant to place the oven's installation in the early construction phases of the building. At present, we are considering this an intervention made late in the occupation of the building, but prior to the collapse of the tile roof, which appears to have fallen on top of the oven. However, we note that the tile collapse of Phase Four (below) did not cover the oven as

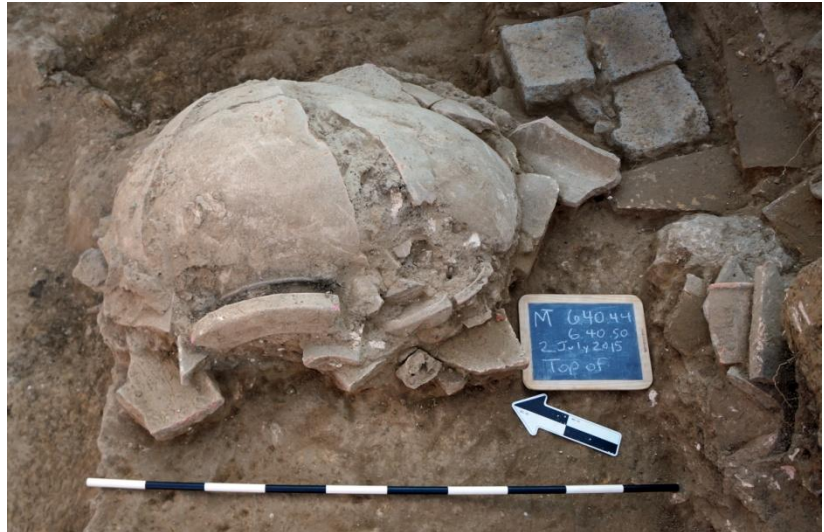
Fig. 14. Smashed pithos in Trench 40 (Room 3), looking east.

Phase Four represents the abandonment and destruction of the rooms within Trench 40. The tiled roof collapsed after 211 BCE, as the coin finds from Room 3 indicate. According to our present interpretation, this terminal collapse of the roof tiles does not appear to have been connected with the violence that characterized the Roman siege of 211 BCE, as no evidence for destruction by fire or burning has so far been found within the building. Rather, the collapse of the roof may have been the end result of a longer process of deterioration. The soil among the tiles contained ample traces of wall plaster and dozens of iron nails, surely elements of the room's timber superstructure. A flattened and broken - but remarkably complete - second pithos was discovered surrounded by tiles Room 3. Next to this pithos lay a circular pithos lid and the upper element of a "hopper-rubber" type millstone, both of which rested directly on the beaten-earth floor surface (fig. 14). Although the deposition of the pithos was consistent with the other debris of Phase Four, the vessel's complete preservation suggests to us that it was present in the room during Phase Three, and thus may have served a function similar to that of the intact pithos, discussed above.

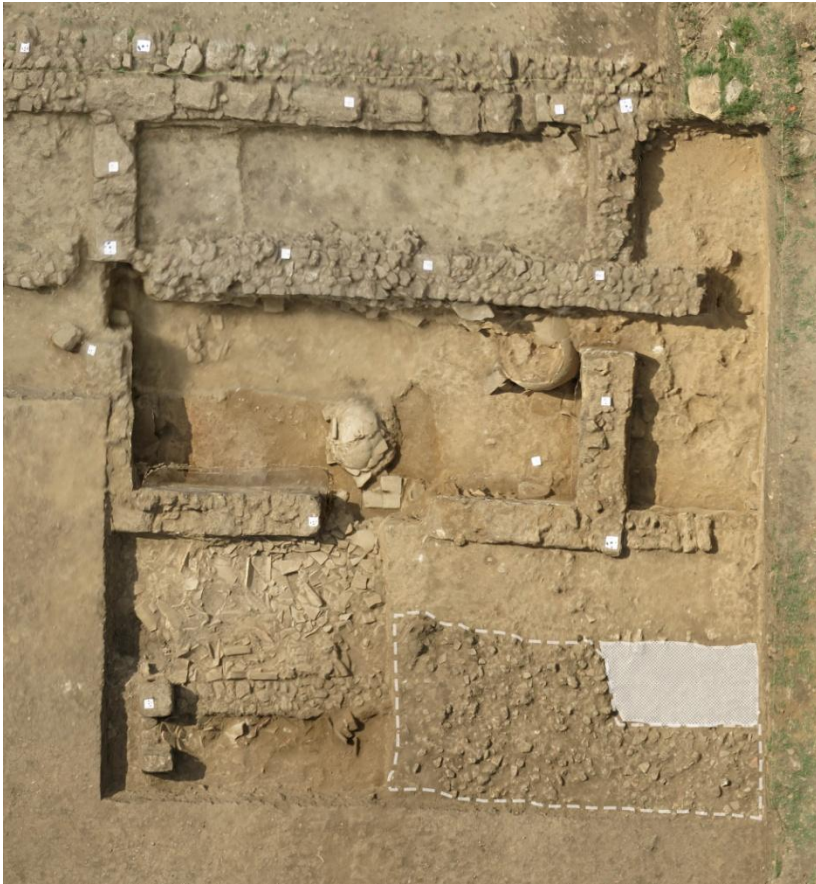
Fig. 15. Aerial orthophoto of Trench 40. Dashed line indicates extent of rubble surface belonging to Phase Six. The white shaded area indicates where a portion of the rubble was removed by excavators.

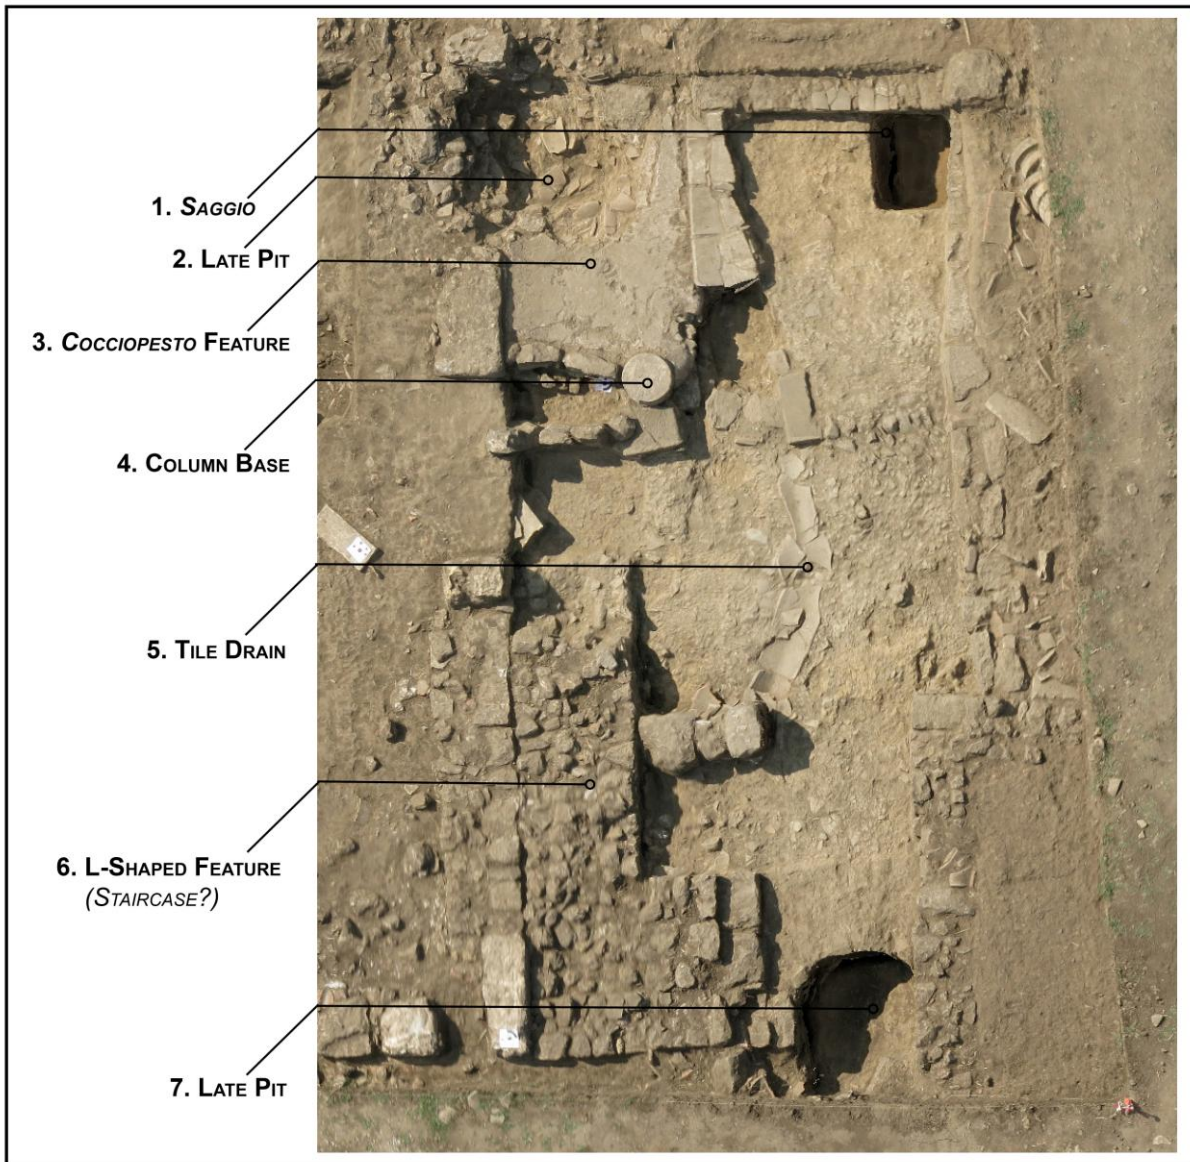
Fig. 16. Aerial orthophoto of the eastern half of Trench 39 (Room 6), indicating the location of key features discussed in text.

At the southwest corner of Room 6 (formed by walls J and N''), an L-shaped stone feature was set with its long axis running North-South along Wall J (fig. 16, no.6; fig. 17). This feature does not bond with either wall

In the northwest corner of Room 6, a *cocciopesto* surface was installed in a roughly rectangular area bounded by Walls J, L, and to the south by a line of stone terminating in the column base (fig. 16, no. 3). The eastern edge of the surface was defined by a line of terracotta brick fragments set along the edge of the *cocciopesto* to create a straight line. While the selection and placement of fragments produced an impression of whole bricks broken in place, amphora and tile fragments set vertically in the spaces between them demonstrates that the broken pieces were intentionally set together. The *cocciopesto* surface was damaged in the northwest corner by a large pit, dug at some later time (Phase Seven: fig. 16, no. 2), which also seems to have destroyed a portion of walls J and L. Another smaller pit (also Phase Seven) had been dug against the column base at the southeast corner of the *cocciopesto* surface. Removal of the soil filling this second pit revealed the end of a terracotta water pipe, which ran under the *cocciopesto* pavement. This pipe was oriented in the direction of a shallow drain formed by a line of upturned roof tiles laid end-to-end (fig. 22). The curving line of tiles ran southeast from the *cocciopesto* feature into the southern half of Room 6 (fig. 16, no. 5). Although the small pit near the column base has destroyed any direct connection between the water pipe and the line of upturned tiles, it is not unreasonable to suppose that the two features were originally linked and served to channel water to the south and out of the room. The use of waterproof building material (*cocciopesto*)

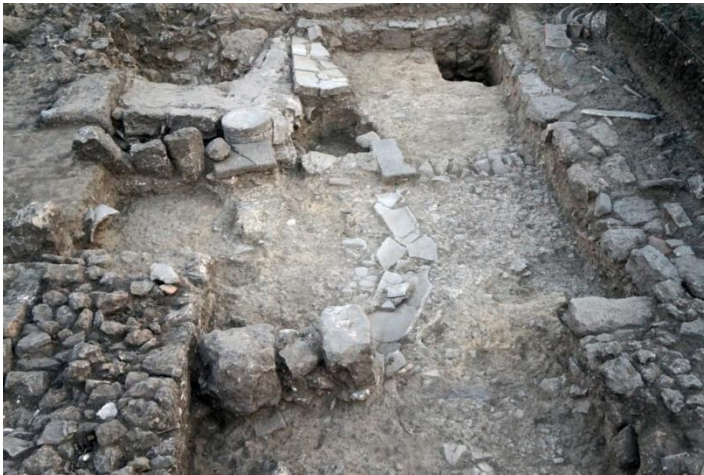
Fig. 17. Aerial orthophoto of the possible foundations for a staircase in Trench 39 (Room 6).

and so should postdate their construction, although perhaps by only a short period of time. Most of the body of the feature was constructed with small stones set in mud mortar, but the eastern end of the short axis preserved larger blocks that formed two stepped courses. The feature may therefore have been the stone foundations of a staircase, added to give access to the roof or an upper story (likely constructed in perishable materials; see below for further discussion). Staircases in ancient Greek houses were often located in the courtyard.

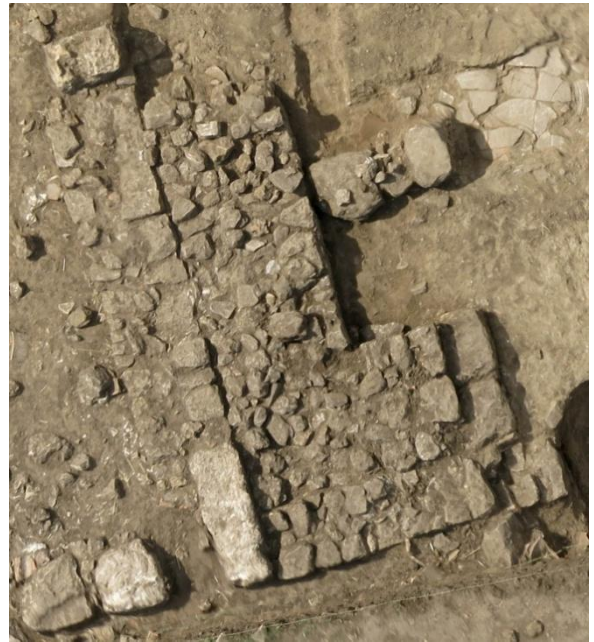
Fig. 18. View of Room 6, looking north.

A floor surface consisting of finely crushed, yellowish stone (identifiable as the local sandstone bedrock) belonging to this construction phase was identified and partially excavated. This surface of redeposited bedrock (fig. 18) extended throughout the open area of Room 6, ran up to the walls that defined the room in all directions, but not over top of the L-shaped feature. A small *saggio* (ca. 30cm x 60cm x 35cm) was dug through this surface in the northern part of the room against Wall L (fig. 16, no.6; fig. 19). This *saggio* produced little diagnostic material aside from some black-gloss sherds, which are only generally attributable to the 3rd century BCE (fig. 20). The comparative lack of inclusions in such a thick deposit (ca. 35cm in depth), as well as its position below a well-preserved floor surface, suggest that this fill was deliberately added to raise the ground level, possibly early in the occupational history of the Contrada Agnese. This was done, we believe, to create a floor surface in Room 6 at the same elevation as the floor in Room 5.

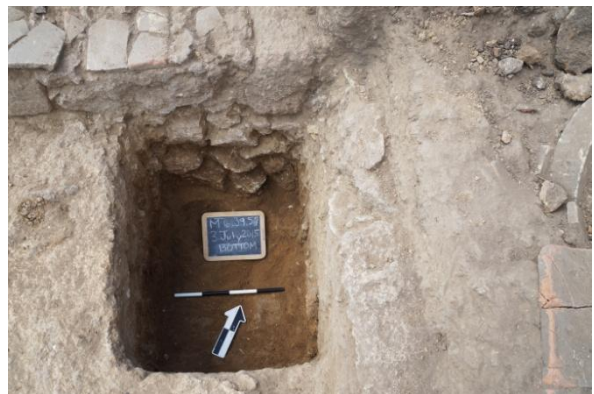
Fig. 19. *Saggio* dug through the late floor surface in Trench 39 (Room 6), looking north.

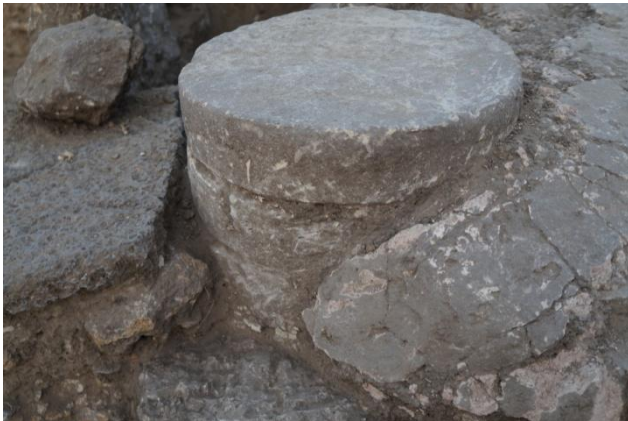
Fig. 21. *Cocciopesto* platform and stacked terracotta column drums (detail).

its immediate relationship with the features described above is as yet unresolved. The standing remains consisted of three stacked terracotta column drums (thickness ca. 8cm; diameter ca. 36cm) resting on what appeared to be a roughly-cut rectangular stone base. The stone base on which the terracotta column drums stand does not appear to have been finished, as there was no evidence for the application of a plaster coat or the refinement of the stone's visible faces. That the base itself rested on the yellow crushed bedrock surface (fig. 16, no. 4; fig. 21) would appear to indicate the column was a late addition to the space²¹. This is further suggested by the column's placement, close to the doorway that connected Rooms 5 and 6, which would have partially restricted one's line of sight (and possibly one's movement) between the two spaces. Future work may clarify the situation, but at present we tentatively place the column as a late modification in Phase Two.

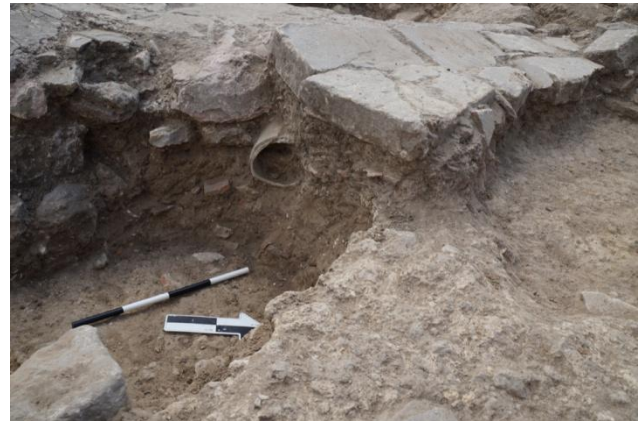
Fig. 22. Terracotta tube in section, running under the *cocciopesto* feature in Trench 39 (Room 6), looking west.

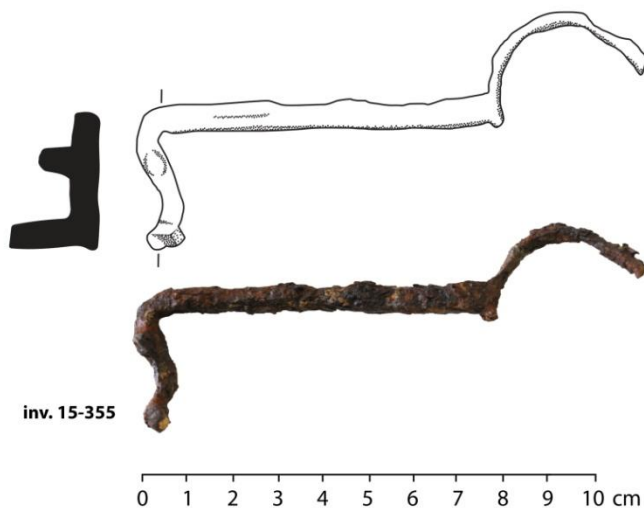
Fig. 23. Inv. 15-355. Iron key from Trench 39 (Room 6). Drawing by Mali Skotheim.

On top of the upturned roof tiles and throughout Room 6, a thin layer of brown silt was deposited, perhaps evidence that the room was occupied and used while the drain remained open. This soil contained a badly damaged iron key (fig. 23), along with some bronze and iron fragments and partially intact pottery, which may support the hypothesis that the silty soil accumulated while the space was in use. Over the brown silty soil, a surface composed of large ceramic fragments was laid down (fig. 24). Pithos body fragments and lids covered the drain and extended south into the rest of Room 6, although never reaching any of the walls. This layer, which we have interpreted as a partial pavement, may well have originally been placed directly on the upturned tiles that formed the drain, in which case, the silty soil that accumulated between the two could have simply filtered down through the interstices. It is also possible that the pithos fragments were laid over the drain after it had already been covered with silty soil; if water continued to drain along roughly the same path, the pithos fragments may have been put down to create a walking surface in otherwise muddy soil. Several of the pithos fragments, including both lids and body fragments, appear to have been broken in place, so that initially the surface may have been composed of fewer, larger fragments that the inhabitants of the space broke down by walking over them.

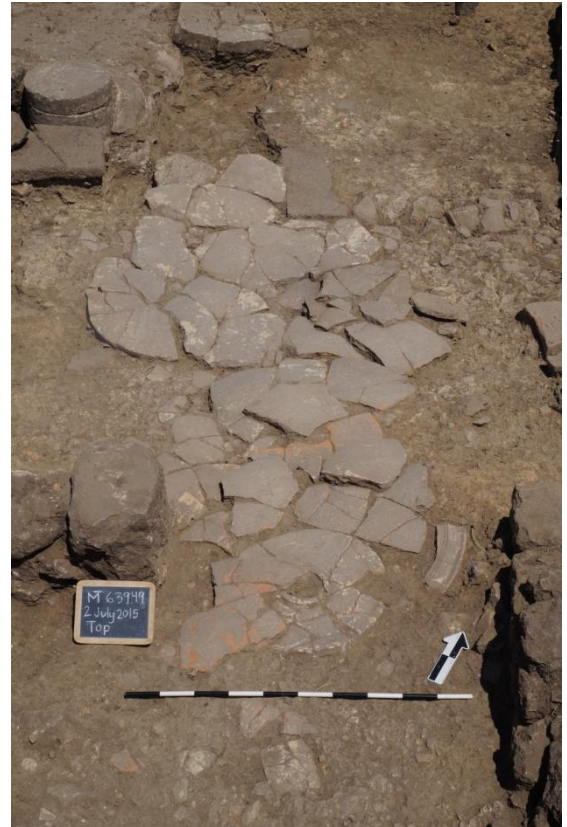
Fig. 24. Pithos fragments used as pavement in Trench 39 (Room 6), looking north.

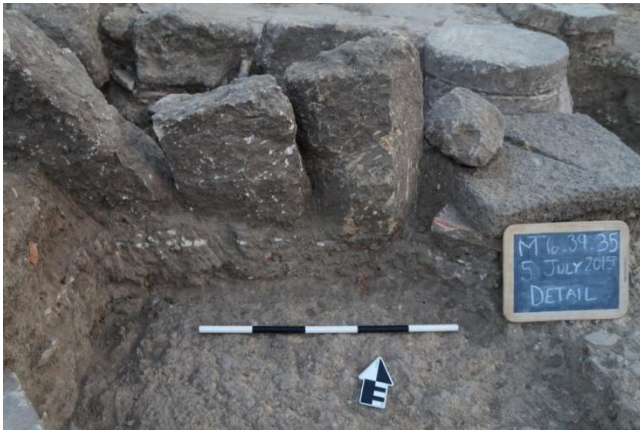
Fig. 27. Upright stone feature south of *cocciopesto* in Trench 39 (Room 6), looking north.

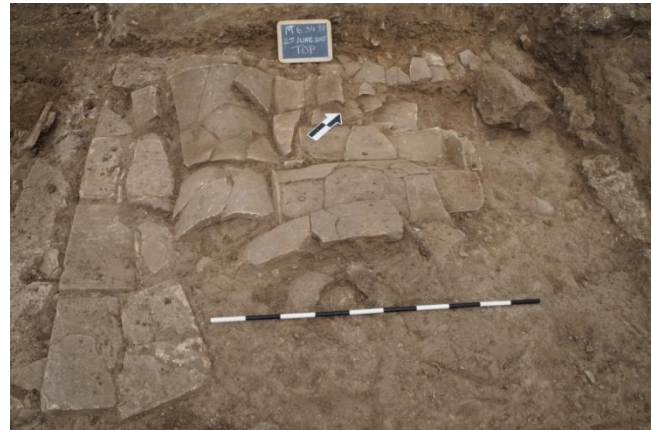
Fig. 28. Intentionally stacked roof tiles in Trench 39 (Room 6).

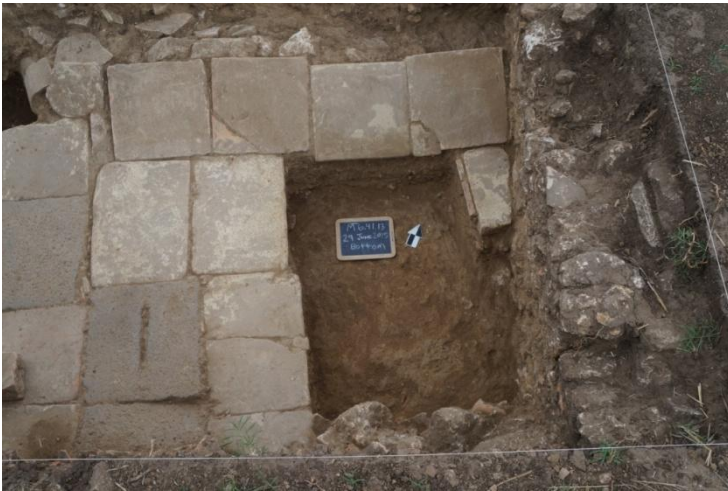
Fig. 29. Brick-and-millstone pavement in Trench 41, looking north.

Following the construction of Wall V, a pavement composed of terracotta bricks and volcanic millstones was installed (fig. 29)²⁵. The pavement appears to have been damaged or partially dismantled in antiquity. The exact function of this feature is not immediately evident, given its limited size (1.35m x 1.95m) and irregular shape. Pavements of terracotta bricks are found elsewhere at Morgantina in a variety of domestic, commercial, and industrial contexts²⁶. None of these pavements, to our knowledge, incorporate millstone fragments, which in this instance may have simply been inclusions of convenience.

The pavement abuts Wall V and is thus clearly of subsequent construction. Two bricks belonging to the pavement were lifted in order to recover datable material below. From the soil layers immediately underlying the bricks, excavators recovered several fragmentary black-gloss vessels of mid-third century date, including a nearly complete locally-produced cup in the style of an Attic Type A squat conical *skyphos* (fig. 30). These squat conical *skyphoi* are considered by Shelley Stone to be “characteristic of the second half of the [third] century”²⁷. This deposit also contained a worn bronze Siculo-Punic coin struck sometime between 310 and 280 BCE, further corroborating a mid-third century date for the laying of the pavement (fig. 31)²⁸. Because Wall V continued down well below the brick-and-millstone pavement, an earlier floor surface associated with the wall may lie at a lower level. Accordingly, we have currently assigned this higher pavement to Phase Three, perhaps to be associated with the renovations to the building documented in Trenches 39 and 40.

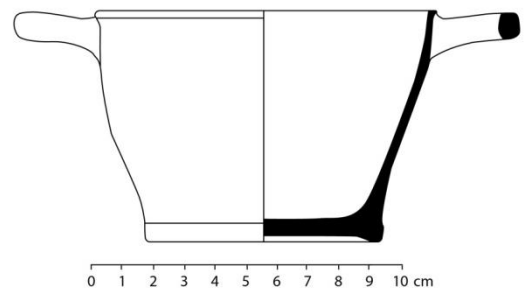
inv. 15-212

Fig. 30. Inv. 15-212. Squat conical skyphos from deposit below brick-and-millstone pavement in Trench 41. Drawing by Mali Skotheim.
