Preliminary Report on the 2016 Field Season of the American Excavations at Morgantina: Contrada Agnese Project (CAP)

In its fourth season, the American Excavations at Morgantina: Contrada Agnese Project (CAP) continued archaeological investigations inside a modest house of Hellenistic date located near the western edge of the ancient urban center at Morgantina. Previous CAP excavations, conducted between 2013 and 2015, had verified the presence of an adaptive urban grid in this portion of the ancient city and, moreover, revealed much of the northern part of the building that occupied Lot 1 of insula W13/14S. Following the 2015 excavations, we came to identify this building as a modestly-appointed house that had been occupied for roughly 50 to 75 years, beginning in the second quarter of the third century BCE. The 2016 CAP season represented a significant expansion of the excavation, as four large trenches were set across the entirety of the lot, with the twin goals of resolving stratigraphic questions that remained from previous seasons and exploring the lesser-known southern area of the building. In this report we describe newly excavated evidence for the construction and use of

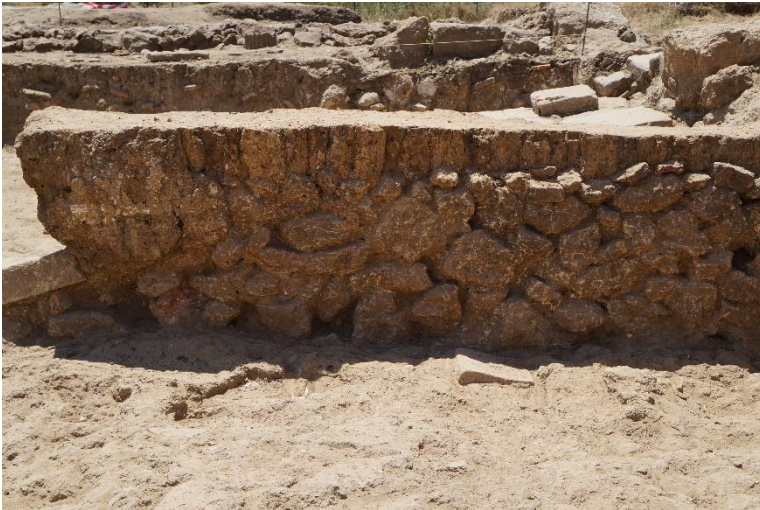
Fig. 4. East face of Wall QQ showing *pisé* and plaster (detail).

earthen wall itself was quite sandy, unusual in rammed-earth construction, but the preservation of the plaster facing and the contrast with the brown, silty soil surrounding the wall makes it abundantly clear that the upper elevation of the wall was executed in rammed earth¹¹.

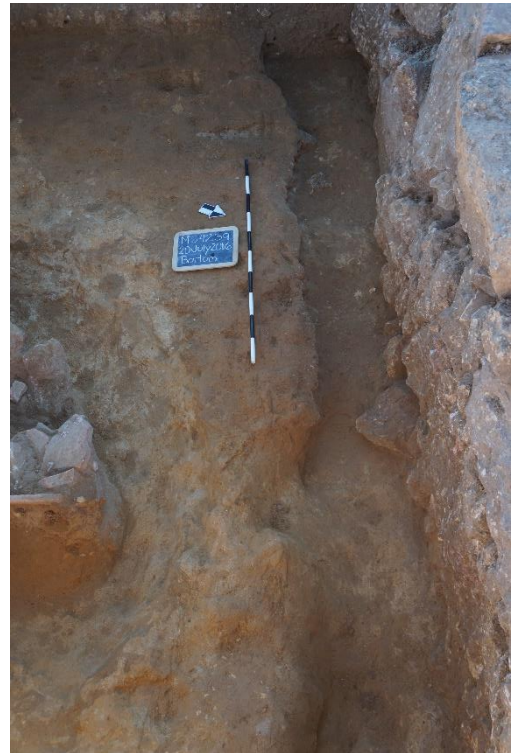
Fig. 5. Excavated construction trench of Wall H, looking west.

Also in Trench 42, we discovered a foundation trench for Wall H, cut into the unconsolidated bedrock of the Contrada Agnese, which presents as a highly compact, sandy yellow layer overlying solid sandstone below. The foundation trench ran the length of Walls H and H1 in Room 2a, and was filled by a soft, brown-yellow soil that had few inclusions. It did not contain datable material aside from a single fragment of black gloss ware, possibly a skyphos, which can be attributed broadly to the third century BCE (figs. 5-6). Despite the lack of diagnostic material recovered within the fill, we can confidently assign this foundation trench to Phase 1 since it was cut to accommodate the construction of Wall H, the northern lot wall of our building. Unfortunately, this discovery does not help us refine our chronology or phasing.

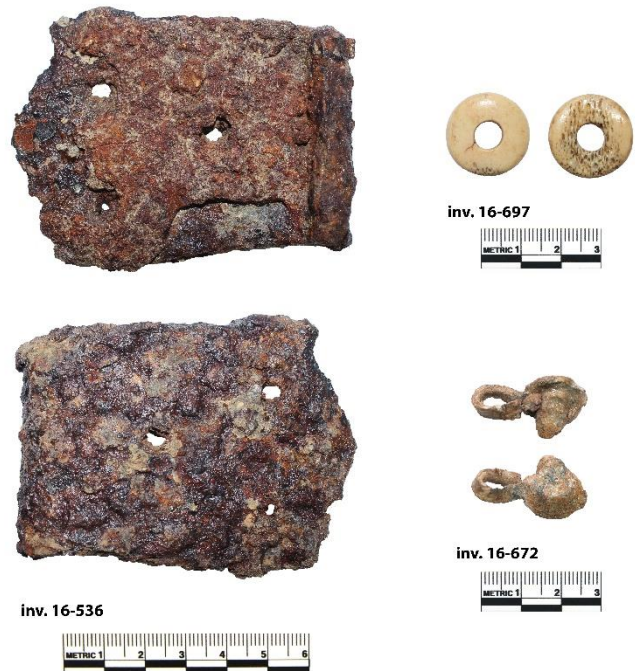
Fig. 7. Objects recovered from the Phase 1 floor in Room 2a.

A surface formed by an aggregate of yellow crushed bedrock (6042053 and 6042054) was the lowest and earliest floor in the area of Room 2a, and we place it in Phase 1 along with the construction of the walls that defined the room. After the walls were built, a sandy fill was deposited over the exposed bedrock surfaces on which Wall H and Wall QQ were laid, and then the floor surface itself accumulated through use. Embedded in the floor we found ceramic material consistent with the previously established third-century date for the building's earliest occupation: black gloss fineware from the middle of the third century BCE at the latest. This surface corresponds in both its construction technique and elevation to surfaces found to the south in Trench 43 (see below) as well as to the lowest surface in Room 3, discovered in 2015¹². Notable finds from the floor in Room 2a included an undecorated lead seal 16-672, a circular worked bone button 16-697, and an iron plate hinge likely for a door 16-536 (fig. 7).

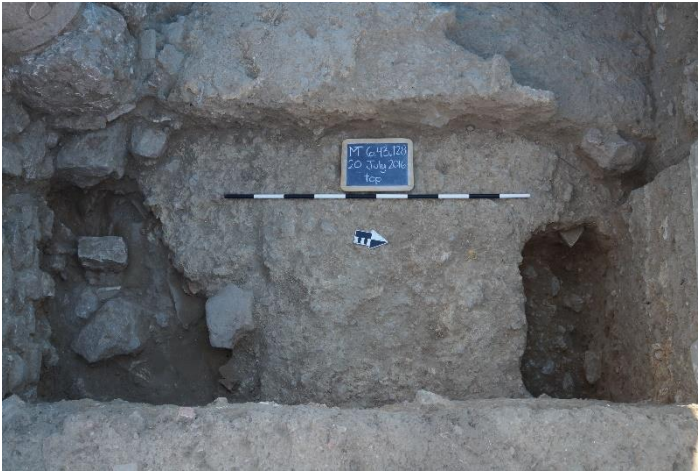
Fig. 8. Crushed bedrock surface in Trench 43 (Room 8), looking west.

In the transition area between Room 6c and Room 8, a small *saggio* revealed a poorly-preserved surface composed of the characteristic yellow, crushed bedrock aggregate (6043128) (fig. 8). The relationship of this surface to Wall L was difficult to interpret, in part because the surface was cut twice in antiquity. While both cuts did touch the southern face of Wall L, neither was regular enough to be considered a foundation trench, and in one area untouched by these cuts the crushed bedrock surface reached nearly to the edge of Wall L. Both cuts were filled while the surface was in use, although neither fill deposit produced any datable material beyond the presence of non-diagnostic black gloss sherds. As noted above, the elevation of this floor surface matches that of the earliest floor level found in Room 3 in 2015 (6040055). It is also only 20 cm below the Phase 1 floor surface in Room 2a (6042053 and 6042054), which would suggest that either the floor level of Room 2b matched that of Room 3, and the threshold between 2a and 2b mediated the change in elevation, or the floor level of Room 2b matched that of 2a, and the threshold between 2b and 6c/8 mediated the elevation change.

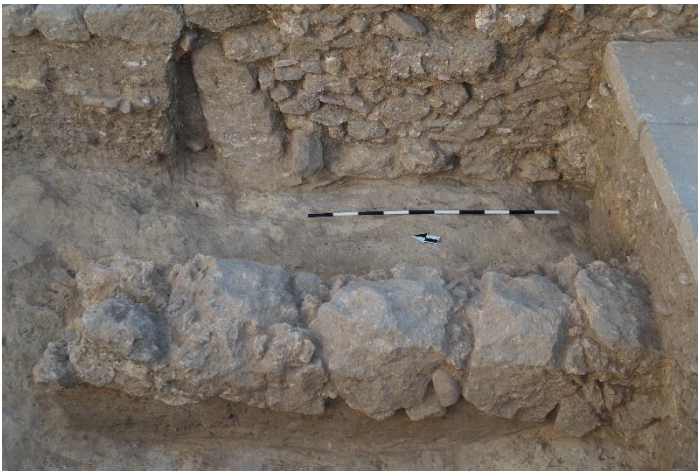
Fig. 9. Wall C3 in Trench 44 (Room 5), looking east.

Trench 44 produced the most significant discovery for the building's earliest phase: evidence for an early phase of construction that predated the creation of Room 5. This stretch of wall, C3, survives only in its lowest foundation course, but aligns perfectly with sections of Walls C, C1, and C2 documented in previous field seasons (fig. 9). C3 is bedded on sterile sandy soil, directly overlying bedrock, and it was covered and put out of use in Phase 2. The discovery of this abandoned section of Wall C3 strengthens an earlier hypothesis that in the building's initial construction, Walls C, C1, C2, and C3 defined the western extent of the Southeast Building, while Wall A extended the property boundary to the west in a later phase (fig. 10). Further support for this hypothesis came in the form of a partially preserved Phase 1 floor surface of crushed bedrock aggregate encountered to the east of Wall C3 (6044071). This surface was cut to build Wall J1 in Phase 2 but could have originally extended into Room 6 (fig. 11). This surface is the lowest one so far encountered in the building, roughly 35 cm below the Phase 1 floor at the column in Rooms 6c/8 (6043128). Thus there must have been another inflection point between the area of the column and the area of Room 5. To the west of Wall C3, there is little evidence for an early surface aside from the natural bedrock, which slopes sharply downward to the west. The area west of Wall C3 may have been an exterior space with no constructed surface until activities in Phase 2 began.

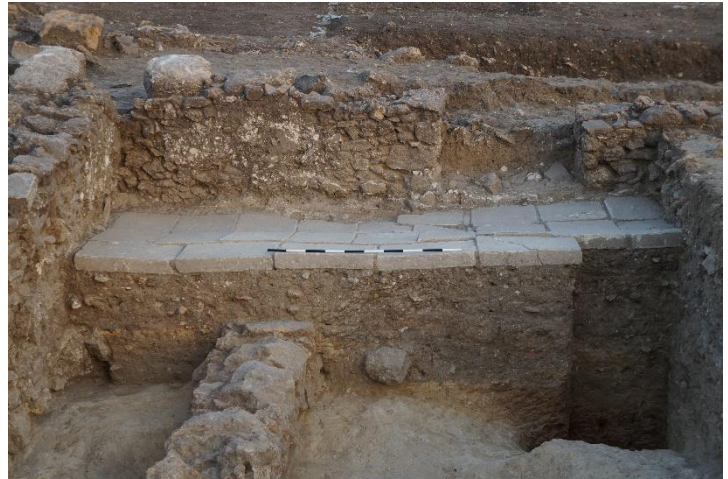
Fig. 11. Phase 1 surface in Trench 44 preserved in the section east (left) of Wall C3, with Phase 2b brick paving of Room 5 and doorway in Wall N, looking south.

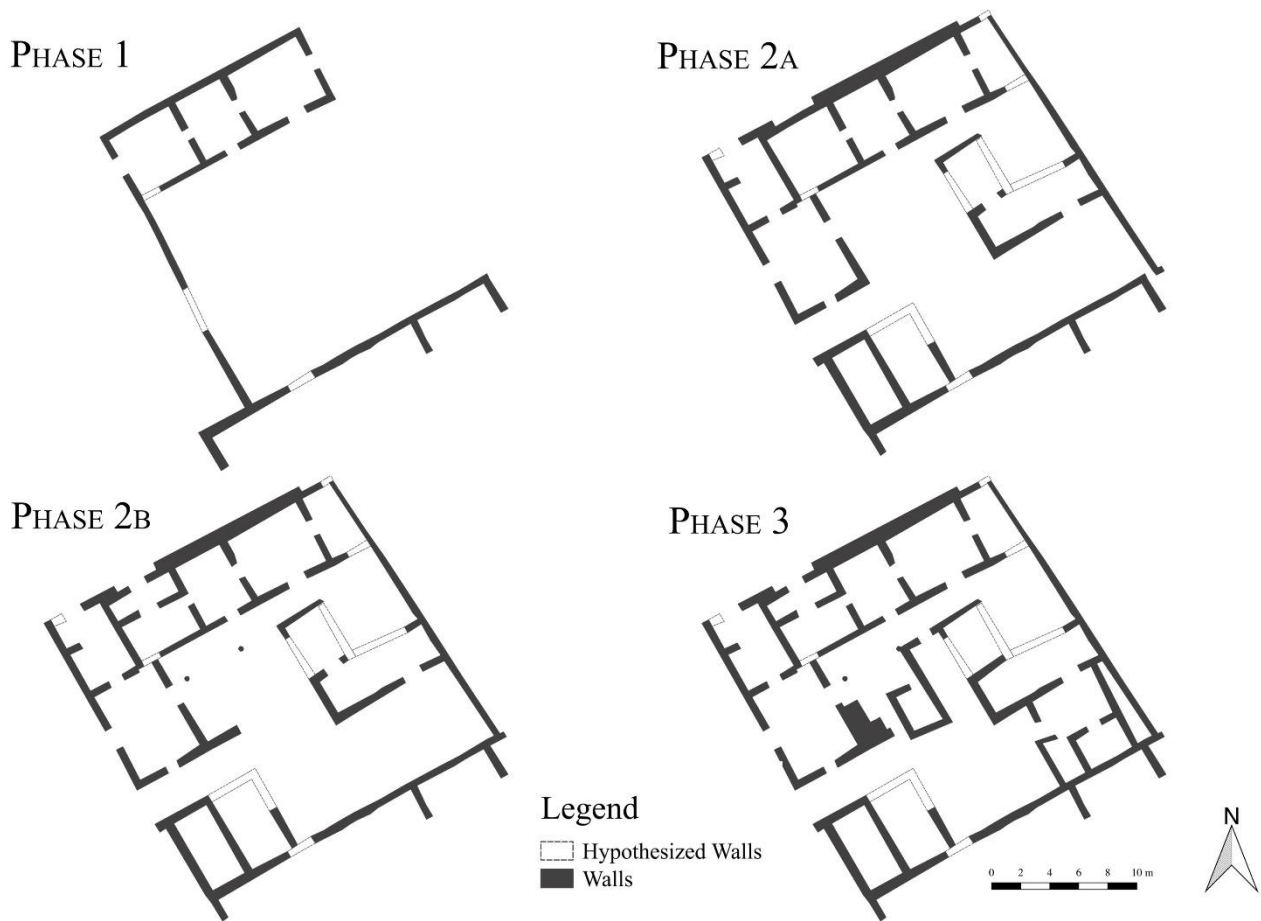
In summary, we can confidently propose that the Phase 1 building consisted of the northern rooms 2a, 2b, and 3, with an open court to the south bounded to the west by Walls C, C1, C2, and C3 and extending over the area that would later be divided into Rooms 6, 8 and 11 (fig. 13). Thresholds led from Room 8 to Rooms 2b and 3. Rooms 2a, 2b, and 3 communicated directly and composed the building's main suite of rooms. The relationship between Room 11 and the court was still unclear after the 2016 season. An interesting characteristic of this first construction phase is that the floor levels in the structure seem to have varied by up to 35cm, perhaps because

Fig. 13. Hypothetical plan of construction phases in the Southeast Building. Drawing by Jared Benton.

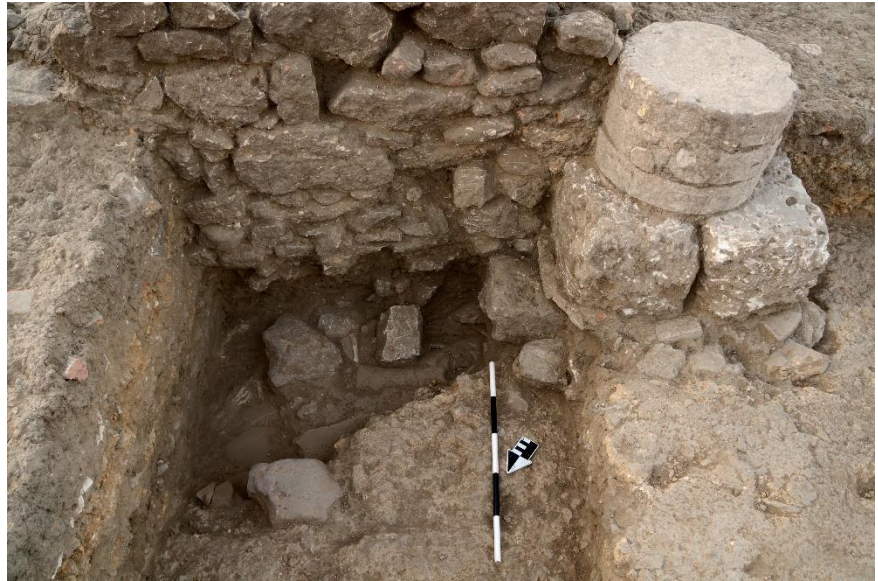
Fig. 14. Brick column with stone foundation (Phase 2b) at the intersection of Walls M and X in Trench 43 with earlier floor surfaces (Phase 2a) below, looking south.

The most crucial area of Trench 43 for the building's architectural phasing is a brick column resting on a stone foundation that was dug into a floor at the corner where Walls M and X meet (fig. 14). The relationship of these different architectural components as explained below provides strong evidence for construction sequencing between Phases 2 and 3, and we have therefore split Phase 2 into two parts (Phases 2a and 2b) in order to reflect this sequence. The resolution of the datable material recovered does not yet allow us to establish a precise chronology for the two sub-phases, though Trench 44 also revealed construction activity that suggests Phase 2 should be subdivided (see below). Further excavation may provide sufficient evidence from elsewhere in the building to promote these sub-phases to true phases in their own right, but for now we maintain them as part of a building-wide Phase 2.

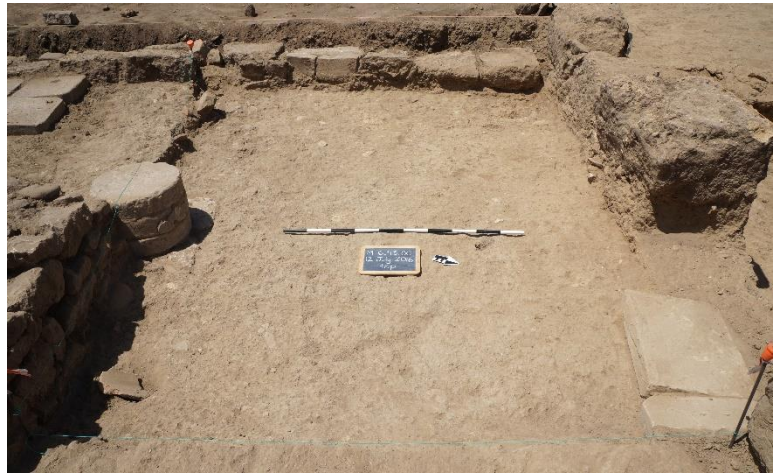
In this second part, Phase 2b, the Phase 2a floor (6043097) was cut to form a hole that was filled with small stones and tile fragments, on which a foundation of two rectangular cut stones was laid to support a column consisting of terracotta drums (diameter 35 cm), of which three were found *in situ* (see fig. 14). At the moment when this column was installed, the surrounding floor was raised to the height of the top of the foundation stones with a levelling fill capped by another crushed bedrock surface (6043084) (fig. 16). The leveling fill below this surface was generally devoid of inclusions but we did recover some fragments of black gloss pottery, including the base of a skyphos datable to the second half of the third century BCE, as well as a Syracusan bronze *litra* dated 240-215 (inv. 17-22; fig. 17)¹⁶. We can thus propose 240 BCE as a *terminus post quem* for this intervention and for Phase 2b itself.

Fig. 16. Phase 2b crushed bedrock surface in Trench 43 (Room 6c), looking west.

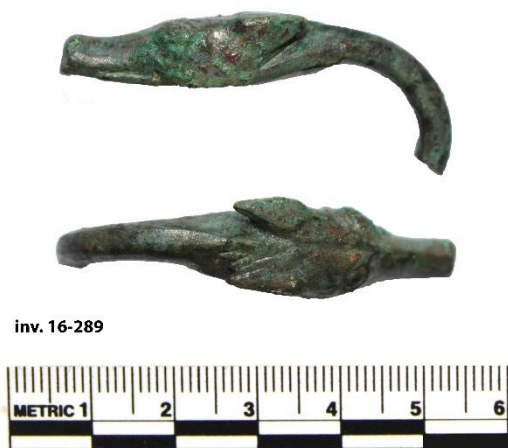
Fig. 19. Inv. 16-289. Bronze ladle handle in the shape of a dog's head from Room 5.

In Phase 2b, the floor level was raised in Room 5 by some 20cm, just as it was found to be the case in Rooms 6c and 8. This floor took the form of a paved brick surface (6044052) over a rectangular area in the southeast portion of the room (see fig. 11). This paved surface (EL 602.53 masl) corresponds roughly in elevation with a section of brick paving, or possibly a small platform, found in the same room in 2014 (EL 602.63 masl). At the level of the paving, and extending throughout the room, was a hard packed soil (6044054) that raised the room's floor level from the Phase 2a level and served as a bedding for brick paving that was later robbed out, or possibly constituted the room's principal floor north of an intentionally partial brick pavement. From this packed-earth surface came the handle of a bronze ladle (*simpulum*) in the shape of a dog's head (inv. 16-289; fig. 19). Handles of this type have been found elsewhere at Morgantina; they are generally dated to the

¹⁷ For dog-head shaped *simpula* handles, see GUZZO 2003: 56-57, 80 who publishes a silver specimen belonging to the hoard of Hellenistic silver from Morgantina.

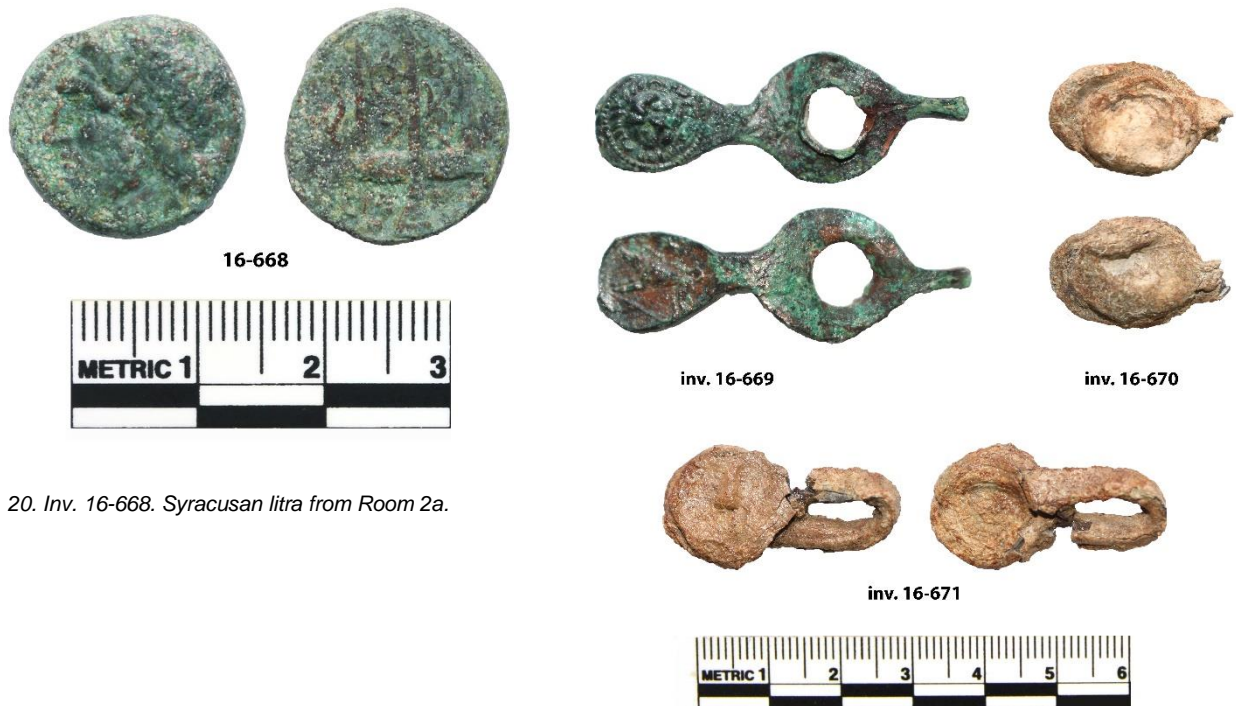
Fig. 20. Inv. 16-668. Syracusan *litra* from Room 2a.

In Trench 42, a packed-earth floor surface (6042049) extended across the entirety of Room 2a over Wall RR and the bench VV, demonstrating that those features were out of use in this phase. The levelling fill under this floor can be dated post 240 BCE by a bronze *litra* of Hieron II (inv. 16-668; fig. 20)¹⁹. Also mixed into the fill were two lead mercantile seals with illegible stamps (inv. 16-670; inv. 16-671) and one bronze mercantile seal with a lion's face stamped on one side and a boar stamped on the other (inv. 16-669; fig. 21). In Room 2b the floor level was ca 10cm lower (6042048), and the elevation difference was mediated by a brick threshold serving as a step. Although this threshold was constructed of brick fragments and is otherwise fairly rudimentary, one of the fragments next to the door jamb does preserve a small depression that may be a pivot hole for a door hinge (fig. 22). In Room 2b, we found on the floor a nearly complete terracotta figurine in fragments (inv. 16-656), and a kiln spacer (inv. 16-679; fig. 23)²⁰. The Phase 3 surface contained a concentration of 47 bronze coins in the southeast corner of the room, which we interpret as a dispersed hoard. While most of the coins were Syracusan issues of the mid-third century, among them were two Roman *unciae* (inv. 16-453 and 16-458) that yield a *terminus post quem* for the final activity on this surface of 214 BCE (fig. 24)²¹.

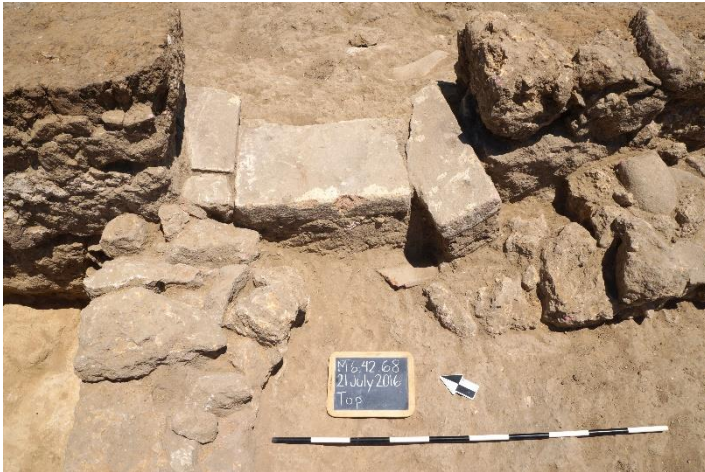
Fig. 22. Brick threshold between Walls QQ and QQ1, looking east.

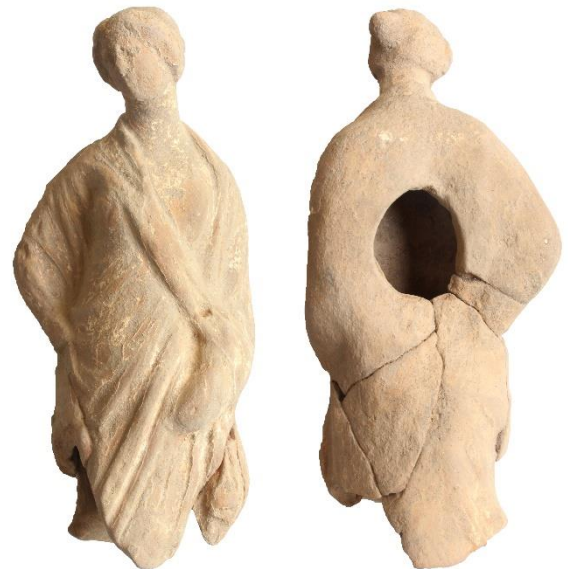
inv. 16-656

Fig. 23. Inv. 16-656. Terracotta figurine from Room 2b.

²⁰ For this type of terracotta figurine, see *MS I*, no. 374a ("Standing woman type A"). GIUNTA 2008: 161 publishes more than two dozen kiln spaces of similar form that were found in the dump of Hellenistic kiln at Gela.

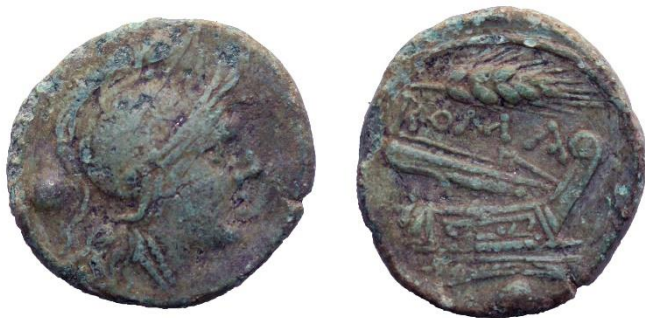
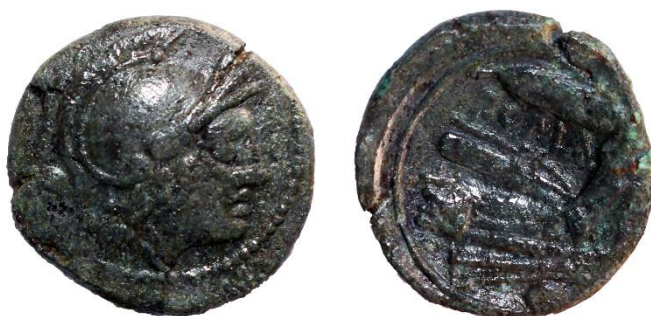
inv. 16-453

inv. 16-458

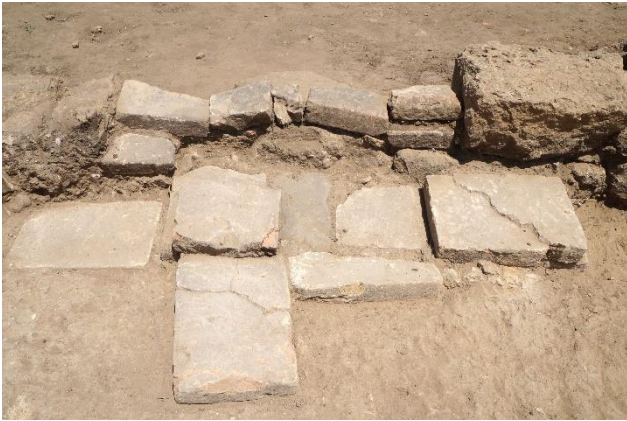
Plateia B, also contains a brick with a circular depression next to the door jamb (like that mentioned for the doorway between Rooms 2a and 2b), indicating that this opening was secured with a swinging door. A brick threshold was also added between Room 2b and Room 6b, though it did not preserve any evidence for the operation of a door. The Phase 3 floor level in both 2a and 2b is consistent with that of newly formed Rooms 6c, 6a, & 8 (see below). We note that here no floor surface was found between the earliest floor (Phase 1) and the installation of the final floor (Phase 3) before abandonment.

Fig. 25. Doorway between Walls H and H1 leading from Plateia B into Room 2a, looking north.

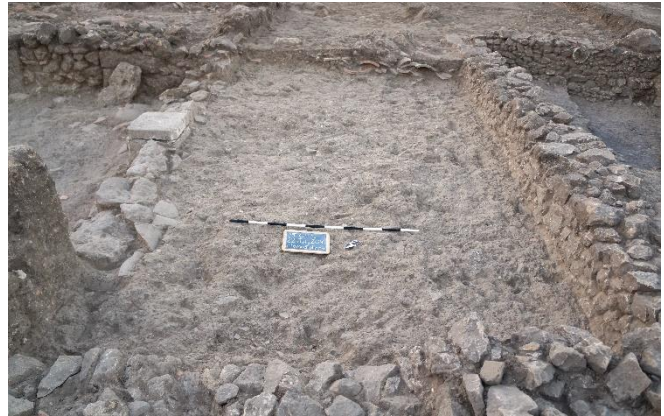
Fig. 26. Step between Rooms 10 and 11a with bricks embedded in Wall R1, and stone pier at far left, looking south.

A series of stones laid in a line between Rooms 10 and 11a and at the level of the Room 10 floor surface marked the transition from one room to the other (fig. 26). These stones created a step that negotiated the small difference in floor elevations from Room 10 (6043075 at EL 602.69-602.85 masl) down into Room 11a (6043090 at EL 602.44-602.67 masl). The boundary between those rooms was further defined by the short spur wall (Wall R) which extended 0.54m south from the stone pier, and by the placement farther south of a column formed by square brick drums, two of which were preserved in situ with their plaster facing (2.17m from the center of the pier to the center of the new column base). Neither Room 10 nor Room 11a were excavated below the Phase 3 surfaces, and both will be further investigated in future seasons. Lying on the packed-earth surface in Room 10 (6043075) we recovered a Roman silver *quinarius* (inv. 16-712), which exhibits almost no sign of wear from circulation. Since this coin was found below a well-preserved tile fall layer, it provides a *terminus post quem* of 211 BCE for the last occupation-related activity here before the collapse of the roof (fig. 27)²³.

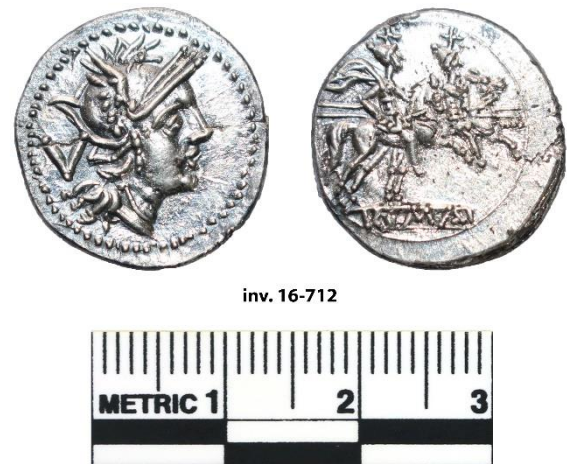
Fig. 27. Inv. 16-712. Roman *quinarius* from Room 10.

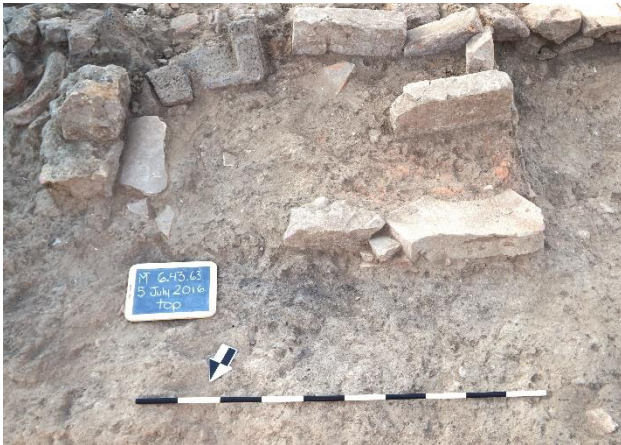
Fig. 28. Brick platform with burned soil and ash in Room 8, looking south.

as a simple platform. We note that the elevation of this platform corresponds precisely to the level of the step that was installed in this phase to mediate a change of elevation from Room 6c down into 6a (see above).

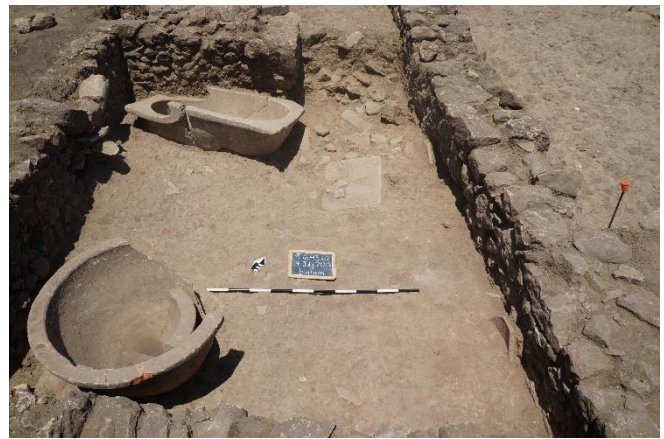
Fig. 29. Room 7 with early Phase 3 surface showing the empty basin and bathtub, looking north.

Rooms 7 and 11a are of particular interest in Phase 3. The walls of Room 7 (Walls O, O1, O2, O3, P, X, and Y) were built in what had been open courtyard, creating a roughly rectangular space near the center of the building. Excavations inside Room 7 came down on a packed earth surface (6043091) at the bottom of the walls, which is the earliest floor so far encountered in the room. A large terracotta basin of the “bacino a campana” type

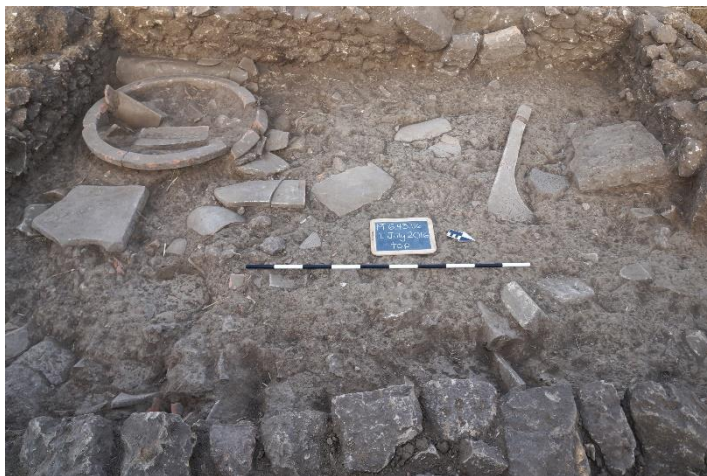
Fig. 30. Room 7 with later Phase 3 resurfacing showing the tops of the basin and bathtub, with the drain in Wall Y visible at far left, looking west.

was subsequently placed in the southwest corner of the room, as well as a terracotta bathtub in the northwest corner, during this phase of occupation and possibly in preparation for the modification that followed (fig. 29)²⁴. Later in the phase, a levelling fill raised the floor level, capped by a packed earth surface (6043056) level with the top rim of the basin and, presumably, the rim of the bathtub (fig. 30). The bathtub was found sitting at an oblique angle, which we suspect is the result of eventual subsidence in the soil. It too likely sat on the older floor (6043091) when the levelling fill was added around it and the rammed-earth floor surface was laid down at the level of its rim, as was certainly the case with the basin. A re-used section of terracotta pipe was found in Wall Y just south of the basin at this Phase 3 floor level,

where it would have served to divert any liquid that overflowed the basin from the earthen floor out into the southern part of the lot, which even in Phase 3 seems to have remained a mostly open space. The remains of three coarse ware vessels, a Greco-Italic amphora, and a ceramic *mortarium* were found broken in place on this higher surface (fig. 31).

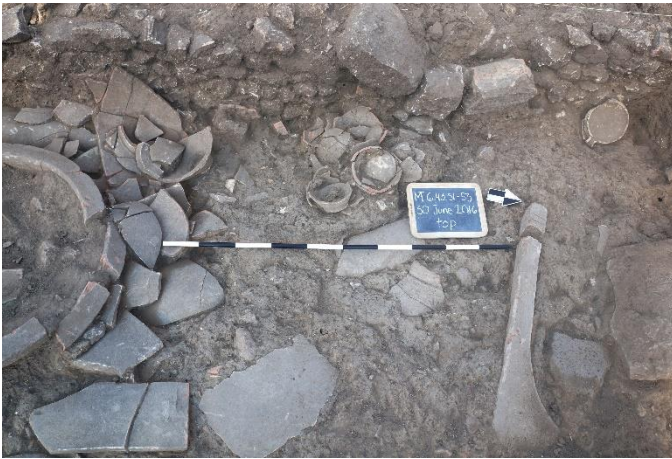
Fig. 31. Vessels in situ on the Phase 3 surface in Room 7, looking west.

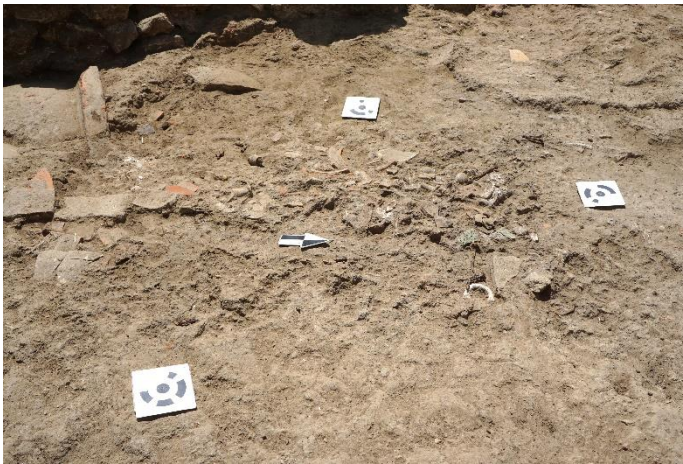
Fig. 32. Cluster of finds in situ in Trench 43 (Room 11a), looking west.

The Phase 3 floor (6043090) in Room 11a (formerly Room 9) preserved a remarkable assemblage of small objects. The intended functions of the room as a whole are as yet unclear, but the concentration of some 67 objects scattered narrowly in the center of the room leads us to hypothesize that they were gathered in this space during a period of cleaning or spoliation of the building at the end of Phase 3, or alternatively that these various and sundry items were contained in a box or bag left on the floor (figs. 32-33). Among these were a solid lead U-shaped handle, possibly for a vessel (inv. 16-584), an iron arrowhead of “Cretan” type (inv. 16-597), and a fragment of an iron key (inv. 16-595)²⁵. The deposit also contained two small terracotta medicine pots (inv. 16-575 and inv. 16-576) of the same shape as the lead medicine pot found in 2015, though unfortunately without inscriptions²⁶. Twelve astragaloi, with holes drilled through their centers, may have been held together with wire, as one of the examples (inv. 17-84) preserves a piece of bronze wire through its central hole. The lone coin recovered among this assemblage was a bronze *litra* of Hieron II, cut in half, (inv. 16-563)²⁷. Thirty-one iron nails and nail fragments, three river pebbles, and a handful of fragmentary metal pieces completed the assemblage.

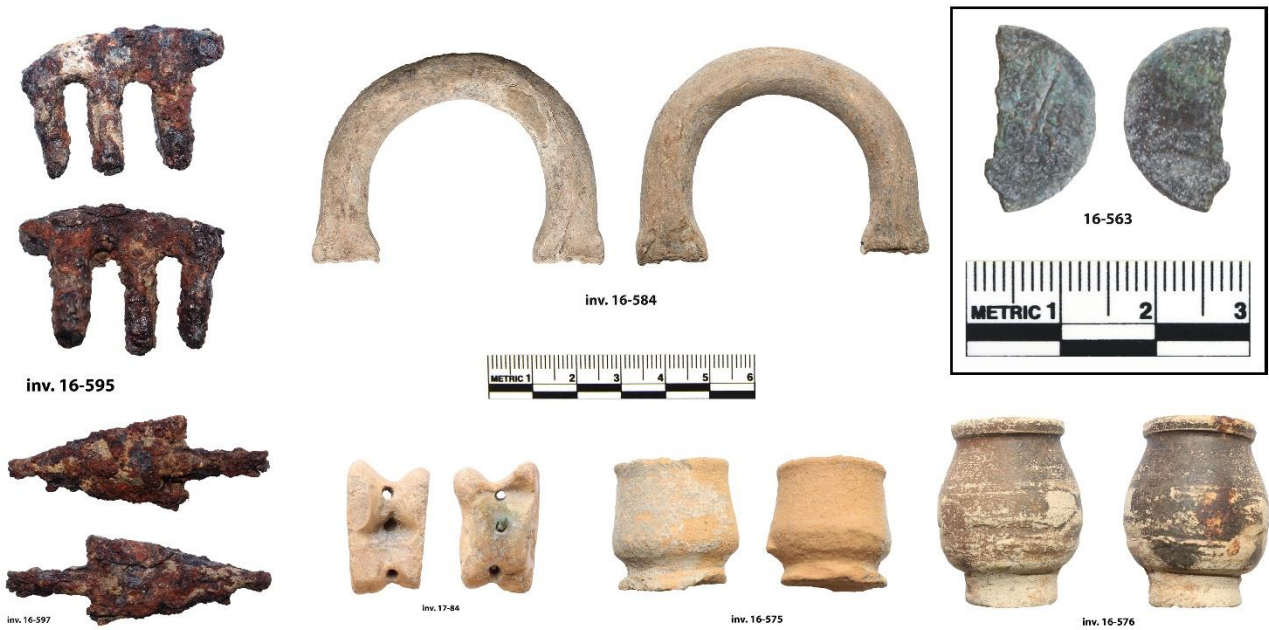
Fig. 33. A selection of objects recovered from the cluster of finds in Trench 43 (Room 11a).

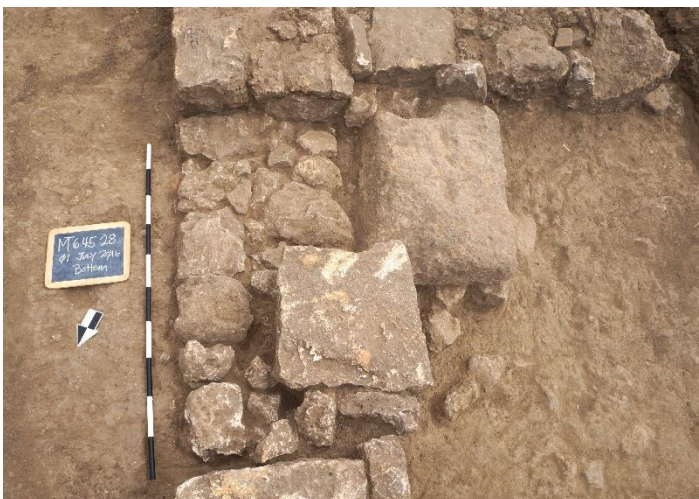
Fig. 34. Possible door in Wall GG2 (Trench 45), looking south.

with a step from the narrow trapezoidal space in the southeast corner of the building into Room 16 (fig. 34). The large smooth blocks just inside Room 16 appear to rest on a pavement of hand-sized cobblestones (of which a small patch was also found further away from the wall), and they do not appear to have been displaced from the wall; rather, they may be the remains of steps down into Room 16 (fig. 35).

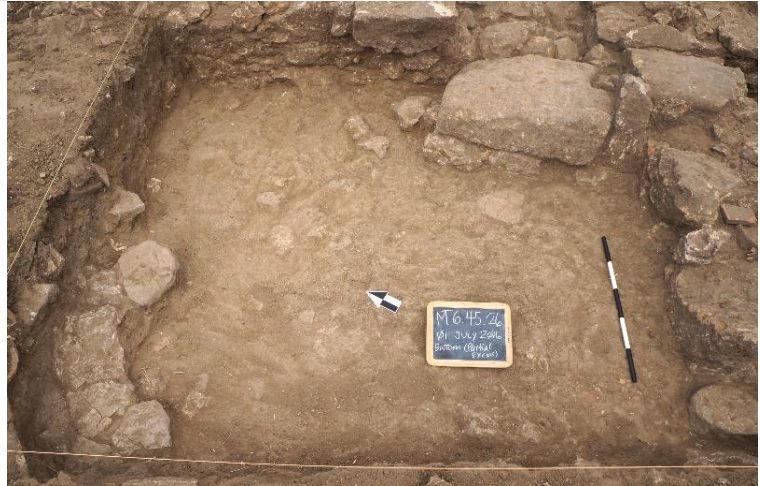
Fig. 35. Room 16 (Trench 45) with cobblestone paving remnants visible underneath the stone step and at bottom left, looking east.

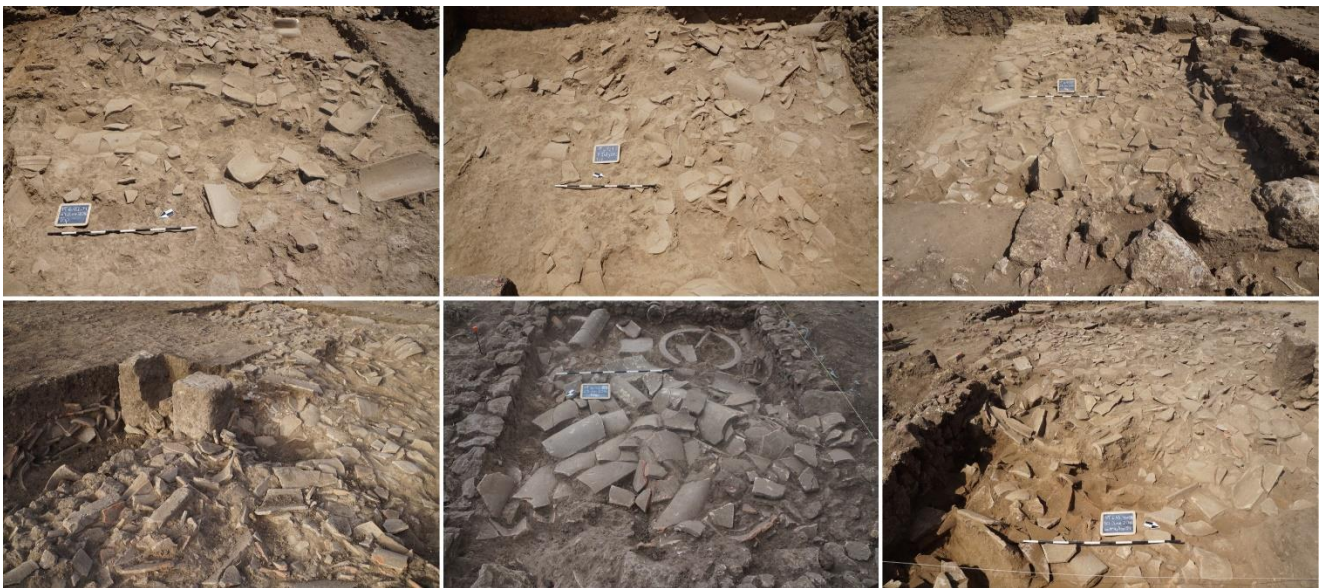
Phase 4 represents the abandonment of the building and eventual collapse of the roof and its tiles, all of which were found resting on the Phase 3 floor surfaces. Our 2016 excavations discovered tile collapse layers in Rooms 2a, 2b, 5, 6c, 7, 8, 10 (formerly Room 7), Room 11a (formerly Room 9), and possibly Room 18 (fig. 36). All of these rooms were likely covered by tile roofs in Phase 3, with the possible exceptions of Rooms 10 and 18, which may have stood open and into which tiles from adjacent roofed spaces could have fallen when their roofs collapsed. Analysis of the deposits sealed by these collapses indicate a *terminus post quem* around the end of

Fig. 36. Composite photo of tile falls. Clockwise from upper left: Room 2a, looking east; Room 2b, looking west; Room 5, looking north; Rooms 10 and 11a, looking west; Room 7, looking south; Rooms 6c (background) and 8 (foreground), looking west.

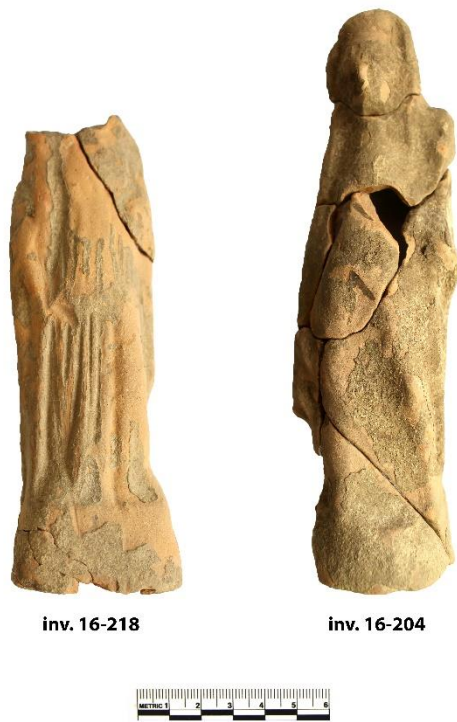
Fig. 37. Inv. 16-204/207/210/215 and 16-218. Terracotta figurines from Room 2a.

In Trench 42, the tile collapse filling Room 2a contained a large number of terracotta figurine fragments. 17 identifiable fragments were recovered, and some joins were found among them, representing a minimum of five mostly complete figurines (fig. 37)²⁸. These join an already large number of terracotta figurines (and fragments thereof) recovered from the northernmost rooms of the Southeast Building during excavations of previous seasons. It is also possible that the deposition of the nearly complete figurine (inv. 16-656) on the floor in Room 2b (6042048), discussed above as evidence of Phase 3 occupation, may represent a period of abandonment in Phase 4.

²⁸ Both figurines illustrated here are of common types found in Hellenistic contexts at Morgantina; see *MSI*, 134, no. 68 and 134, no. 78.

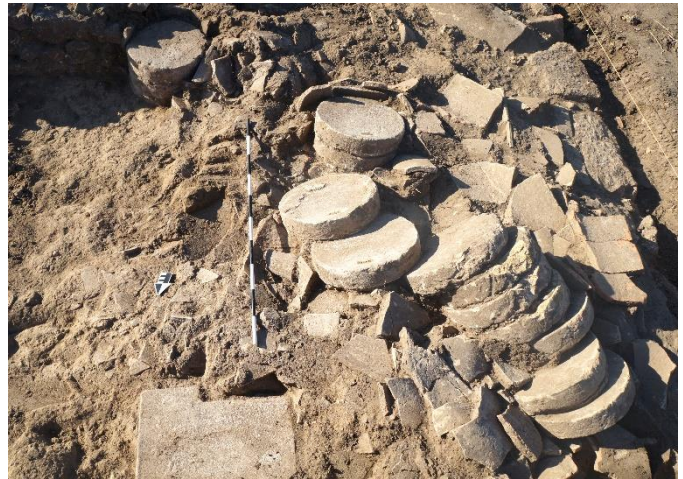
Fig. 38. Collapsed column drums in situ over tile collapse in Room 6c, looking south.

One interesting aspect of the building's collapse became clear in the area of Trench 43, where a number of brick column drums still attached to each other with mortar were found fallen over the tile collapse in Room 6c near the Phase 2b column base discussed above (fig. 38). This situation suggests that the roof collapsed before the column did, which is not unexpected, but is nevertheless a clear illustration of a formation process that is not always visible in the archaeological record. The preservation of

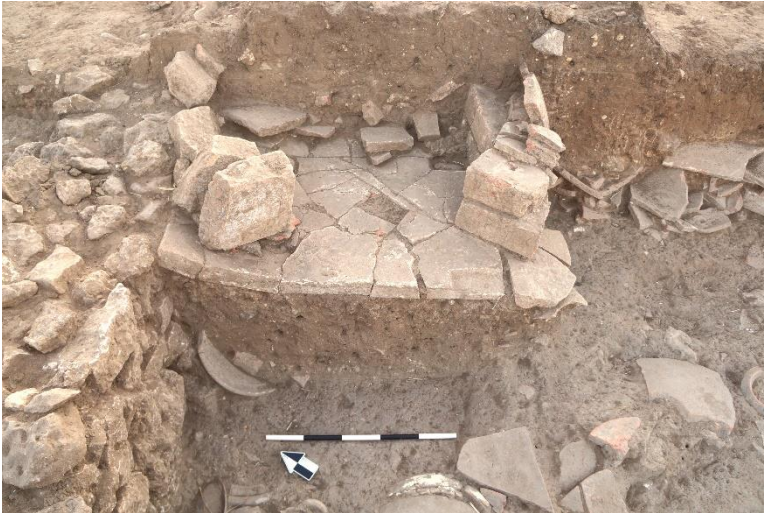
Fig. 40. Oven built over clean fill in Room 11a, looking east.

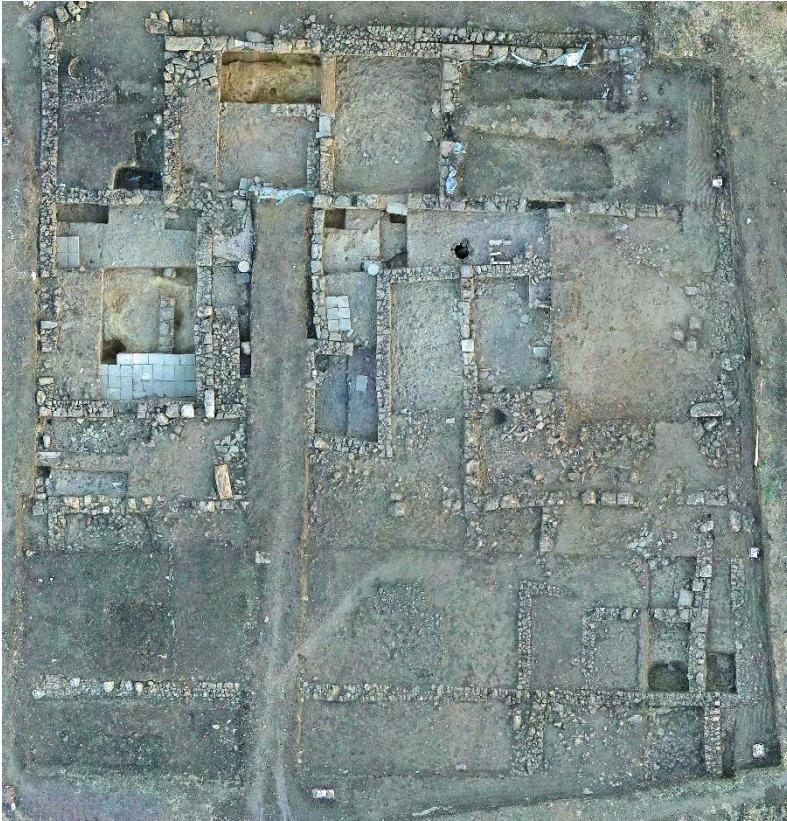
Fig. 41. Aerial orthophoto of the Southeast Building at the conclusion of the 2016 season.
