Preliminary Report on the 2017 Season of the American Excavations at Morgantina: Contrada Agnese Project (CAP)

In its fifth season, the American Excavations at Morgantina: Contrada Agnese Project (CAP) continued archaeological investigations inside the Southeast Building, a modestly-appointed house of Hellenistic date located near the western edge of the city. The 2016 CAP season had revealed the full extent of the property's boundary walls and allowed us to propose a cohesive phasing scheme for the building's construction, occupation, and abandonment. We suggested that the house was occupied for approximately 60-75 years, beginning in the second quarter of the third century BCE. The 2017 CAP excavations resolved a number of remaining questions, particularly those concerning the phasing of the boundary walls, the layout of interior spaces in the southern and eastern parts of the building, and the nature of domestic activities at different stages of the house's occupation. This report describes the results of these excavations and proposes a new account of the building's early development. The discovery of two large rotary millstones within the building raises the possibility that

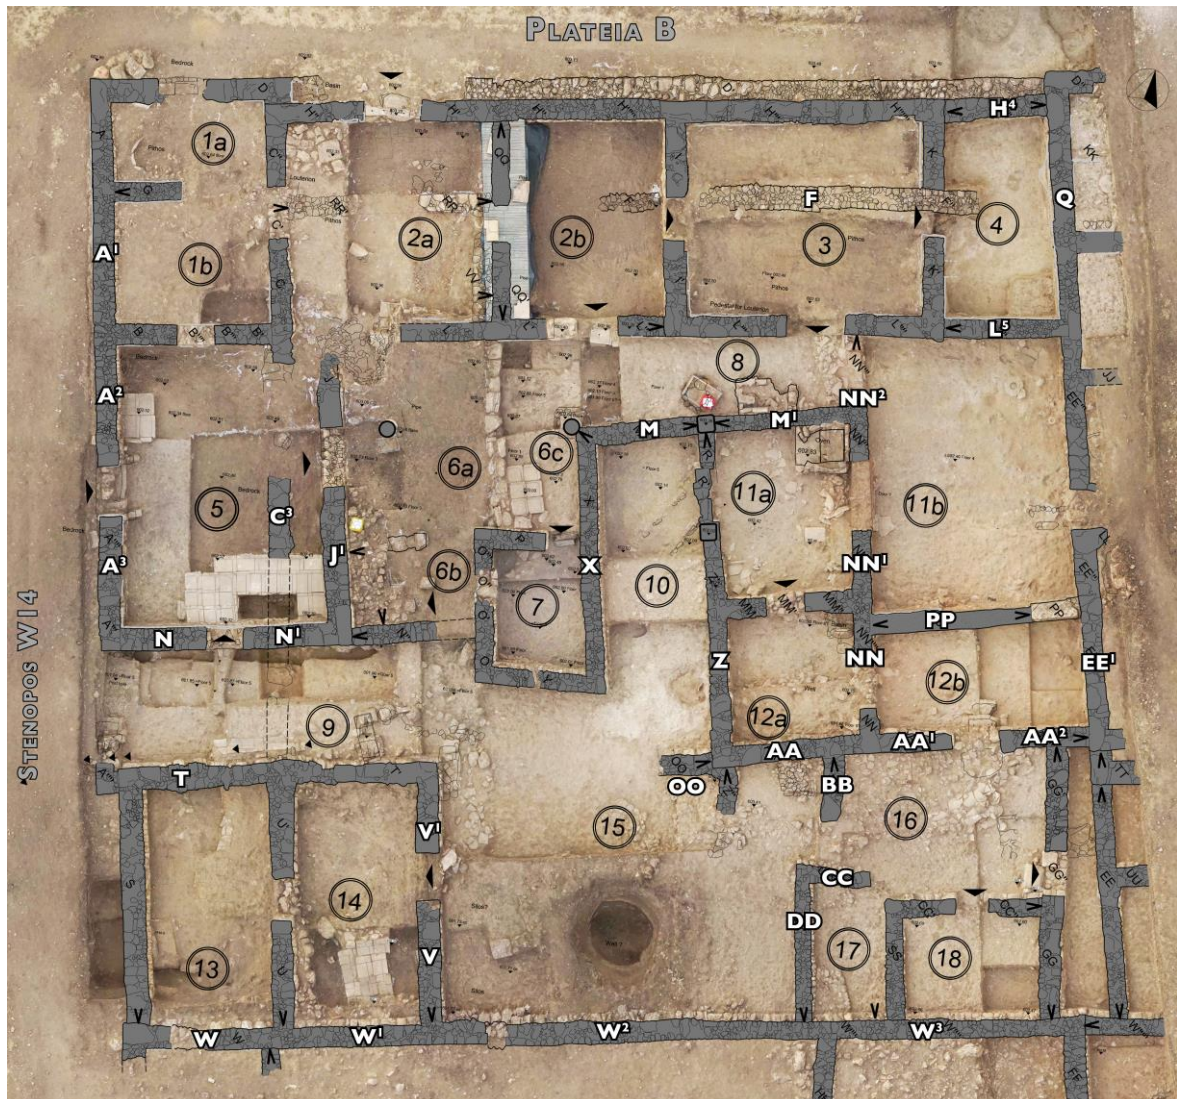
Fig. 1. Orthorectified aerial photo of the Southeast Building, with overlaid state plan, indicating room numbers and wall names. Drawing by G. Filantropi.

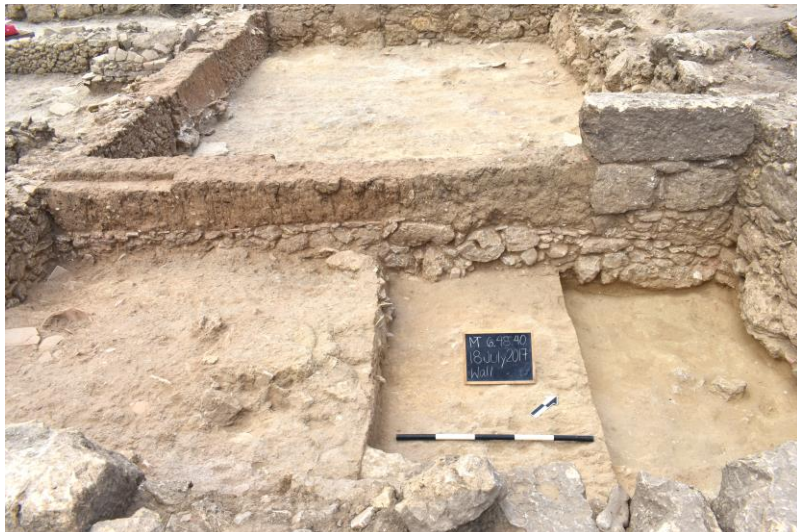
Fig. 4. Wall PP separating Rooms 11b and 12b, looking north. It is composed of a lower foundation of stone courses supporting a pisé superstructure. In Room 12b in the north, the earliest Phase 1 surface of redeposited yellow bedrock aggregate is visible.

Room 11b was corroborated by Trench 48. Notably, this wall was constructed of pisé or rammed-earth set atop a low stone socle (fig. 4). Walls of similar construction had been previously identified as part of Phase 1 construction in Room 2 during the 2016 season¹⁴. As in that case, portions of white wall plaster were discovered intact on the vertical face of Wall PP along its northern side. A surface of redeposited yellow bedrock aggregate (6049063) served as the earliest floor in Room 11b.

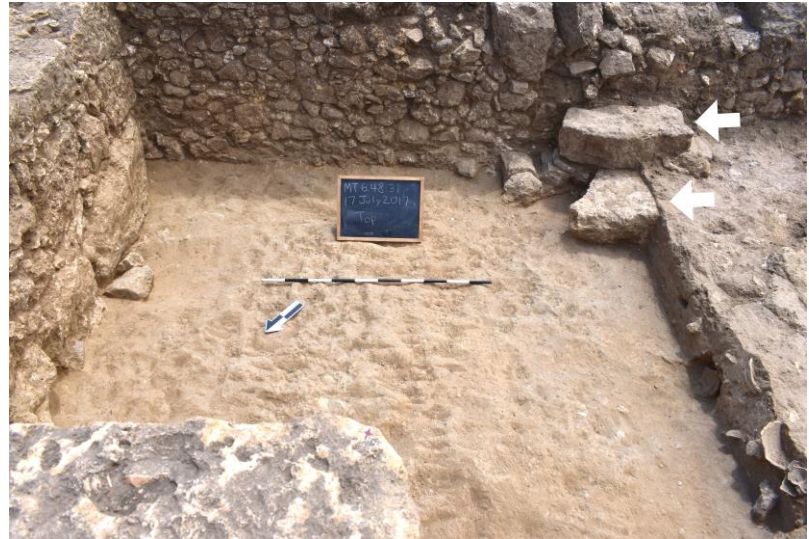
Fig. 5. Room 12b, looking south. Phase 1 beaten earth surface with stone steps leading up to Room 16.

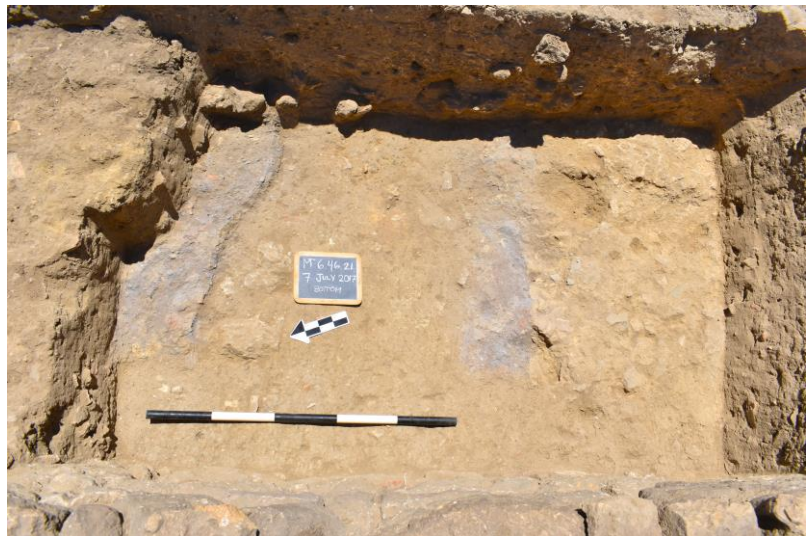
Fig. 6. Room 9, looking south. Phase 1 surface of unconsolidated bedrock and bluish substance resembling kiln dust.

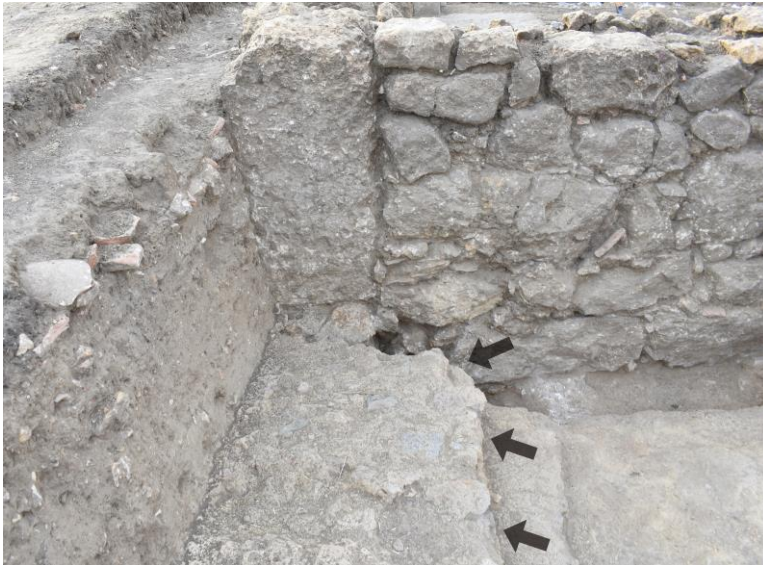
Fig. 7. Room 9, looking north. Phase 1 concrete-like pavement at entrance from stenopos W14, indicated by arrows.

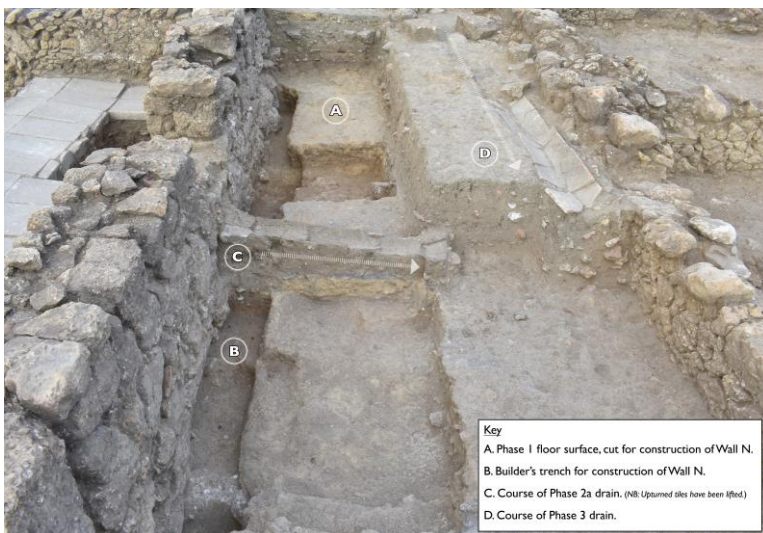
Fig. 8. Room 9, looking east. All building phases exposed, including: (A) Phase 1 floor surface, (B) Phase 2a construction trench for Wall N, (C) Phase 2a drain, and (D) Phase 3 drain.

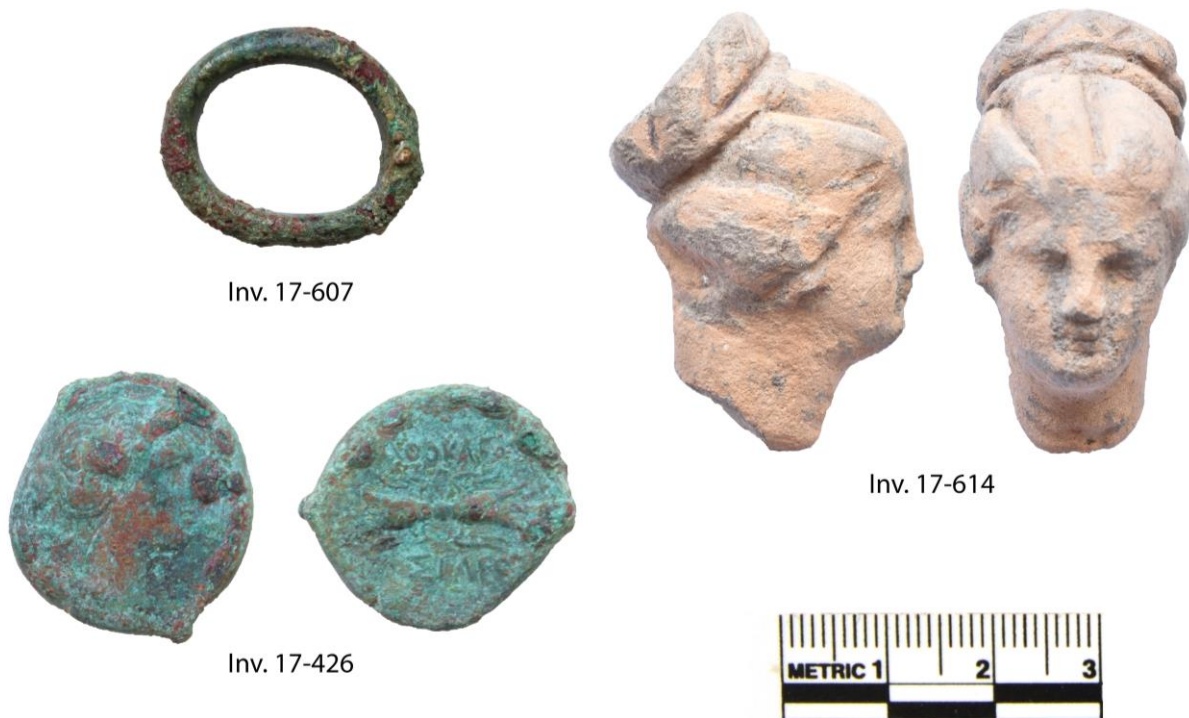
Fig. 9. Finds from levelling fill for Phase 2a surface in Room 9.

In the newly-created Room 9, a fill of gray soil with inclusions of crushed yellow bedrock was deposited in substantial quantities to raise the level for a new surface of hard-packed crushed yellow bedrock (6046011). This new floor sat some 50cm above the crushed yellow bedrock surface of Phase 1. Among the various small finds found in this fill were the head of a terracotta figurine (Inv. 17-614), a bronze ring (Inv. 17-607) and a bronze coin struck at Syracuse during the reign of Agathokles, which predates this phase considerably (Inv. 17-426; fig. 9)¹⁸. During the leveling process, a channel made of repurposed terracotta roof tiles was installed under the doorway running south from Room 5 into Room 9 (see fig. 8, C). This feature would have drained excess water flowing from Room 5 to an area outside of the building in the south. The full course of the channel could not be determined, as it appears to have been cut off in both directions at some point in antiquity. In Room 9, the drainage channel was covered with rocks and additional fill that, when surfaced (6046021), created a gradually sloping path leading from the building's courtyard out into the street.

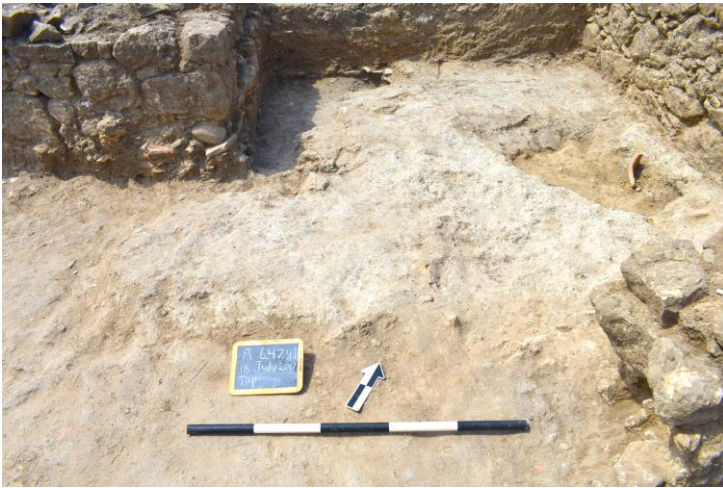
Fig. 10. Room 10/15, looking north. Phase 2a surface of compacted mortar and plaster in the courtyard.

The northern part of the central courtyard, i.e. Room 10, also yielded evidence of modest occupation without substantial alteration to the building's architecture. A highly-compacted surface of mortar and plaster (6047041) abutting Walls Z and OO represents the earliest identifiable floor in the southern part of Room 10 (fig. 10). In the northern part of Room 10, Trench 49 documented successive resurfacings of yellow bedrock aggregate (6049018, 6049041), which raised the level of the open courtyard by about 30-40cm. It is possible that the accumulation of ash created by repeated burning activities prompted the inhabitants of the house to periodically resurface the area at higher and higher levels. In that case it must be asked why the waste from this burning activity was not disposed of elsewhere.

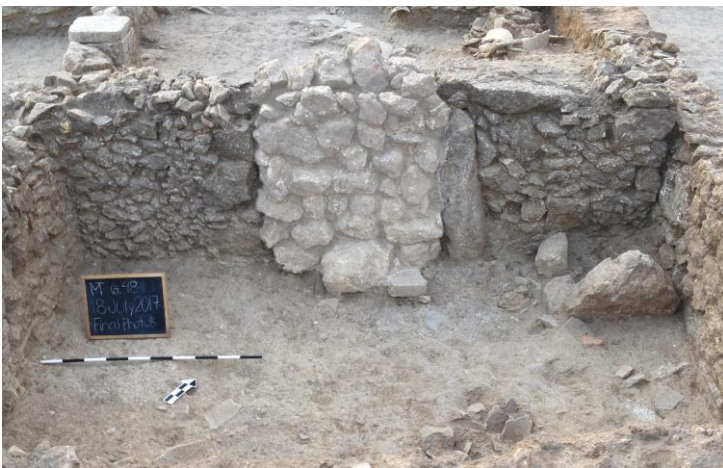
Fig. 11. Room 12a, looking north. Phase 2a blocked doorway (highlighted in white) between Rooms 11a and 12a.

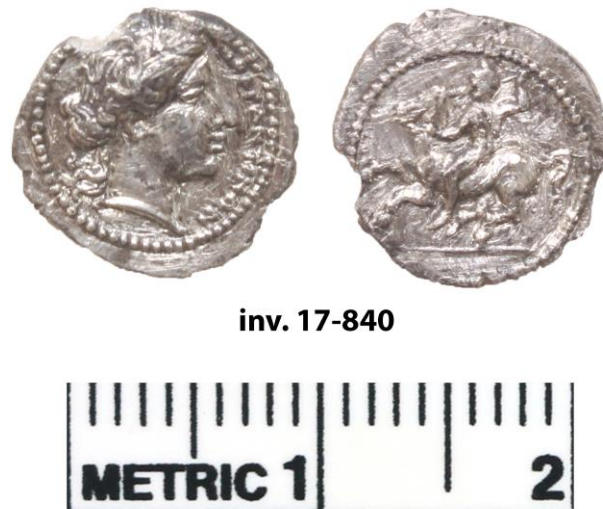
Fig. 12. Inv. 17-840. Silver litra coin struck at Morgantina (ca. 344–317 BCE).

¹⁹ Inv. 17-840. AR. 0.61g, 10.74mm, 5h. Obv. Laureate female head r.; at r., ΜΟΡΓΑΝΤΙΝΩΝ / Rev. Cavalryman galloping l. Morgantina; Date: ca. 344–317 BCE. Ref.: MS II, no. 244.

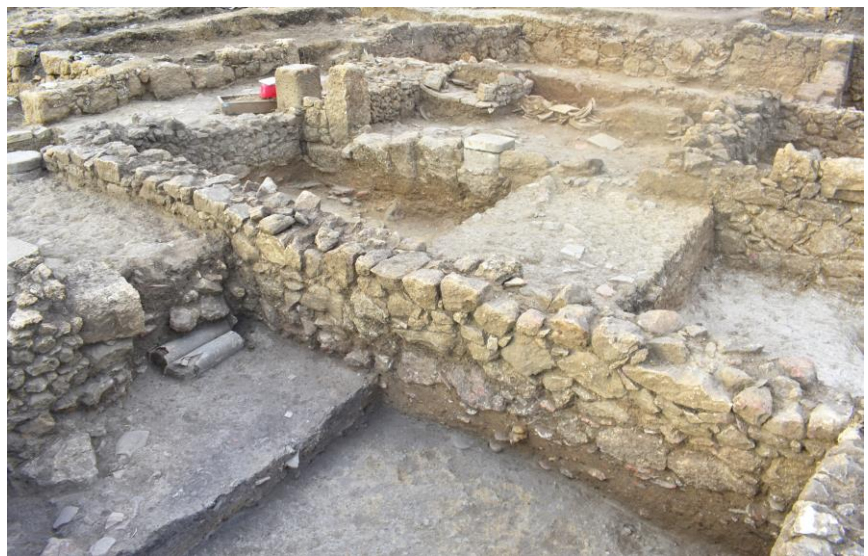
Fig. 13. Photo taken from the southwest corner of Room 7, looking northeast into Room 10 and beyond. In the foreground, Phase 3 wall of Room 7 (Wall X) built directly on top of Phase 2 surface, itself partially excavated to reveal the Phase 1 surface of crushed yellow bedrock aggregate.

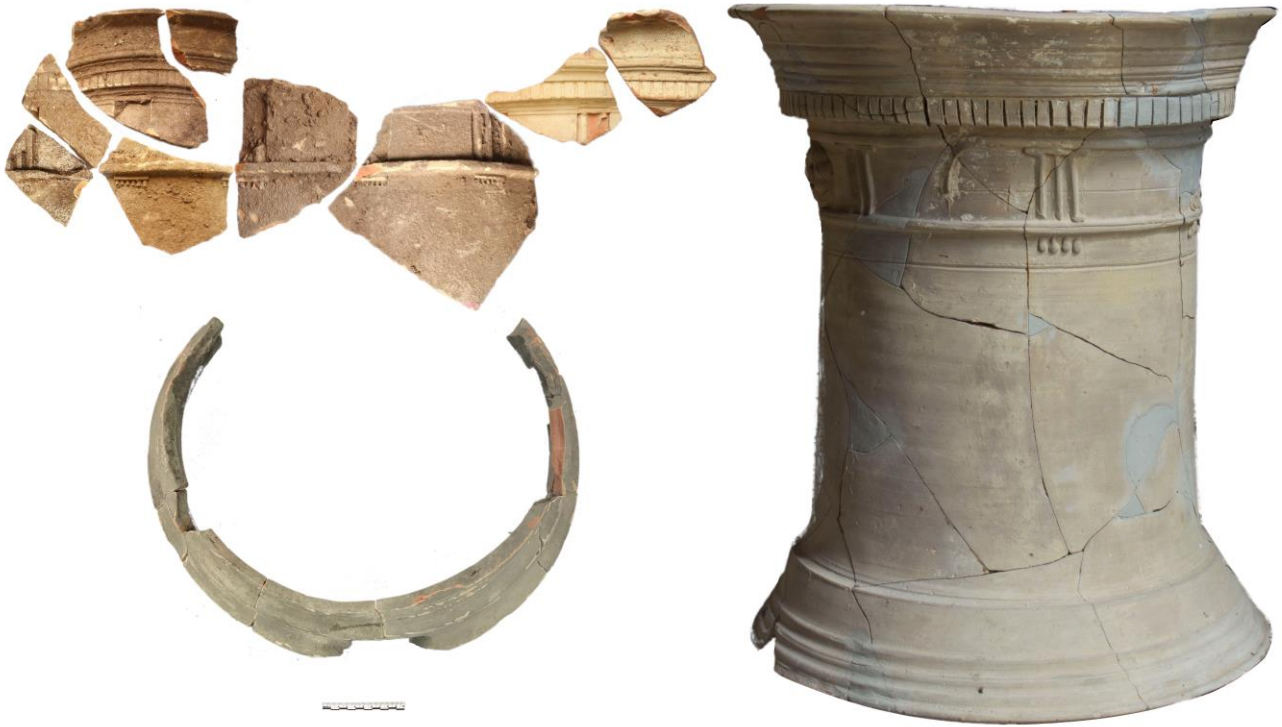
Fig 14. At left, fragments of terracotta altar found on Phase 3 surface of Room 15; at right, a complete altar from Morgantina for sense of scale and form.

A range of materials was found resting directly on top of this Phase 3 floor surface, including many objects associated with religious practices. Among these were the remains of a large cylindrical terracotta altar, measuring 50cm in diameter, which we discovered scattered in the northern area of Room 15 (fig. 14)²⁴. Nearly

the full circumference of its base was preserved, and the rim and upper body could also be substantially restored. The altar's decorative scheme features a cornice with dentils overhanging a Doric frieze, making it quite similar in appearance to the large terracotta altars found elsewhere at Morgantina, including in the House of Eupolemos and the North and South Sanctuaries²⁵. The large size of the altar, its relatively complete condition, and the fact that its fragments were found on a surface suggest that it was probably used not far from the concentration of fragments. We note that a circular pit filled with gray ash and charcoal lay just to the east of these altar fragments in the southern part of Room 10, which was not separated from Room 15 by any architectural feature. While the process leading to the formation of the pit is not known for certain, its proximity to the altar raises the possibility that it may have contained burnt refuse from sacrifices.

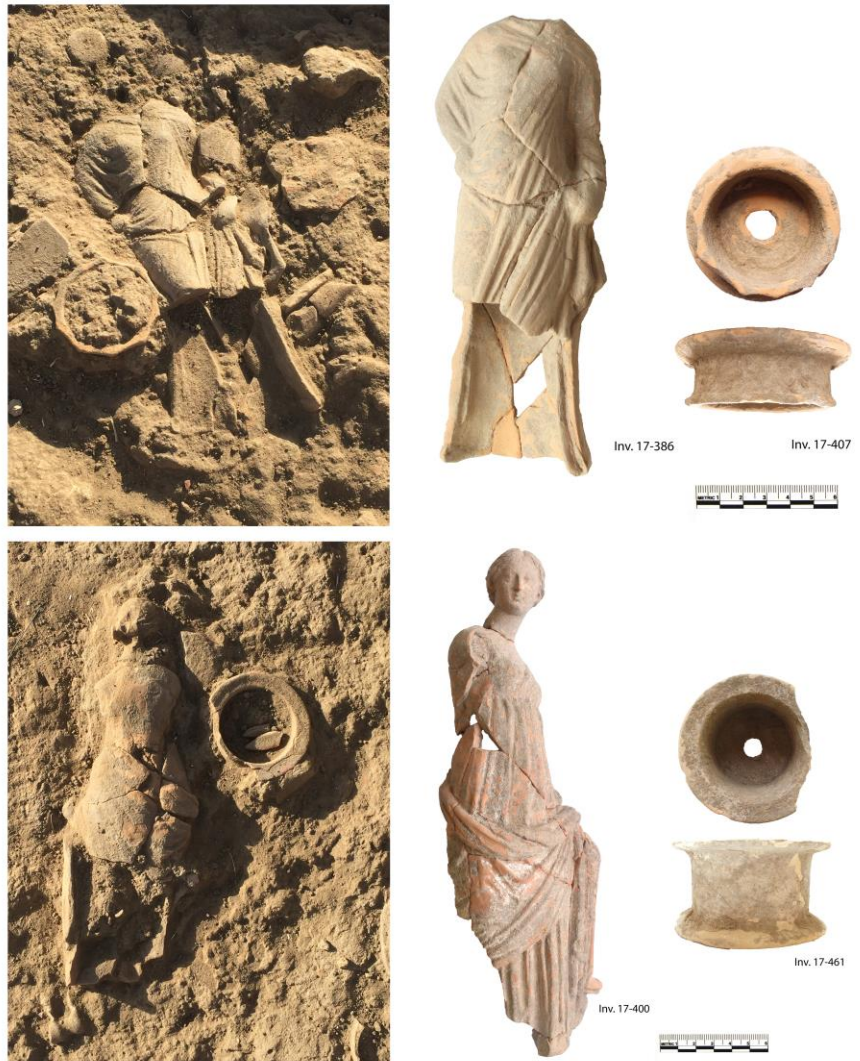
Fig. 15. Terracotta female figurines found on Phase 3 surface of Room 15.

Along the western side of the Room 15, excavators also discovered several moldmade terracotta female figurines. These were found lying on the surface of the courtyard in close proximity to one another and alongside the spool-like bases on which they once stood. Given their relatively good state of preservation, we may hypothesize that the figurines belong to a primary deposit of material and might even have once stood in the general vicinity, perhaps on a shelf or low platform along the western wall of the courtyard. While the excavations across the broader site at Morgantina have produced thousands of figurines of the draped female variety, few have been found together with their bases²⁶. These finds from 2017 may thus shed valuable light on the use and display of these seemingly ubiquitous objects within the context of the ancient household. Here, we note two particularly well-preserved figurines from the courtyard assemblage (fig. 15). One (inv. 17-386) represents a draped female figure wearing a himation; it belongs to a well-attested mold series that originated in Syracuse²⁷. The second (inv. 17-400) is of a type not otherwise attested at Morgantina; it represents a female figure dressed in a high-girt chiton, belted under the breasts, with a himation worn low across the body. Traces of added gold, visible under a microscope, were identified in several places on the surface of the fig-

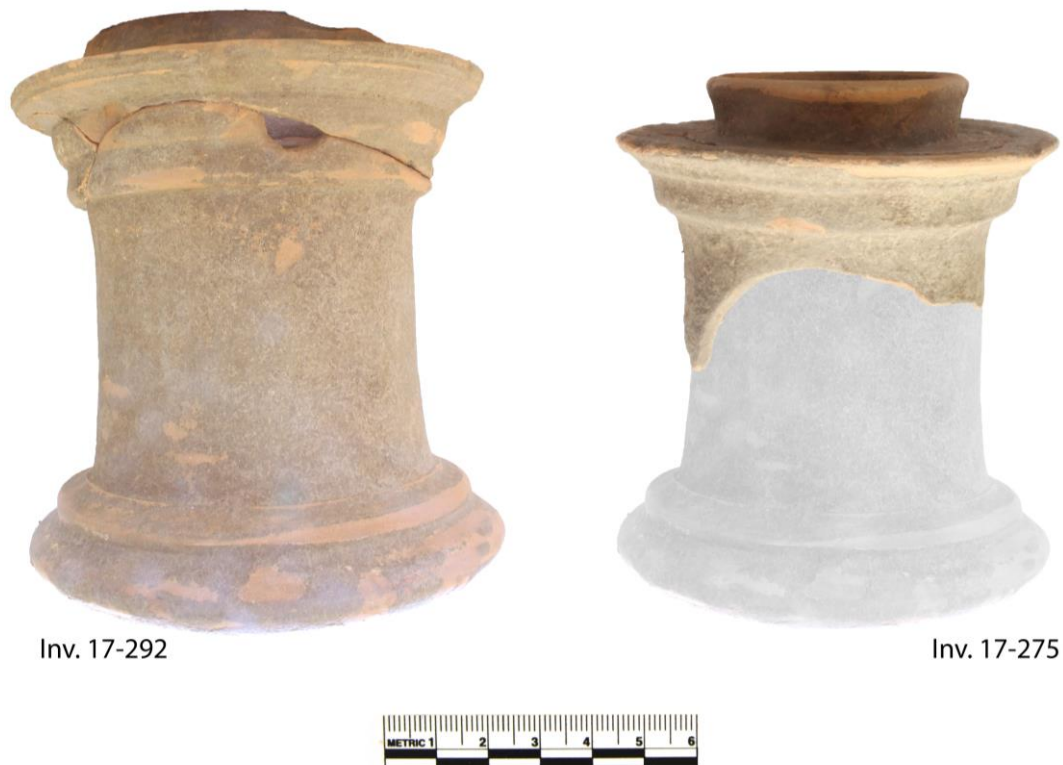
Fig. 16. Miniature terracotta arulae found on Phase 3 surface of Room 15.

re's drapery. The remains of two miniature terracotta arulae were found in close association with the figurines on this surface (inv. 17-275, 17-292; fig. 16). The abundance, preservation, and character of the floor assemblage suggests that the courtyard may have served as a privileged location for ritual activity in the house during this phase. The courtyard may also have been the site of religious practices even earlier in the building's history. In Phase 2a a rectangular platform was constructed against the east phase of Wall V1 in the same area where the small arulae were deposited later.

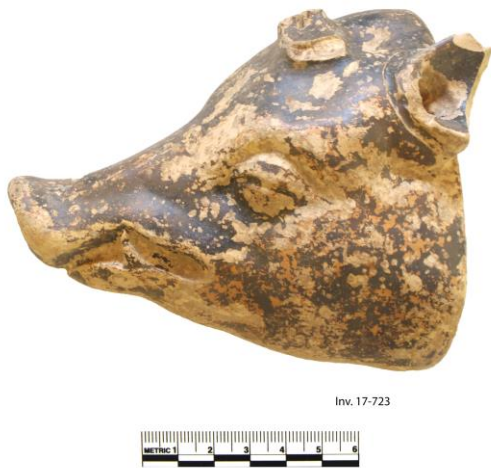
Fig. 17. Inv. 17-723. Guttus in the shape of a boar's head found on Phase 3 surface of Room 11b.

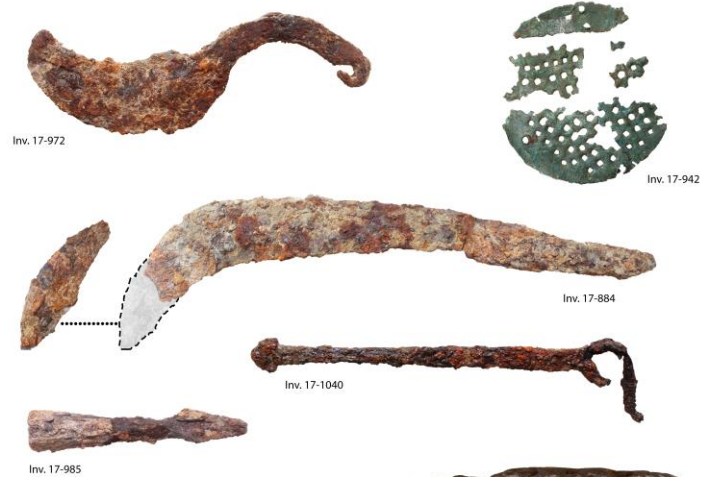
Fig. 18. Assorted tools found on Phase 3 surface of Room 11b.

A large number of tools and artifacts related to household production were also discovered resting on the Phase 3 surface in Room 11b. Among these, excavators recovered 16 discoid loom weights, a bronze grater, several stone weights—including one carved of lava stone and inscribed twice with the Greek letter *delta* (Δ)—a lava-stone quern, and various iron implements of sundry application (fig. 18). Most strikingly, the upper and lower elements (*catillus* and *meta*) of a large, Morgantina-type, rotary millstone were found on this floor surface, suggesting that grain was milled here (fig. 19). We note that the upper and lower elements of multiple hopper-rubber millstones have also been found throughout the house. Some were even used as building materials and incorporated into floors as pavements, like those documented in Room 13 during the 2015 season³¹. The clear investment in milling technologies by the owners of the house suggests that they have specialized in the milling of grains.

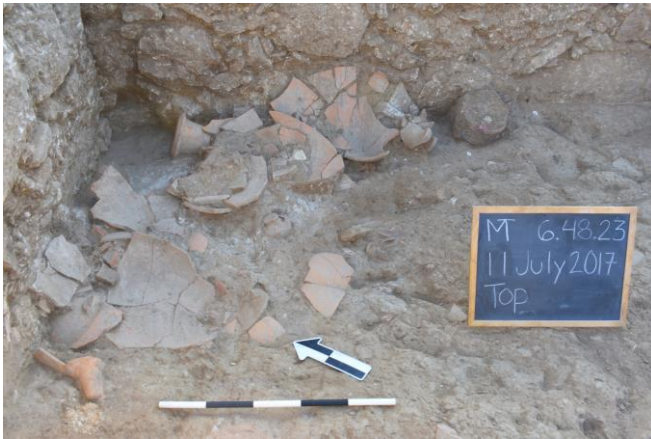
Fig. 20. Room 12b, looking east. Greco-Italic amphorae and cooking wares smashed against Phase 3 surface.

Immediately to the south of Room 11b, Trench 48 documented little substantial activity in Phase 3. Occupation is attested by several vessels found resting on the last surface of Room 12b, including the remains of four nearly complete Greco-Italic amphorae and a concentration of assorted cooking and dining vessels, which had been smashed in the northeast corner of the room (fig. 20). This concentration of vessels may be an indication that Room 12b served as a storeroom during this last major phase of occupation.

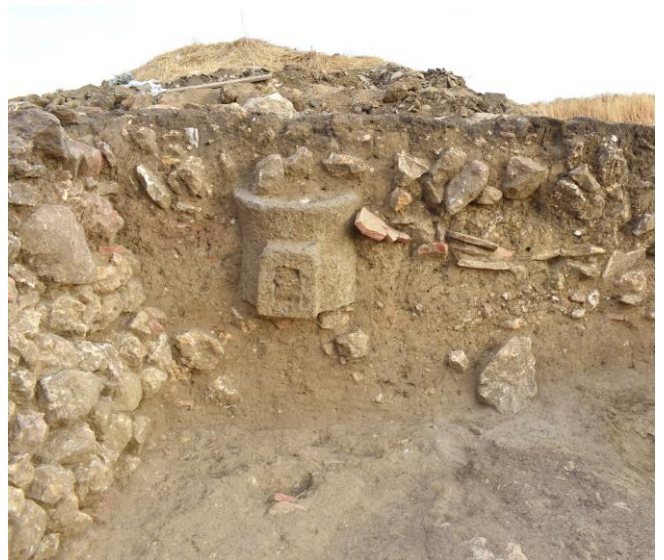
Fig. 22. Room 13, looking south. Catillus of a second Morgantina-type rotary millstone resting against the building's southern lot wall.

Finally, in Room 13, the *catillus* of a second Morgantina-type rotary millstone like that found in Room 11b was discovered resting on a beaten-earth surface against the building's southern lot wall (fig. 22). Much of Room 13 had been disturbed by modern activity, including excavations carried out in the early 1970s by Dr. Hugh Allen, but the southern- and easternmost portions of the room had remained untouched. The placement of the *catillus* in the room clearly predated the collapse of the building, as indicated by the layer of roof tiles and rubble that ran above the top of the millstone³⁵. This *catillus* was likely originally joined in Room 13 by a *meta* discovered in the neighboring House of

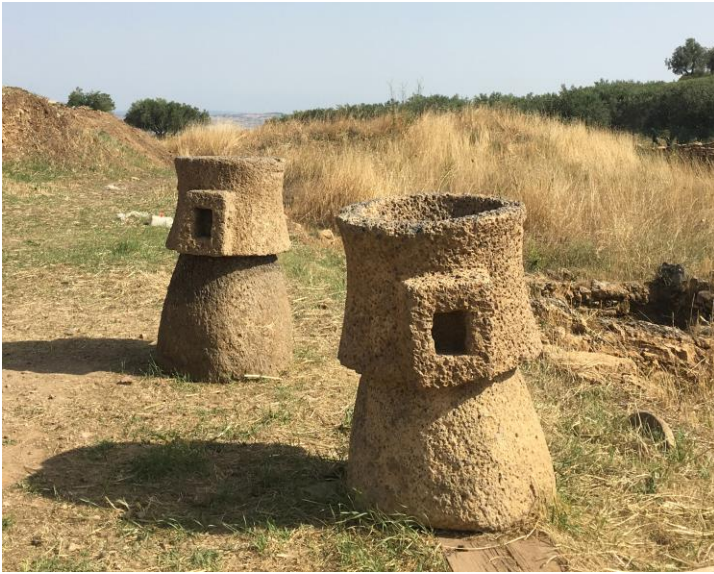
Fig. 23. Rotary millstones from Southeast Building. In foreground, catillus from Room 13 placed on top of meta found in the House of Two Skeletons in 2004; in background, catillus and meta from Room 11b.

the Two Skeletons in 2004³⁶. To test this hypothesis, we placed the *catillus* on top of the *meta*, and then traced a line around the point at which the two pieces met with a piece of chalk. Upon removing the *catillus*, we found that the wear pattern visible on the upper portion of the *meta* matched precisely with the area covered by the *catillus*, leaving us with little doubt that the two were used together in antiquity (fig. 23).

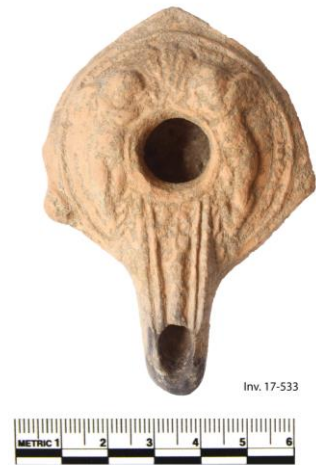
Fig. 25. Inv. 17-533. Moldmade lamp with relief decoration of two erotes.

connections, both commercial and cultural, with Ptolemaic Egypt. As one of the cities subject to Hieron's political authority during this time, Morgantina would have benefited from the ties between the two Hellenistic kingdoms. This lamp and its counterpart from the East Hill are among the material vestiges of this cross-Mediterranean interconnectivity.

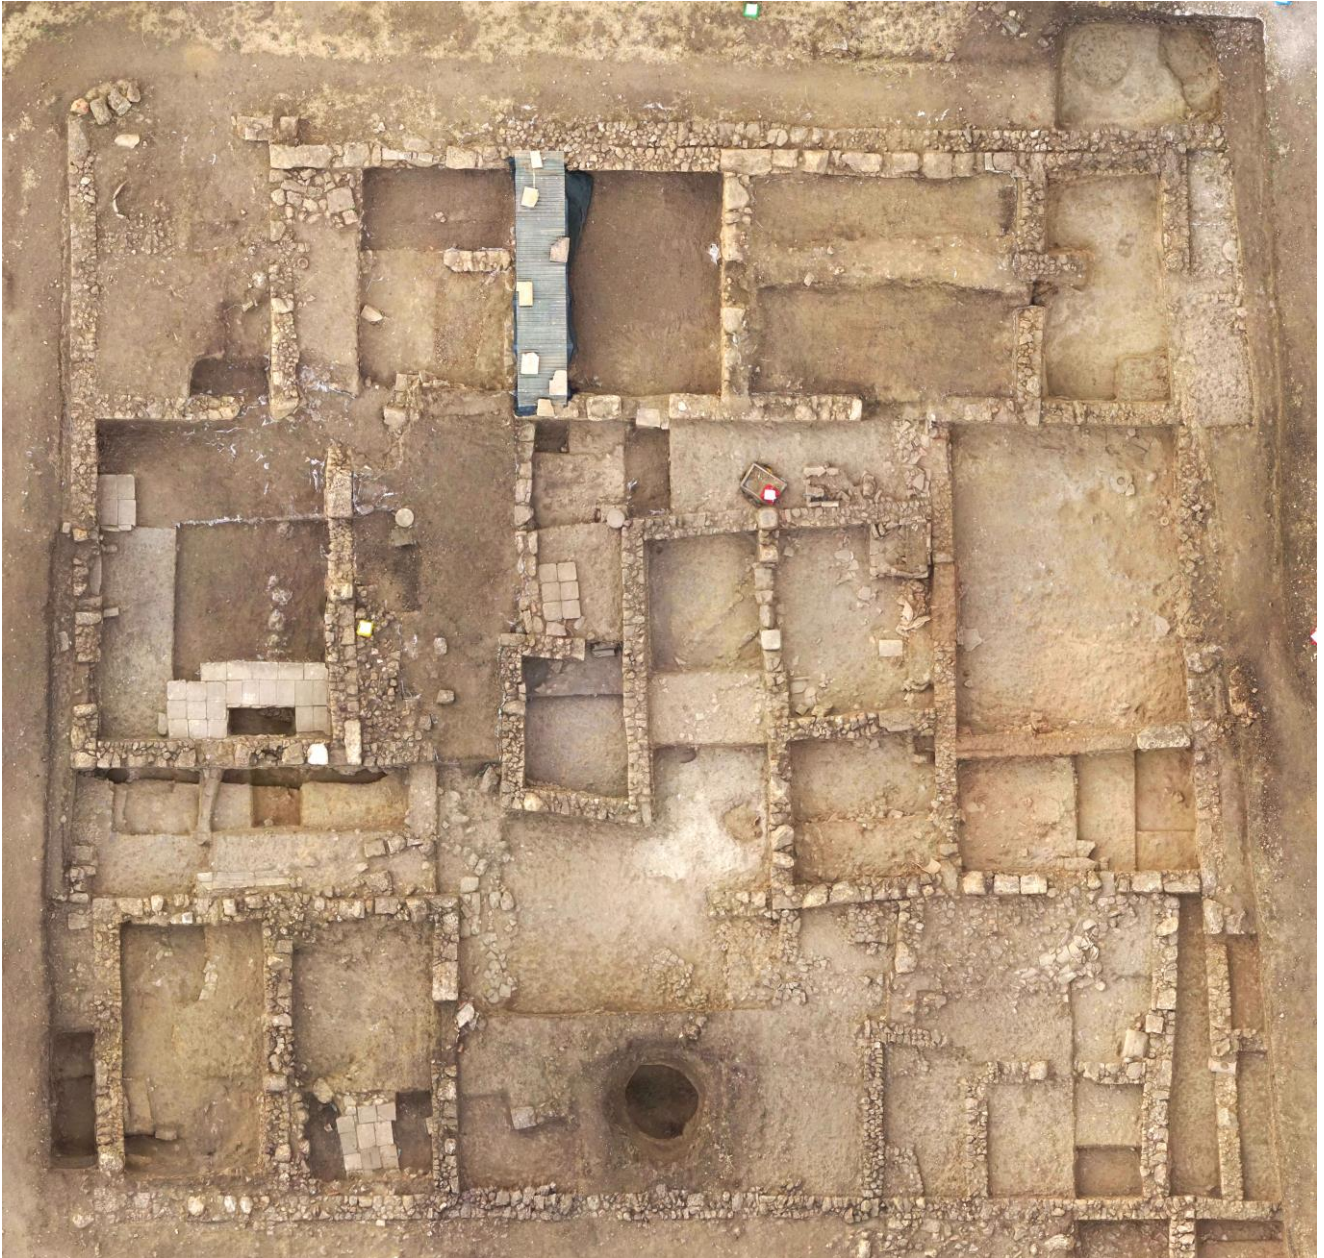
Fig. 26. Aerial orthophoto of the Southeast Building at the conclusion of the 2017 season.

By the close of the 2017 season we had finished defining the limits of the property, as nearly every room of the building was at least partially excavated (fig. 26). Nevertheless, some questions could not be directly addressed this season. Targeted excavations in the future could clarify the phasing of the western boundary wall, identify Phase 1 surfaces in the southern part of the building, resolve the relationship between the Southeast Building and the property to the east, and explore Room 1, which was exposed in previous seasons, but only partially excavated. Further excavations could also refine the absolute chronology of the construction, occupation, and abandonment of the Southeast Building.
