Dearfield: An Early 20th Century African-American Community in Northeastern Colorado: Report to the Colorado State Historical Fund on 2012 Archaeological Field Investigations

**Dearfield: an Early 20th Century African-
American Community in Northeastern
Colorado: Report to the Colorado State
Historical Fund on 2012 Archaeological Field
Investigations**

Colorado SHF Grant #2012-AS010
Archaeological Assessment of Dearfield Townsite

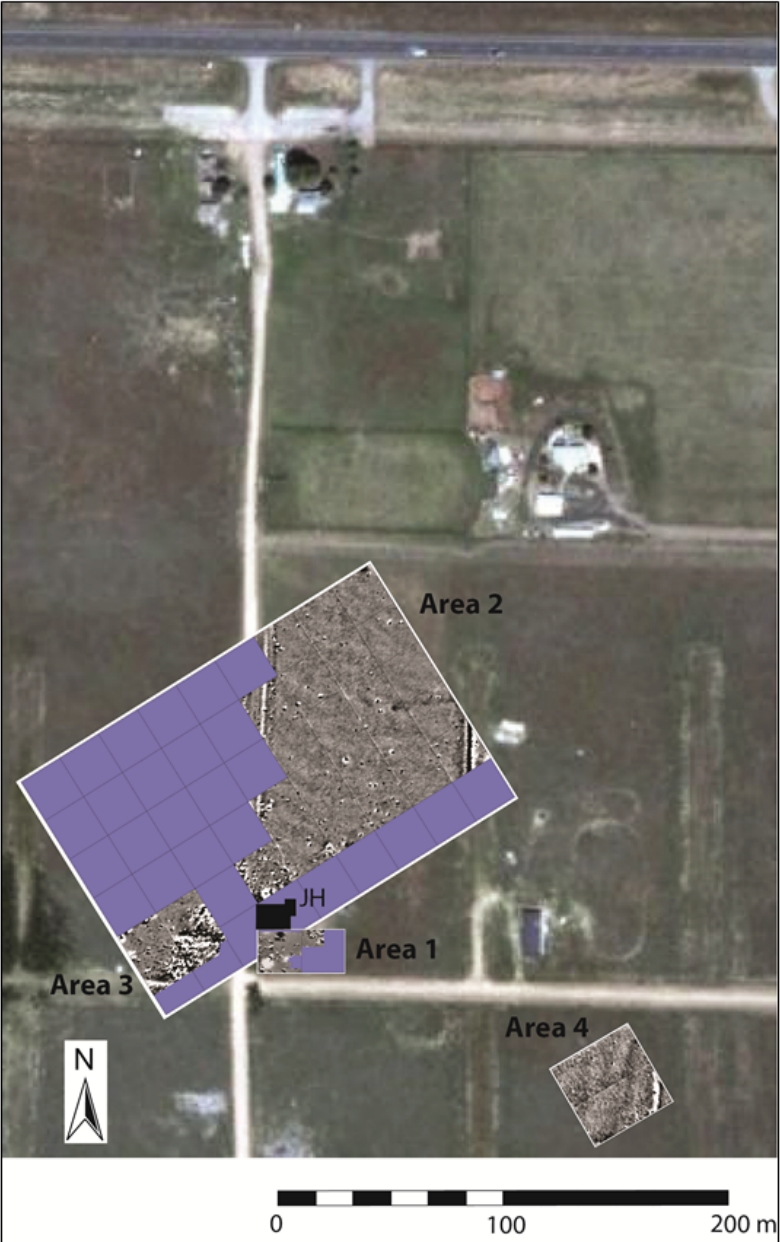
JH=Jackson House

planning and executing the more rigorous and extensive 2012 survey, are reported elsewhere (Creekmore 2011, 2012). Our 2012 geophysics survey covered the area immediately around the standing Jackson House as well as a few isolated survey grids in the supposed location of the church (Figure 2).

UNC's magnetometry survey team collected data with a Geoscan FM-256 gradiometer in 20m X 20m grids at 8 samples per meter with 0.5m-spaced, zig-zag traverses. Traverse spacing was chosen to reflect half the size of the smallest feature that we expect to potentially identify, ca. 1m wide privies. The team experimented with higher resolution, 16 samples per meter, but found that large amounts of metal debris in many grids caused the FM-256 to malfunction because it could not log the very high values fast enough to maintain spatial accuracy. By collecting all grids at 8 samples per meter it was possible to combine and process all adjacent data in single composites. The FM-256 is able to record changes in magnetism up to roughly 1m beneath the ground surface, but features in soils with low magnetism, materials or objects with very high magnetic values may be sensed at depths just over 1m (Clark 2000:78 – 80).

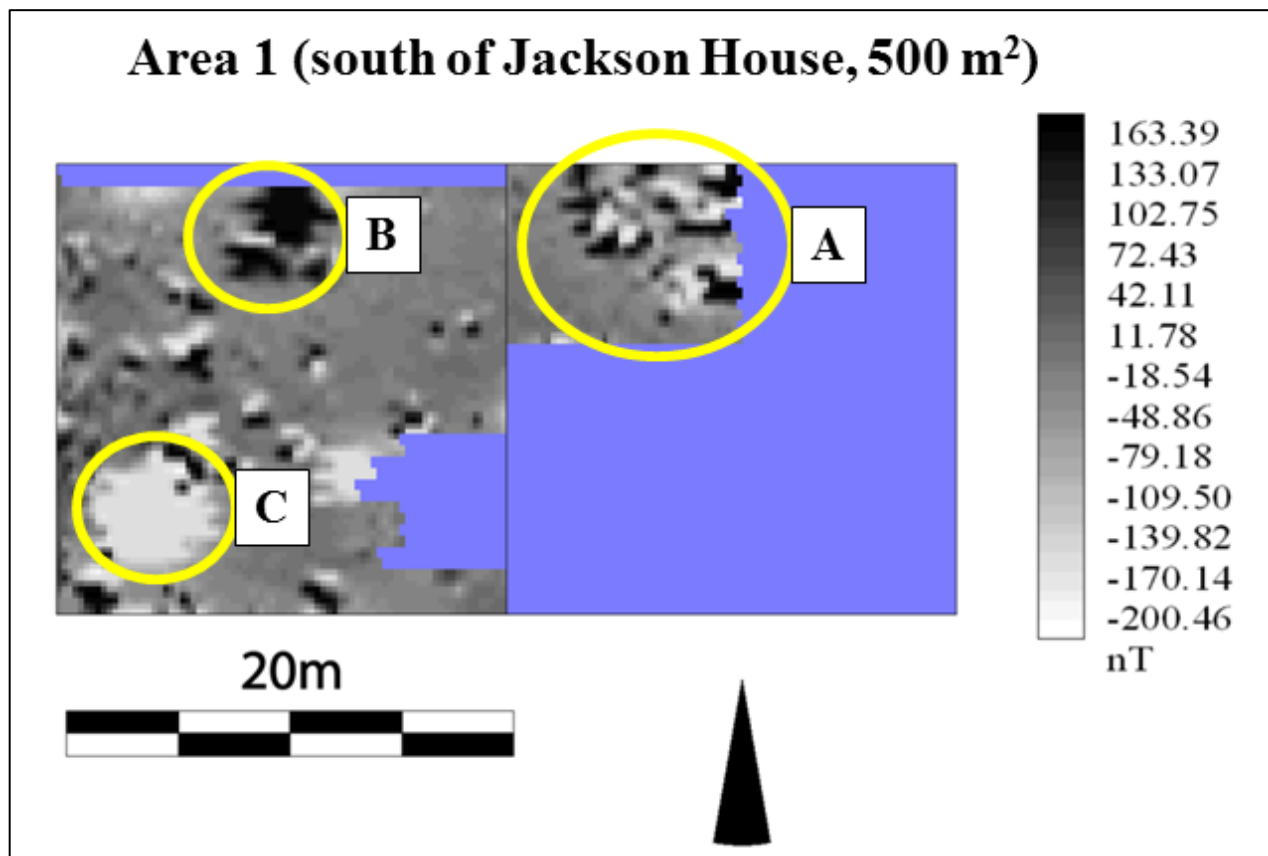
Figure 3. Area 1: South of Jackson House, after processing (zero mean traverse and destagger applied). A: Strong negative anomaly: tin can burn pile consisting of metal tripod wrapped in chicken wire and filled with burned cans. B: High positive anomaly with no obvious surface correlation. C: Cluster of dipolar anomalies: area of tin roofing, nails, and other metal debris.

In order to fit grids into a small open space between the Jackson House and the fence by the road to the south, large debris piles to the east, and the large tree to the west, we collected data from west to east, parallel to the house. Groundcover consisted of sparse grass. During the survey, we observed many metal objects on the ground, including tin cans, nails, tin roofing, and other debris. These materials appear in the magnetogram (see Figure below) as strong dipolar (hi/lo) values marked by localized, paired black/white areas. The most notable anomalies in this area included a large, strong negative anomaly surrounding a standing tin can burn pile consisting of metal tripod wrapped in chicken wire and filled with burned cans (Figure 3:A), a large strong positive anomaly next to the Jackson House (Figure 3:B), and a cluster of dipolar anomalies in the back yard of the house (Figure 3:C). Anomaly B probably derives from a large ferrous object buried in this area. Anomaly C clearly corresponds to metal debris on the ground surface. Notably there is a relatively magnetically quiet area in the space between anomalies A, B, and C. This suggests that there was not a structure in this area, since other areas with evidence of structures correspond to dipolar clusters.

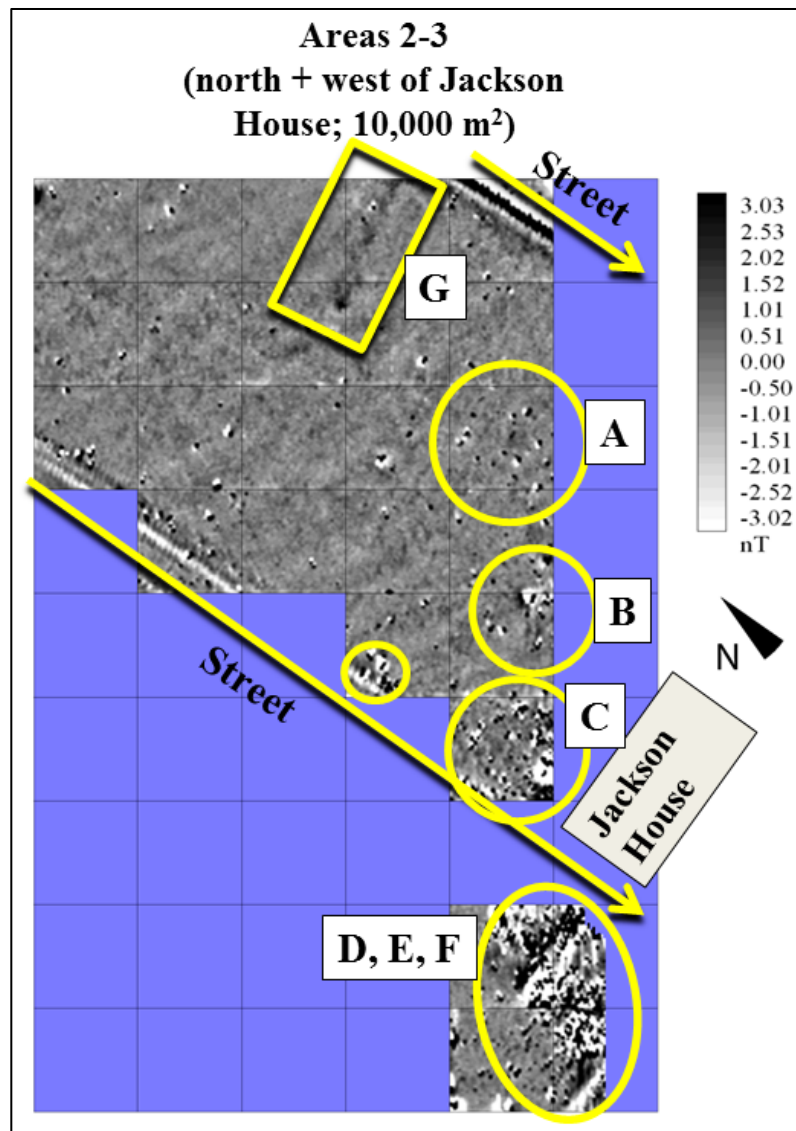
Figure 4. Areas 2-3: North and West of Jackson House, after processing. A-F: clusters of dipolar anomalies. A-C: adjacent to Jackson House. D, E, F: mounded ruins (Barn Pavillion), possible well, high anomaly (metal concentration/dump??. G: long, linear anomaly (former ditch?).

The large area between the Jackson House and the corral contains many isolated dipolar anomalies that most likely source to metal objects (small circled areas in Figure 4). Several clusters of dipolar anomalies occur just north of the Jackson House, with smaller clusters along the western street (Figure 4:A-C). Anomaly C is in the area where the Jackson House was set temporarily when the foundations were rebuilt over a decade ago. Thus, metal debris in the area

This area is bracketed by streets and ditches visible on the ground surface and in the magnetogram. There is one significant non-ferrous, linear anomaly in this area, Anomaly G (Figure 4: C). This anomaly has values elevated by just a few nT, indicating a soil source rather than a ferrous source. This anomaly is roughly perpendicular to the road to the east, suggesting that it may correspond to a pathway or drainage connecting the road to a lost structure, although there is no evidence for a structure aside from these isolated dipolar anomalies.

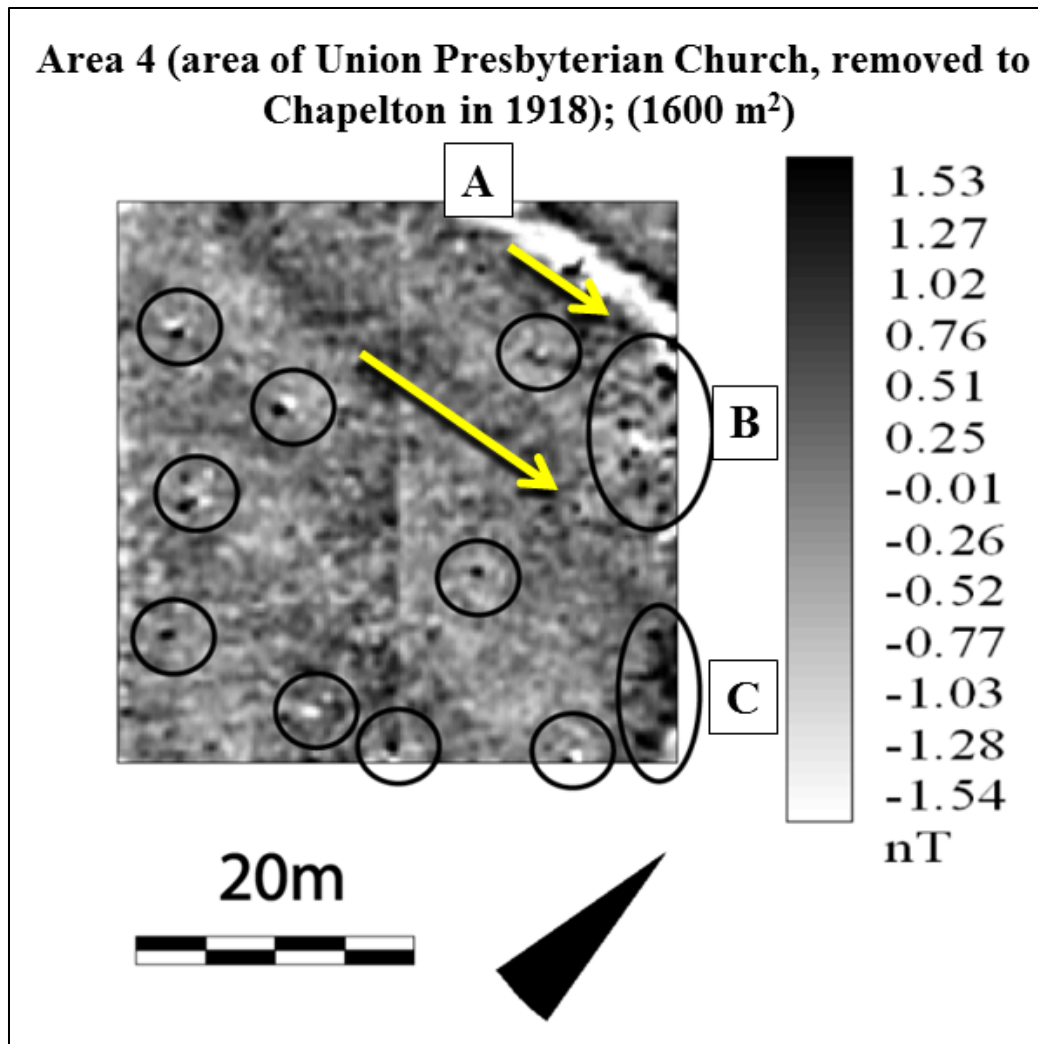
Figure 5. Church lots area (4), after processing, anomalies marked. Unlabeled circles indicate isolated dipolar anomalies. A: Ditch along street to the north. B: cluster of dipolar anomalies. C: higher positive values near the ditch next to the road to the east (just off-grid).

The amount of ferrous materials is very small, suggesting that either there was not a structure at the location or that the area was kept very clean and the structure was removed before it was allowed to collapse and scatter debris.

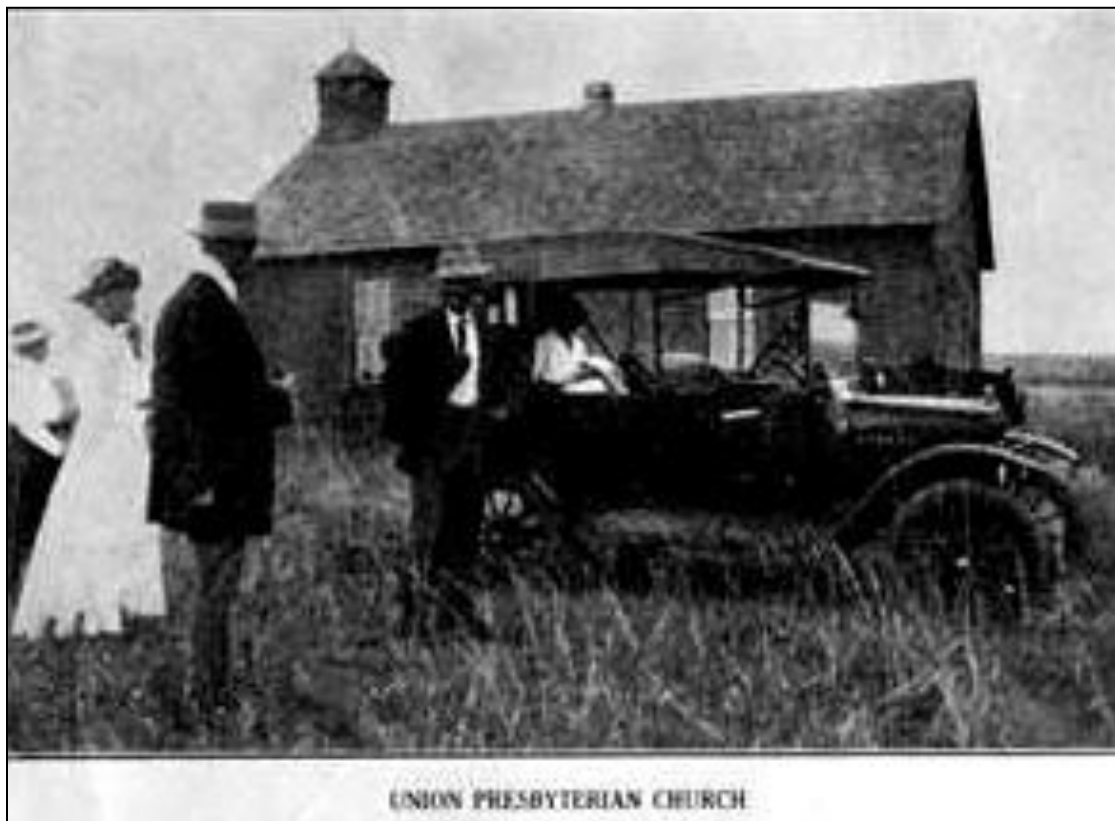
Figure 6 . Photograph of the Dearfield Union Presbyterian Church, ca. 1918-1919. Source: W. Harsha 1919 Remarkable Progress at Dearfield. *The Southern Workman* 48(4):185.

A photograph of the Presbyterian church (Figure 6) was shown in another article by the same author (Harsha 1919) three years later.

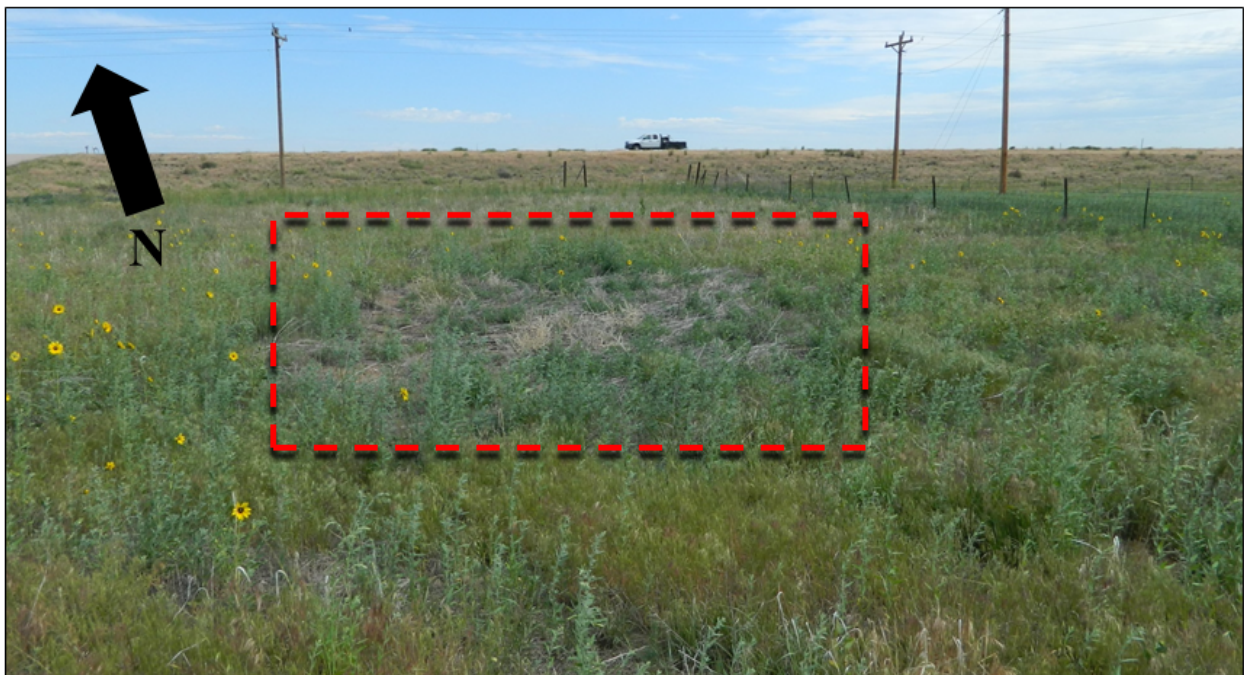
Figure 7. Physical footprint location of “House in Block 4” in July 2011.

local resident informants, were designed to determine when the building was removed from its 1994 and what its earlier history was in relation to the historic town of Dearfield. Excavations of the location where the “House in Block 4” stood in 1994 took place in 2011. Detailed results of those excavations are described in UNC’s 2011 research report (Brunswig and Kordischova 2012: 11-25). The structure’s former location was physically evident in a rectangular patch of brown vegetation and scatter of building debris (bricks, window glass, nails, plaster, etc.) southeast of the Dearfield filling station (Figure 7).

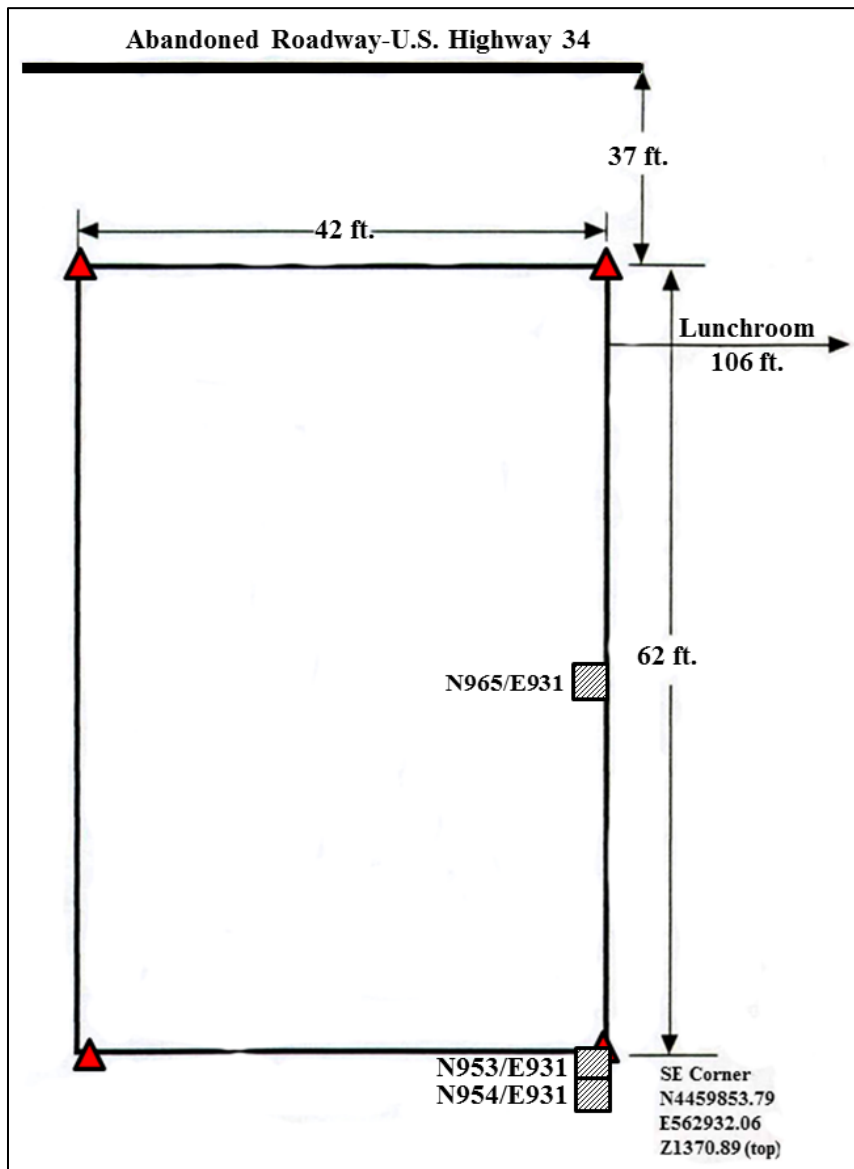
Figure 8. Outline map of the “Cement Foundation” structure showing its dimensions, distances to the Lunchroom, the now abandoned-corridor of U.S. Highway 34, and locations of the 2012 UNC test excavation units.

SHF-grant funded field investigations at Dearfield in July 2012 included three 1-meter test unit excavations at the Foundation (5WL744.2) structure/feature (Figure 8).

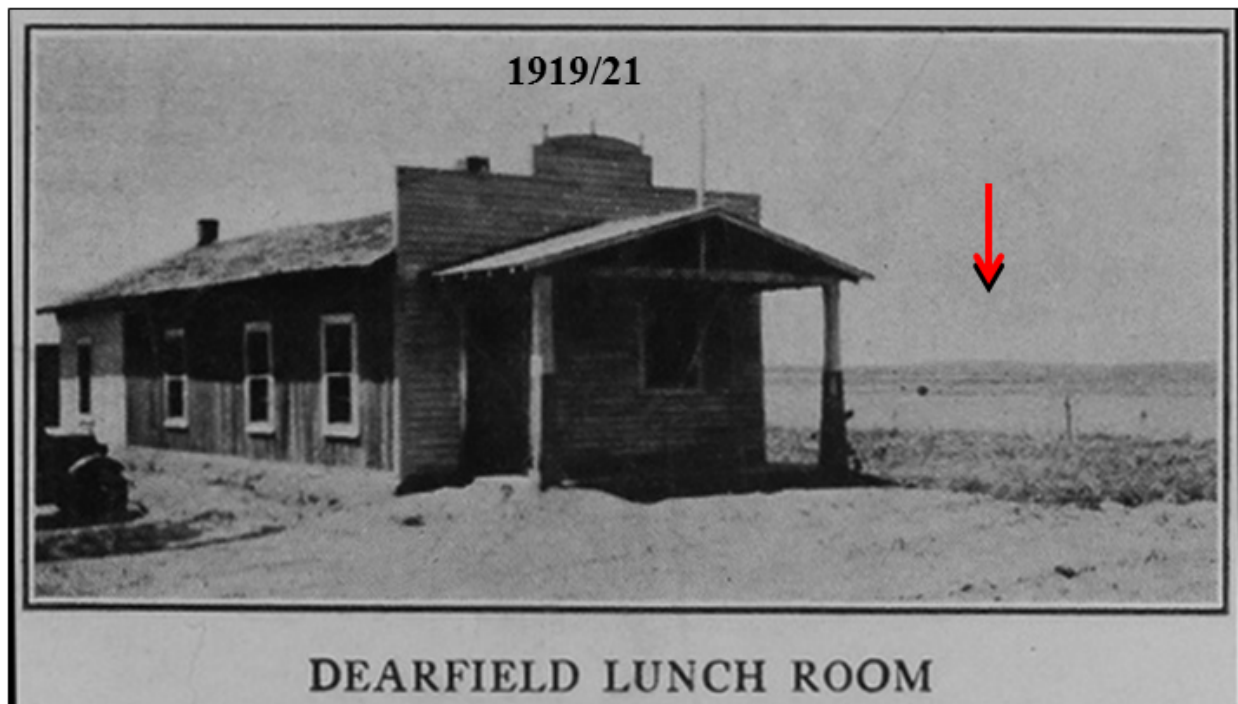
Figure 10 . Historic photo of the Lunchroom showing the area to the west (red arrow). It shows the Barn Pavillion previously identified once sitting on the concrete “foundation” did not exist at that location in *circa* 1919-1921. Photo is from the Dearfield’s Valley Resort

The poster was part of an advertising campaign to attract regional African American visitors to the town site in order to help to stimulate economic and social prosperity through recreational opportunities (fishing, hunting, week-end dances) once commodity prices dropped after World War I. However, early in the Dearfield Dream Project, a computer-based comparison of the foundation's current physical dimensions with those reconstructed from the above historic photo of the actual Barn Pavillion in the valley resort poster showed the actual pavillion was somewhat smaller than that of the existing concrete foundation. Further, a 1919-1921-era photo of the Lunch Room (5WL744. 1), located immediately east of the foundation (Figure 10 below), showed neither the presence of a building nor a concrete foundation in its current location..

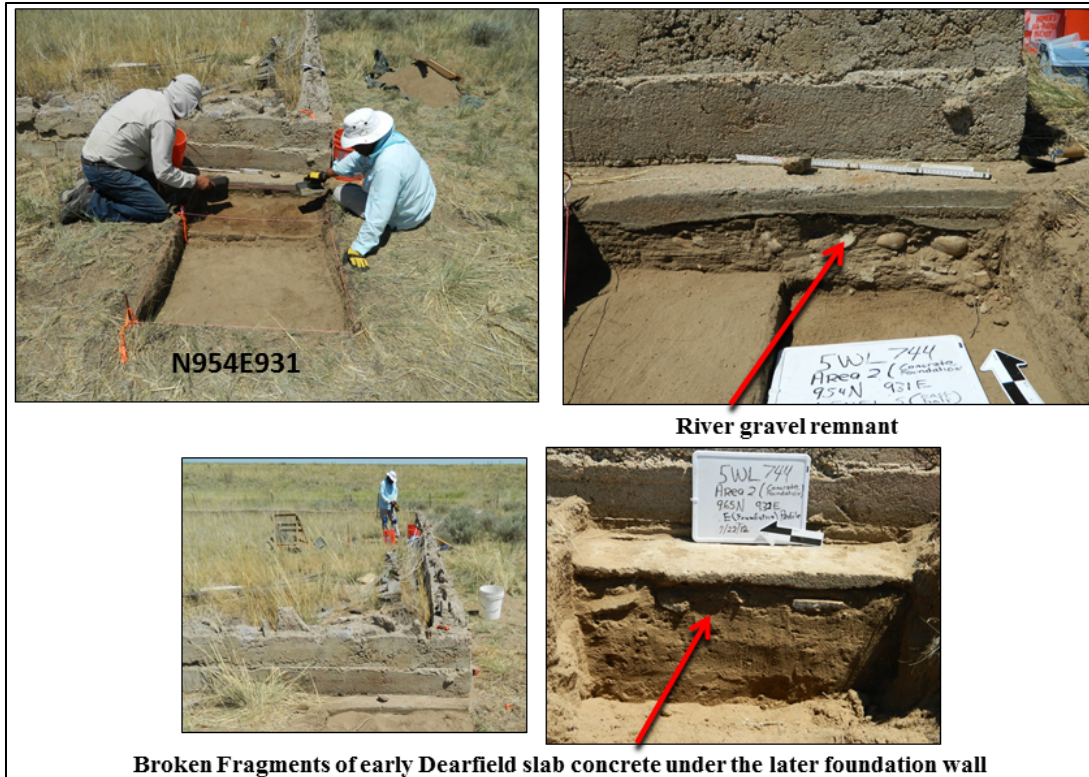
Figure 12. Foundation wall excavation unit photos showing earlier aggregate construction material (top photos) and earlier broken concrete slab fragments, all dating to earlier Dearfield and pre-dating construction of the wall.

Test excavations at both locations alongside the foundation established that its construction was mid-20th rather than early 20th century. It was determined that the wall's base at both locations overlay cultural deposits dating to the early-mid Dearfield occupation periods. In the southeast corner of the structure, two excavation units uncovered river gravel and cobbles from the South Platte, consistent with aggregate used to manufacture the rough hand-poured concrete found in other site building foundations dating to the site's early construction period (Figure 12, upper photos). The aggregate material does not occur naturally in the fine dunal sand on which all the site's buildings are built and its presence below the wall is interpreted as remnants of a concrete-manufacturing aggregate pile used to make concrete for nearby buildings, including the adjacent Lunchroom and Blacksmith's Shop. Artifacts found embedded in the loamy sand matrix below the foundation base (described below) provided additional evidence that the wall post-dated the early decades of the town site. Interior (east) wall excavation provided even further evidence of its later construction. As shown in Figure 12 (lower photos), broken pieces of concrete pavement underlie the base of the foundation wall footings, concrete which has been broken up and transported (deposited?) from earlier floors or slabs elsewhere.

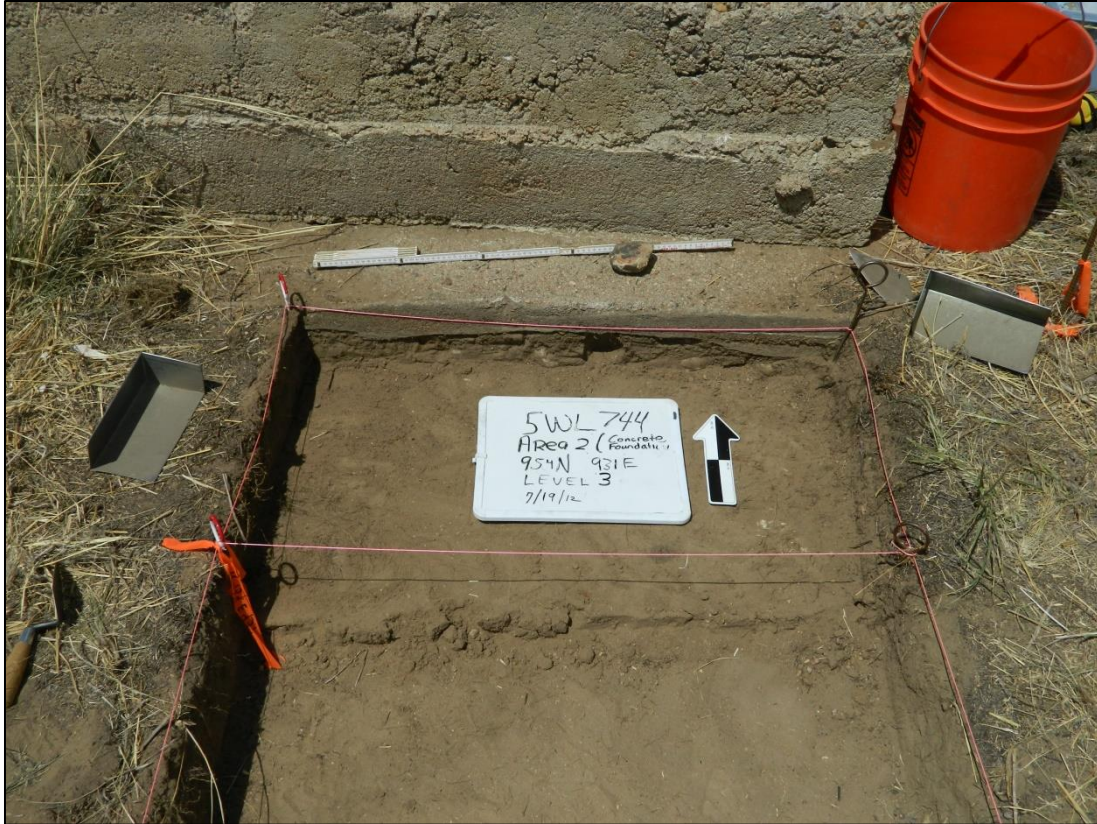
Figure 13. Photo of the southeast corner exterior wall excavation units. Note the wider footing which extends beyond the wall and its relative thin nature, extending 7-8 cm below the modern ground surface.

Two excavation units were placed against the southern edge of the foundation wall with the east edge of the units being aligned with the north-south exterior margins of that wall (Figure 13).

The wall was poured over a thin (7-8 cm deep) footing which extended 10-12 cm outside (and inside) the wall itself.

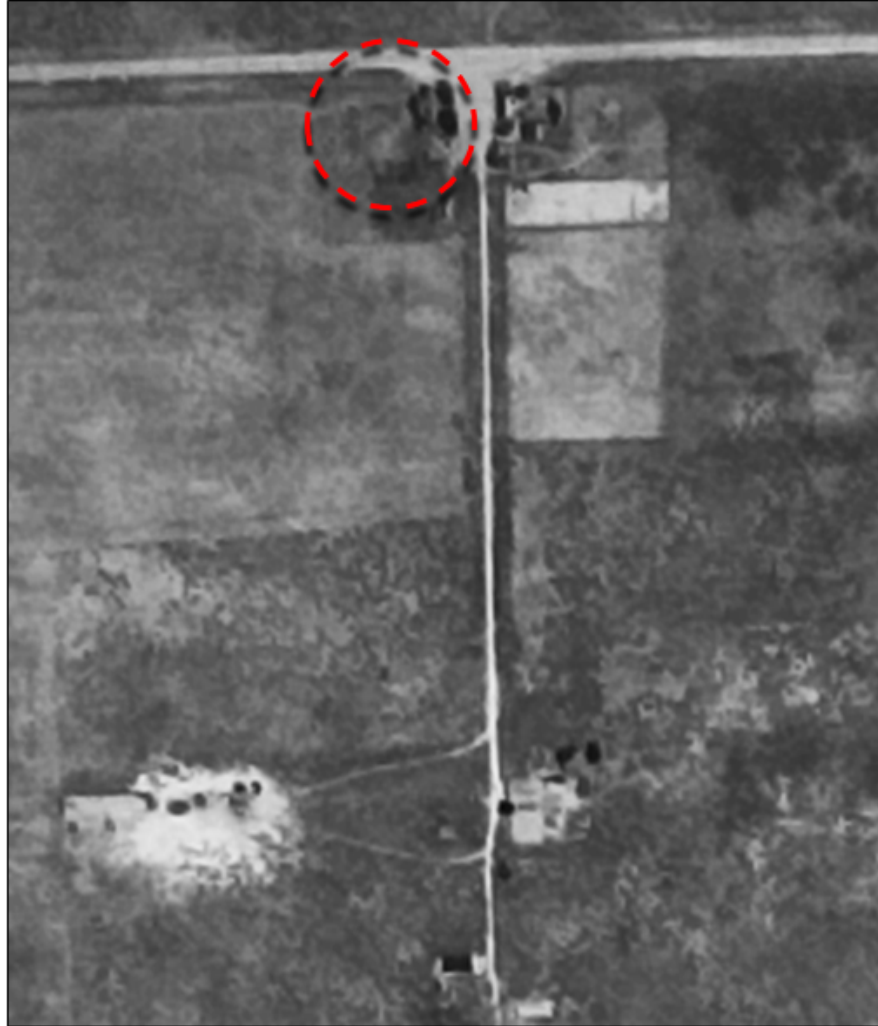
Figure 14. 1949 Aerial photo of the Dearfield town site. The red dashed circle shows the Lunchroom and the concrete foundation area to the west. Although there is insufficient detail to see if the foundation is present, it is apparent no building occupies the location in 1949.

Along with the early Dearfield Lunchroom photograph not showing a building to the west, a 1949 aerial photograph fails to show a later building at the same location (Figure 14).

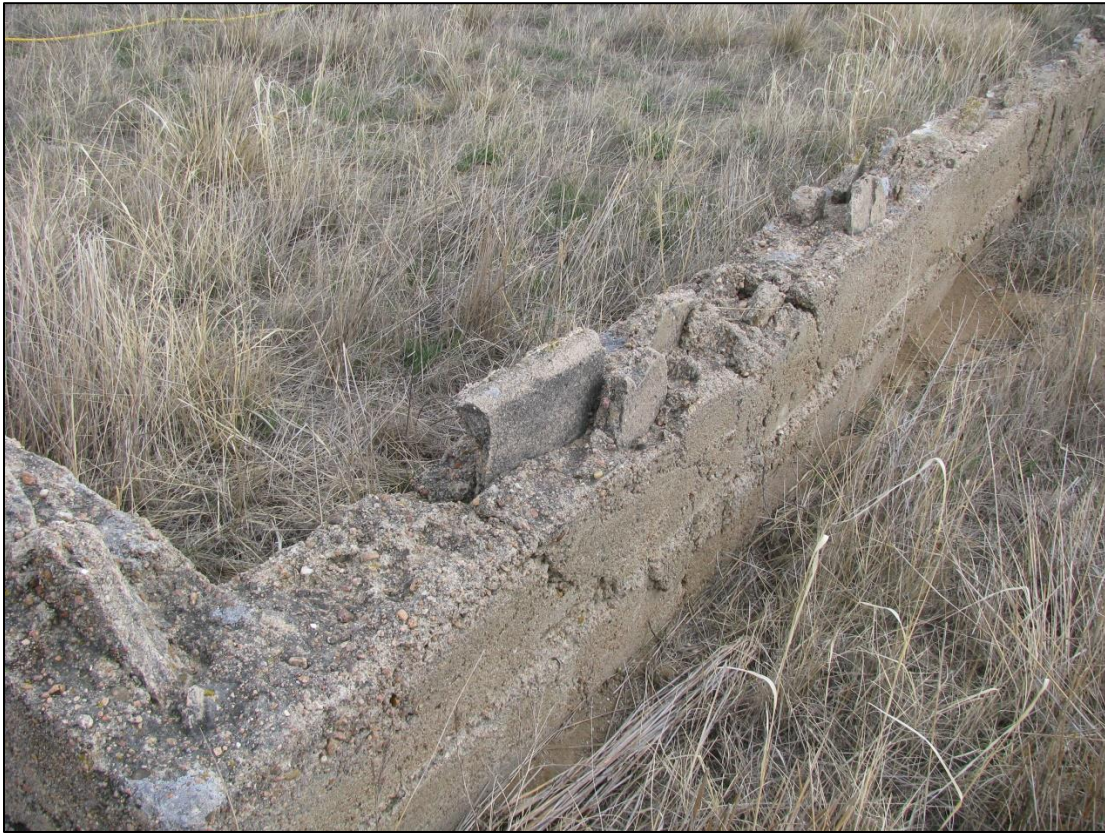
Figure 15. Section of the concrete wall showing broken slabs and chunks of broken concrete set into the formerly wet concrete along the top of the wall, creating an uneven jagged effect incompatible with supporting a building floor and walls.

concrete wall was inset with upward projecting, jagged chunks of broken concrete emplaced when the wall was constructed (Figure 15).

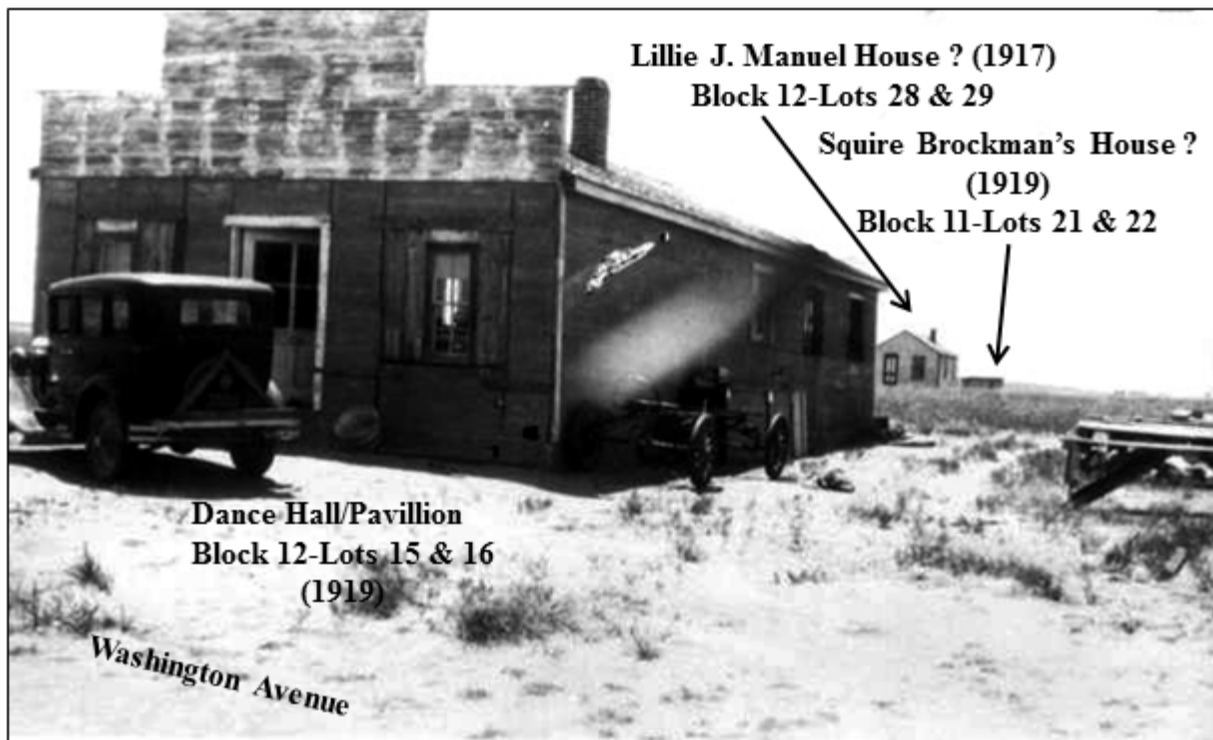
Figure 16. Photoshop-processed historic photo of the Dearfield Barn Pavillion with two houses in the background. Photo from Black American West Museum archives (from copy not original).

most distant of two houses visible in the photo's background resembles the low pitch, north-south roof peak profile and central door flanked by side windows perspective of the Squire Brockman house, still partially intact some distance west of the Dearfield Lodge/Jackson House (cf., Brunswig and Kordischova 2012:45-46). The closest, intervening house in the photo is now missing although limited historic surface debris in the area where it may have once existed is still present. That house, provided the Block 12, lots 15 and 16, location of the Barn Pavillion (west of the Dearfield Lodge) is correct, sits on Block 12 lots 28 and 29) which were then owned by Lillie J. Manuel (Waddell 1994:Appenix 12). The town lots on which the Barn Pavilion is suspected to have been located (Block 12, lots 22, 23 and 24) was purchased originally by Charles W. Brown and Burt Griffith in early 1914. A Denver Star article recorded the purchase:

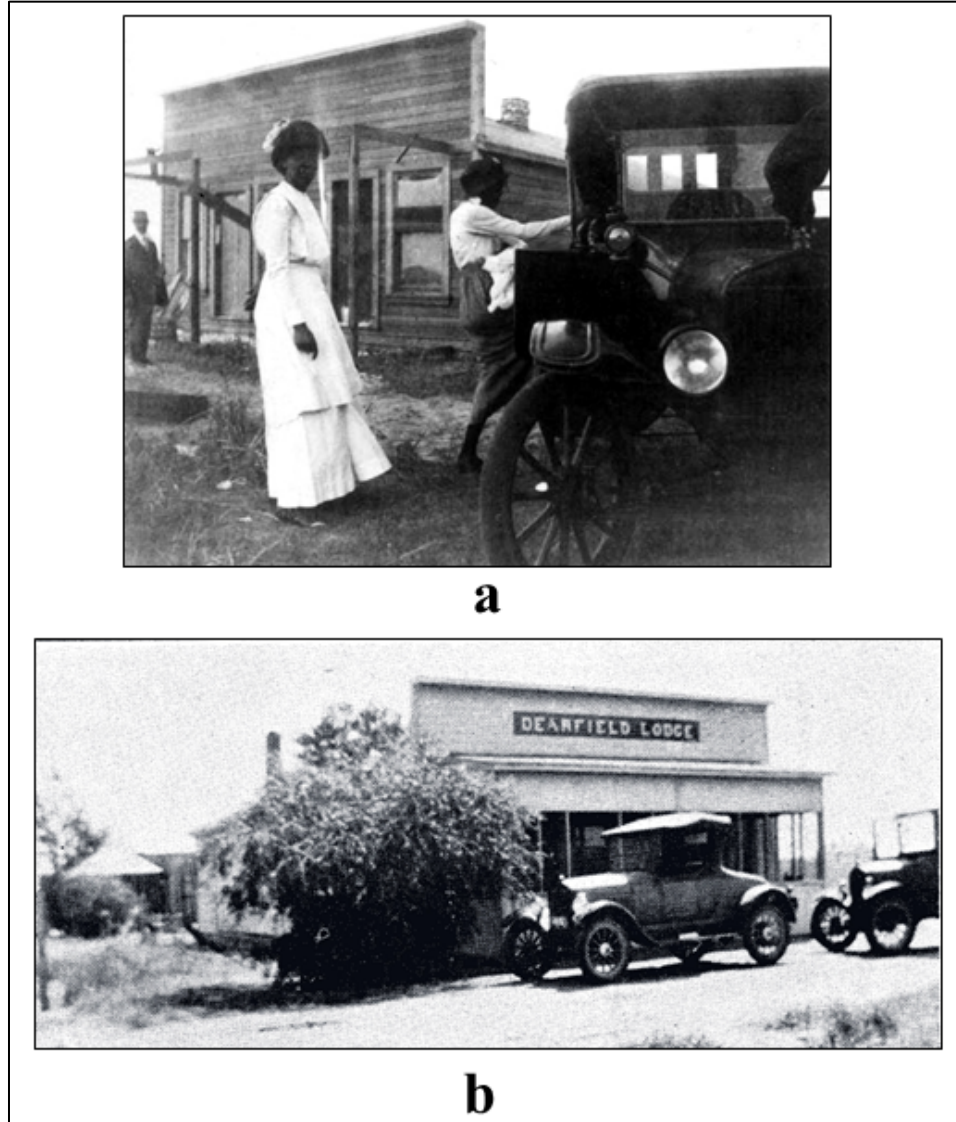
Figure 17. a: early phase (circa 1914-1918) of Dearfield Lodge completion. Note the front porch remains incomplete and the lodge sign and building’s white paint are still missing. The woman in the photo may be O.T. Jackson’s wife, Minerva. Photo from Denver Public Library Archives. b: fully completed version of the Dearfield Lodge with outbuildings visible in the back-yard (circa 1918-1921). Photo from Dearfield Resort advertising poster shown in Figure 9 above.

Archival and historic photographic sources indicate that the Dearfield Lodge, now known as the Jackson House, was constructed between 1914 and 1918, presumably by its original lots owner, O.T. Jackson, founder of Dearfield (Figure 17a and b).

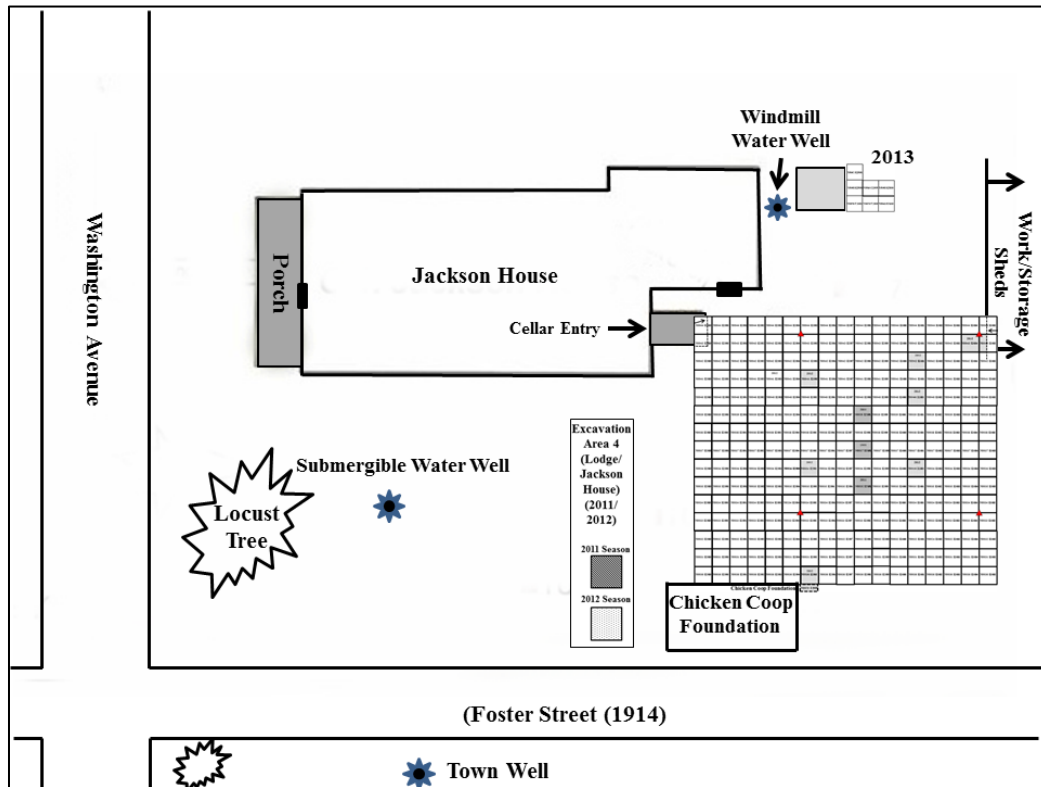
Figure 18. Plan map of the Dearfield Lodge/Jackson House showing the 2011-2012 and 2013 excavation blocks.

Excavations of eleven broadly spaced 1 m² grid units within an open area southeast of the Dearfield Lodge/Jackson House took place in 2011 (Brunswig and Kordischova 2012) and 2012 (this report) and excavation of a smaller grid block was done immediately east of the house was done in 2013 (Figures 18, 19, and 20).

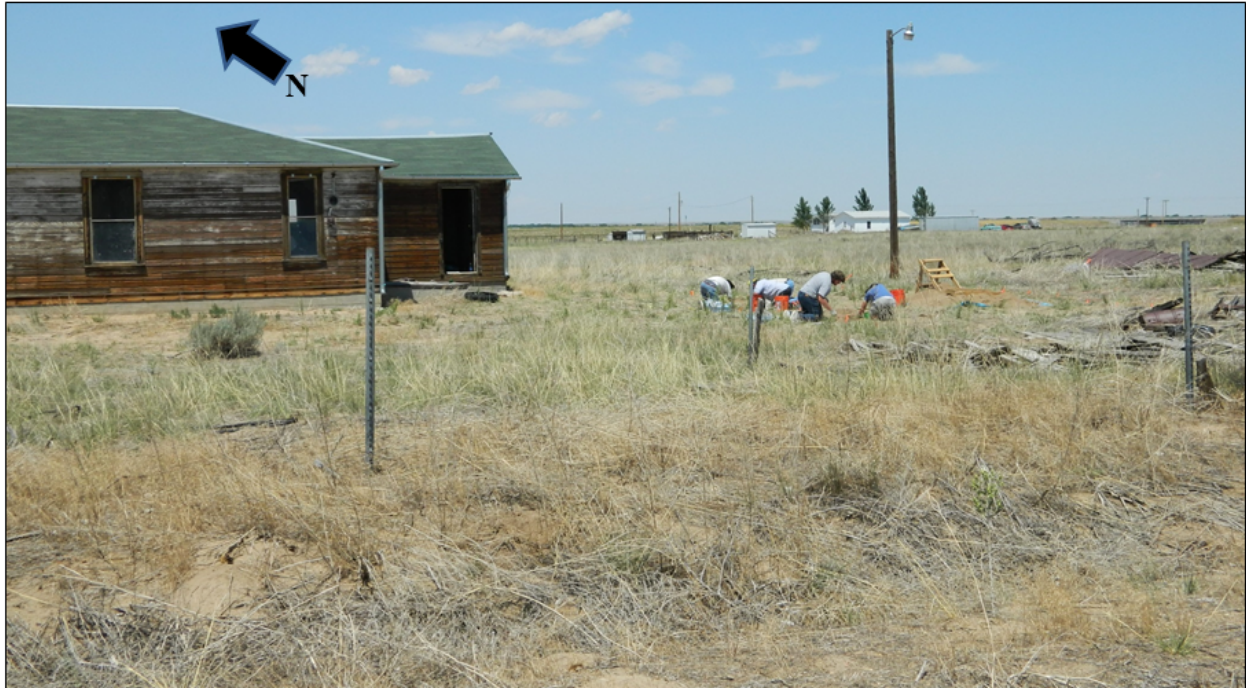
Figure 19. Overview of the southeast half of the Dearfield Lodge/Jackson House backyard area where test excavations were conducted in 2011 and 2012.

Figure 19 shows on-going excavation of the southeast backyard area in 2011. Fallen remains and concrete foundation of a chicken coop are visible in the center right of the photograph and a tin roof and fallen wall debris are visible beyond the coop area.

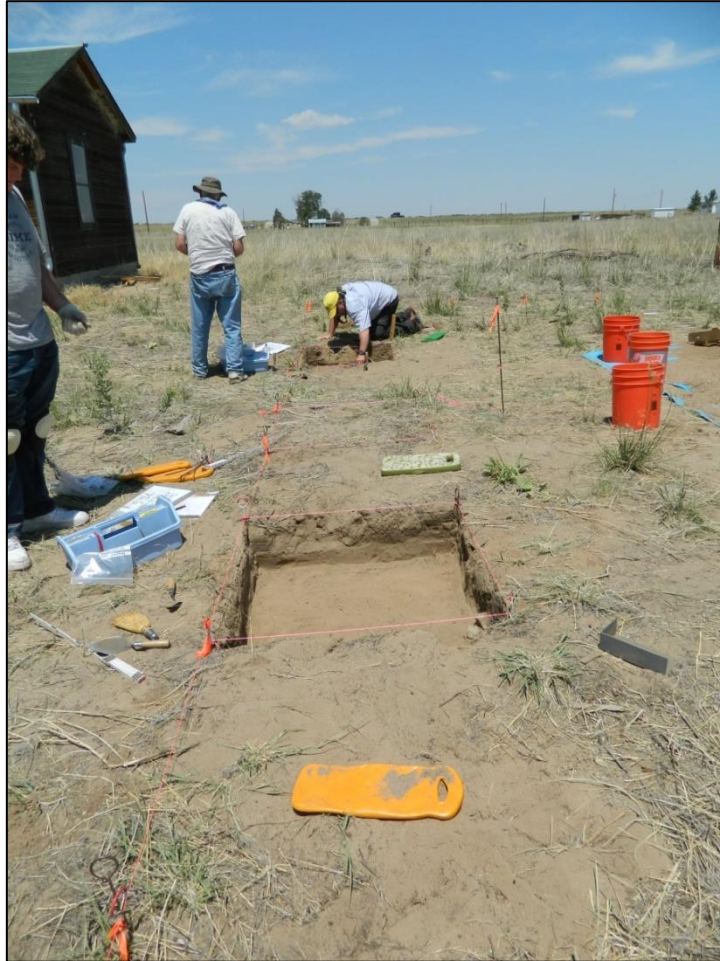
Figure 20. North overview of the western-most line of 1 m² grid units. The near unit is N9936 E2995 and the further unit is N9941 E2995.

Figure 20 (below) provides a north overview of 2011 excavation units.

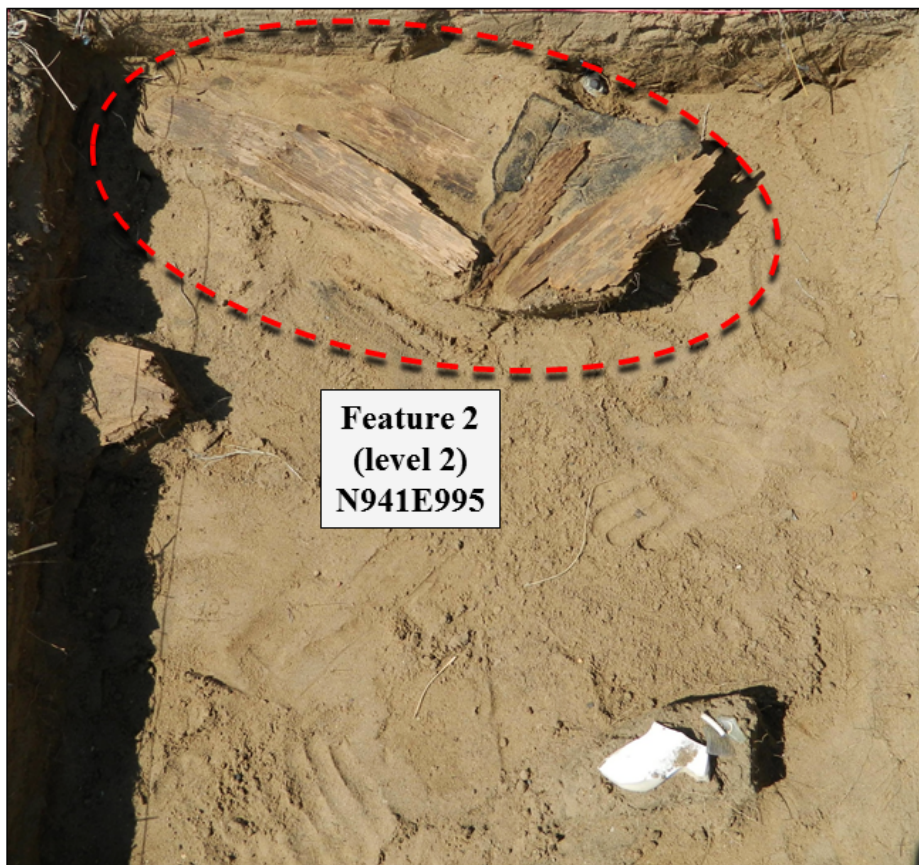
Figure 21. Feature 2-mass of wooden shingle still attached with roofing nails to undelay tar paper.

Representative examples of features include the following. Feature 2 (2011), shown in Figure 21, is a section of wood shingles still attached to thick “underlayer” tar paper. Consultation of pre-2001 Jackson House stabilization/conservation photos (ca. 1990-1998) show that the house had heavily weathered asphalt-composite shingles, probably applied to its roof 20-40 years previously (between 1950 and 1970) and prior to the passing of the house’s last occupant, Jennie Jackson. This would mean that the wood shingles of feature 2 likely pre-dated 1950-1970. Since a storage/work shed lying collapsed at the eastern boundary of the house’s backyard still retain its metal roof sheeting, the wooden shingles didn’t derive from that structure and probably reflect an earlier roofing of the house. The shingles and tar paper were found embedded in levels 2-3, ~5-10 cm below the modern ground surface.

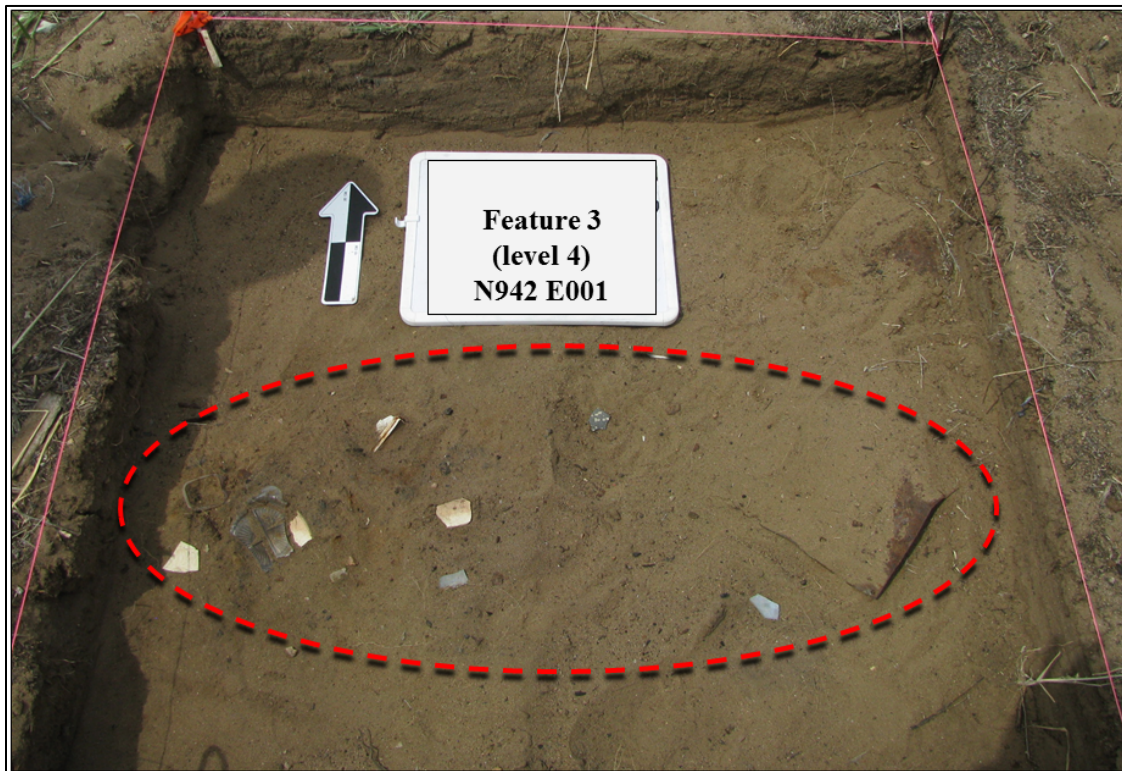
Figure 22. Feature 3-probable trash burner clean-out dump pile with mainly domestic artifacts (metal food can remnants, porcelain plate sherds, a broke ash tray...) mixed with small charcoal fragments and ash.

Feature 3 (2012) provides another example of a feature type encountered in the backyard's southeast quadrant. It was documented from level 4 (16-25 cm below surface) and provides a good representative example of a scattered domestic trash midden (Figure 22). It was found to contain flattened and fragmented sanitary food cans, broken white plate porcelain, a broken ash tray fragment, metal sheeting with small intact nails, and window glass, all mixed with fine charcoal and ash. The presence of charcoal and fine ash without evidence of soil reddening suggests a trash burner clean-out pile.

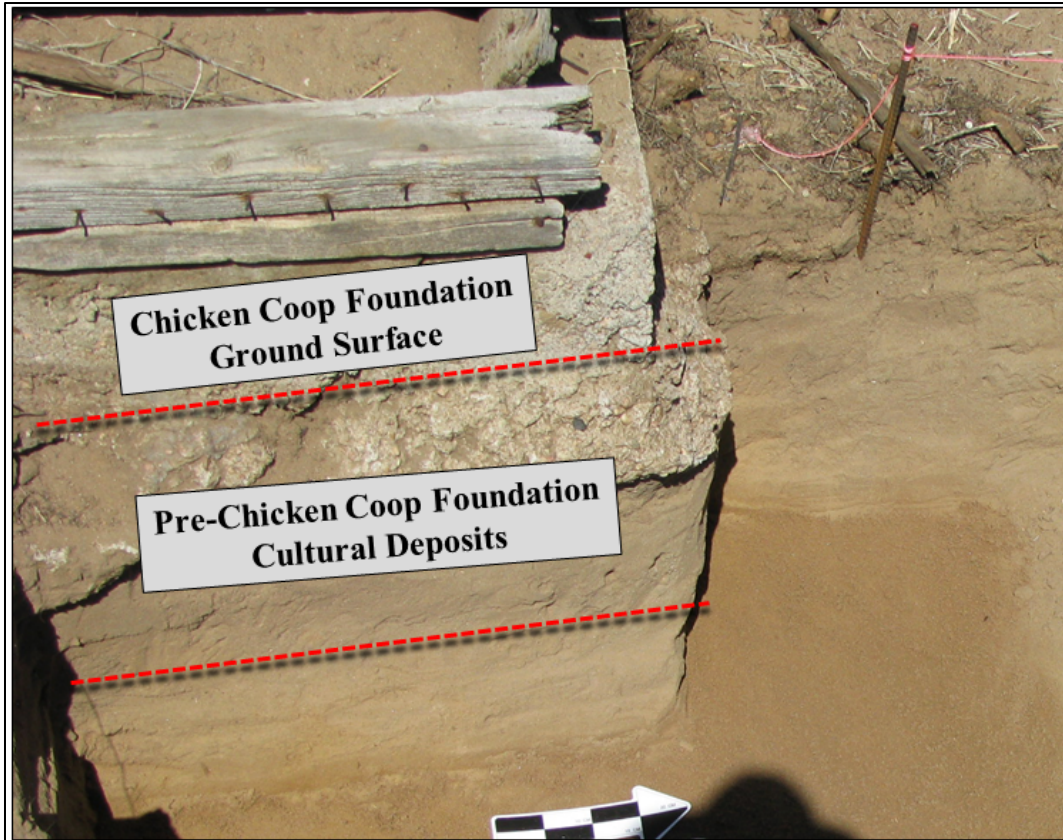
Figure 23. Profile of the northeast corner of the Dearfield Lodge/Jackson House chicken coop. Cultural deposits are marked by the two horizontal red dashed lines. The darker soil zone below the foundation base and the lower line represent pre-coop construction occupation of the house lots.

in chicken yard (cf., Brunswig and Kordischova 2012:27-29). The excavation (Figure 23) extended below the concrete wall footings and documented cultural deposition, marked by a darker soil with glass, nails, charred wood, concrete and brick fragments, and, interestingly, fragments of oyster shells, all mixed with fine ash and charcoal. The post-chicken coop foundation deposits were 20 cm thick (extending to level 9, 40+ cm below surface) and rested on a natural light yellow sand surface (see Figure 23, lower profile). The stratigraphic sequence suggests that the chicken coop may have been a later addition after the Dearfield Lodge ceased to be used for lodgers and the Jackson family permanently occupied the building by the mid to late 1920s. The presence of crushed oyster shells in deposits below the foundations, fed to chickens to increase calcium in their systems for laying less fragile eggs, suggests that chickens were probably being raised in the backyard with the earliest construction of the Dearfield Lodge but that an earlier chicken coop did not have a concrete foundation. Only later (by the mid-late 1920's or 1930s?), was the coop rebuilt (or temporarily shifted off and then reshifted back on) with a new concrete foundation. In addition to the crushed oyster shell, the presence of fine eggshell in the earlier cultural deposits would also reflect their being mixed with chicken feed to also increase levels of calcium for better quality eggs.
