Dearfield: An Early 20th Century African-American Community in Northeastern Colorado: Report to the Colorado State Historical Fund on 2012 Archaeological Field Investigations

**Dearfield: an Early 20th Century African-
American Community in Northeastern
Colorado: Report to the Colorado State
Historical Fund on 2012 Archaeological Field
Investigations**

Colorado SHF Grant #2012-AS010
Archaeological Assessment of Dearfield Townsite

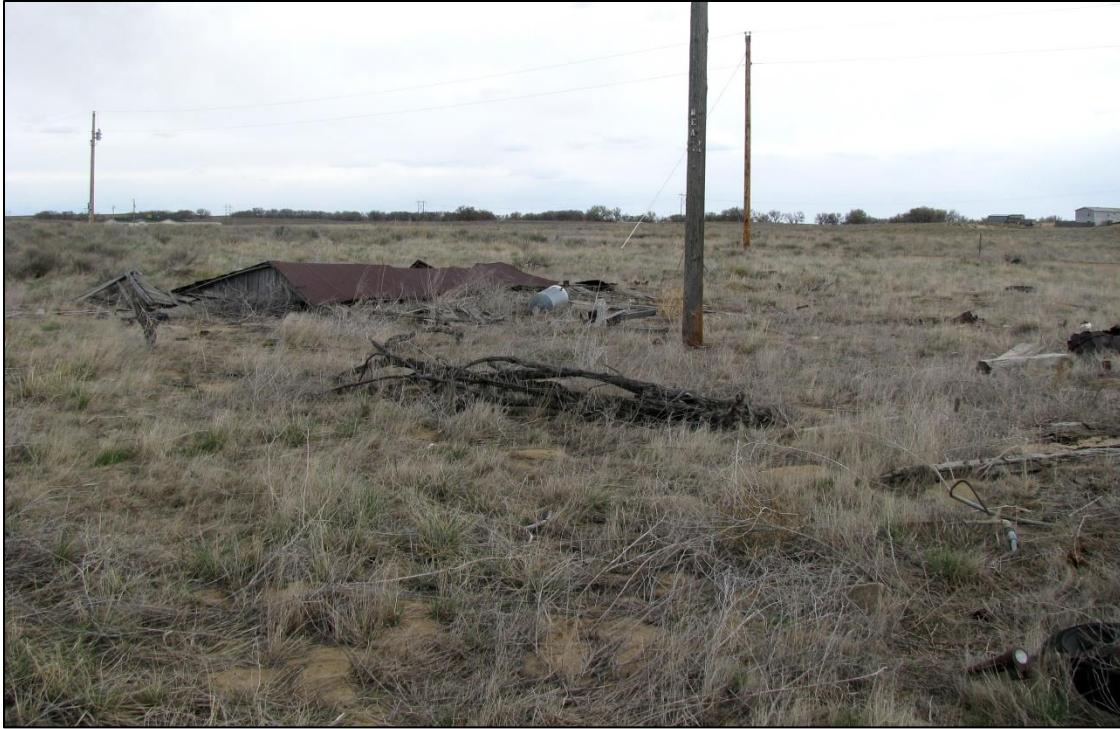
Figure 25. View to southeast east of the Dearfield Lodge/Jackson House showing the roof of the collapsed shed known to have been present in early Dearfield.

Just inside the eastern boundary of the Dearfield Lodge/Jackson House lots once stood a long north-south oriented work and storage shed. The shed was constructed early in Dearfield's history and the earlier Figure 17b historic photograph of the Dearfield Lodge clearly shows the shed standing the lodge's backyard. At some time in the past half century, the shed collapsed and lies on the ground with its roof largely intact today, shown in Figure 25).

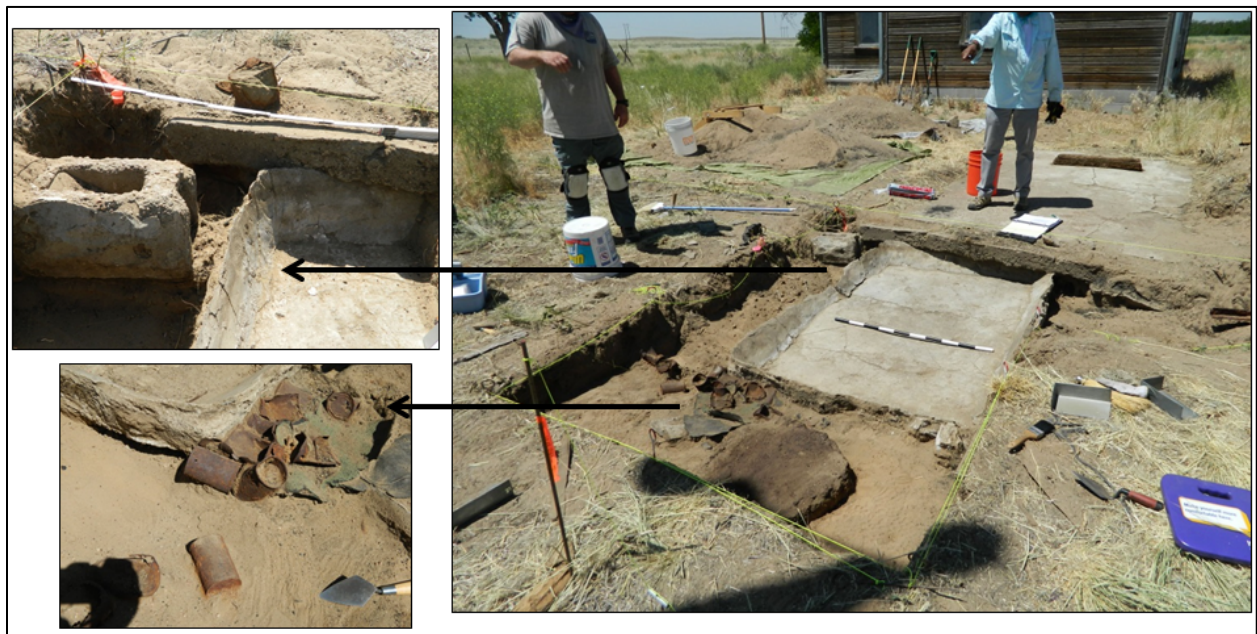
Figure 27. Overview of the concrete mixing trough (Feature 6, right photo) uncovered in 2013 along with a concrete block (upper left), a sanitary food can dump (Feature 8) at the trough's southeast corner and a fused rusted metal mass (Feature 9) east of the trough.

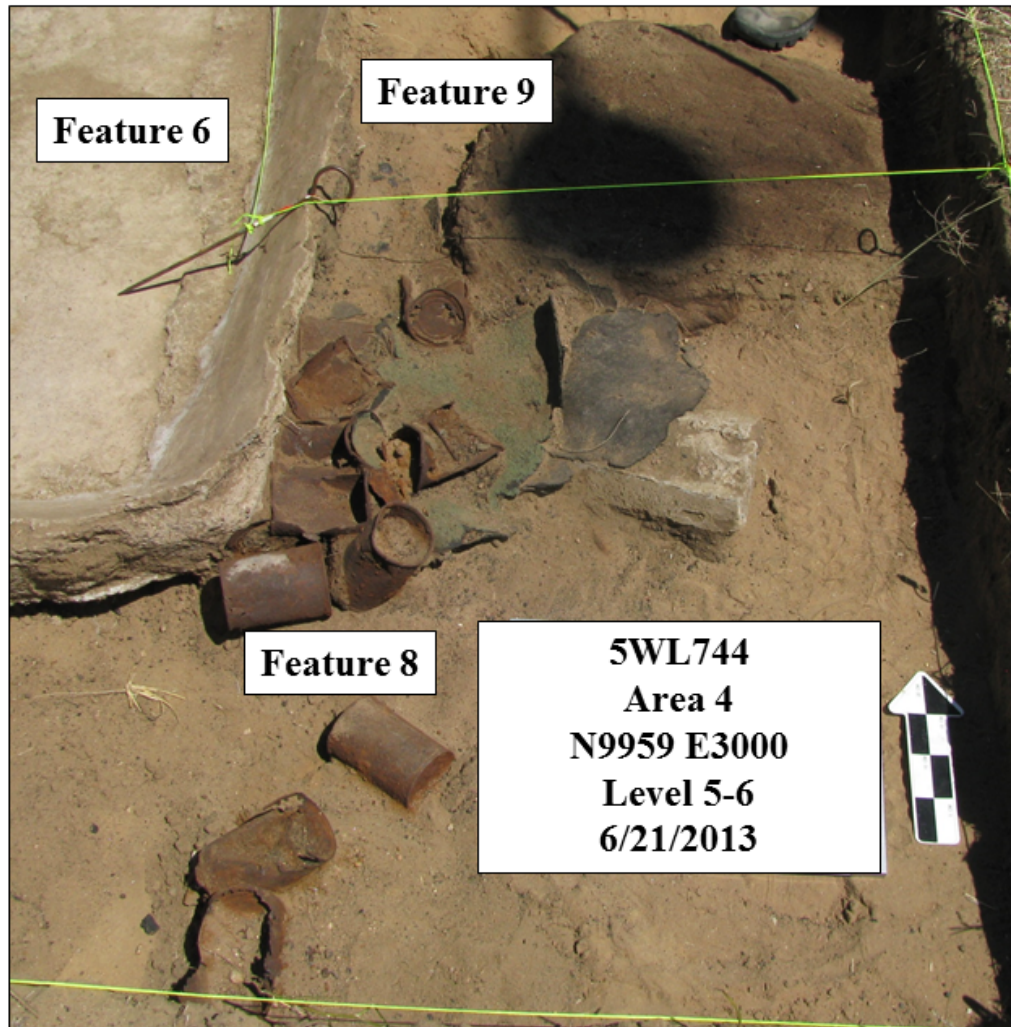
Figure 29. Close-up photo of the can dump and metal “mass” features (8 and 9) at the east end of the concrete mixing trough (Feature 6).

Feature 6 concrete mixing trough (Figure 29). Feature 9 is a disintegrated rust-fuse mass of largely unidentifiable metal situated off the eastern end of the trough feature. Feature 8 is a can dump, consisting of several sanitary (food) cans corresponding to the lapped side-seamed type first manufactured in 1904 and becoming almost universally common by 1911 (cf., Horn 2005:4).

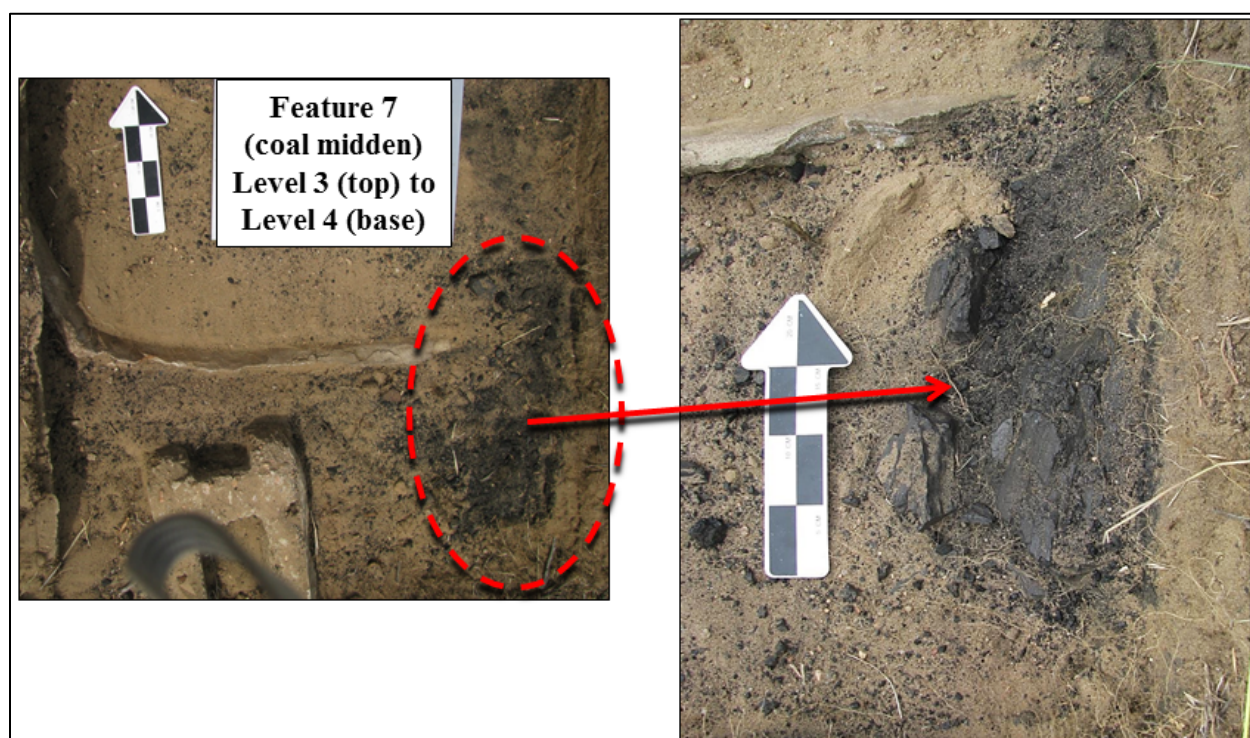
Figure 30. Photographs of the southeastern corner of the Feature 7 coal concentration, illustrating the large size of coal pieces found in that part of the feature.

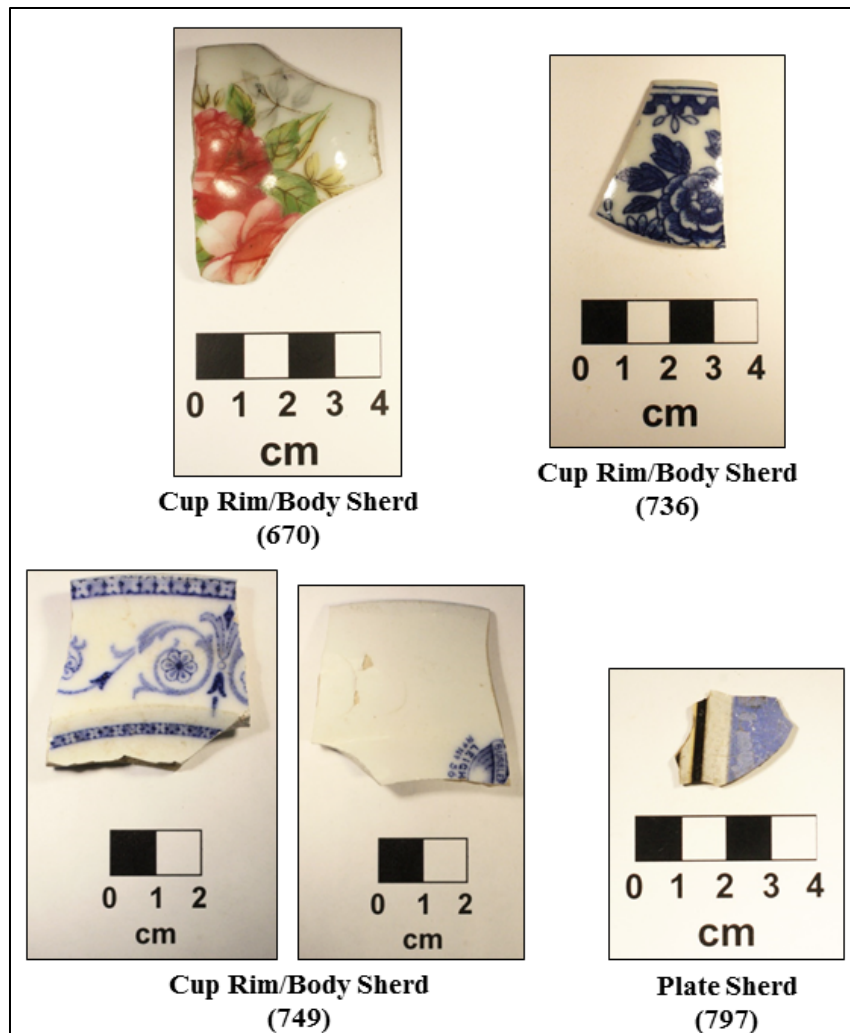
Figure 31. Examples of Dinnerware sherds recovered from the Dearfield Lodge/Jackson House excavations (2011-2112).

As discussed in the earlier “Cement Foundation” section, both high and lower quality dinnerware are occurring in site cultural deposits. Figure 31 shows examples of three fine-quality tea (or coffee) cup sherds and a plate sherd of what was probably more of “everyday” dinnerware. One cup sherd (Figure 31, no. 749) was identified as being from the Leighton pattern manufactured by Burgess and Leigh of Burslem, Staffordshire, England (Kowalsky and

Kowalsky 1999: 134, 521, and 613). Maker's marks on one of the lodge/Jackson House sherds provided a pattern patent registration number 567168/1910 showing it was being produced between 1910 and 1950. This particular sherd was found in level 4 at a depth of ~18 cm. A second cup sherd with an elaborate blue flower design (Figure 31, no. 736) is also fine-quality porcelain. As noted earlier in the "Cement Foundation" section, it appears in deeper deposits below that structure and while its manufacturer and manufacturing date have yet to be determined, its pattern corresponds well to early 20th Century English porcelain designs. Other yet-to-be catalogued examples from the 2013 excavation east of the house were found in deeper (levels 4-5) deposits. Of course, the pattern may have been in use early in Dearfield's occupation history and discard of its broken pieces could easily span decades with gradual breakage of individual setting pieces. A third design occurs on a fine-bone china cup sherd, consisting of pink and white flower pedals and green leaves over a white glazed background (Figure 30, no. 670). Again, the pattern is reminiscent of earlier 20th Century ceramics but an exact match to the pattern has not been yet found. Finally, a plate sherd with a light blue broad stripe and a narrower black stripe represents a lower quality, probably more every day dinnerware example (Figure 30, no. 797). The sherd was found on the surface and is a match for a similar sherd found east of the Lunchroom building by one of the authors (Brunswick) in 2012.
