# Assessing the Sheltering Response in the Middle East: Studying Syrian Camps in Jordan

**Abstract**—This study focuses on the sheltering response in the Middle East, specifically through reviewing two Syrian refugee camps in Jordan, involving Zaatari and Azraq. Zaatari camp involved the rapid deployment of tents and shelters over a very short period of time and Azraq was purpose built and pre-planned over a longer period. At present, both camps collectively host more than 133,000 occupants. Field visits were taken to both camps and the main issues and problems in the sheltering response were highlighted through focus group discussions with camp occupants and inspection of shelter habitats. This provided both subjective and objective research data sources. While every case has its own significance and deployment to meet humanitarian needs, there are some common requirements irrespective of geographical region. The results suggest that there is a gap in the suitability of the required habitat needs and what has been provided. It is recommended that the global international response and support could be improved in relation to the habitat form, construction type, layout, function an

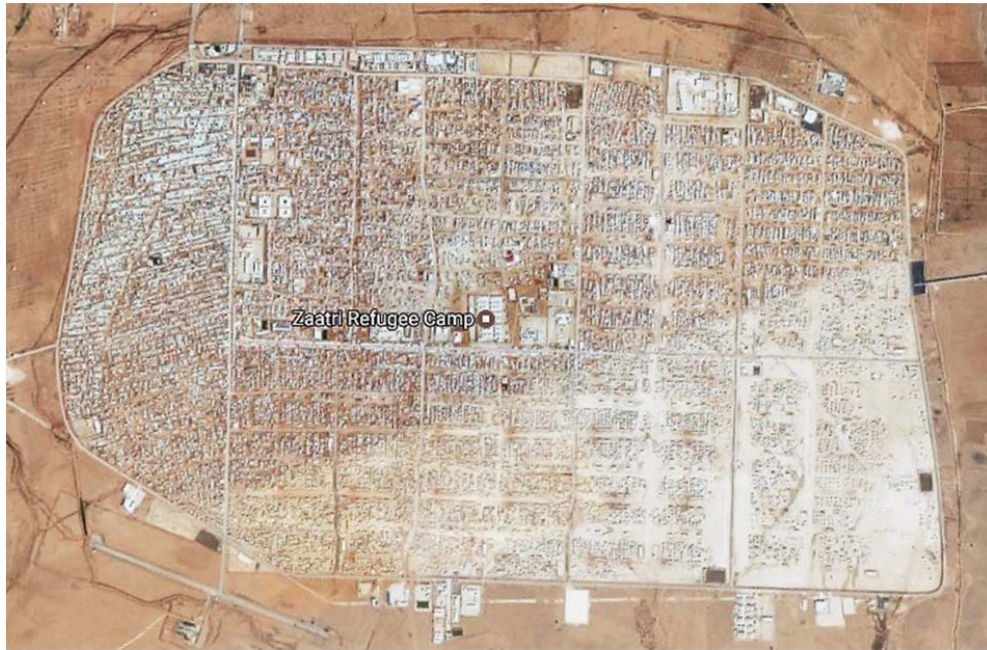
Fig. 1 Zaatari camp general map [10]

Zaatari camp has an area of 5.3km<sup>2</sup> [7], hosting 79,737 refugees [4]. It is divided into 12 districts, each district breaks up into numbered parcels of land with defined borders called 'blocks', and each block has many shelters (Fig. 1). Azraq has an area of 14.7km<sup>2</sup> [8] hosting 53,833 refugees [9]. The camp is divided into villages, blocks, streets, and numbered shelters. Only villages numbered three and six were opened and used when the study was taken. The outline of the camp is shown in Fig. 2.

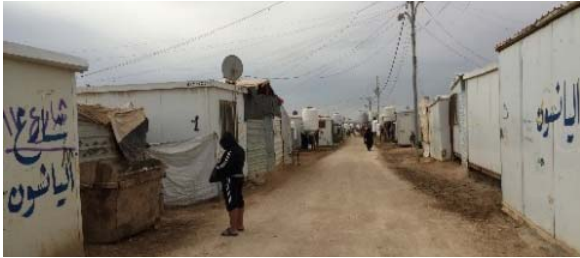
Fig. 3 Zaatari camp street view [13]

When the Zaatari camp was opened in July 2012, the UNHCR provided 70,000 emergency tents to families. But due to the climatic extremes in Jordan and specifically in the northern desert where the camp is located, ranging from winter heavy snow storms to summer high temperatures of over 40°C, agencies decided to replace tents with a more dignified and protective pre-fabricated shelter [9]. The shelter dimensions are (5 m x 2.5 m). The formal original layout of the camp was a grid system where shelters were organized in rows. However, the residents then re-positioned their shelters in compound-like areas, usually forming a U-shape or courtyard. This new layout allowed them to live closer to their extended families and helped in other cases to reconstruct their previous community layout. But these changes formed a maze-like camp map [12]. A street view of the camp is shown in Fig. 3.

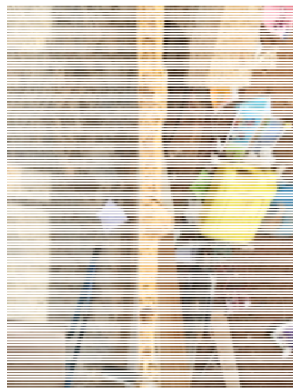
Fig. 4 A section in the wall [13]

- *Walls and roofs:* The prefabricated shelters were made from polyurethane insulated sandwich panels. A section of the wall can be seen in Fig. 4, which was recycled from a shelter's wall and used as a side garden fence. The shelters' quality differs from one to another, but the majority have weaknesses in building fabric leading to air,

dust and water ingress. This is a contributing source towards health problems affecting camp residents.

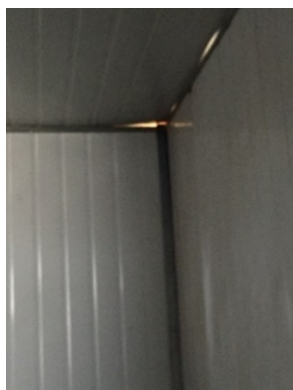
Fig. 5 Gaps between junctions [13]

In an attempt to seal the shelters, especially the roof-wall junctions (Fig. 5), the residents covered the roofs using fabrics they had or bought them, if they could afford them. Some families also tried to expand their shelters by enclosing a space using corrugated sheets and then covered it with fabric,

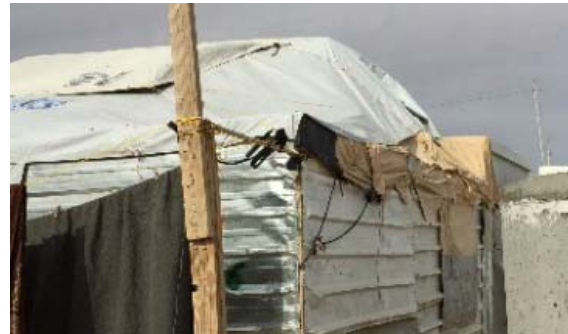
Fig. 6 Extended area example [13]

which is not a durable solution and cannot replace a proper roof (Fig. 6). The expanded area fulfilled some major needs such as providing separated sleeping areas for different genders and ages within the family, or providing a separate area for socializing and receiving guests. Social interaction can be an important aspect to communities in general. This is perhaps more critical for refugees to assist interaction and alleviate the trauma of leaving their home and country.

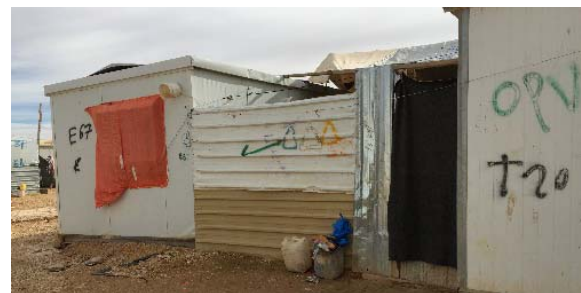
Fig. 7 A covered window to protect the privacy [13]

ventilation function of the shelters. Residents covered their windows from the outside or from the inside (Fig. 7) due to passers-by being able to look into the shelter. Residents stated that having privacy was a necessity and a priority and aligned strongly with cultural and religious beliefs.

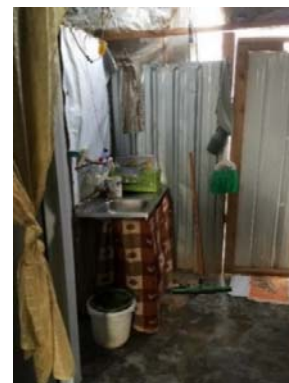
Fig. 8 Self-built kitchen [13]

- **Facilities:** When the camp was first opened, the kitchens and toilets provided were communal. Problems occurred when using such communal facilities from both cultural and privacy/security perspectives. It was found that when residents could afford some materials, they adapted and self-built private facilities adjacent to their shelters. These adaptations included enclosing additional space with corrugated sheets, wood and canvas, if the residents were able to afford materials (Figs. 8 and 9).
- **Outdoor areas:** The courtyard is an important cultural feature in Syrian homes and enclosing an outdoor space

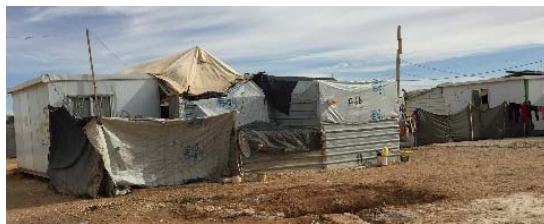
Fig. 10 Private outdoor area [13]

was found to be very important to the camp residents. They often enclosed a space next to their shelter or between two shelters with canvas or corrugated sheets, as shown in Fig. 10. One of the main benefits of such a private area was for women residents to have access to an outside space. This provided safety, privacy and aligned to their cultural needs.

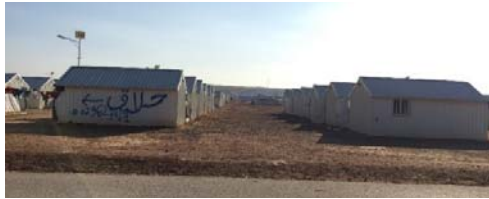
Fig. 13 Street view from Azraq camp [15]

Azraq camp is the second largest formal Syrian refugee camp in Jordan, nearly 50 miles south-east of Zaatari (Fig. 13). It is a purpose-built camp, which has taken account of lessons learnt from the Zaa'tari camp. The camp opened in April 2014 due to the increasing number of refugees in Jordan. It was constructed with 13,500 T-shelter units to accommodate 67,000 refugees [16], but according to UNHCR statistics, only 39,893 Syrians were living in the camp until April 2016 [4]. Recently, since the Zaatari camp was unable to receive more refugees, all new arrivals were directed to the Azraq camp. The number of Syrian residents in the camp until February, 2017 are 53,833 [4].

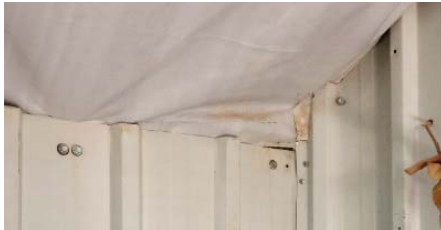
Fig. 14 Sharp edges in cladding [15]

- **Walls and roofs:** The junctions between the walls and the roof are not well-sealed and were found to leak water and dust. Residents mentioned they preferred a flat roof rather than a pitched roof, as they thought this would be easier to seal and it was more familiar to them. Due to the camp's strict policies regarding making any changes to the shelters, residents could not change the roof. The wall heights were low; however, the pitched roof design did provide more head-room. The overlapping of the internal metal cladding sheets resulted in sharp edges, as shown in Fig. 14, and residents had stated that injuries had occurred.

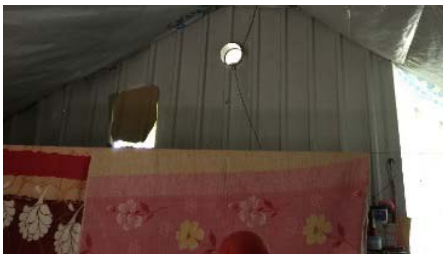
Fig. 15 Blanket dividers [15]

The shelter is a basic design involving a one-room plan. The original design had indicated ‘partitioning wires’ to support fabric room dividers, but were never installed. Residents believe that it is not acceptable culturally nor religiously to have different ages and genders sleeping in the same room. They erected their own fabric dividers using their own sheets or blankets as and when required (Fig. 15).

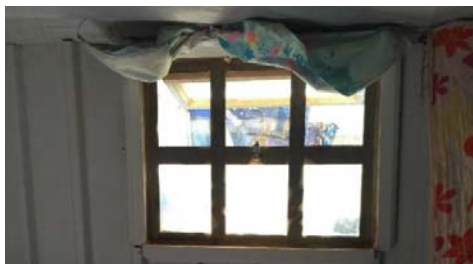
Fig. 16 The T-shelter window [15]

- **Windows:** Shelters in Azraq camp have only one small window (Fig. 16). The problem is increased as residents close their windows and shade them using fabrics because they directly overlook public areas or other residents’ windows and do not provide adequate privacy.

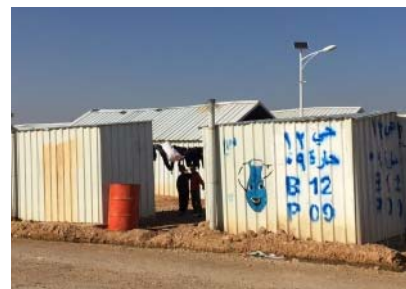
Fig. 19 Communal unit for toilet and shower [15]

- **Facilities:** Toilets are communal in Azraq camp and each unit (toilet and a shower) is used by approximately three families (Fig. 19). Residents had ceased to use the communal showers due to safety concerns and opted to shower in their own shelters using buckets of water. The shelters were not designed to have internal showers nor is their space provision. The main difficulties regarding using communal facilities are:

- hygiene problems: used by large numbers,
- distance problem: using the toilets in winter is problematic, especially for children, due to the distance and the harsh weather,
- ground turns into mud after raining, and
- lack of security and safety: specifically, for children and women at night.

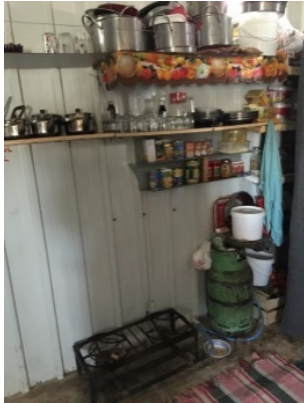
Fig. 20 Kitchen tools [15]

The residents were not provided with private or communal kitchens. Cooking equipment was given to residents to utilize in a corner of their shelters as a kitchen space. This included stoves and gas cylinders as shown in Fig. 20. Cooking inside the shelters was one of the causes behind the respiratory problems the residents had mentioned.

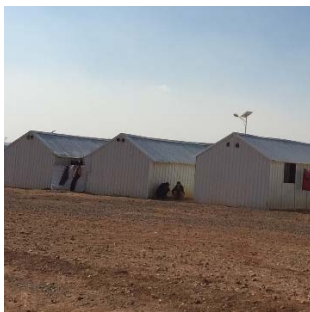
Fig. 21 Original gap between shelters [15]

and an absence of private social spaces whether outside or inside. Fig. 21 illustrates residents sitting in the shade close to the edge of an external wall. This shows the importance of this external space for socializing. The residents tried to overcome the problem by removing the inner lining of the shelter roof (plastic sheeting) to use as an exterior partition to form a private outdoor space (Fig. 22).

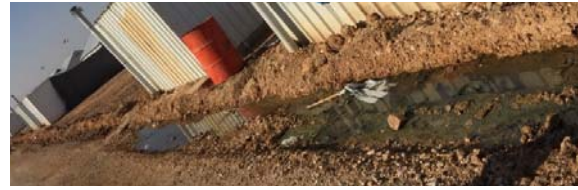
Fig. 23 Surface runoff wastewater [15]

- *Drainage:* The absence of a drainage system is a problem in the Azraq camp. The residents formed ditches to outside pits and aligned different ditches to form a network of surface wastewater channels adjacent to the streets, as shown in Fig. 23. In addition to hygiene problems, it also leads to accessibility issues for people with special needs and elderly, trying to cross over the wastewater.

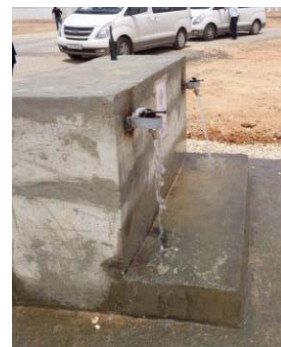
Fig. 24 A water tap [15]

- *Water and electricity:* Water taps are distributed around the camp, as shown in Fig. 24, and are piped from the primary main water tanks located on the camp edge. There is approximately one tap for every three blocks and operates from 7 a.m. – 12 p.m. and from 7 p.m.-12 a.m. Residents fill up bottles or containers (if they have enough) for their daily usage. There is no limit for the amount of water they can take, but there is long distance to reach the closest tap. Children are the primary water carriers, which can be up to 20 liters per day according to the residents.

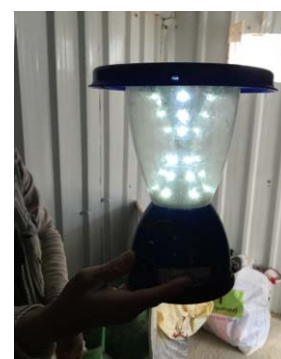
Fig. 25 Solar lamp [15]

The only source for electricity in the Azraq camp is solar lamps (Fig. 25). Shelters have one or two lamps but no additional devices, other than mobile phones, can be operated by these lamps.
