Electrochemical-mechanical corrosion phenomena

Aigerim Omirkhan

Department of Materials

Imperial College London

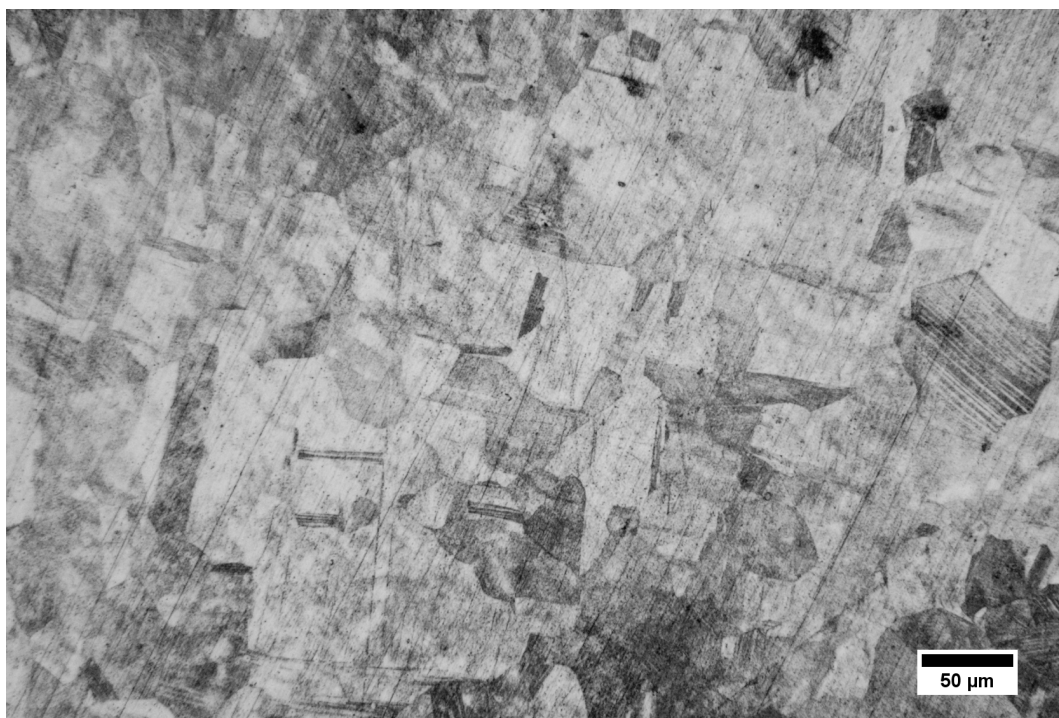
Figure 4.2: Optical micrograph showing the austenitic microstructure of 316 stainless steel rods used to produce working electrode discs. Etchant: Kalling's reagent, time: *ca.* 30 s.

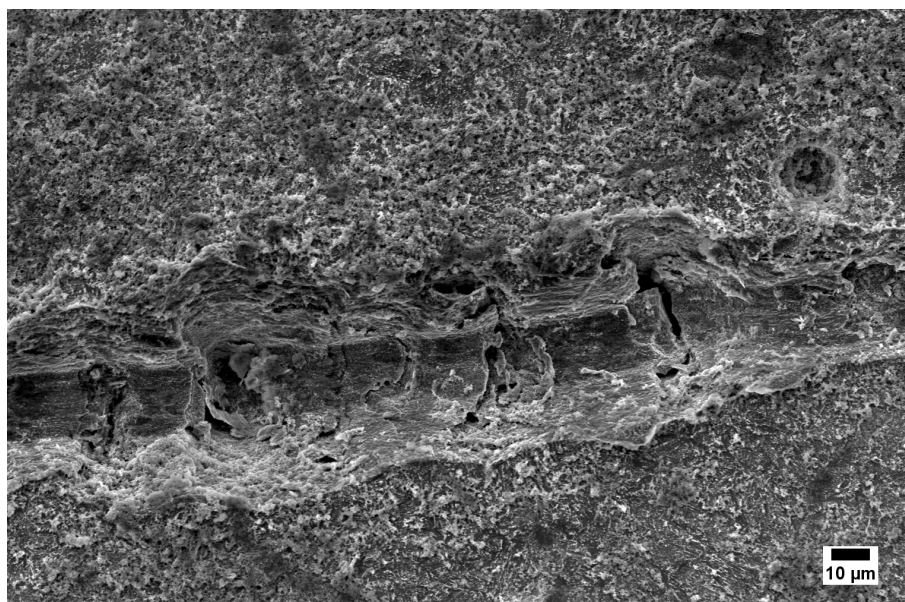
Figure 4.24: SEM micrograph of multiple-scratched X65 carbon steel at applied potential of -0.3 V vs. MSE in pH 4.0 KHP solution deaerated with Ar.

An SEM micrograph of single scratched X65 carbon steel is given in Figure 4.23. The sample appears to be heavily corroded, and the scratch track is barely visible due to the build up of corrosion products along it. Figure 4.24 and 4.25 present SEM micrographs of multiple

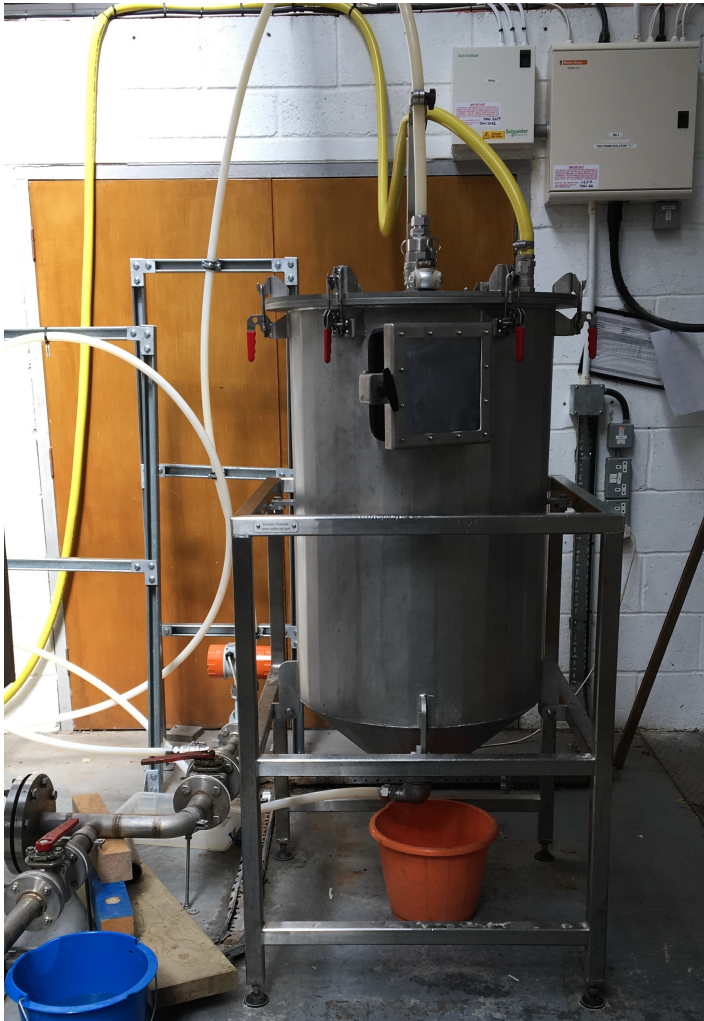
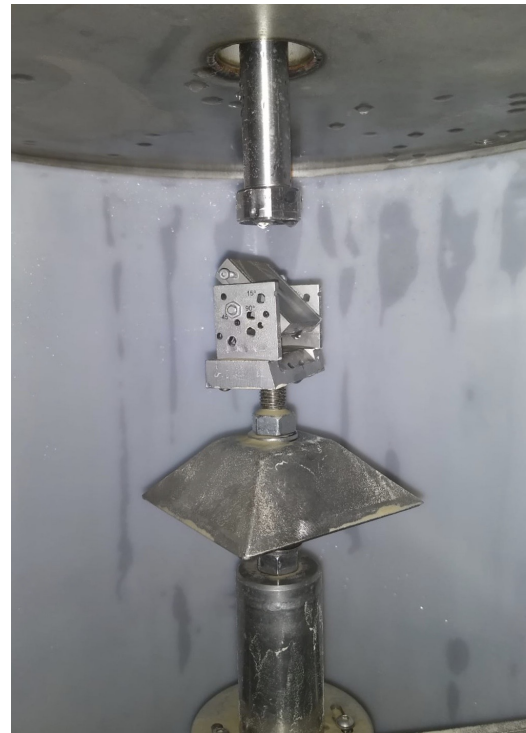
(a)

(b)

Figure 6.6: a) The jet impingement tester at nCATS. b) An image of the chamber interior showing the nozzle and the sample at an angle mounted on a sample holder.

Jet impingement testing was carried out at the national Centre for Advanced Tribology at Southampton. A slurry jet impingement tester enables circulating water with sand using positive displacement pump. The capacity of the tank is 200 L . The flow rate was set to 2.5 $m^3 h^{-1}$ and 6 mm nozzle was used for the tests. This resulted in the jet velocity of $24 \pm 1 m s^{-1}$. The duration of the tests was equal to 1 hour. Note that the solution was allowed to circulate until the development of the desired velocity (usually under a minute) and sand was added afterwards. The beginning of the test was set at the moment of addition of sand. The jet erosion tester and the view of the chamber is presented in Figure 6.6.
