Riding House, Wolfeton House, Charminster Dorset

Tree-ring analysis of further oak timbers

Martin Bridge and Cathy Tyers

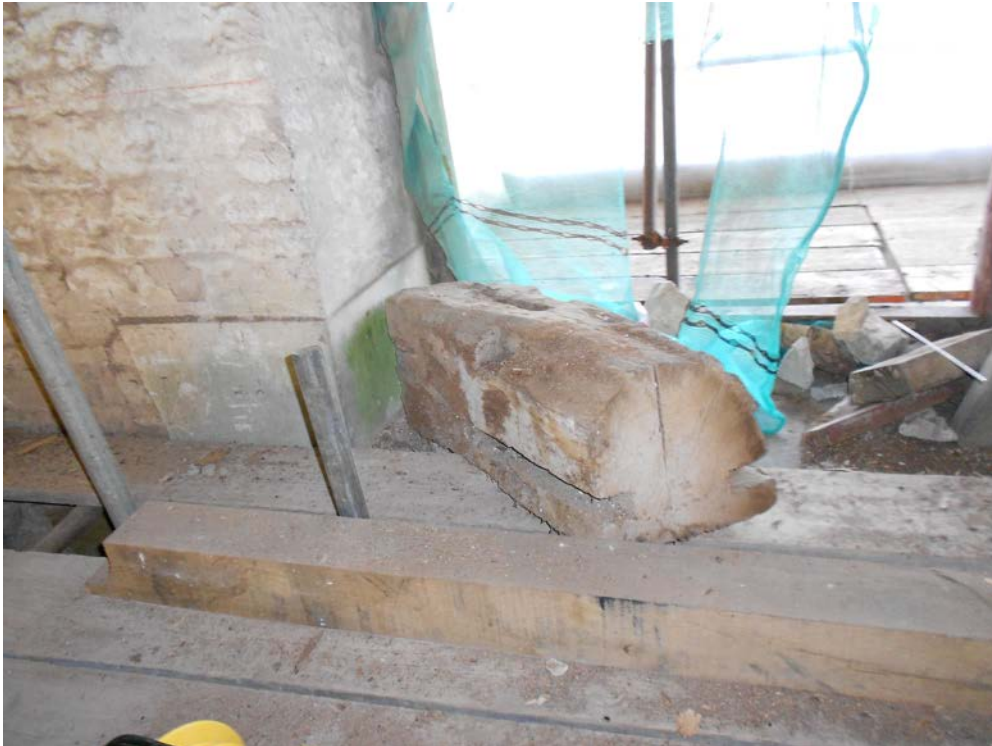
Figure 4: The ex situ floor beam 2 sampled as wlf01, photo Martin Bridge

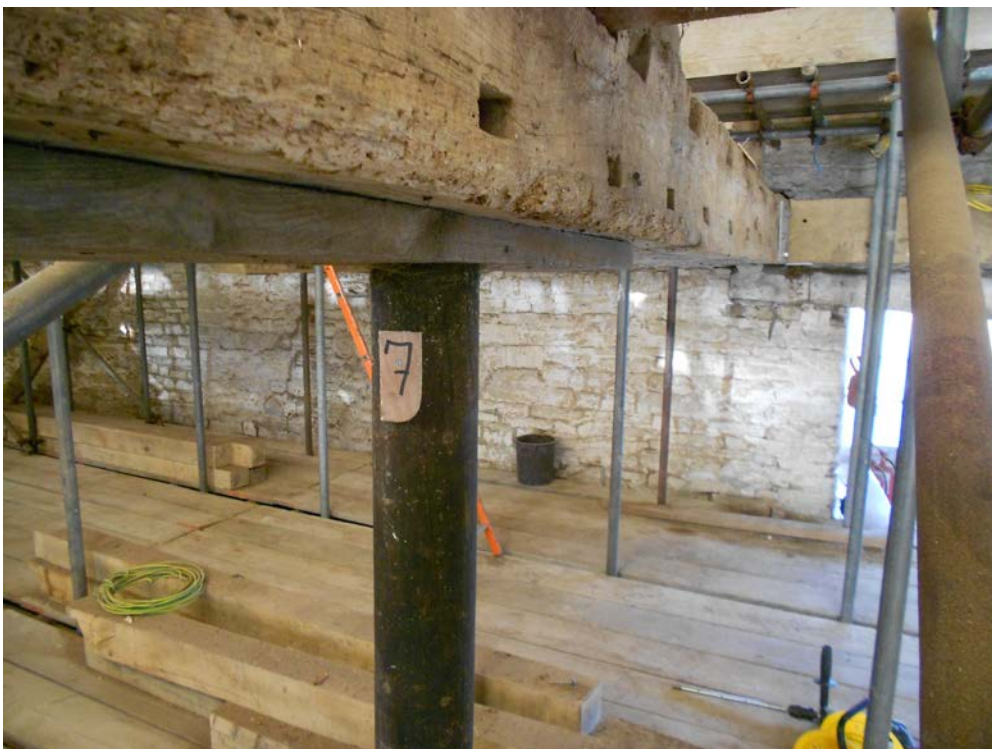
Figure 5: Floor beam 7, sampled as wrh06 and wlf03, photo Martin Bridge
