Inclination of houses induced by liquefaction in the 2018 Hokkaido Iburi-tobu earthquake, Japan

Yuko Serikawa^{1*}, Masakatsu Miyajima¹, Masaho Yoshida² and Kenji Matsuno¹

Keywords: The 2018 Hokkaido Iburi-tobu earthquake, Liquefaction, Damage to houses, Inclination of house

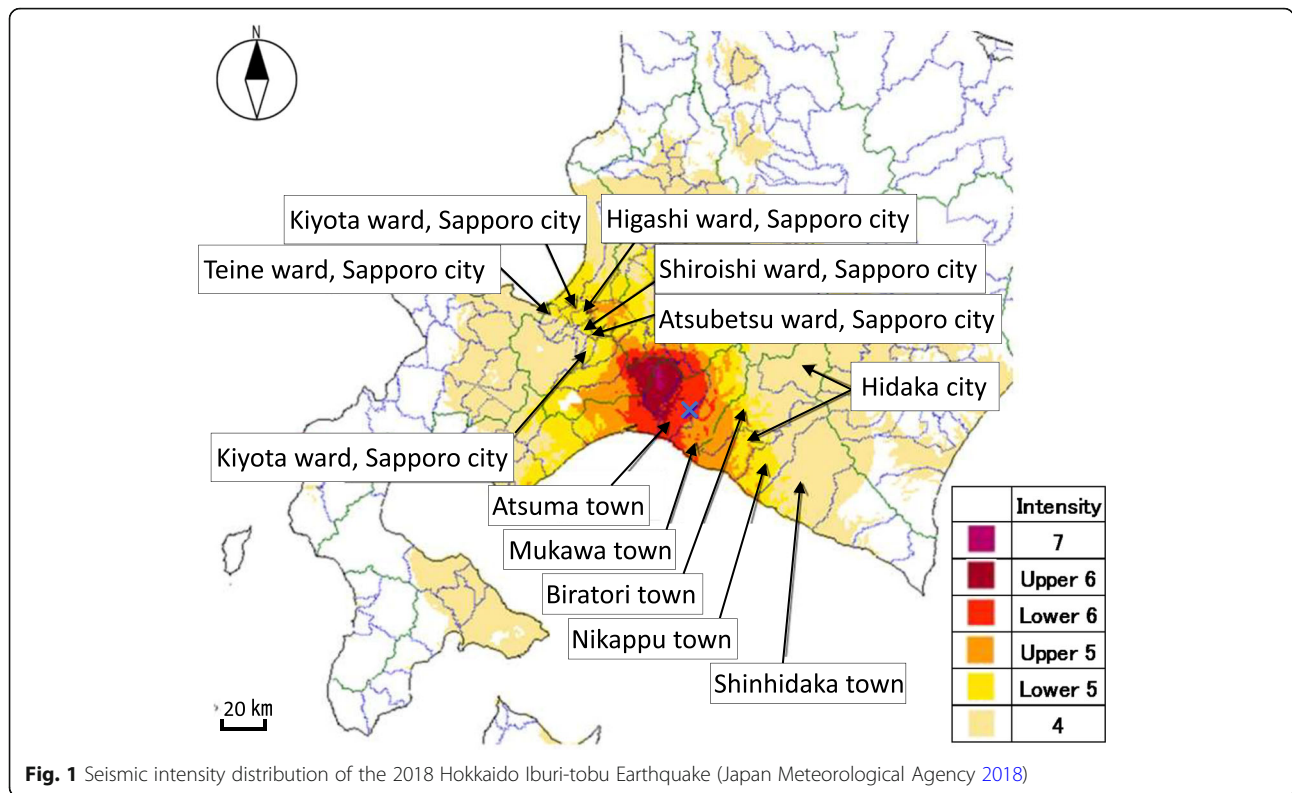
An earthquake of about 35 km depth and Magnitude 6.7 occurred middle east of Hokkaido-iburi region at AM 3:07 local time on September 6th, 2018. Figure 1 shows a distribution of JMA (Japan Meteorological Agency 2018) seismic intensity. A maximum JMA seismic intensity of 7 was observed at Atsuma town. The human damage of this earthquake was 42 deaths, 31 seriously injured and 731 minor injuries. Table 1 lists an outline of the damage caused by this earthquake (Cabinet Office 2018). The damage to houses and buildings were 462 completely destroyed

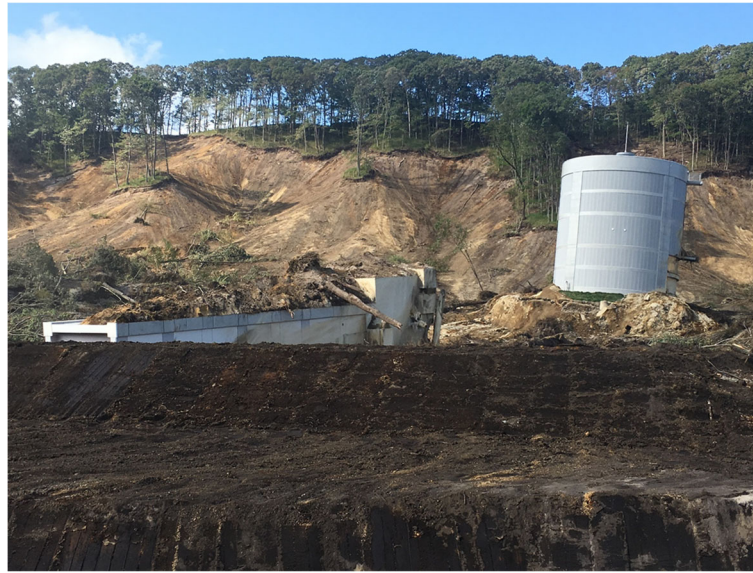
Fig. 2 Landslide at Atsuma town

houses, 1570 partially destroyed and 12,600 slightly damaged houses. Two thousand four hundred fifty-six non-residential buildings were also damaged. The main cause of these damages were landslides at Atsuma near the epicenter. Fig. 2 shows the landslide that occurred at Atsuma. The total area of landslides was about 13.4 km² according to the Ministry of Land, Infrastructure and Transport, Japan. This scale is the biggest in Japan since 1968. One of causes of the landslides seems to be a large amount of water contained in soil because of heavy rain caused by a strong typhoon the previous day. It is considered that the descent pumice layer deposited in this area is highly permeable, and clay is formed by chemical weathering, therefore, landslides are likely to occur.

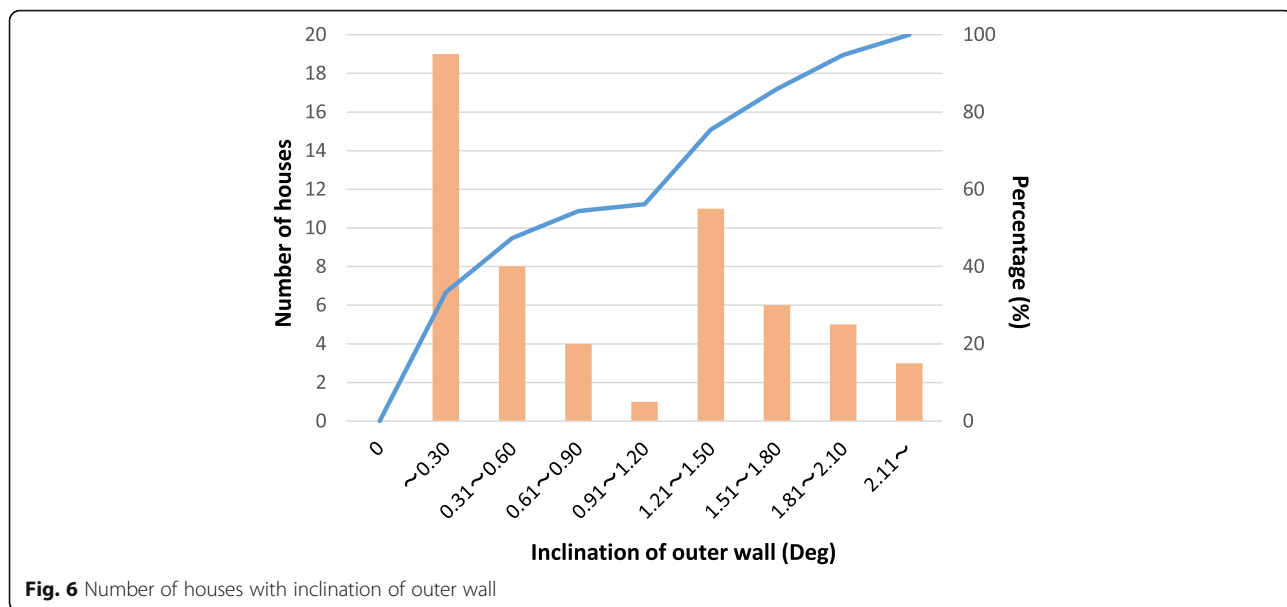
Fig. 6 Number of houses with inclination of outer wall

The number of houses in each inclination angle is shown in Fig. 6. Kohiyama and others conducted a hearing survey on health problems for residents who suffered liquefaction damage during The 2011 Tohoku earthquake, and dizziness gradually occurred when the inclination angle exceeded 1/100 (0.6 degree), revealed that health problems occur. Health problems may occurred at the houses with an inclination of 0.6 degree or more

(Kohiyama et al. 2012), and about 53% of the surveyed houses exceeded it. Survey of inclination of houses was conducted again 1 month after the earthquake. Inclination of houses increased more than 1.8 degrees in some cases by the aftershocks. There were two aftershocks that exceeded JMA seismic intensity 5 between our first and second field survey, and there were houses with large inclinations due to this aftershock. It was difficult for the residents to live there and most of decided to move. Since there are many residents who have difficulties in living, it is thought that the impact of inclination of houses caused by liquefaction on resident’s quality of life very serious.
