Master's Thesis of Engineering

**Fire Behavior of Post-Tensioned
Concrete One-Way Members with
Different Tendon Configuration**

Seoul National University

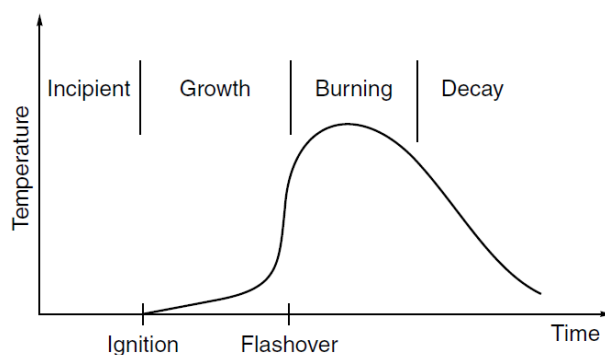
Figure 1-2 shows a typical time-temperature curve for complete process of fire development inside a room. After fire ignites, temperature increases to about 600°C where burning rate increases rapidly, leading to a flashover that is transition to burning period. The burning period seriously impacts structural elements and compartment boundaries. After fuel burns out, temperature drops out in a decay period, leading to eventual end of burning.

Figure 1-2 Time-temperature curve for full process of fire development (Buchanan and Abu, 2017)

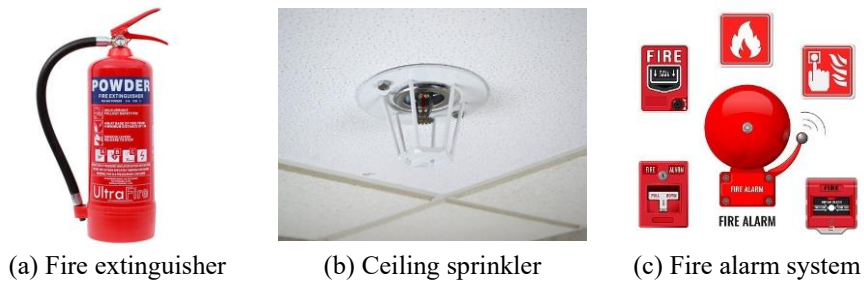
Figure 1-3 Active approach on fire protection strategy

To avoid damage in the fire development procedure, engineers have devised a fire protection strategy in a passive approach and an active approach. An active approach includes alarms/detection systems and sprinklers that can be a direct and fast method for fire protection (**Figure 1-3**). A passive approach designs buildings to achieve fire resistance and structural stability. For simple and convenient design, prescriptive fire design codes are specified. **Table 1-2** is an example of prescriptive fire resistance rating specified by the International Building Code (IBC) of the United States (ICC, 2017).

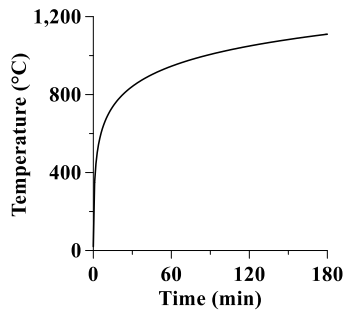
Figure 2-1 ISO 834 standard fire (ISO, 1999)

Setting of the fire test is presented in **Figure 4-8**. Specimens were simply supported on two round-cylindrical supports. Dimensions of the furnace were $6 \times 2.4 \times 1.5$ m (length \times width \times height). In the furnace, a column was set to protect the furnace after a slab ruptured. A four-point actuator was used to apply load on a slab with a 1,050 mm interval. A force of 120 kN was applied using an actuator, which is 40% of the moment capacity of 250 mm thick slabs. For the same condition of all specimens, an equal load was also applied on 280 mm thick slabs. Insulated covers were laid next to the slab on both sides to block pressure and temperature loss. Photographs of the settings are shown in **Figure 4-9**. Heating condition of the furnace was set to follow the standard time-temperature curve specified in ISO 834 (**Figure 2-1**).

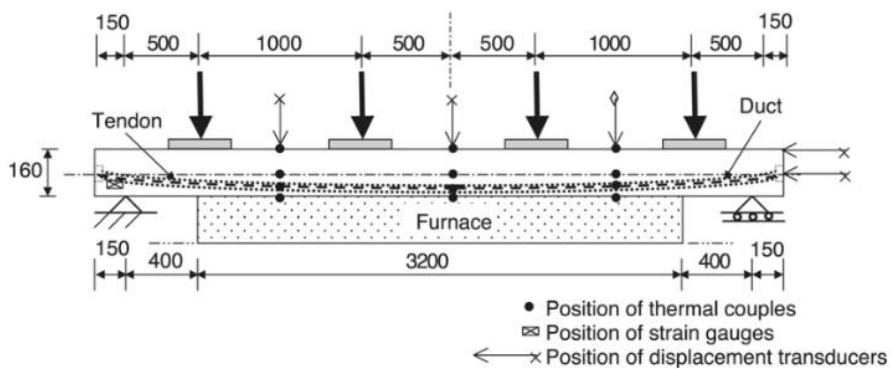
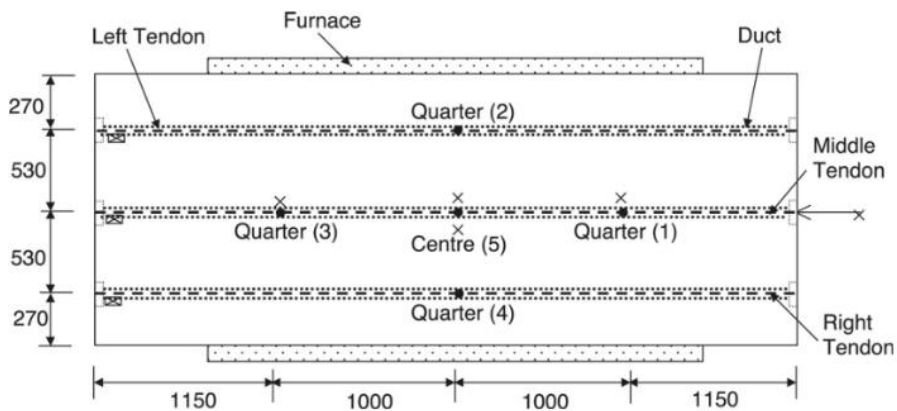
(a) Elevation view of specimen (unit: mm)

(b) Plan view of specimen (unit: mm)

Figure 2-2 Geometry and instrumentations of specimens
(Bailey and Ellobody, 2009)

Fire tests on eight bonded PT concrete one-way slabs were conducted by Bailey and Ellobody (2009). In this research, the fire performance of structures was compared by setting duct type, aggregate type, and restrained conditions differently, although the geometry and prestressing of the test were designed to be identical. Also, two ambient temperature tests were conducted for comparison. The geometry of test specimens and instrumentations are depicted in **Figure 2-2**.

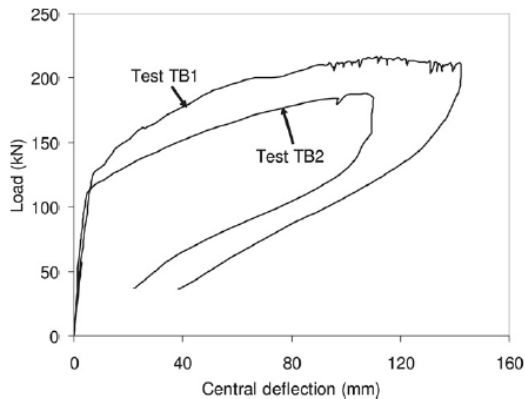
TB1 and TB2 are tests for comparison on fire test specimens that were conducted without temperature control. Both of them were unrestrained and had limestone aggregate. The duct type and concrete strength only differed. Tests for TB1 and TB2 were progressed with an increasing load from 36.7 kN to a failure load where end loads were 216 kN and 188 kN with a deflection in the vertical direction of 120 mm and 108 mm, respectively. In fire tests, not duct type but concrete strength influenced structural fire performance. **Figure 2-3** shows the load-central deflection curve for ambient slabs TB1 and TB2.

Figure 2-3 Load-central deflection curve for ambient slab TB1 and TB2 (Bailey and Ellobody, 2009)

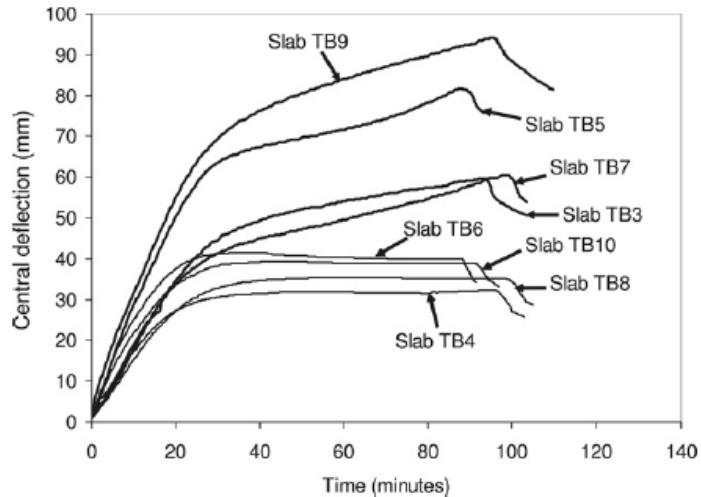
Figure 2-4 Time-central deflection curves for all fire tests (Bailey and Ellobody, 2009)

Fire behaviors of PT concrete slabs were estimated by analyzing the following test results: (i) time and temperature data when the crack propagated, (ii) vertical deflection and horizontal expansion variation, (iii) test termination, and (iv) concrete spalling. Summaries of fire test results are shown in **Table 2-8**, **Figure 2-4**, and **Figure 2-5**.

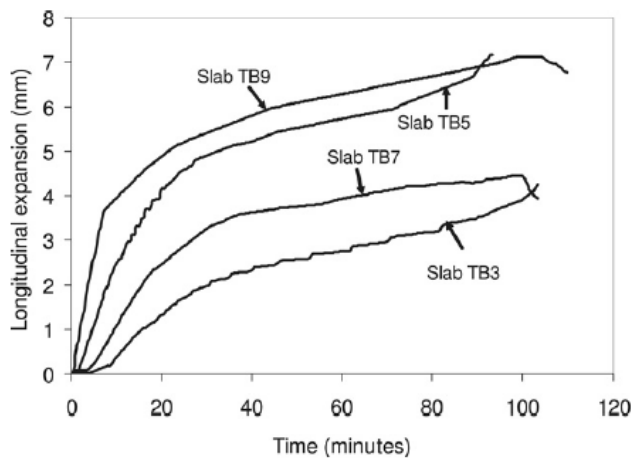
Figure 2-5 Time-longitudinal expansion for Slab TB3, TB5, TB7, and TB9 (Bailey and Ellobody, 2009)

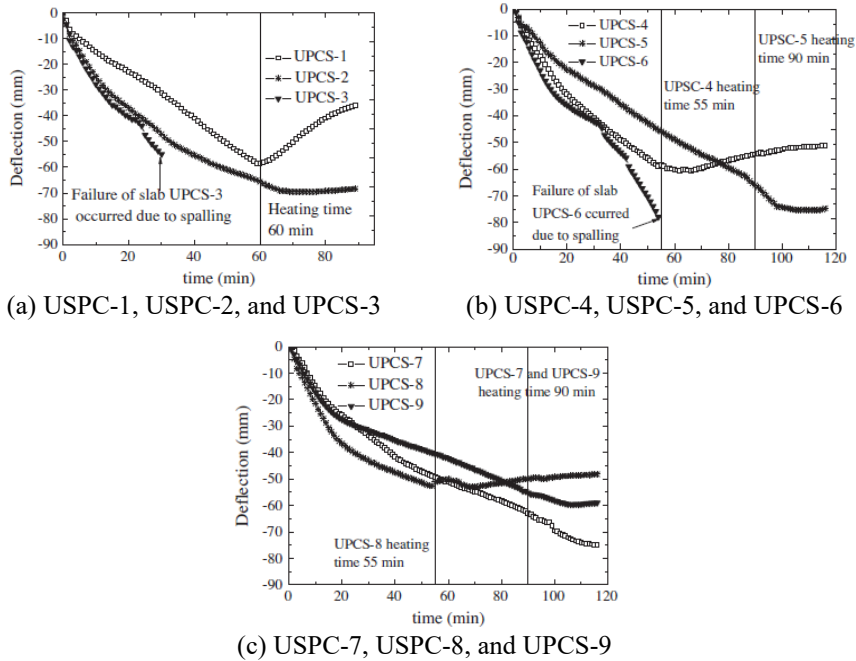
Figure 2-7 shows midspan deflections for nine slabs during and after fire tests. In the initial phase, deflection occurred due to thermal gradients developing in slabs. The intermediate phase also presented an increase in deflection that is because of a material property change. Lastly, at the cooling phase, deflection recovered with property recovery.

Figure 2-7 Midspan deflection-time response in different slabs (Hou et al., 2013)

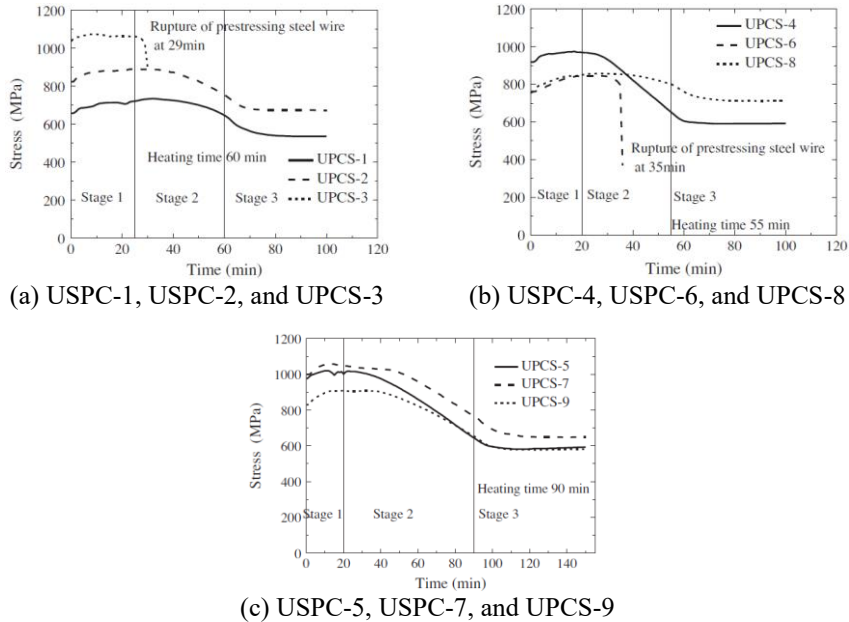
Hou et al. (2013) also measured time to stress graph divided into three stages as shown in **Figure 2-8**. The first stage is the time from 0 to 20 minutes after fire exposure. In all specimens, stress in prestressing steel wires increased during the first stage (in the range of 27 to 100 MPa). This is due to thermal gradients formulated by an increasing temperature that also cause deflections of slabs. The second stage is the time from 20 minutes to the end of the test. During this period, stress decreased conversely (11 to 330 MPa). Although thermal gradients develop, the strength and stiffness of the specimen would degrade as a result of the higher temperature. Eventually, this leads to a lower stress value. The third stage is the cooling phase, where stress decreases to a steady value due to recovery of modulus and creep strains.

Figure 2-8 Development of stresses in prestressing steel wires of test slabs (Hou et al., 2013)

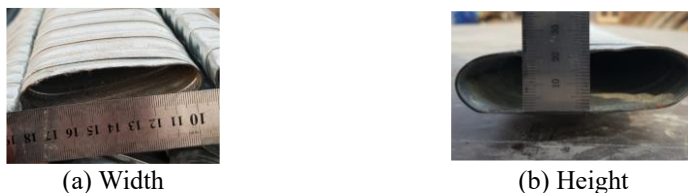
Figure 3-1 Metal duct

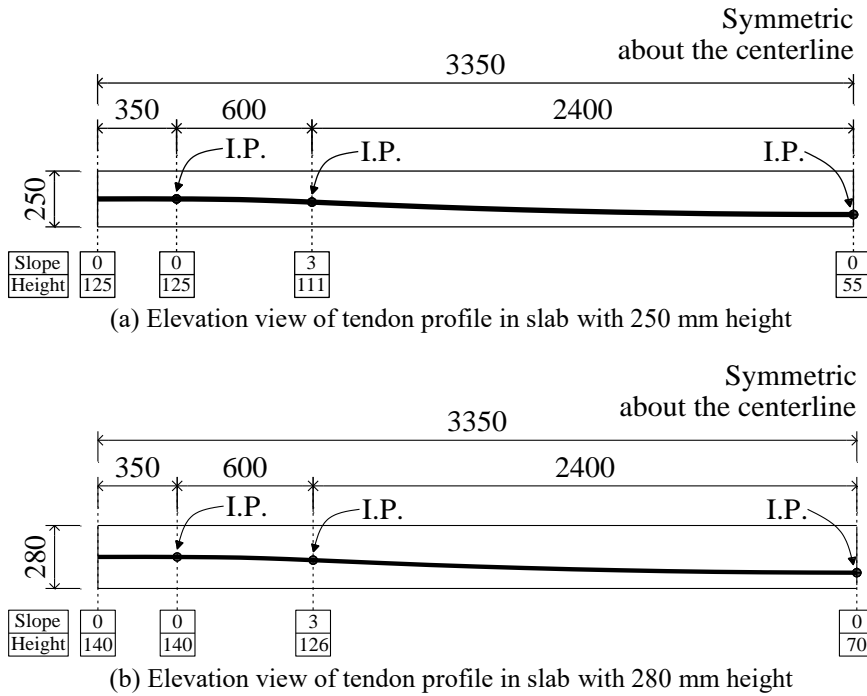
Tendon profile was designed with several parabolas through slabs, and only one configuration of tendon profile was used in specimens. **Figure 3-3** presents the profile of tendon. There were two types of specimens that had different heights. In total, the location where tendon is installed is different, but profile is the same. **Figure 3-3** shows half of the tendon layout that is symmetric about the centerline. Anchorage's location was at the center of gravity of concrete (c.g.c.), in the height of 125 and 140 mm, respectively. There were three inflection points (I.P.) designed in half of the specimen. The first point is 350 mm from anchorage. This point is where roller support is placed, and until the first I.P., heating load is not affected. Tendon profiled straight along the c.g.c. line from anchorage to the first I.P. Since then, considering negative moments near support, tendon profile was designed to have hogging curvature for the length of 600 mm, which is a tenth of the length of the heating length. Tendon profile was set for the rest of the section to reach its lowest point in an upward direction from the specimen's midpoint. This is the position corresponding to 55 and 70 mm from the bottom of the concrete section.

Figure 3-3 Tendon profile (I.P.: inflection point; unit: mm)

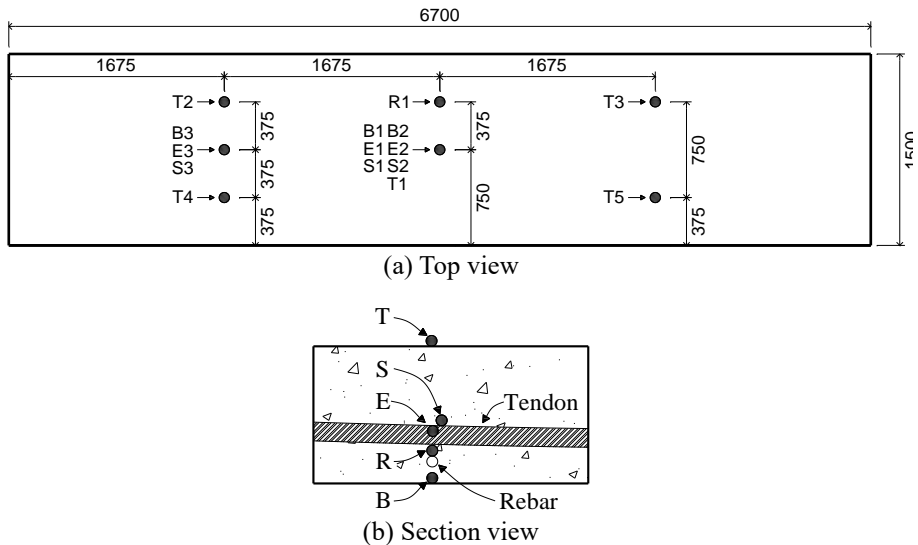
Figure 4-2 Location details of thermocouples (unit: mm)

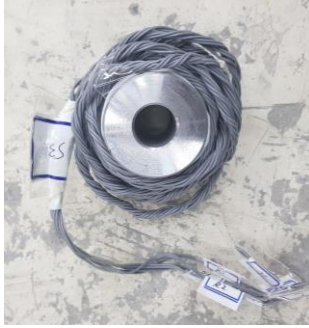
Figure 4-3 Self-made load cells

Load cells were manufactured using S45C steel (outside diameter of 50 mm, inside diameter of 20 mm). Four strain gauges were attached along the outside diameter as shown in **Figure 4-3**. After the process of load cell manufacturing, calibration was performed to find the coefficient factor of load cells by applying force using Universal Testing Machine (UTM; **Figure 4-3**).

(a) Load cells manufactured

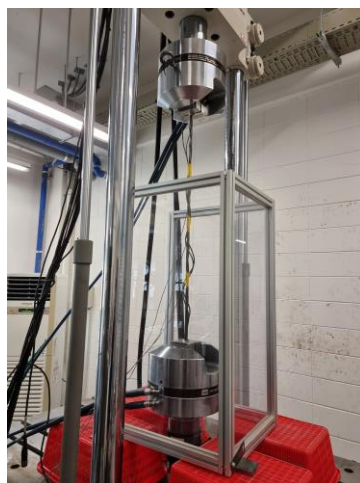
Figure 4-6 Tensile strength testing

In specimens, one type of strand was used: SWPC 7B. Each tendon had seven strands, consisting of six strands with a diameter of 5 mm and one strand with a diameter of 5.2 mm. The six strands were twisted along a 5.2-diameter strand, and the tendon was designed to have an ultimate strength (f_{pu}) of 1,860 MPa. A tensile strength test was carried out for measuring material properties, and the measured stress-strain data is shown in **Figure 4-5**. The tensile strength test was successfully ended, and it was revealed that the tendon had a yield strength of 1,670 MPa, an ultimate strength of 1,896 MPa, and an elastic modulus of 200,000 MPa. The tendon tensile test setup is shown in **Figure 4-6**.

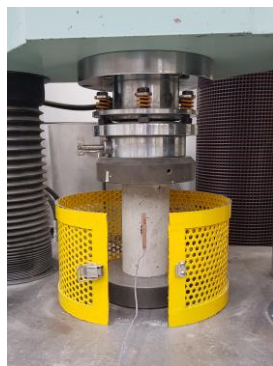
Cast-in-place high strength concrete with a nominal compressive strength of 40 MPa was used for specimens. Also, concrete pouring was conducted on four different days. The compressive strength of concrete was measured at the jacking date and the testing date using cylinder compression testing. Furthermore, concrete splitting tensile tests were also conducted to estimate the tensile strength of concrete. Three tests were conducted for each concrete type, and average values are shown in **Table 4-2**. Pictures of concrete cylinder testing are shown in **Figure 4-7**. Other concrete properties provided by the concrete mixing plant are shown in **Table 4-3**. Concrete elastic modulus was also calculated by measuring stress-strain data from cylinder compression testing. The measured concrete elastic modulus ranged from 14,797 to 23,733 MPa. According to ACI 318-19 Section 19.2.2.1, the elastic modulus of normal-weight concrete (E_c) can be calculated as 29,934.5 MPa when concrete's compressive strength is 40 MPa. However, the concrete compressive strength in the test was small due to severe curing conditions (steam curing and low temperature).

(a) Compression test

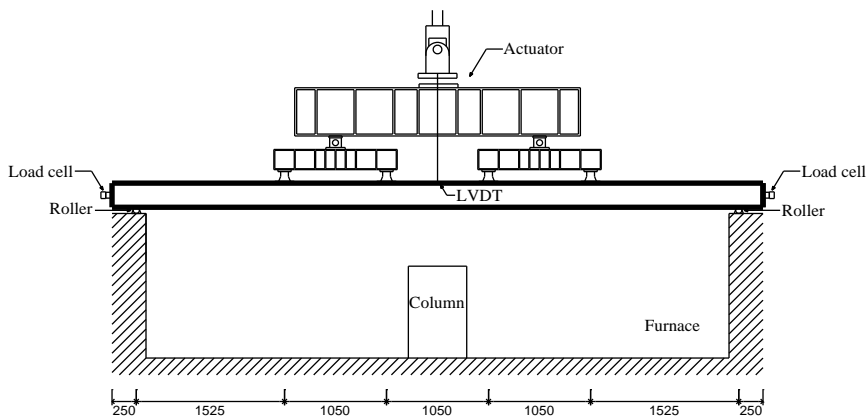
Figure 4-8 One-way PT slab test (unit: mm)

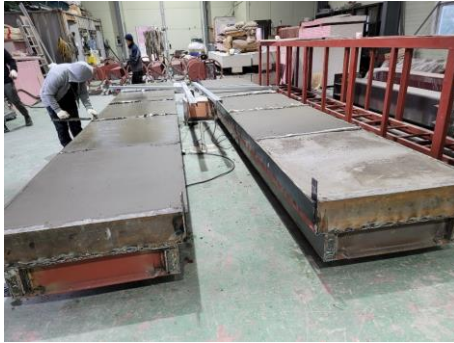
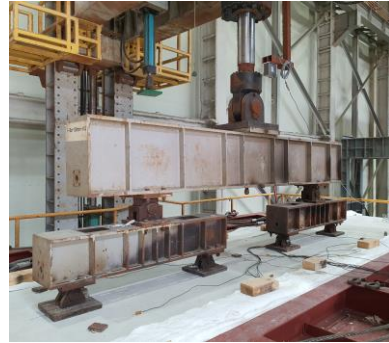
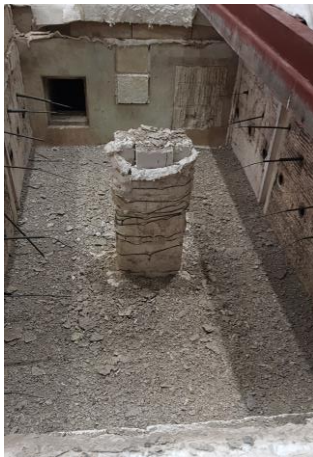
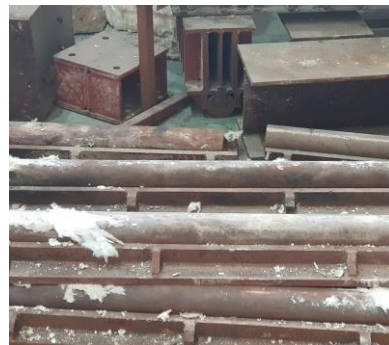
Figure 4-9 Test setup

(a) Insulated cover

(b) Actuator

(c) Furnace

(d) Roller support

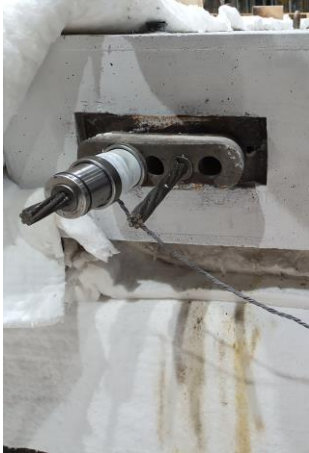
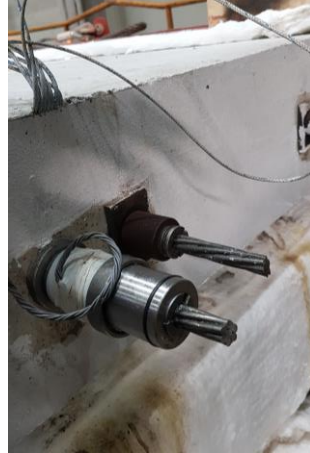
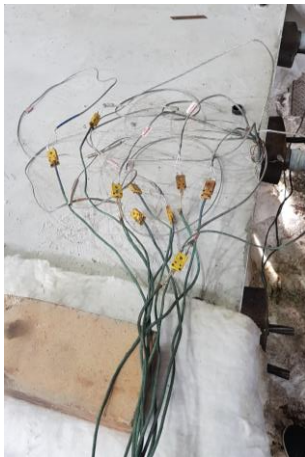
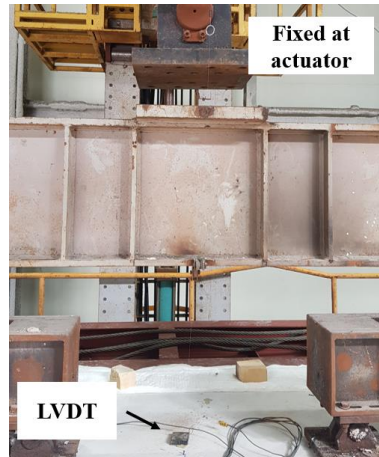
Figure 4-10 Instrumentation

Load cells, LVDTs, and thermocouples were used to collect test data during fire tests. Load cells were installed at both ends of the slab in unbonded cases. Four load cells were installed in one slab, one in the center of the width and one in the quarter of each end, which corresponds to the location of anchorages. For each specimen, a single wire-LVDT was installed at the centroid of the upper face of the slab. This instrument was used to determine the vertical displacement of slabs. Each specimen was equipped with fifteen k-type thermocouples. **Figure 4-2** illustrates the installation location in detail. **Figure 4-10** shows photographs of the instrumentation.

(a) Load cell at support with anchor (PF-U, PF-G)

(b) Load cell at support without anchor (PF-S)

(c) Thermocouple

(d) Wire LVDT

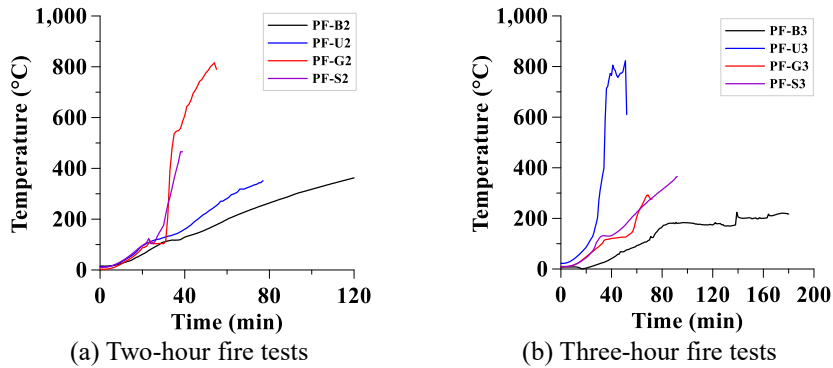
The time-temperature curves for reinforcing bars are shown in **Figure 5-5**. Due to the difference in degree of concrete spalling, even though thermocouples were installed at the same location, the temperature differed by tendon configurations.

Figure 5-5 Time-temperature curves for reinforcing bars

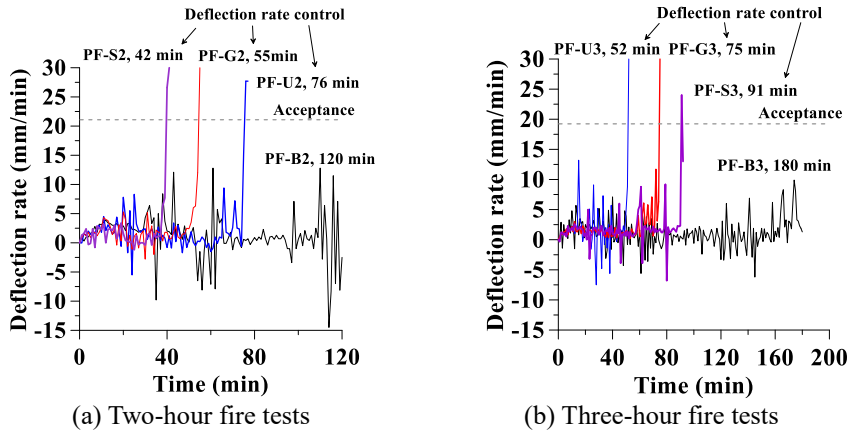
Time-deflection rate curves showed a different tendency depending on tendon configuration, with the presence of a HDPE sheathing appearing to be influential. During two-hour fire tests, G and S types showed a deflection rate of 2.5 to 5 mm/min, whereas B and U types had a deflection rate of 5 to 10 mm/min. This difference became more pronounced as cover thickness increased. Prior to the sudden rupture, G type had a deflection rate of 0 to 2.5 mm/min, while S type showed a deflection rate of 0 to 2.5 mm/min with infrequent peak points (5 to 10 mm/min). In three-hour of fire tests, B type showed a stabilized deflection rate within the range of 0 to 5 mm/min, but U type showed a deflection rate of 5 to 12 mm/min with the earliest rupture time. Because strands of G and S types were sheathed with HDPE covering unlike those of B and U types which were bare mono-stand, it is believed that sheathing has an effect on the deflection rate of structures, which is related to fire performance.

Figure 5-7 Time-deflection-rate curves of fire tests

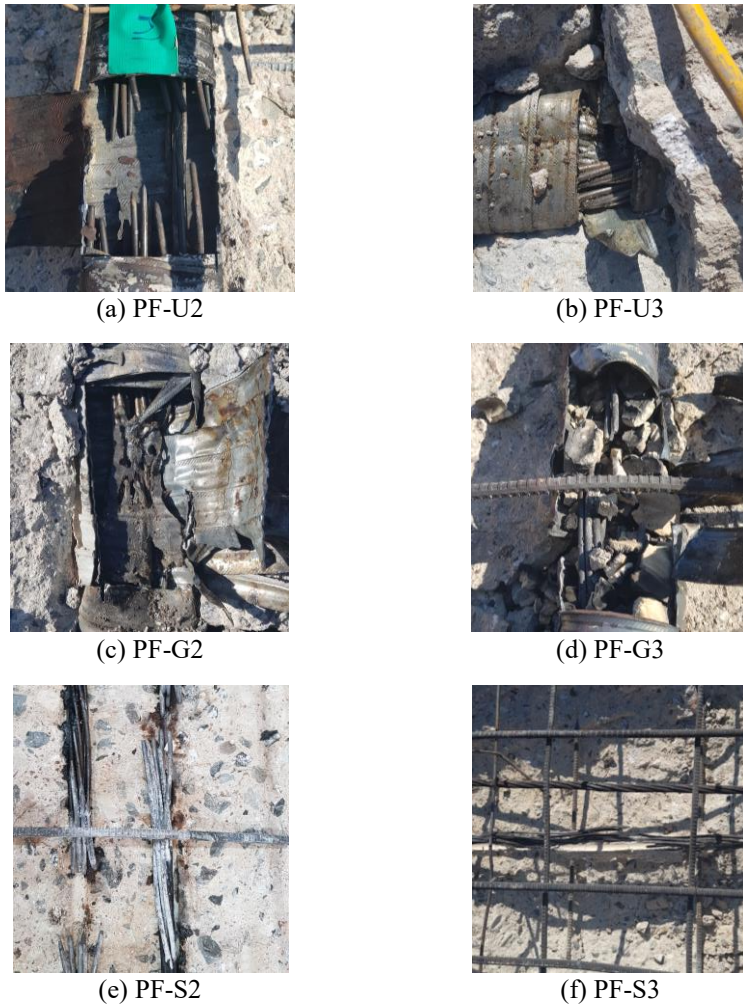
Figure 5-9 Photographs of fractured tendons in unbonded cases

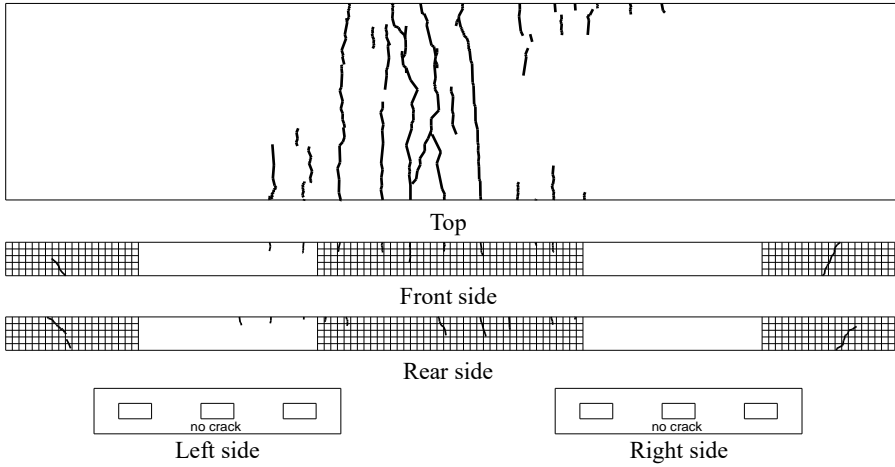
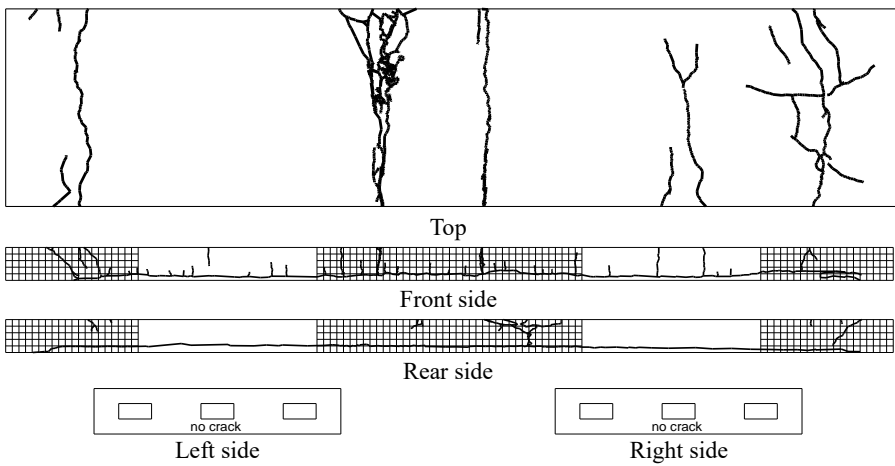
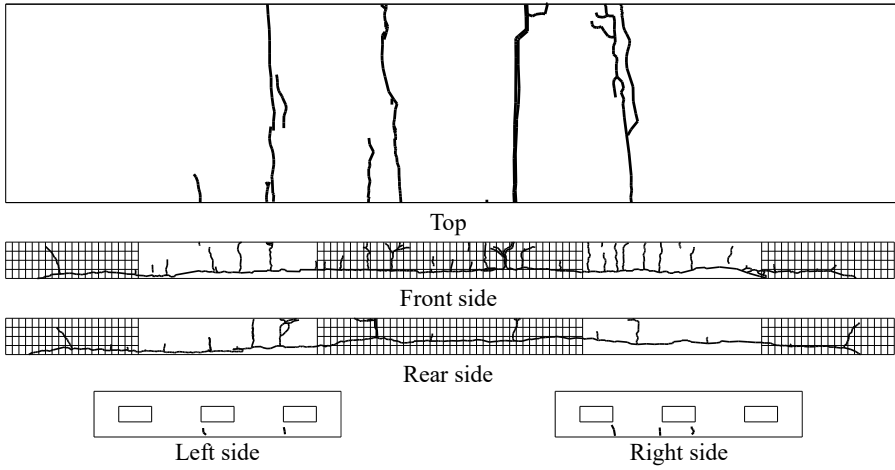
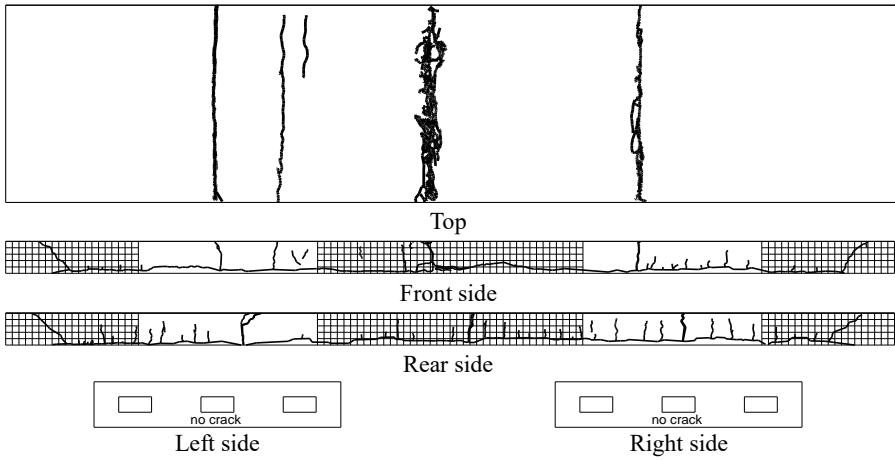
(a) PF-B2

(b) PF-B3

(c) PF-U2

(d) PF-U3

(e) PF-G2

(f) PF-G3

In PF-B3, top crack is predicted at both center and support regions. This is also shown in fire test (**Figure 5-12 (b)**) with center region suffering more severe crack propagation. **Figure 6-18** and **Figure 6-19** show the stress variation over time in the section view at the center and support regions, respectively, for PF-B3.

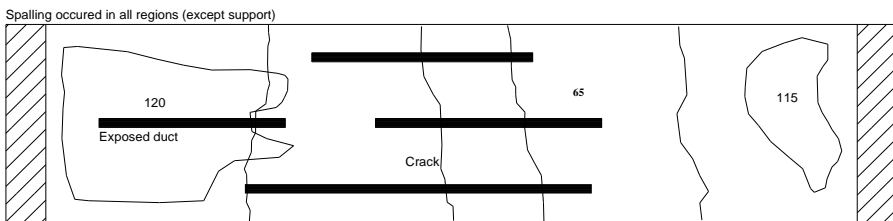
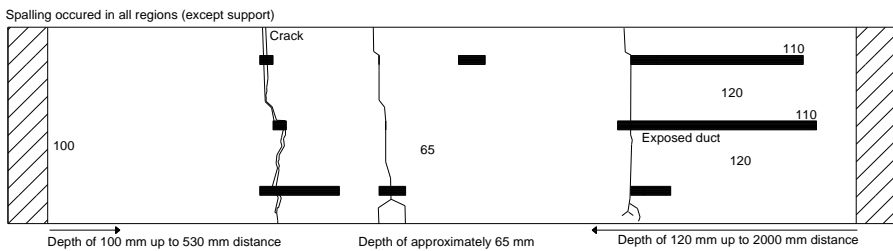
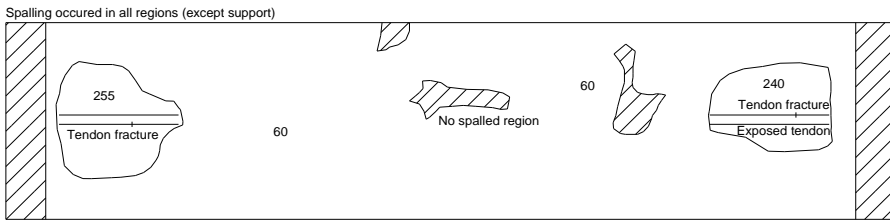
After fire tests, concrete spalling and delamination were observed on the bottom surface of each specimen. The damage and degree of concrete spalling and delamination are illustrated in **Figure 5-14**. Photographs of concrete spalling and delamination are shown in **Figure 5-15**. Minor spalling occurred regionally with depths of 20 to 65 mm in bonded cases. No concrete delamination occurred in PF-B2, while PF-B3 experienced concrete delamination at the anchor zone as a result of increased tendon tensile force and material stiffness degradation caused by elevated temperature. Concrete delamination depths in bonded cases ranged from 75 to 185 mm. Unbonded cases resulted in increased damage and degree of concrete spalling and delamination. Concrete spalling occurred in the majority of the bottom surface between 15 and 65 mm in depth, while concrete delamination occurred between 100 and 260 mm in depth near anchor regions. Specifically, the depth of concrete delamination in PF-U2, PF-G3, and PF-S3 was between 200 and 260 mm (approximately 80 to 90% of the original depth). This resulted in the duct and tendon being exposed to fire, as seen in **Figures 5-15 (c) to (d)**. According to the fire test results, unbonded cases show a greater variation in tensile force in the anchor zone than bonded cases (this could be due to the fact that bonded cases distribute stress from strand to grout to concrete in all regions simultaneously, whereas unbonded cases distribute stress starting from the anchor region to concrete), resulting in more severe concrete delamination at the anchor.

(a) PF-B2

(d) PF-U3

(e) PF-G2

(h) PF-S3

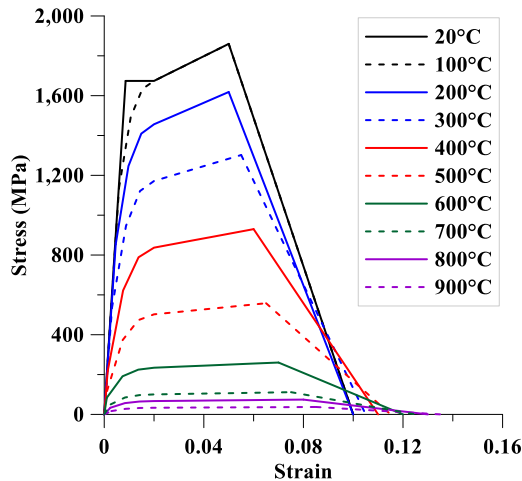
(b) Stress-strain curves of tendon (BS EN 1992-1-2, 2004)

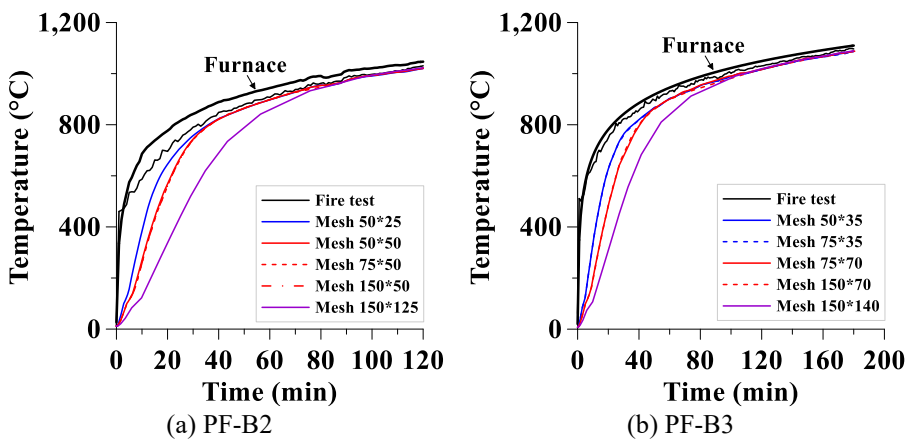
Heat transfer analysis was performed on the PF-B2 and PF-B3 cases. At the bottom of each numerical model, the furnace temperature (**Figure 5-1**) was applied as a heating load. **Figure 6-5** shows the time-temperature curves of furnace, fire test result, and FEA results. To check mesh convergence, the models were meshed differently. As shown in **Figure 6-5**, the mesh interval along the height direction had an effect on convergence but width mesh did not affect convergence for heat transfer analysis. In both PF-B2 and PF-B3, when the mesh interval narrowed, the FEA accuracy increased but the analysis time increased. It was determined that meshing at a height of 50 mm for PF-B2 and 70 mm for PF-B3 is suitable. The time-temperature curves for concrete at the tendon location are shown in **Figure 6-6**. In PF-B2, the FEA and fire test results matched well across all mesh types, but in PF-B3, the fire test result showed irregular fluctuation that made comparison difficult. However, because the bottom time-temperature curves and PF-B2 case matched well, it is possible to estimate that the FEA result may be utilized to analyze the temperature of the concrete at the tendon location. **Figure 6-7** and **Figure 6-8** show the results of the heat transfer analysis in the section view at the middle of the model. Although the FEA was performed in three-dimensional, heat transfer occurred mostly in height direction due to the heating load being delivered uniformly over the width direction. Additionally, heat was transferred up to the height of 75 mm in the PF-B2 case and 110 mm in the PF-B3 case.

Figure 6-5 FEA time-temperature curves for bottom of the slab

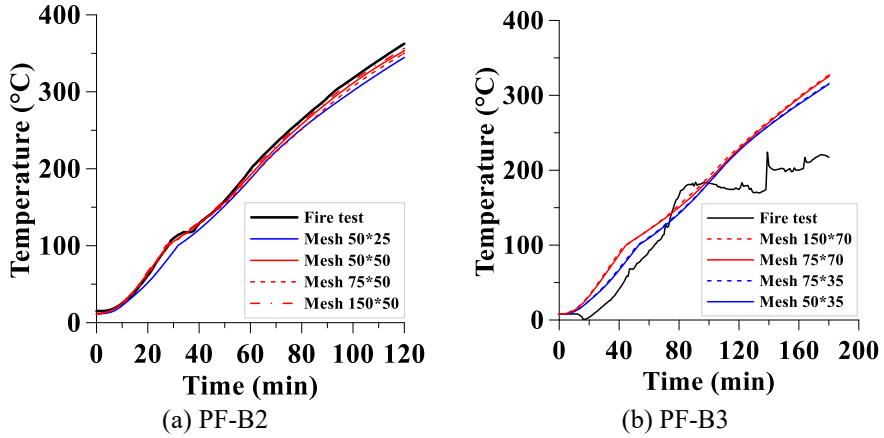
Figure 6-6 FEA time-temperature curves for concrete at tendon location

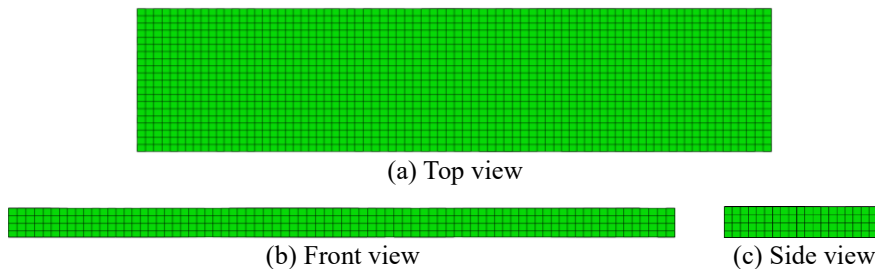
The mesh plan for thermo-mechanical analysis was determined by taking mesh convergence and analysis time into account. Models were meshed in a cube or cuboid shape, which is believed to be the ideal shape for stress analysis. Mesh sizes were designed to be $150 \times 150 \times 50$ and $75 \times 75 \times 50$ for PF-B2, and $150 \times 150 \times 70$ and $75 \times 75 \times 70$ for PF-B3. **Figure 6-9** shows that meshed model of PF-B3 ($75 \times 75 \times 70$) in top, front, and side views.

Figure 6-9 Meshed model for thermo-mechanical analysis

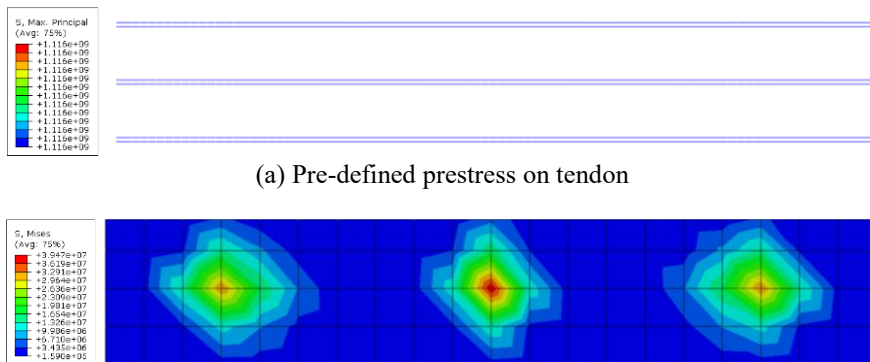
As shown in **Figure 6-10 (a)**, prestress was applied on tendon in the value of 1116 MPa. The effect of prestressing on concrete at anchor zone can be seen in **Figure 6-10 (b)**. After prestressing analysis was performed, the boundary conditions set at the prestressing step were released, and simply-supported condition was newly adapted for the next steps with prestressing load remained until the end of the FEA.

Figure 6-10 Details of model at prestressing step

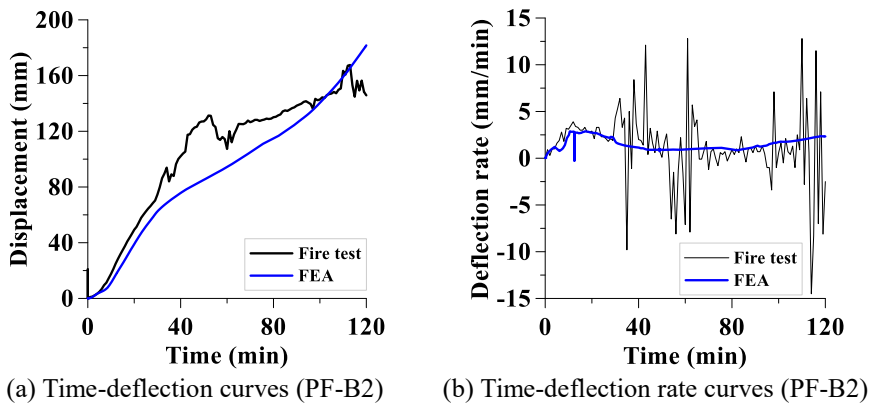
Figure 6-13 shows the time-deflection and time-deflection rate curves of PF-B2 and PF-B3 during fire tests and FEA. Except for the brief period during which an unexpected disturbance occurred, the results of fire tests and FEA matched well. Based on the fact that both the results of the heat transfer analysis (Section 6.2) and thermo-mechanical analysis (Section 6.3) both matched well with the results of the fire tests, it can produce additional data that the fire test could not obtain can be assumed via FEA, and further parametric study using the same material properties and modeling methods can be conducted.

Figure 6-13 FEA and fire test results

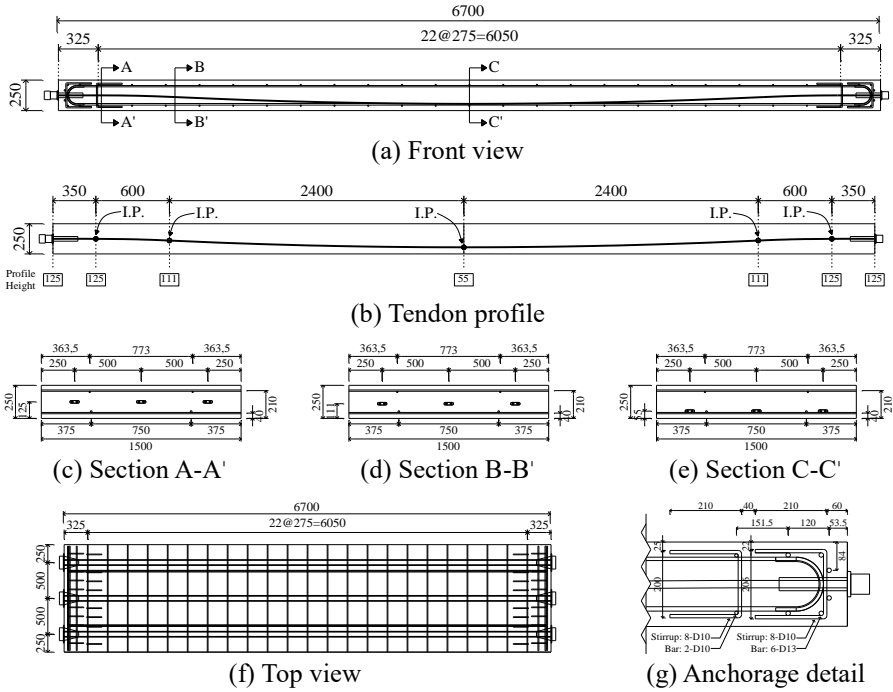
Figure A-1 Details of Specimen PF-B2 (unit: mm)

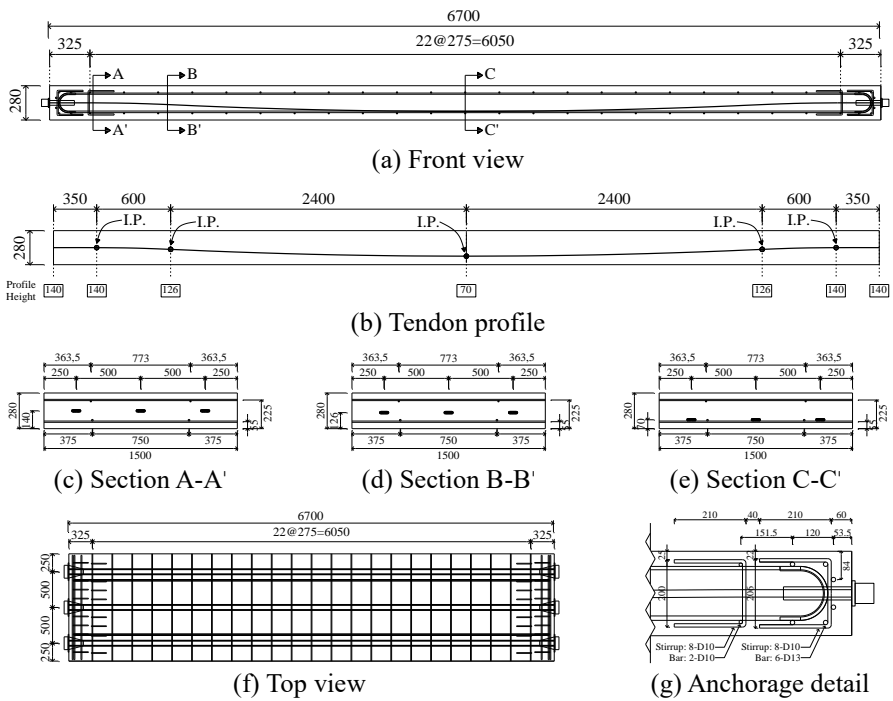
Figure A-2 Details of Specimen PF-B3 (unit: mm)

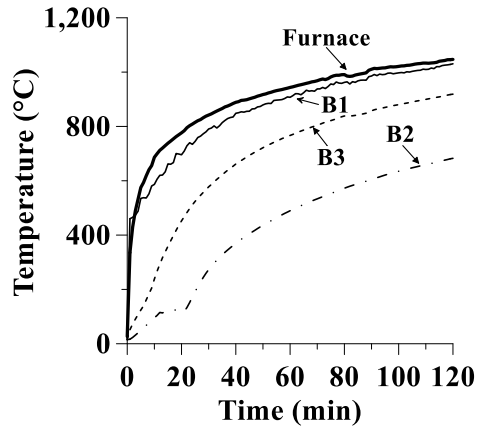
Figure B-1 Time-temperature curves at the bottom of slab (PF-B2)

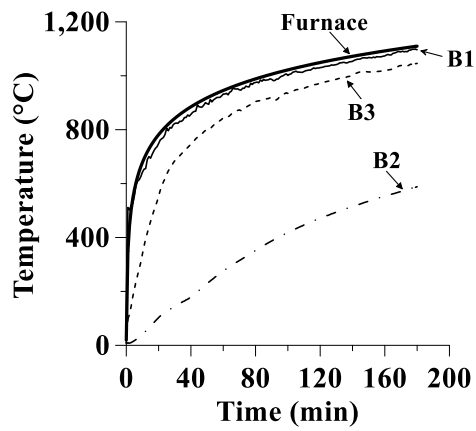
Figure B-2 Time-temperature curves at the bottom of slab (PF-B3)

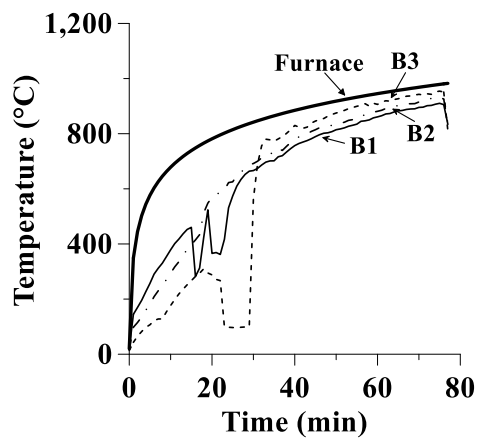
Figure B-3 Time-temperature curves at the bottom of slab (PF-U2)

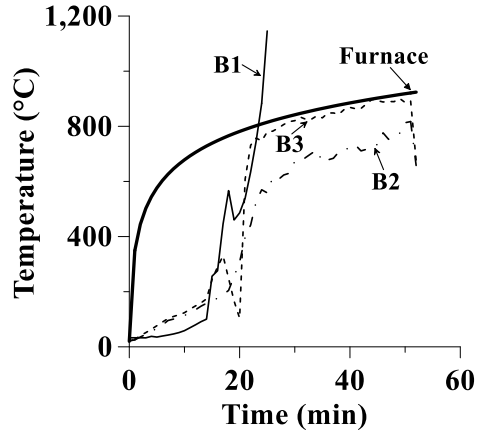
Figure B-4 Time-temperature curves at the bottom of slab (PF-U3)

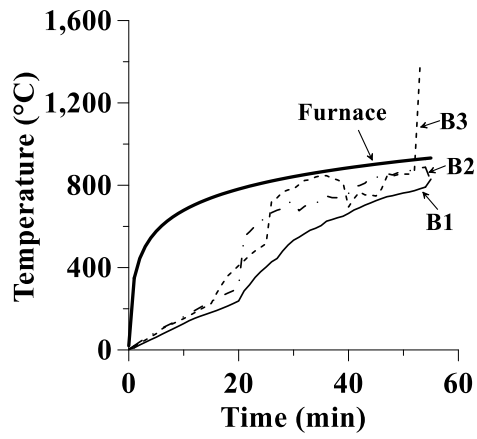
Figure B-5 Time-temperature curves at the bottom of slab (PF-G2)

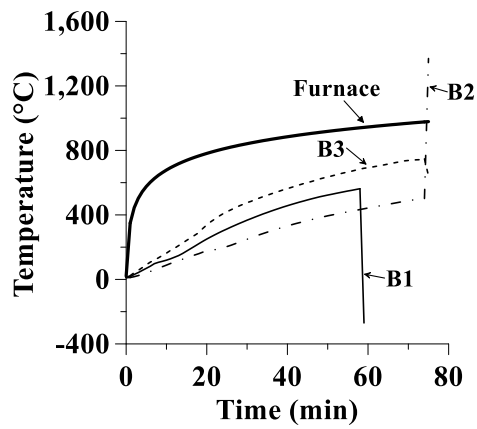
Figure B-6 Time-temperature curves at the bottom of slab (PF-G3)

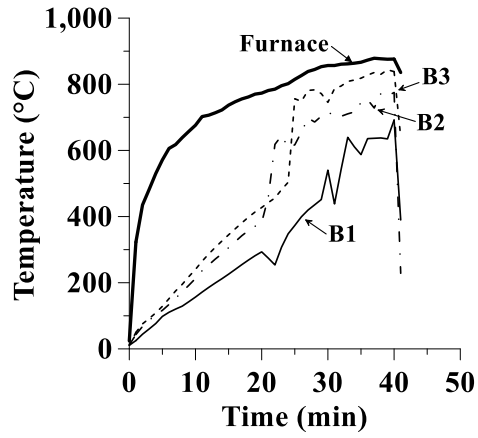
Figure B-7 Time-temperature curves at the bottom of slab (PF-S2)

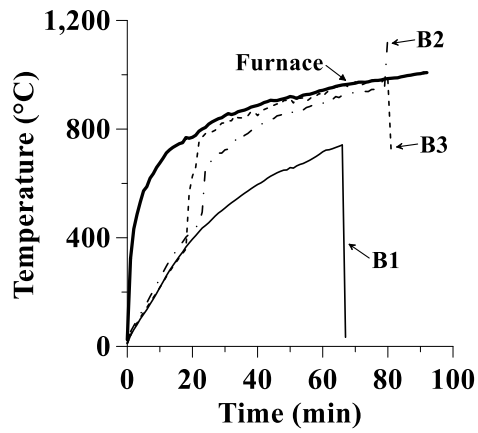
Figure B-8 Time-temperature curves at the bottom of slab (PF-S3)
