MRes – The Science and Engineering of Materials

Deformation of inclusions in rail steel due to rolling contact

Alison Chard

January 2011

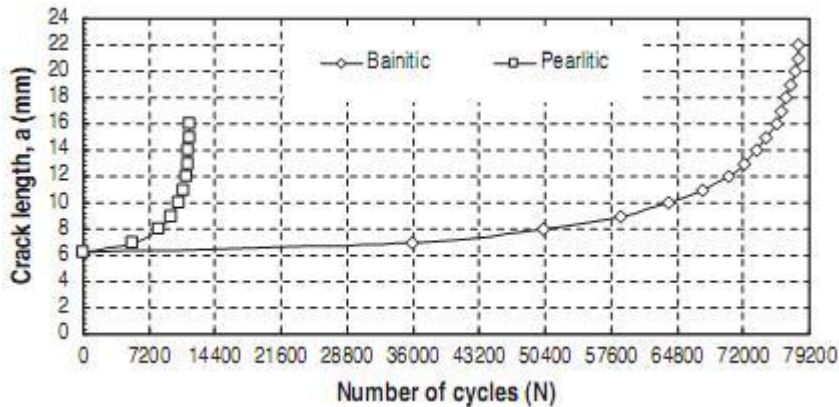
Figure 5: A graph showing crack length depending on number of cycles for bainitic and pearlitic steels based on the averages from 3 macroscopically identical specimens (Aglan, 2006).

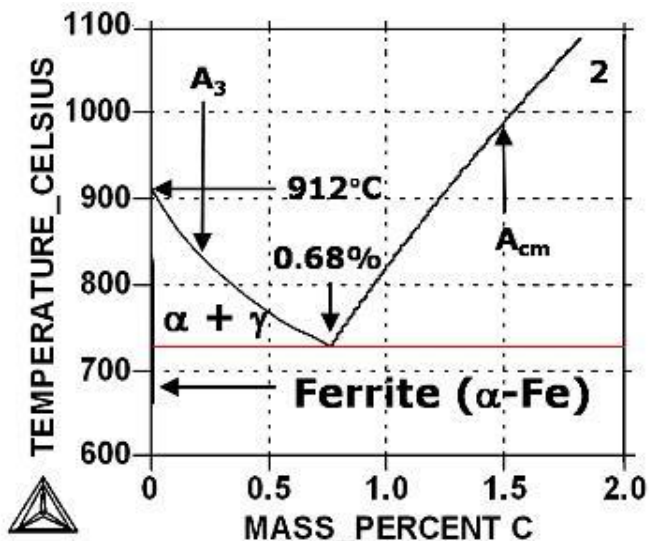
Figure 6: The Iron-Carbon phase diagram. From <http://www.calphad.com/graphs/Metastable%20Fe-C%20Phase%20Diagram.gif>

Pearlitic rail steel typically contains 0.5-1wt% carbon and is made up of alternating layers of soft ferrite and hard cementite (Fe_3C). It can be seen in the phase diagram in Figure 6 that the pearlite is formed from the cooling of the austenitic phase and depending on the amount of carbon in the pearlitic steel there may be pro-eutectoid ferrite or pro-eutectoid cementite formed. The presence of these phases will impact negatively upon the overall properties.

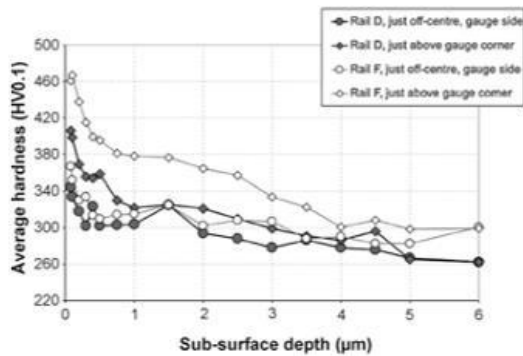
Figure 7: Near surface strained region of micro hardness curves for SUROS tests to run to RCF failure at 150 MPa contact stress and -1% creepage (from Garnham, 2008)

The compressive loading the pearlite undergoes varies with distance from the surface. The surface of the rail will be more heavily loaded. This gives rise to a hardness profile where hardness of the rail changes with depth, which is shown in Figure 7 for rails removed from service.

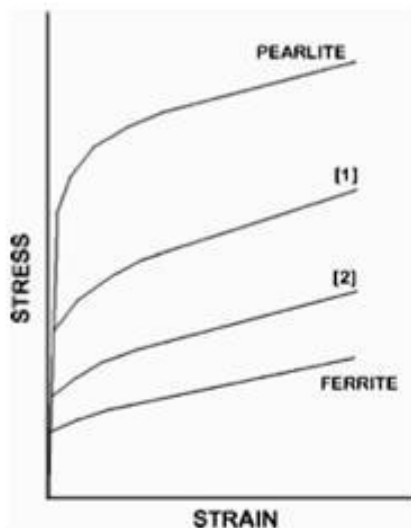
Figure 8: Schematic stress-strain curve for 100% ferrite, 100% pearlite, (1) highly constrained, thin pre-eutectoid ferrite zone in a ferrite-pearlite matrix and (2) lightly constrained, thick pro-eutectoid ferrite zone in a ferrite-pearlite matrix (from Garnham, 2008).

and begins to crack (Franklin, 2008). Cracks have been found to initiate in the pro-eutectoid ferrite. The preferential straining of pro-eutectoid ferrite, as the softer phase, compared to the pearlite results in cracking which decreases the fatigue life of the rail (Garnham, 2008). The difference in strain between PE ferrite and pearlite can be seen in Figure 8 which shows the stress strain curve for 100% pearlite and 100% ferrite. The difference between the yield points can be clearly seen.

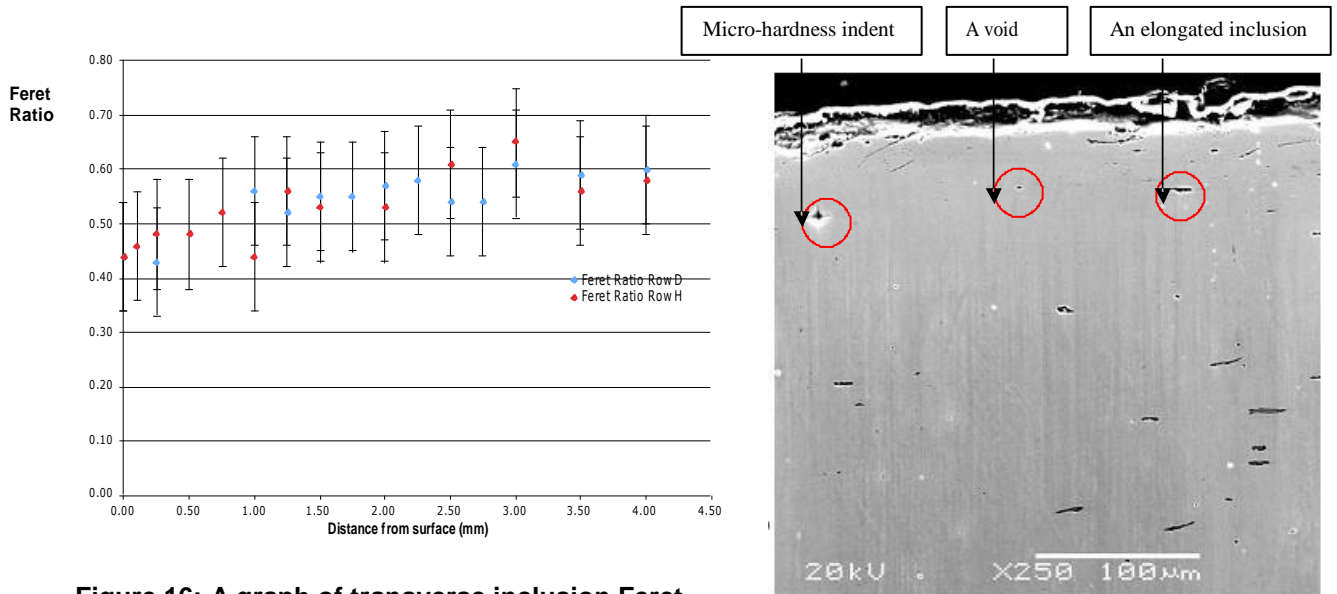
Figure 16: A graph of transverse inclusion Feret ratio with distance from surface for a 260 grade rail steel.

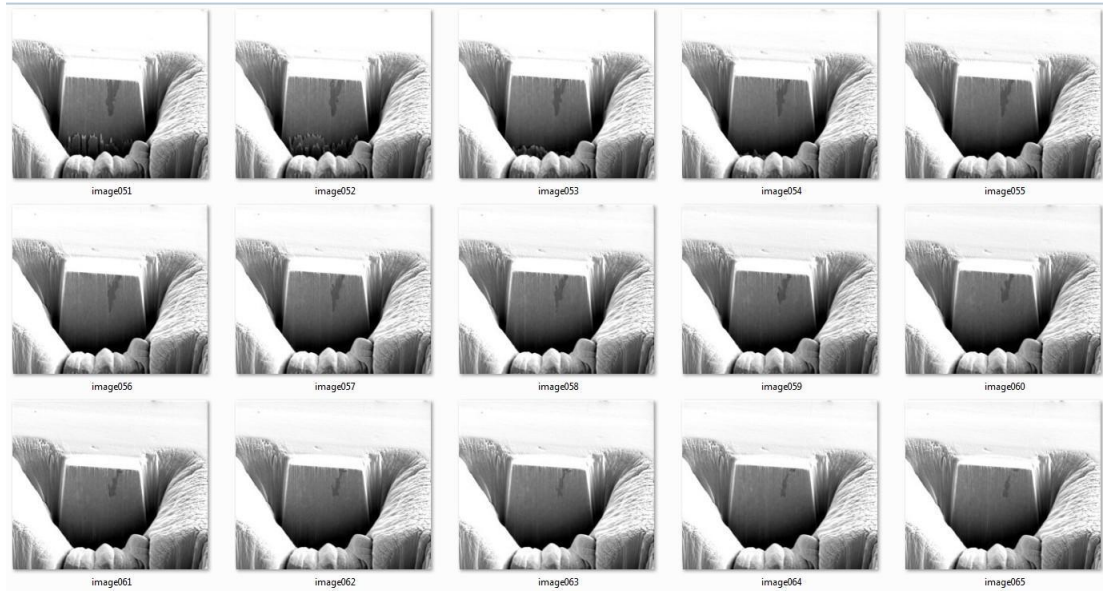
Figure 19: Successive FIB slices through rail steel showing the variation in inclusion deformation.

The FIB images showed that the MnS inclusion does not deform uniformly through the material. The slices show a constantly changing cross section of inclusion as shown in Figure 19.

Figure 19 shows an inclusion with an F max of 6.4 µm and an Feret ratio of 0.35 which is consistent with inclusions seen on 2D micrographs. The voids seen in the FIB images are also present in the 2D micrographs as can be seen in Figure 17. Figure 17 also shows the non-uniformity of the inclusions in the steel however it is much clearer on the 3-D images in Figure 19. The inclusions shown in Figures 18 and 19 also show the inclusions elongated normal to the rolling direction which relates to the shear angle data in Table 3 showing the rail deforming with the direction of train travel.
