HYDROLOGICAL ANALYSIS
OF THE TRURO FLOODS
OF JANUARY AND OCTOBER 1988

M C Acreman

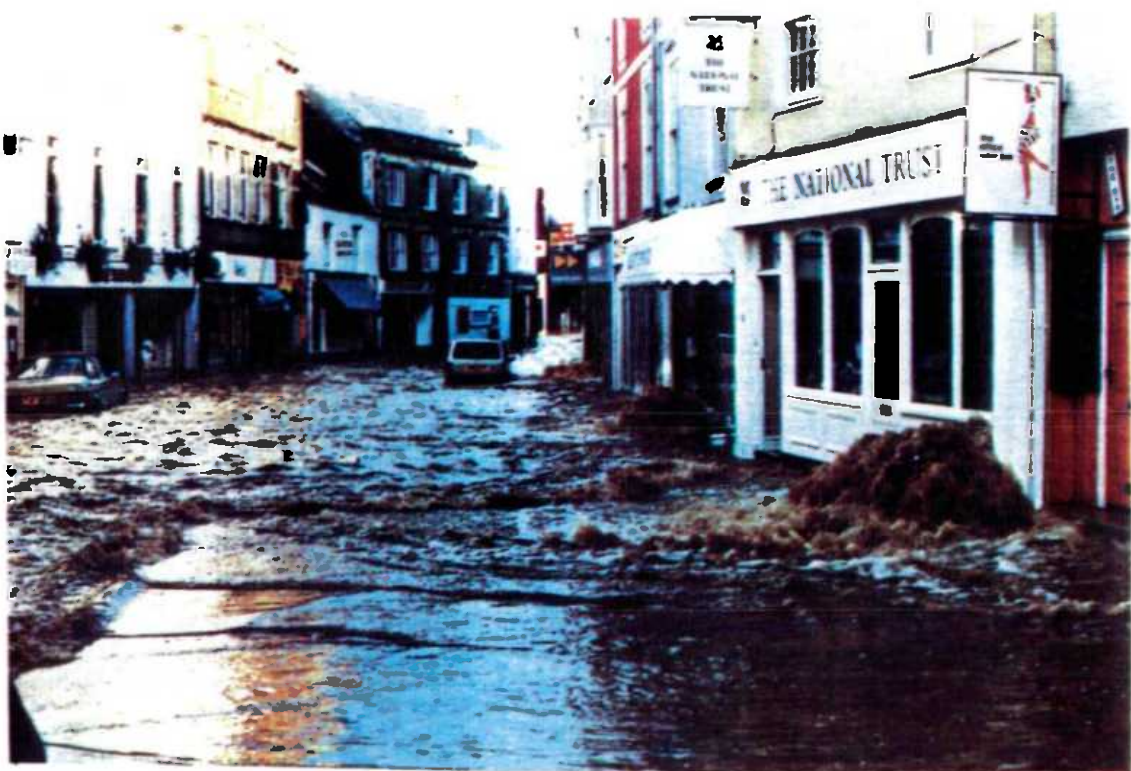
Plate 4.2 Flooding in Truro city centre due to river culvert surcharging through access manholes
