Siege Archaeology of the English Civil Wars: Establishing a methodology to unlock the archaeology of attack and defence at early modern siege sites

Richard Jeffrey Leese

A thesis submitted to the University of Huddersfield in partial
fulfilment of the requirements for the degree of Doctor of
Philosophy

The University of Huddersfield in collaboration
with English Heritage

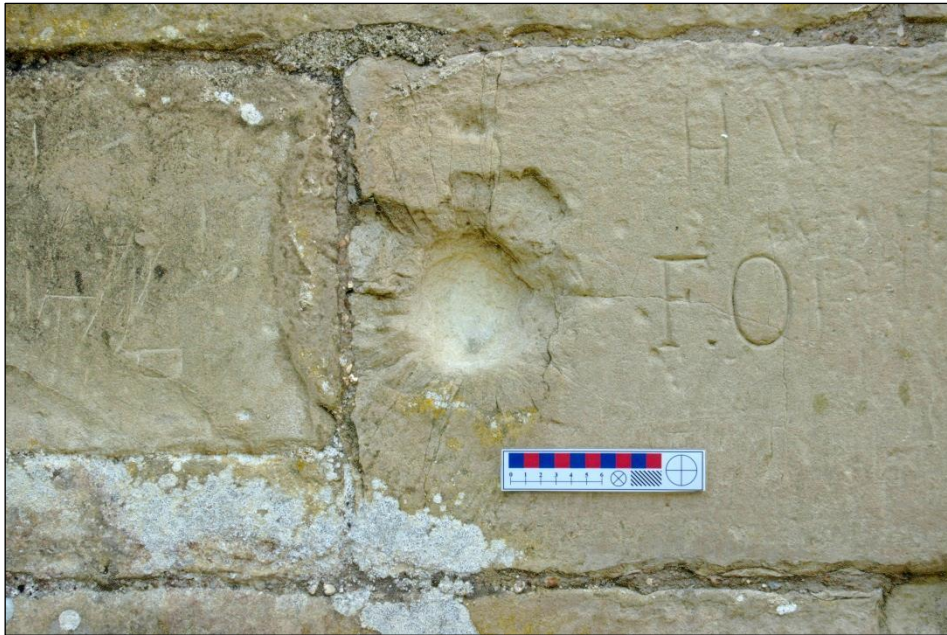
Figure 2: Photograph of a suspected artillery impact scar at Old Wardour Castle, Wiltshire

On the gatehouse wall there is present of a much larger impact scar just to the left of the main doorway. The scar is approximately 7cm in diameter within the inner-scar and 13cm overall across the width of the spalling (Figure 2), and is significantly larger than observed small-arms scars. A short distance to the right on the flanking doorway pillar there is the trace of a second, possibly similar scar, though this appears to have resulted in the destruction of part of the curved stonework on that feature and as a result no clear scar remains to be compared.

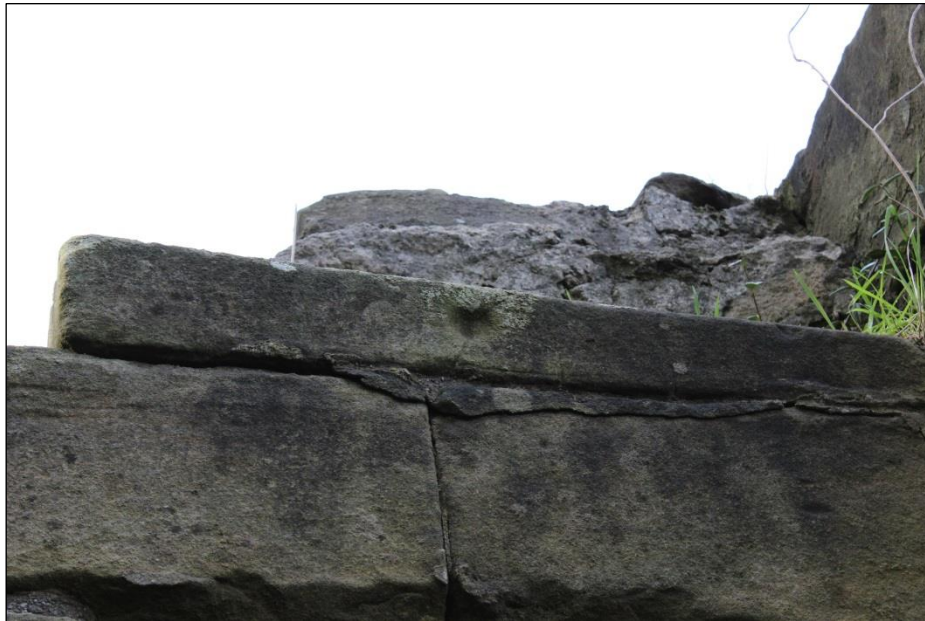
Figure 3: Photograph of an impact scar on a surviving castle wall section at Pontefract Castle, West Yorkshire

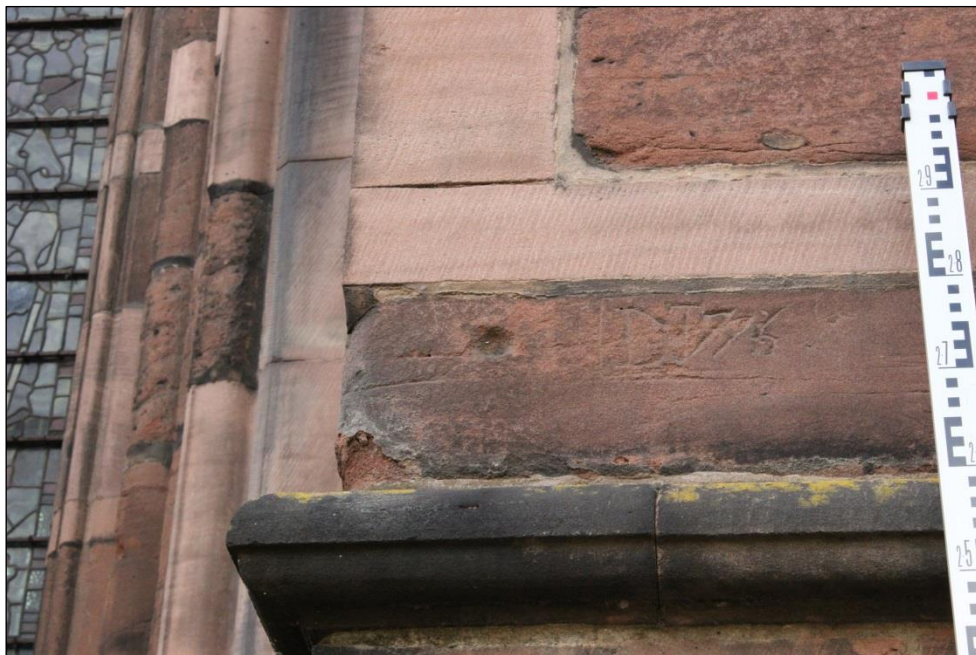
Figure 5: Photograph of stone replacement adjacent to an impact scar at Chester Cathedral

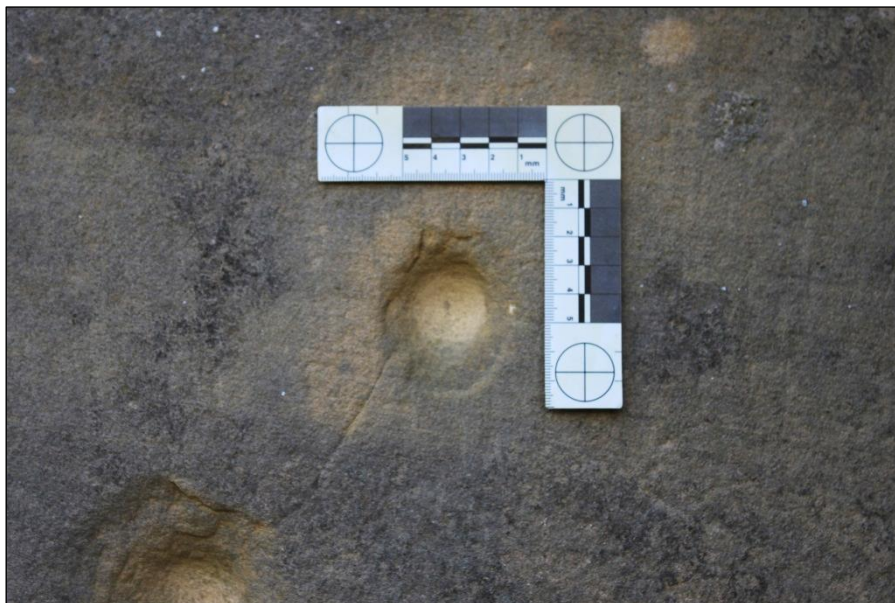
Figure 7: Photography of an impact scar showing characteristic cup shape of the inner scar, in addition to spalling and radial fracturing

The principal feature of an archaeological impact scar is that of the inner scar. This feature above all others is necessary for the positive identification of a mark on a surface as being an impact scar caused by a projectile. Where a complete impact scar is present on a worked stone surface, the inner scar takes the form of an ellipse when viewed perpendicular to the impacted surface, with a smoothed interior if examined in cross-sectional (Figure 7). In instances where a bullet has struck on the edge of a block or a shaped surface such as a window mullion, the ellipse of the inner scar may only be partially complete due to fracturing of the stone block between the impact point and the edge-surface. The remnant of the scar on the remaining surface frequently retain some of the scar shape and associated features, enabling identification and frequently some degree of measurement to be undertaken.

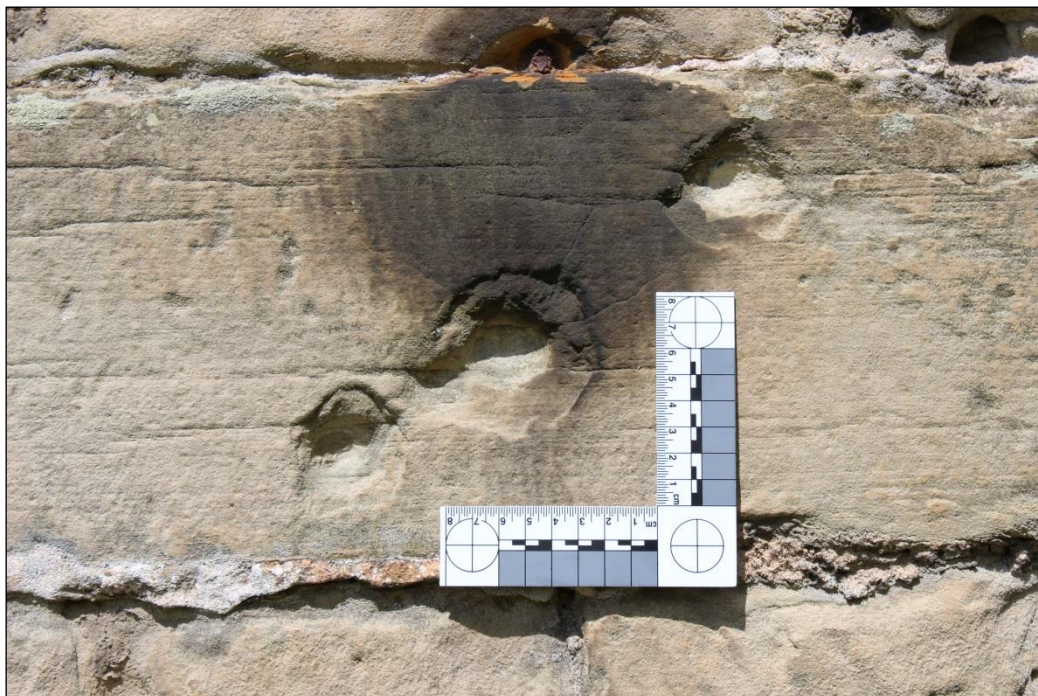
Figure 9: Photograph of scars showing prominent outer spalling at Ashby Castle, Leicestershire

Immediately adjacent to and surrounding the outer circumference of the inner scar is outer spalling. As with the inner scar the process of formation of this feature is not entirely clear. The outer spalling may represent the impact deformation of the bullet removing a largely circular layer of material through abrasion of the bullet lead as it flattens and fragments radially, or the displacement of material from the block surface as the deforming lead expands outwards from within the space of the inner scar. Spalling may also be a partially a result of the loss of edge surface material around the impact scar that has been cracked or weakened as a result of the impact and gradually been removed by weathering processes. High speed footage taken from experimental firing seems to suggest the displacement of the adjacent surface stone by the expanding bullet (dependent on the degree of penetration of the bullet) is the most significant cause, however archaeologically observed examples display evidence of spalling loss expanding close to faults or edges of the stone blocks, indicating fracturing travelling towards weaknesses in the structure of the stone.

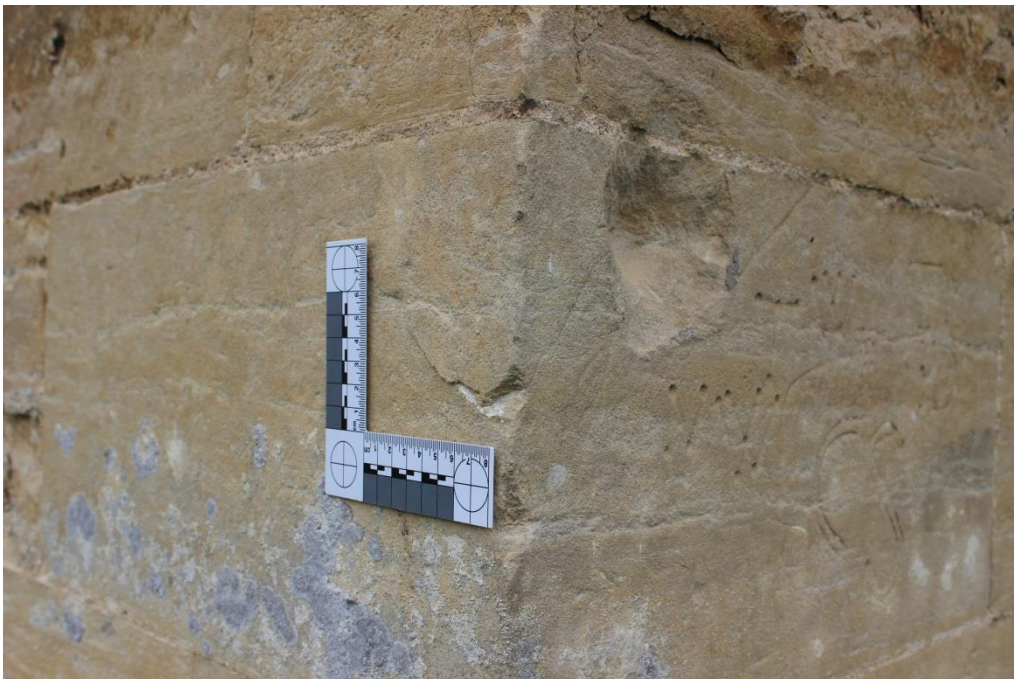
Figure 10: Photograph of an impact scar from Hillesden church, Buckinghamshire, showing a radial fracture emerging from an adjacent surface of the impacted block

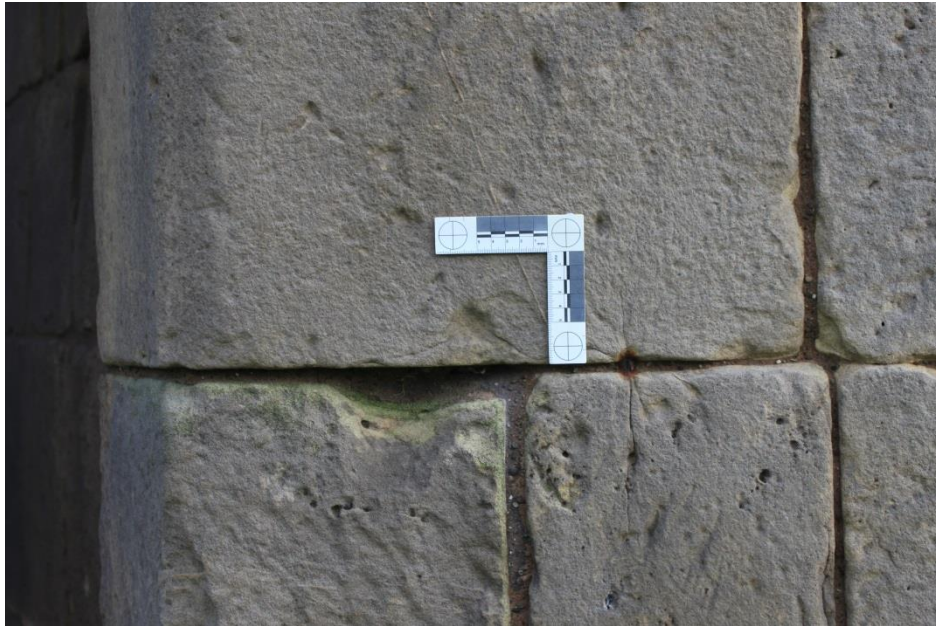
Figure 11: Photography of an impact scar surrounded by numerous features that mimic aspects of early modern small-arms impacts

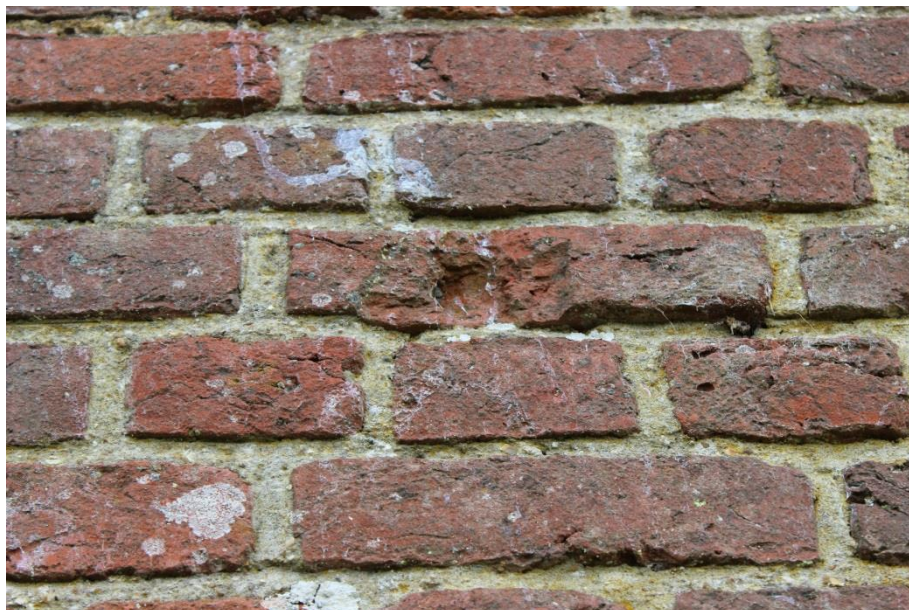
Figure 12: Photography of an impact scar on a brick wall at Basing House, Wiltshire

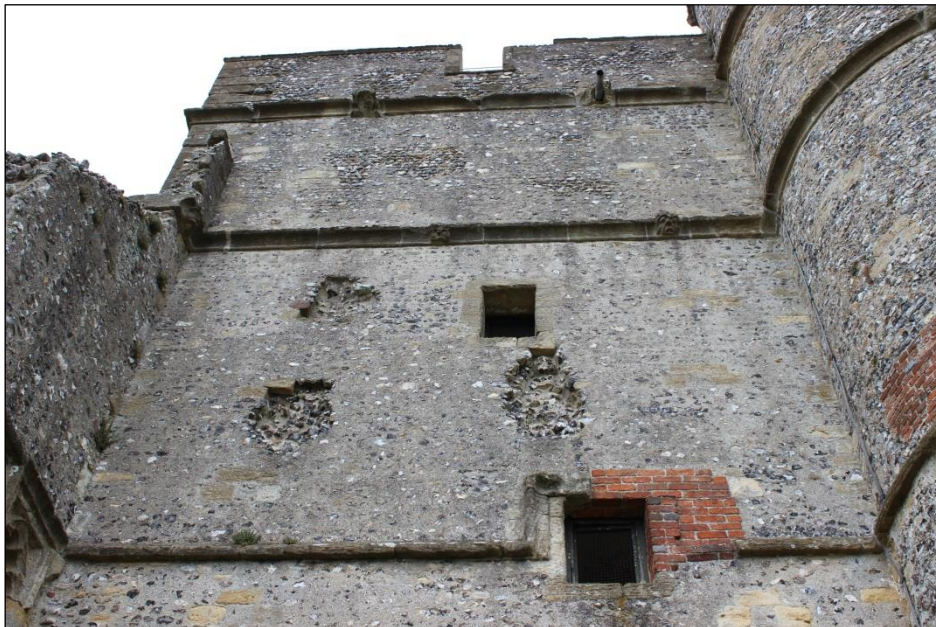
Figure 13: Photograph of artillery damage at Donnington Castle, Berkshire

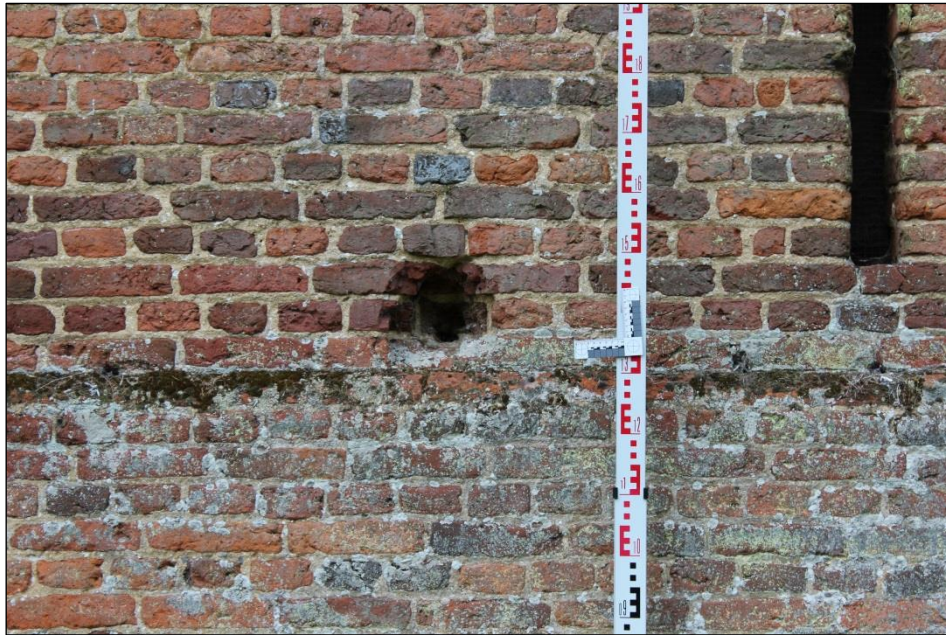
Figure 14: Photograph of artillery impact on brickwork at Basing House, Wiltshire

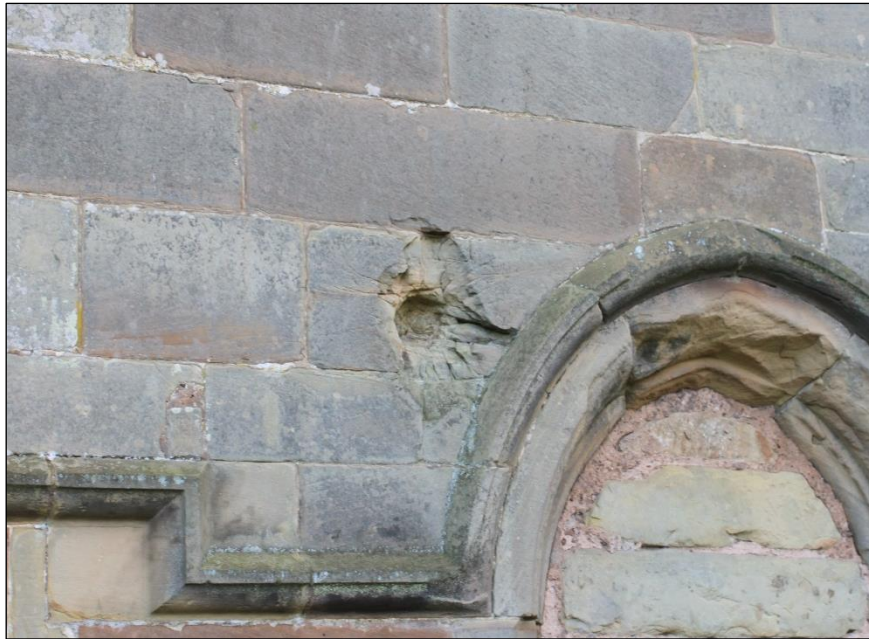
Figure 15: Photograph of an artillery round shot impact at Tong church, Shropshire

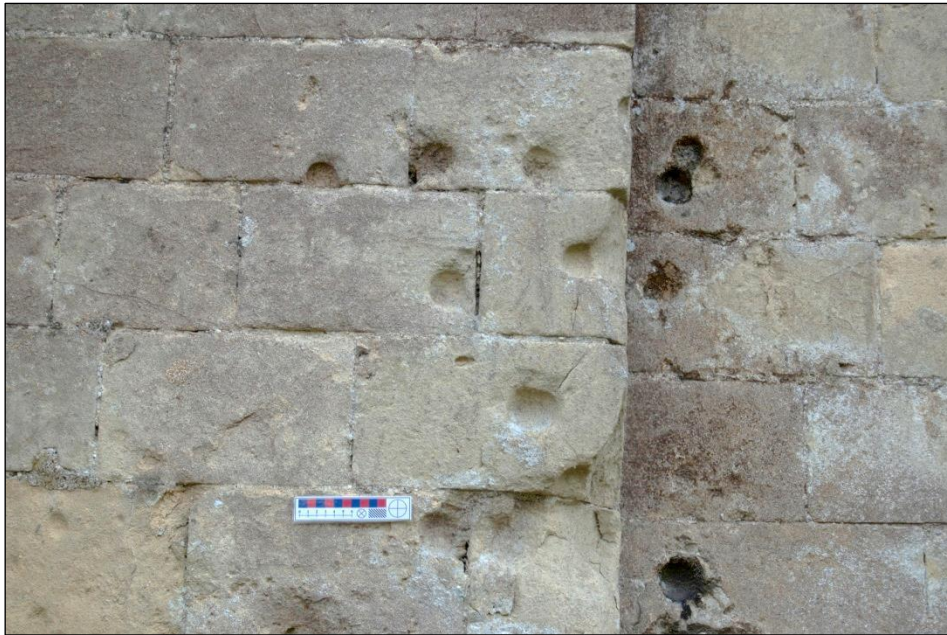
Figure 16: Photograph of possible hail shot impacts on St. John's church, Devizes, Wiltshire

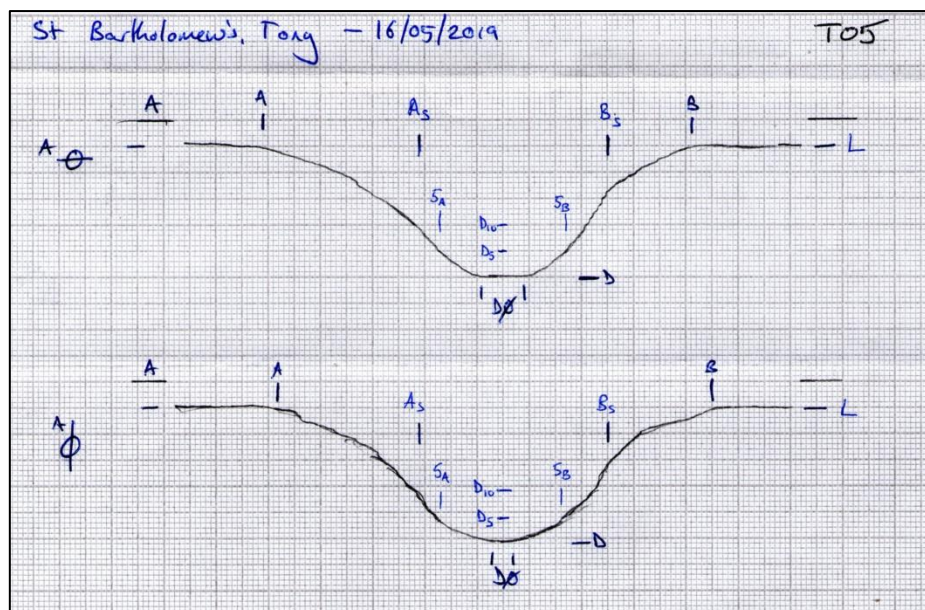
Figure 19: Image of an annotated recording sheet after analysis of the scar features

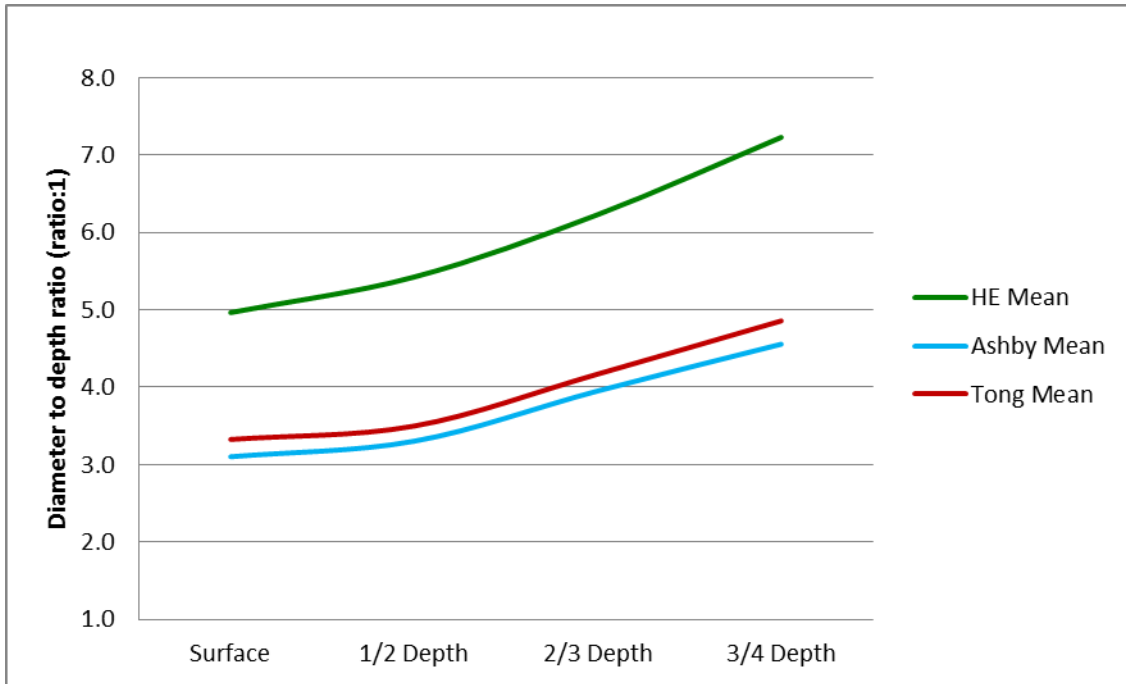
Figure 23: Graph showing ratio relationship of scar diameter to depth at various points of penetration into the surface

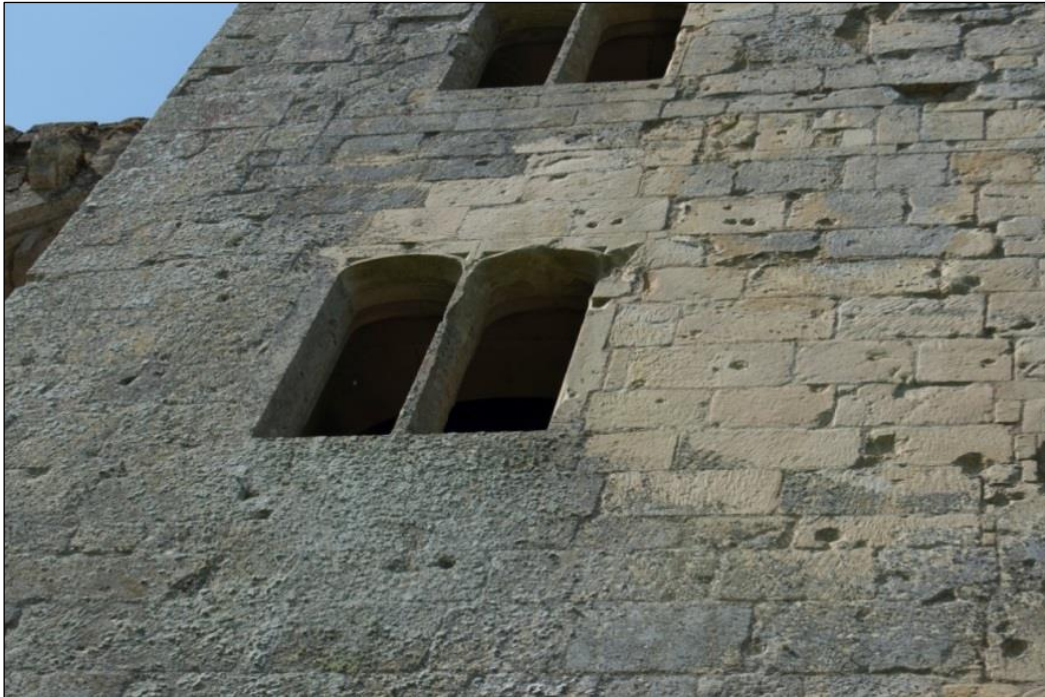
Figure 35: Photograph of a window opening on the 'right' tower of the Old Wardour gatehouse, illustrating the visual contrast for identifying scars on the bare ashlar, and on surfaces covered in textured lichen

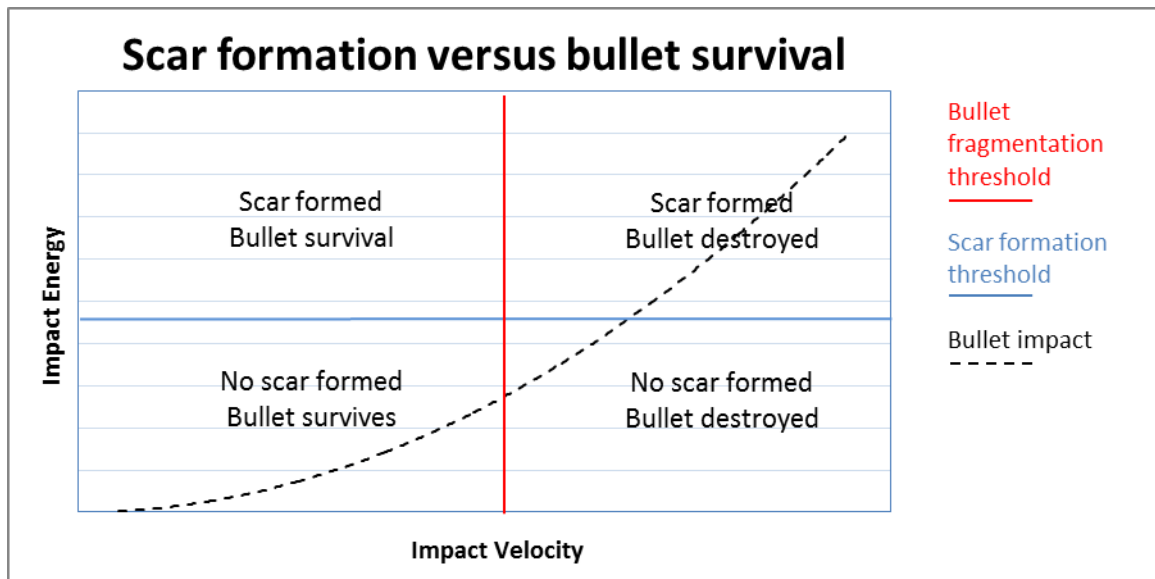
Figure 40: Chart illustrating impact outcomes for bullet and impacted surface. Here the hypothetical threshold (represented by the bullet impact curve) indicates a scenario where intact impacted bullets could not have produced an impact scar.

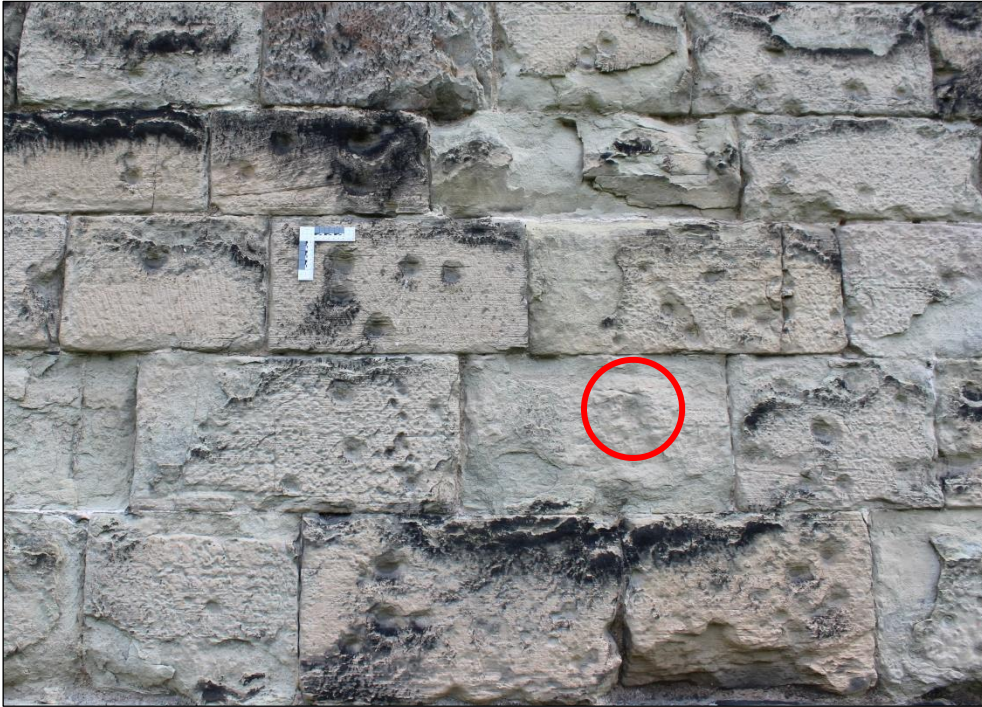
Figure 41: Photograph of impact scars at Ashby Castle. Circled is a scar where the original surface level has been lost due to weathering

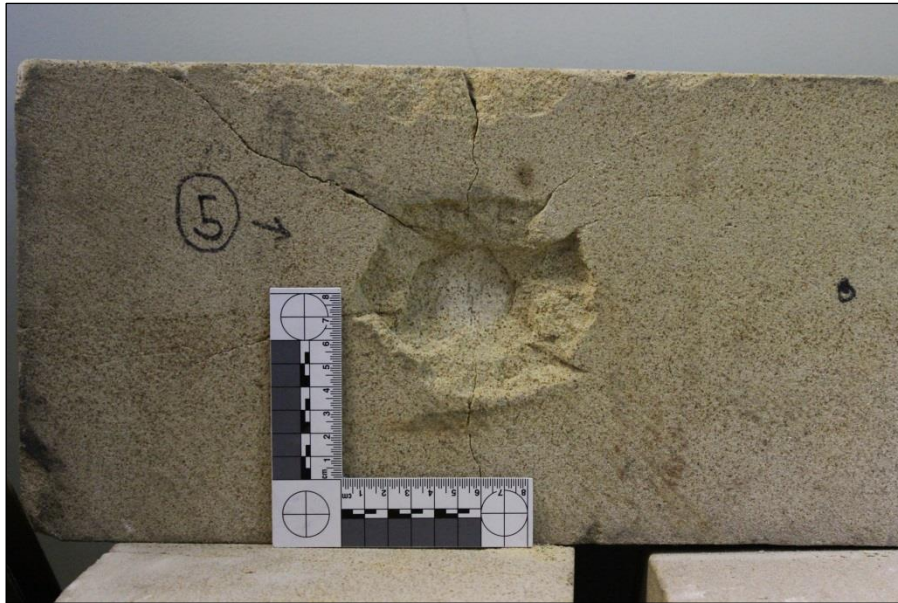
Figure 45: Photograph of experimental impact 5 from Wynne (2012), showing the excessive depth of the spalled radius at the edge of the scar

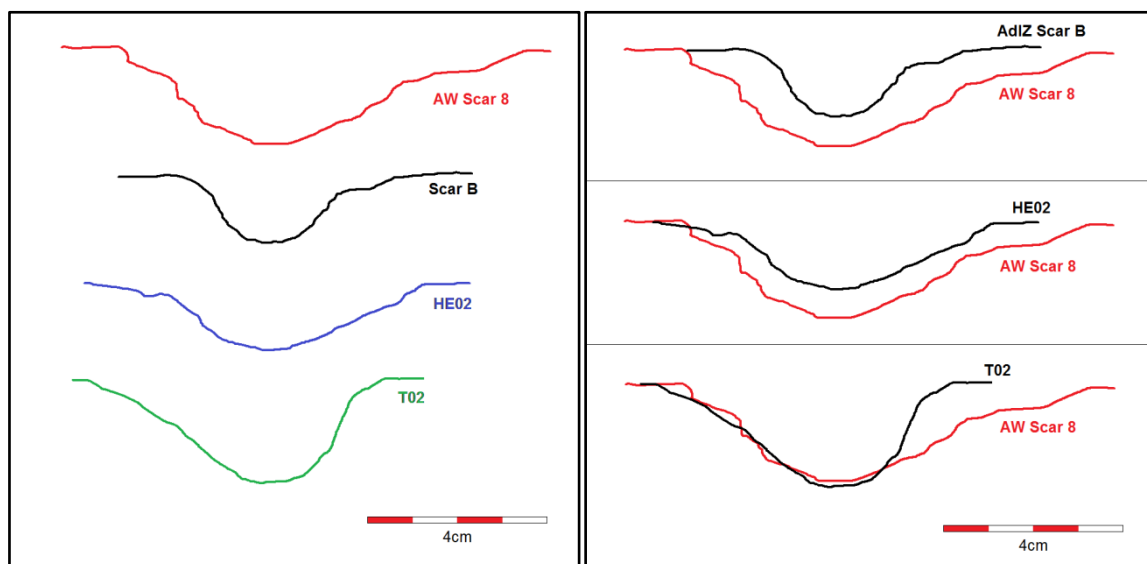
Figure 48: Cross sections of scar 8 compared with sampled scars

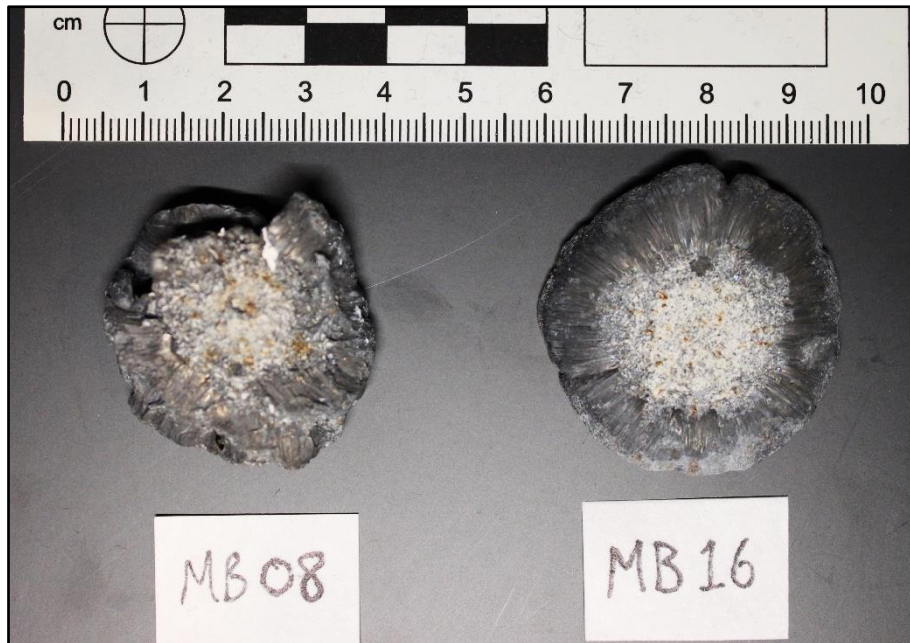
Figure 50: Resultant impacted bullet MB08 from shot 4 showing unusual, stepped impact surface, compared with MB16 from shot 3 which shows typical radial striations and embedded block material

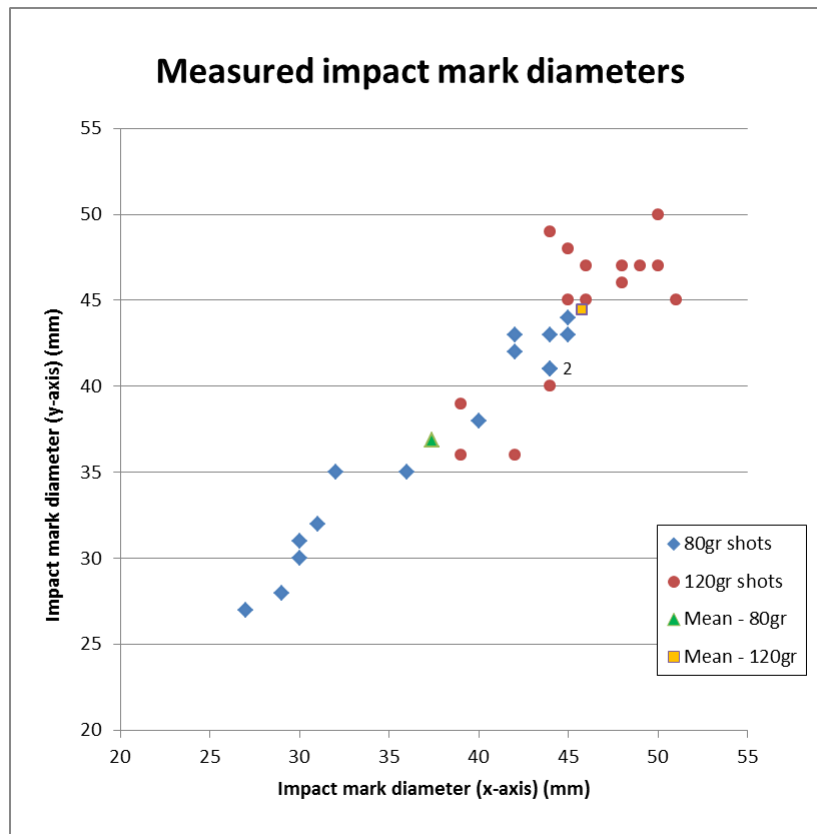
Figure 54: Plot of measured diameters for all impacts produced during experiments at the Yorkshire Shooting Centre, Mirfield (2019)

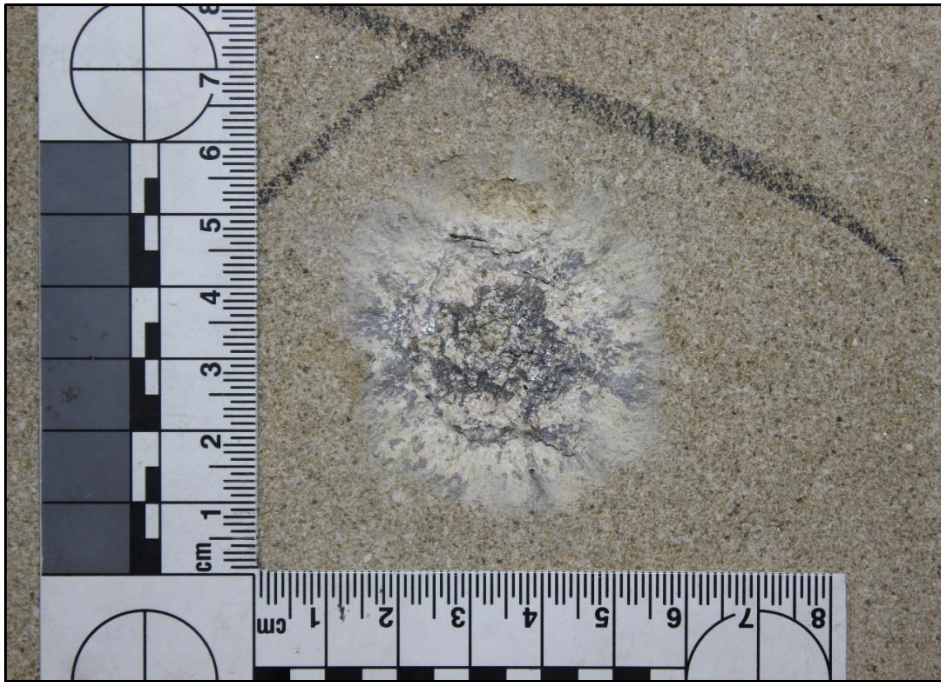
Figure 58: Impact mark F120 immediately after formation

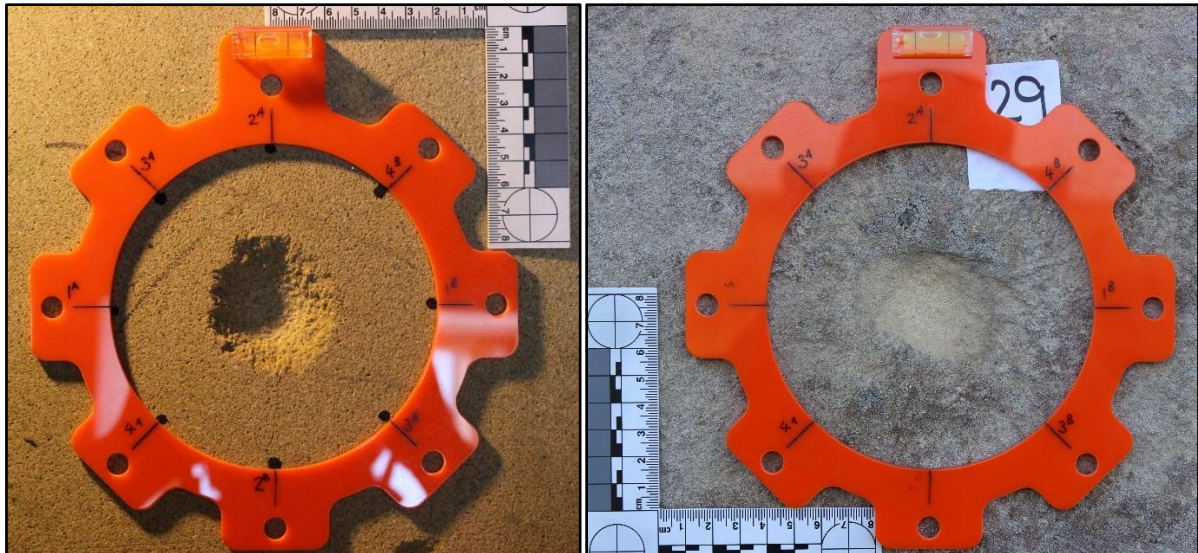
Figure 60: Internal surface texture of scar F120 (left) compared with scar E29 from Moreton Corbet Castle (right)

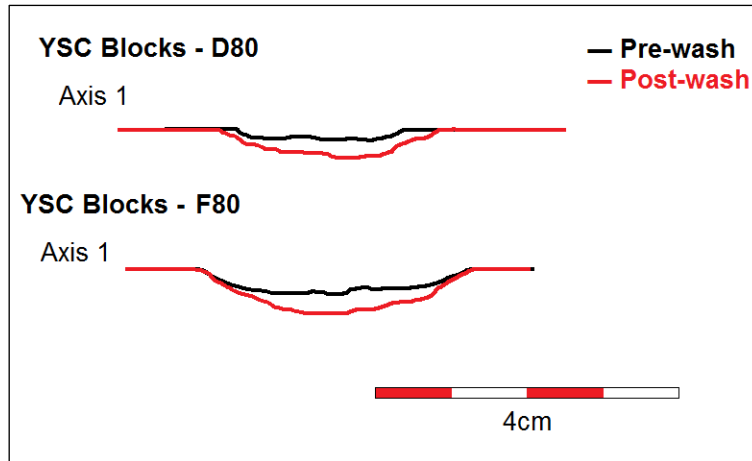
Figure 61: Traced horizontal cross-sectional profile comparison for 80gr impact scars before and after pressure washing

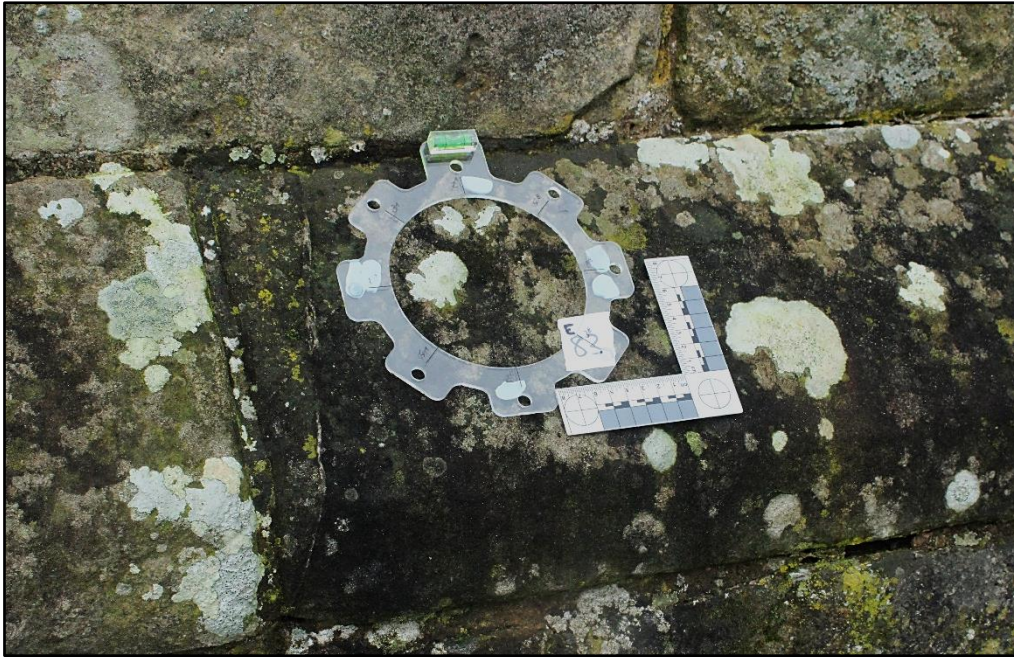
Figure 79: Impact scar E83 located on backwards-sloping wall surface on Moreton Corbet Castle

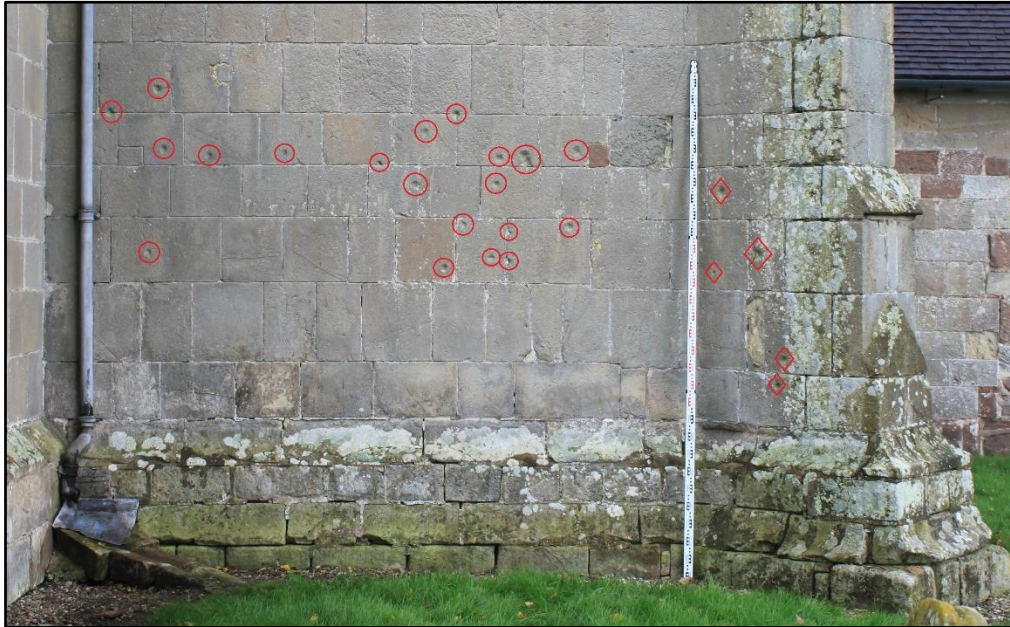
Figure 83: Grouping of scars on eastern end of the south aisle exterior wall bearing measured scars C01-26. Scars are indicated by red circles for clarity, red diamonds indicate scars C01-05 on the angled buttress. This wall faces towards Moreton Corbet Castle

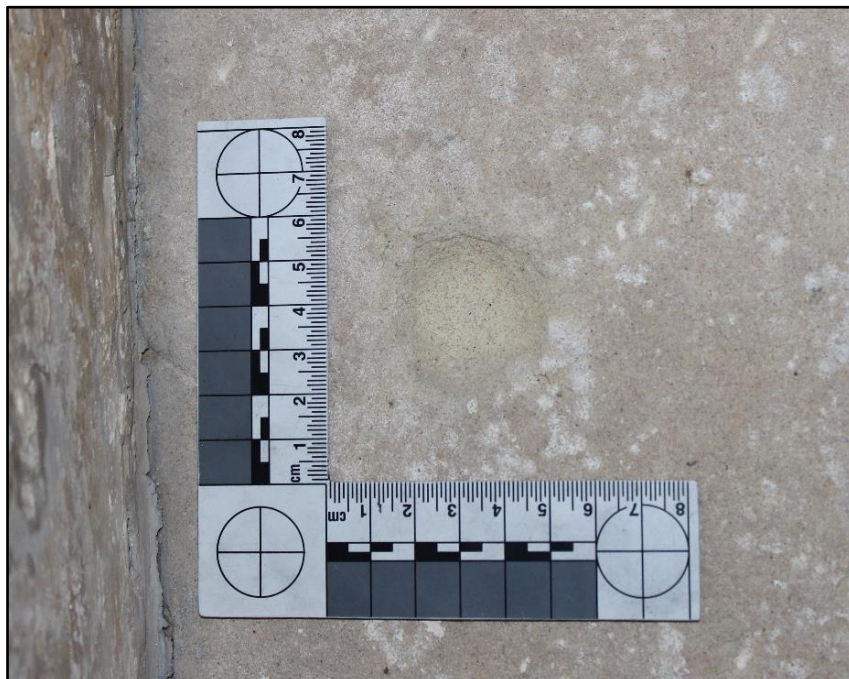
Figure 84: Internal scar in the squire's pew at St. Bartholomew's Church, Moreton Corbet. The scar shows the same internal cup-shape as seen elsewhere, and lighter stone in the base of the scar in comparison to the case-hardened patina on the block surface
