Dimensioning metallic inserts of stone claddings: a case study

This study proposes a methodology for dimensioning metallic inserts for the indirect fastening of granite claddings. The proposed methodology intends to solve an existing problem, observed in a case study analyzed in the city of Porto Alegre, Brazil. This case study is a residential building, which presents a severe detachment of the external granite cladding, generating serious materials' damage in the building, also compromising the users' safety. The pathology observed in this case study, evaluating the causes beyond the detachment of the granite cladding. The façades orientation and the exposure to prevailing winds could contribute to the claddings' degradation condition. Nevertheless, the design and execution conditions seem to be the main cause of the existing condition of the case study under analysis. The evaluation of the case study reveals that the absence of an intermediate layer of metallic inserts in association of the presence of strong winds in the region, lead to an overload of the granite plates in their midline, causing the rupture of the elements, and, consequently, to the partial detachment of the s

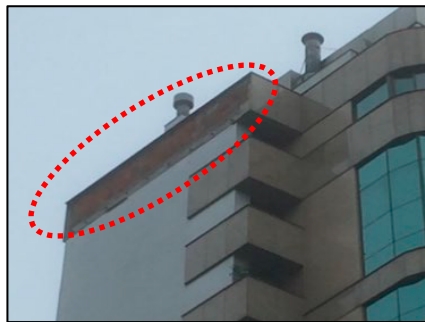
The stone plates cracking, with the consequent detachment from the substrate of a building with ten years of service is the pathological condition under analysis. Fortunately, only material damages were observed, resulting from the fall of heavy plates from more than 42 meters high. The anomalies occurred in the higher part of this fourteen-story building located in the city of Porto Alegre, in the southern region of Brazil. The owners wanted to know the origin of this anomaly and consequently who was the responsible for it. The building is vulnerable to the effects of prevailing winds, since is not protected by adjacent buildings. The cladding mainly presents a southeast orientation (Figures 1 to 5), and the detachment of the cladding occurred in a stormy day with strong winds (around 33.5 meters per second, from southeast direction).

Figure 1. View of the region with detachment of stone elements (façade facing southeast)

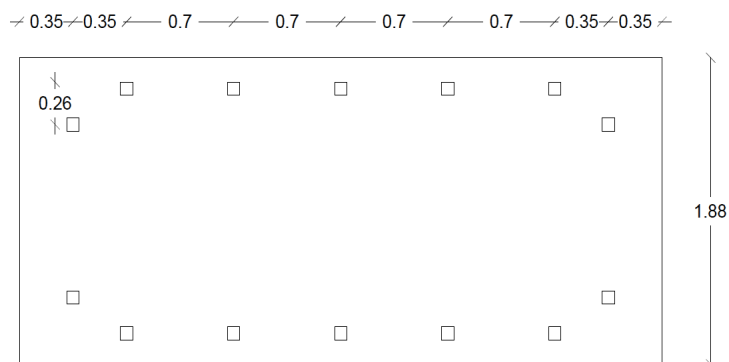
Figure 4. View of the quantity and disposition of the metallic inserts (according to local)
