HOT SPOT ANALYSIS OF POTENTIAL SANITARY SEWER EXFILTRATION IN CRYSTAL CREEK WATERSHED

Adam Schumacher, Michael Reisner, & Kevin Geedey
Augustana College, Rock Island, IL

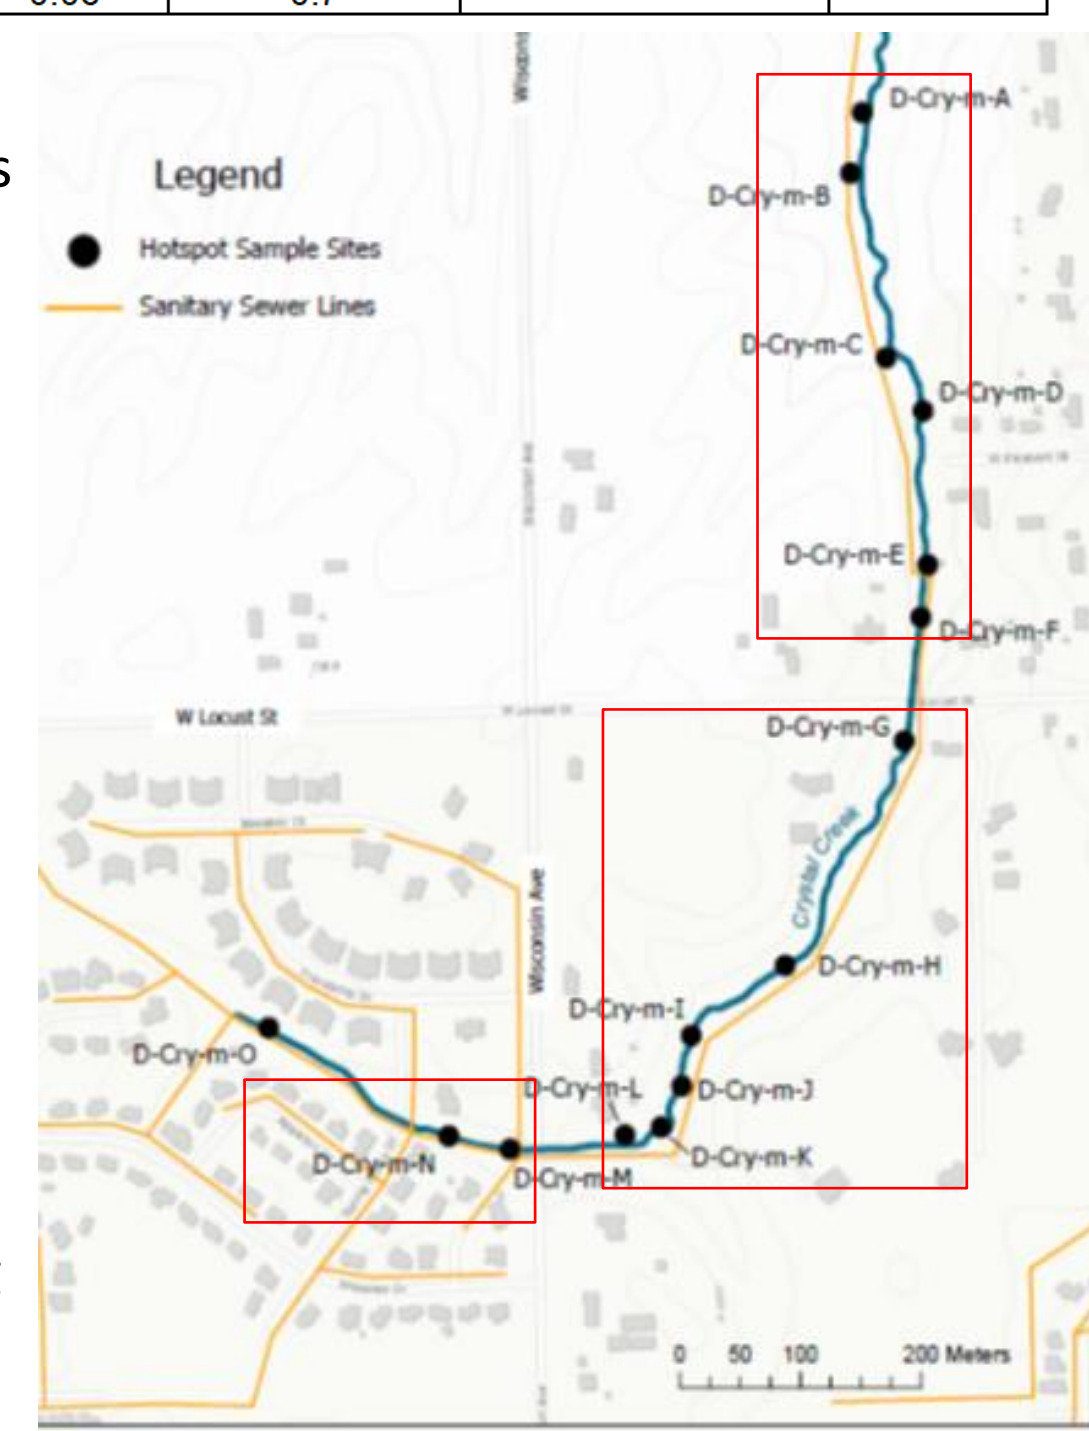
Figure 2. Crystal Creek Watershed stream reaches assessed with intensive sampling.

- We conducted intensive, 25 m increment, sampling within the reaches upstream of the sites where at least 4 of the indicators exceeded the thresholds (Fig. 2, red rectangles).
- pH, specific conductance (SPC), and dissolved oxygen (DO) levels were taken using YSI Pro-Plus Multi-parameter sondes.
- Ammonia and phosphate were measured using EPA colorimetric methods.
- Biological Oxygen Demand (BOD) was assessed using a modified USGS method.⁴
- Escherichia coli* (*E. coli*) and fecal coliforms analysis was performed using IDEXX Colilert™ and Quantitray™.

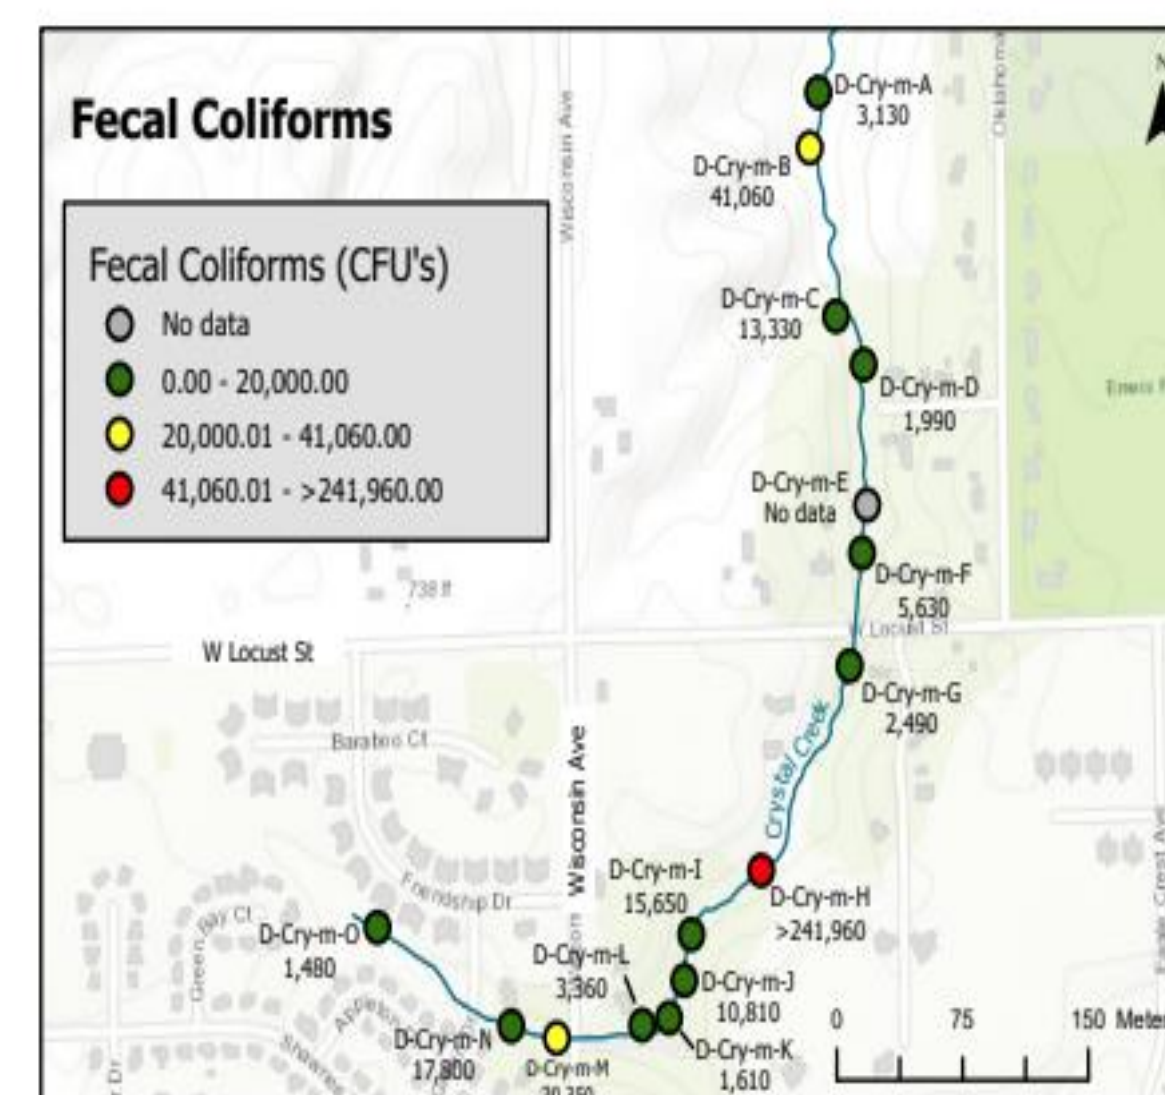
Figure 3. Fecal coliform levels (color) at sampling locations (circles) along Crystal Creek.

There were strong correlations among six of the eight indicators (Table 2). Dissolved oxygen levels strongly correlated with all five other water chemistry-related indicators, while ammonia and BOD were strongly correlated with four of the water chemistry-related indicators. Fecal coliform levels and Specific Conductance levels were uniformly high across all the assessed reaches (Figs. 3-4).
