Engineering reconnaissance following the August 24, 2016 M6.0 Central Italy earthquake

ENGINEERING RECONNAISSANCE FOLLOWING THE AUGUST 24, 2016M6.0 CENTRAL ITALY EARTHQUAKE

## ENGINEERING RECONNAISSANCE FOLLOWING THE AUGUST 24, 2016 M6.0 CENTRAL ITALY EARTHQUAKE

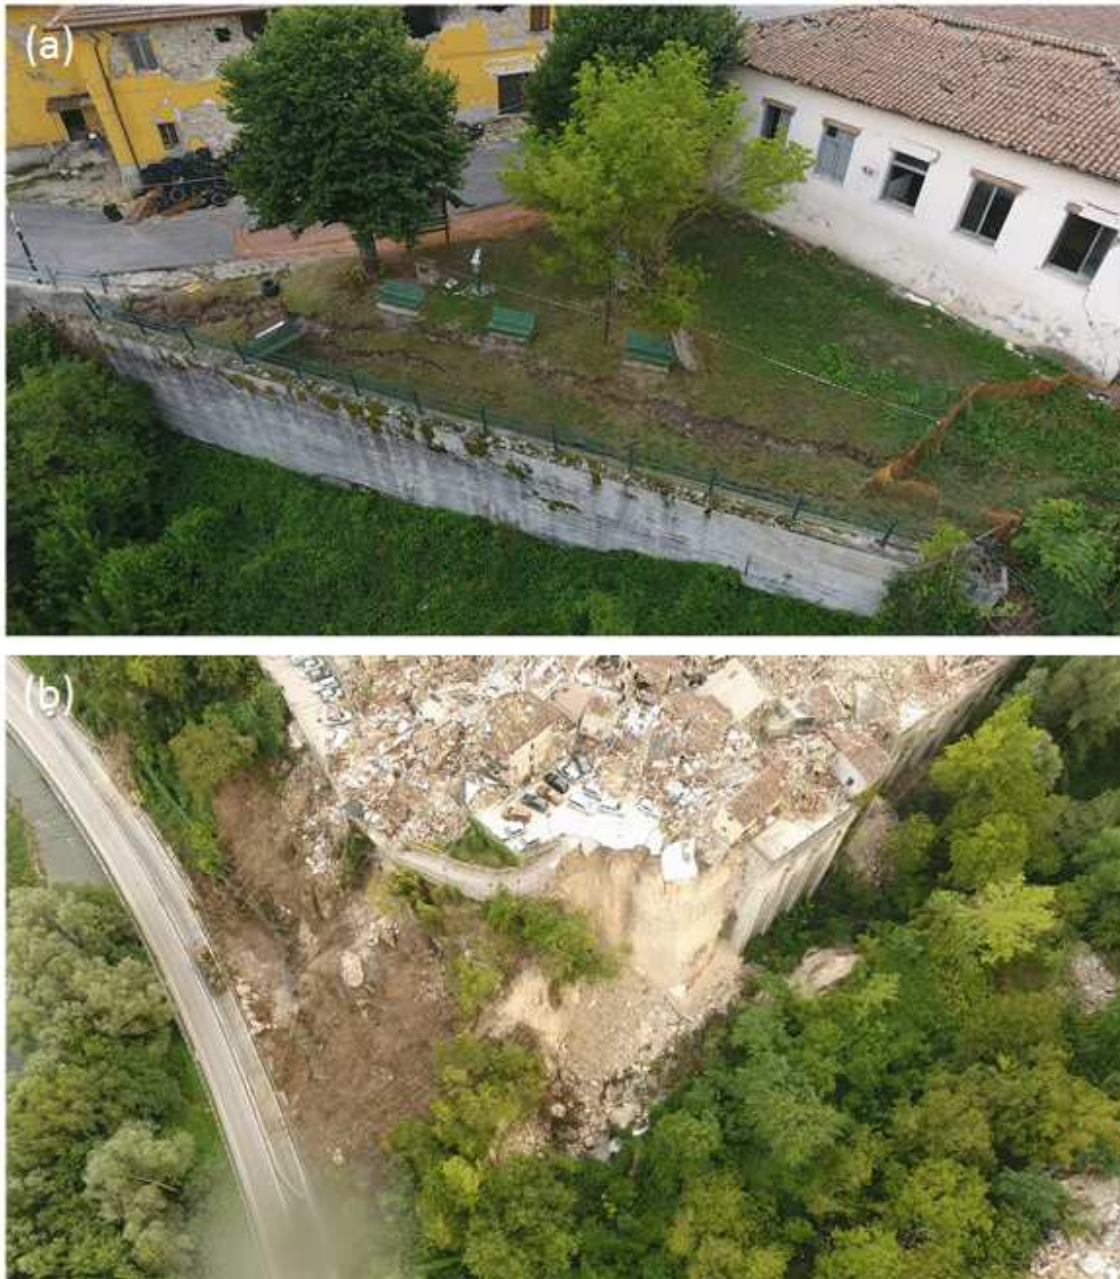
Using a DJI™ Phantom 4 drone, a customized Align™ T-Rex 800 drone, and an Ebee Sense Fly drone, we imaged the four locations shown in Figure 1. These data will be used also for high resolution digital map creation (orthophoto) Digital Surface Model (DSM) and 3D models of the acquired areas. Information on where to find down-sampled video for two of these locations (Accumoli and Pescara del Tronto) are provided on the Central Italy Earthquake event page within the GEER Association website ([www.geerassociation.org](http://www.geerassociation.org)). Figure 6 shows aerial photos taken by drones at Accumoli (Figure 6a) and Pescara del Tronto (Figure 6b).

**Fig 6** – Aerial photos taken by drones at: (a) Accumoli (N42.69425, E13.24993, 9 September 2016); and (b) Pescara del Tronto (N42.750401, E13.272109, 9 September 2016).

Observed landslides were mainly small rock failures (wedge slides, topples and slides in intensely fractured/weak rocks) which very often generated rockfalls. One of the largest failures occurred on a slope that, in the past, was involved in similar instability phenomena (Pescara del Tronto, just above the Salaria State road, Figure 6b). In several instances (specifically Tufo, Pescara del Tronto and Accumoli, Figure 6a), retaining structures underwent displacements and rotation (toppling) with consequences to the backfill and hence to the areas behind (including roads).

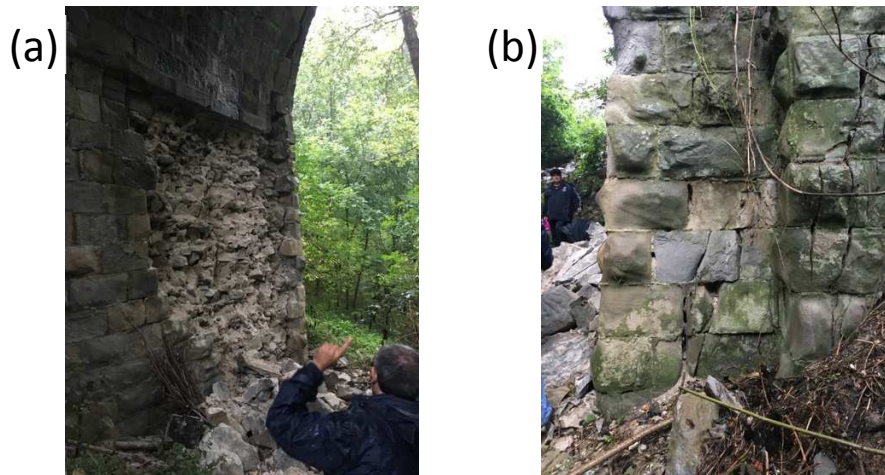
We found no evidence of damage to any of the contemporary bridges. We found damage to two arch masonry bridges at the locations shown in Figure 1. One of these bridges is near the village of Tufo on the Roman-era Trisungo route. The bridge had some cracking and spalling of exterior masonry elements, apparently exacerbated by settlement at the east support of the arch, as shown in Figure 7.

**Fig 7** – Roman-era bridge along the Trisungo route (Tufo area – Arquata del Tronto): (a) spalling and (b) cracking of exterior masonry elements. (N42.735389, E13.253611, September 7 2016).

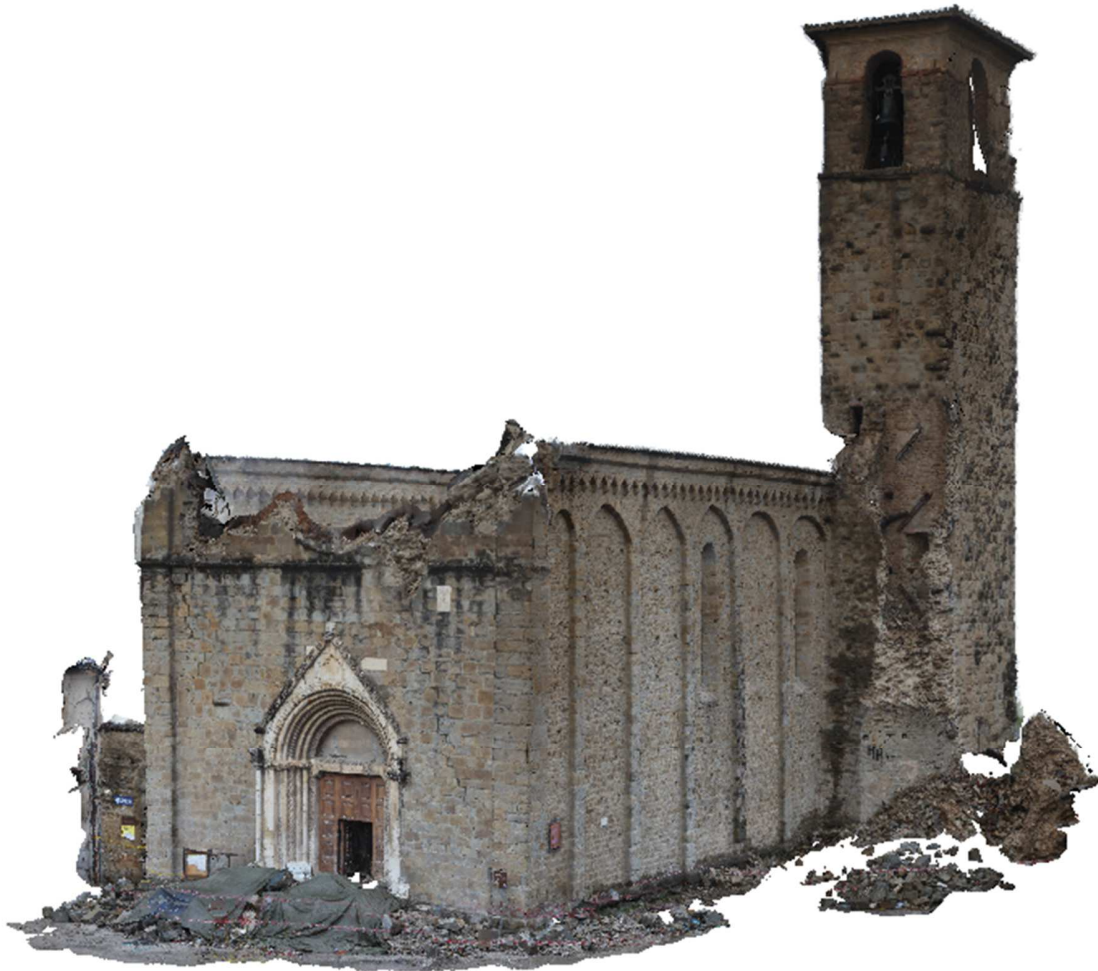
We also performed detailed aerial imaging of the Pescara del Tronto village, which will support the development of a 3D model for subsequent damage studies. Aerial flights were not authorized over the structures in the village of Accumoli during our reconnaissance. Close range photogrammetric survey for Digital Surface Model generation was also completed for the Sant'Agostino church and its bell tower in Amatrice (Figure 9), which can be used to generate 2D or 3D models of the structure.

**Fig 9** – 3D textured model of the Sant’Agostino church and its bell tower in Amatrice. (N42.628, E13.2914, September 7 2016).
