Stone roofing in the Aosta Valley, Italy: Technical properties and durability of traditional Lithotypes

Stone Roofing In The Aosta Valley, Italy: Technical Properties And Durability Of Traditional Lithotypes

Rossana Bellopede^{1*}, Lorena Zichella¹ and Paola Marini¹

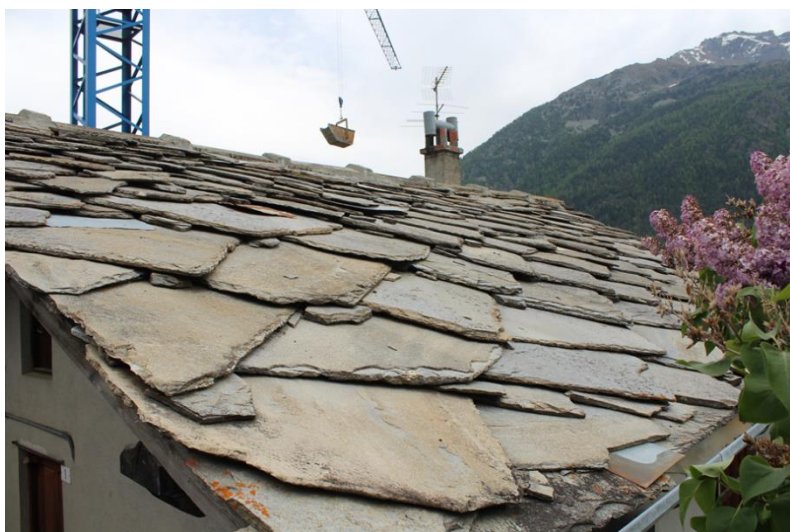
Figure 7. Calcschist CM roofing in Lignod after renovation.

In Ayas municipality, Lignod hamlet, the slabs of the roof in Fig. 7 have been recognized as Calcschist according to the comparison with the specimens brought by the laboratory. These slabs were similar but less weathered than those of Fig 6 on the left: the whole house was restructured in the early 2000s.
