Vinyl-Asbestos Floor Risk Exposure in Three Different Simulations

Lorena Zichella * , Fiorenza Baudana, Giovanna Zanetti and Paola Marini

Department of Environment, Land and Infrastructure Engineering (DIATI), Politecnico di Torino, 10129 Turin, Italy; fiorenza.baudana@polito.it (F.B.); giovanna.zanetti@polito.it (G.Z.); paola.marini@polito.it (P.M.)

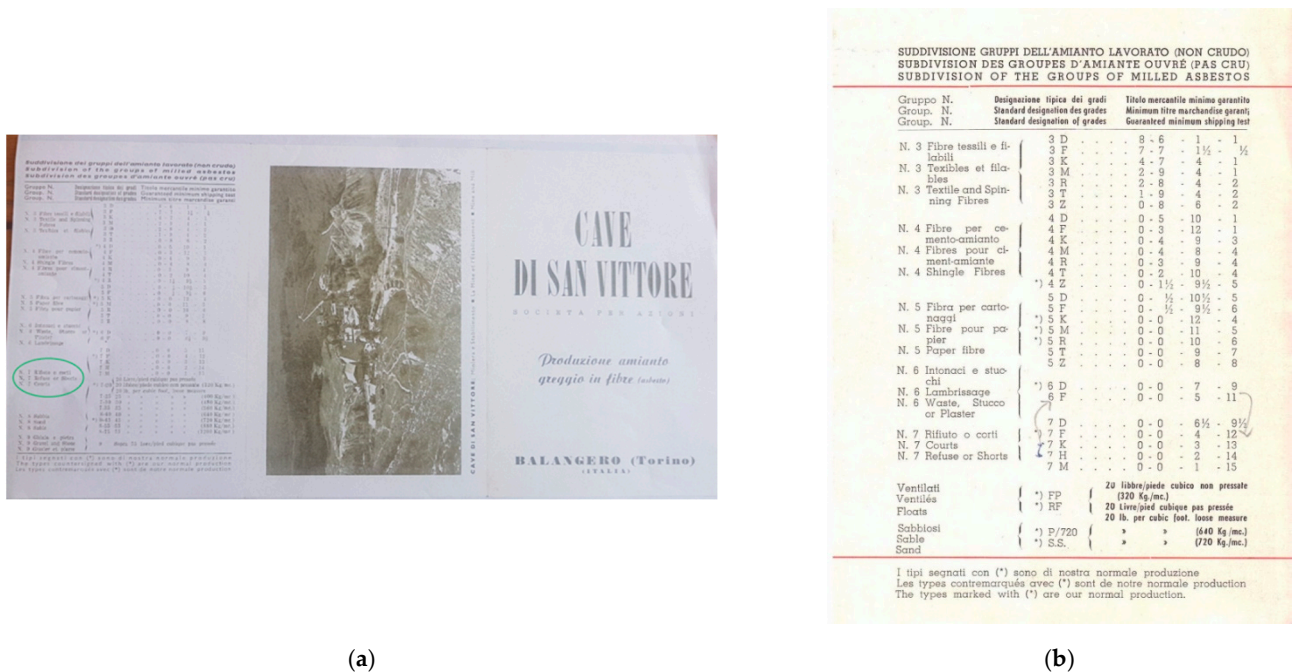
Figure 1. (a) San Vittore (Balangero, Turin, Italy) quarry, flyer extract for asbestos fiber production. Asbestos group 7 is circled in green, probably used for vinyl-asbestos floor. (b) Particularities of the subdivision of the group of milled asbestos (source: https://it.wikipedia.org/wiki/Amiantifera_di_Balangero; accessed on 10 January 2021).

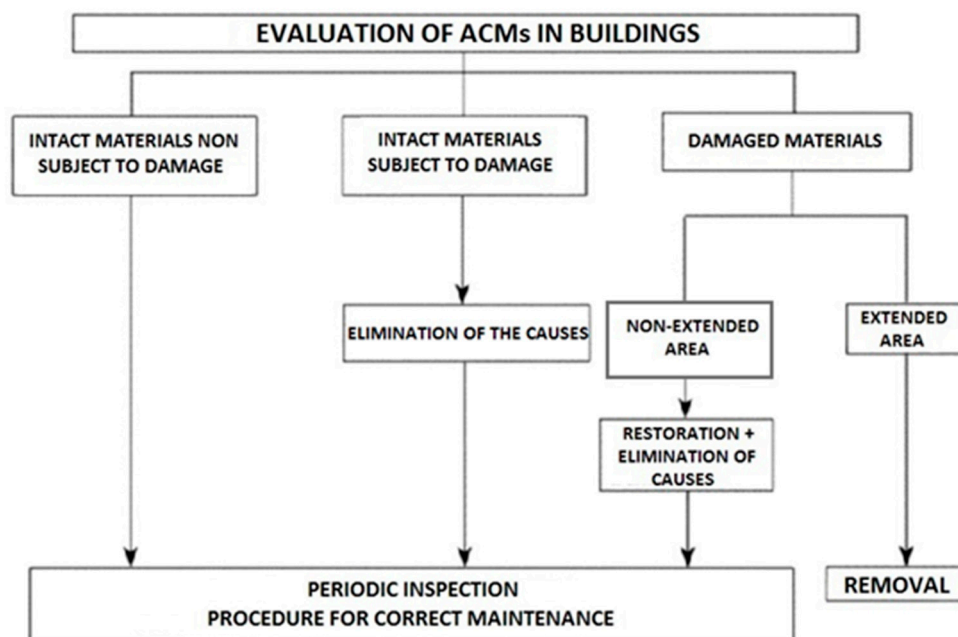
Figure 2. Evaluation scheme of asbestos-containing materials (ACMs) in building and recommendations (from Article 1, Annex: Standards and Technical Methods for Risk Assessment, Control, Maintenance and Remediation of Materials Containing Asbestos Present in Building Structure, Risk Assessment, Table 2 of M.D. 6/9/94 [4]).

Figure 2 describes the different situations that can occur during the evaluation of ACMs in buildings and the related recommendations in these different cases required by M.D. 6/9/94 [4].

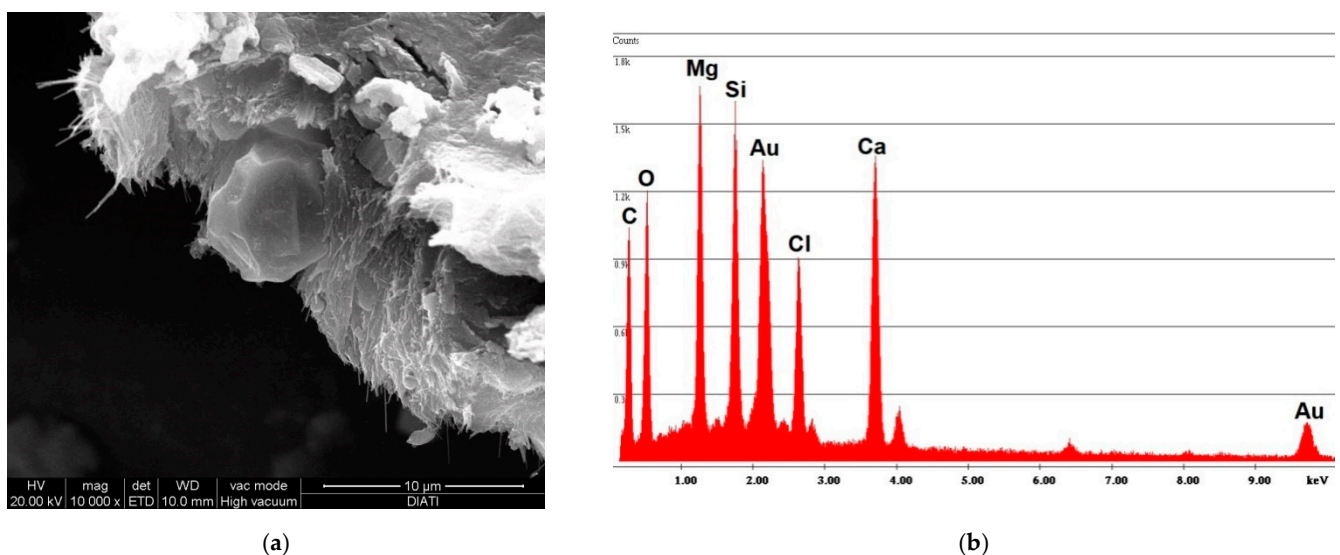
Figure 4. F sample SEM analysis. (a) Photo of incorporated fibers of chrysotile; (b) spectrum of chrysotile and vinyl chloride composition.

The simple abrasion of surface tile powder was analyzed with SEM/EDS; Figure 4 shows the spectrum obtained by analyzing the powder from vinyl F. The photo on the left shows how the fibers are completely incorporated within the vinyl matrix. The spectrum shows both of the elements that compose chrysotile, Mg and Si, where the Mg peak is greater than the Si peak; the spectrum also reports the elements that compose the vinyl matrix, Cl and Ca.

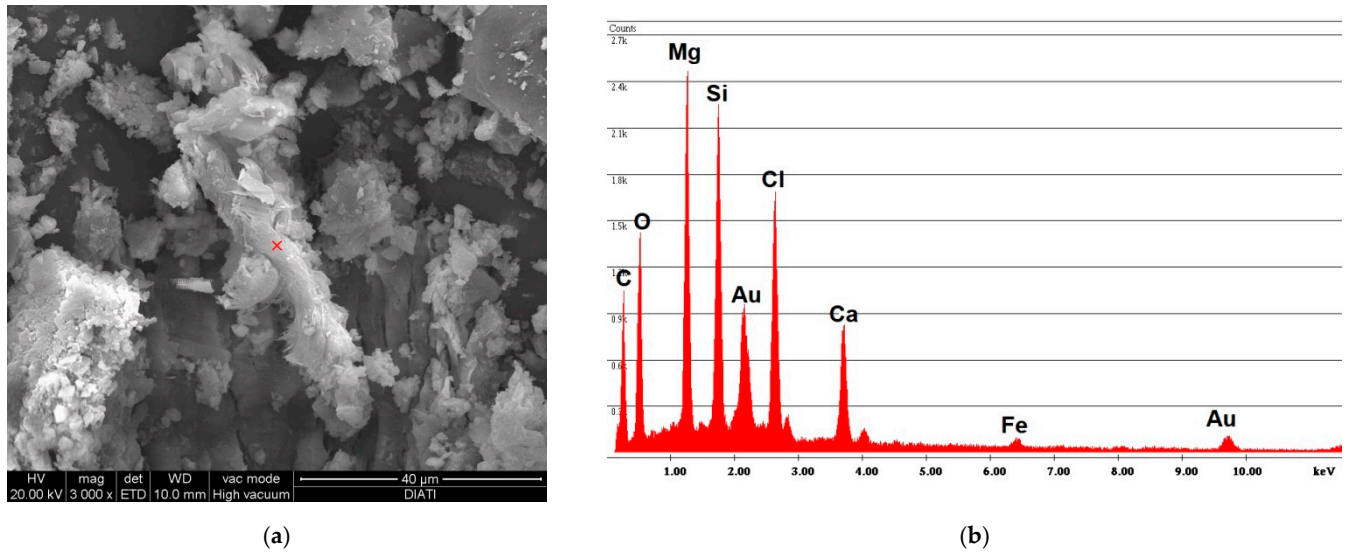
Figure 5. R sample SEM analysis. (a) Photo of incorporated fibers of chrysotile; (b) spectrum of chrysotile and vinyl chloride composition.

Figure 5 shows the same analysis, performed on the powder obtained from the vinyl sample R. In addition, in this case, the fibers are incorporated in the vinyl matrix; the spectrum confirms this aspect due to the presence of Mg and Si components of the chrysotile.

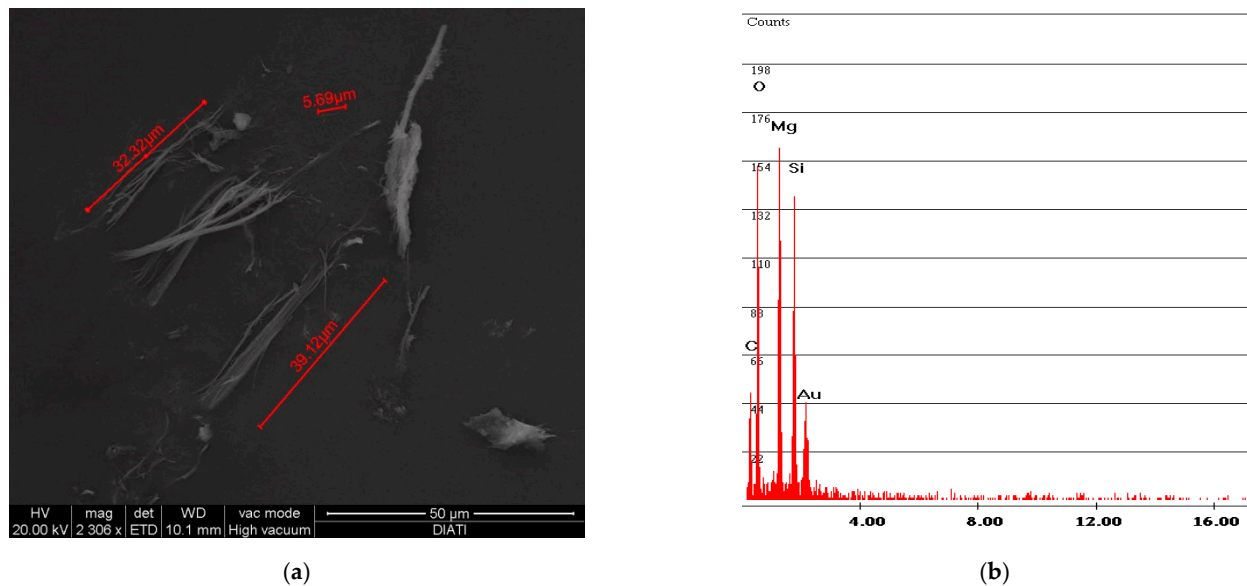
Figure 6. F sample SEM analysis. (a) Photo of free fibers of chrysotile with measurement values; (b) spectrum of chrysotile.

Figures 6 and 7 show the free fibers obtained, respectively, from samples F and R. The measurements of the fibers of both samples are in line with the particle size dimension declared by Petry US Patent [2], that is, below 2 μm . A difference can also be observed between the particle size dimension of sample R and sample F: the older and more rigid sample R has smaller fiber sizes than sample F.

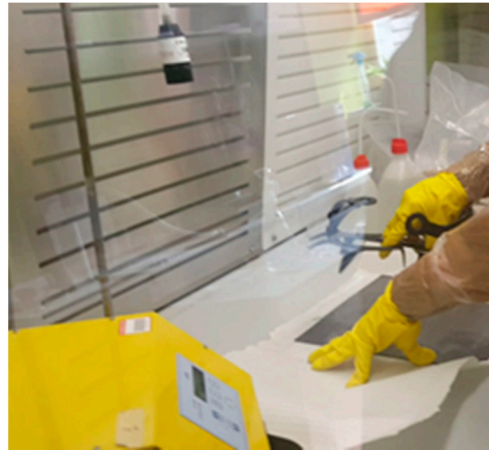
Figure 10. Vinyl tile crampon test inside the confined hood.

A vinyl floor is subject to pedestrian traffic. This test was carried out using NiCrMo steel crampons (Camp_Cassin brand (Premana, Italy)) with Hardness HRC (Rockwell scale) $53 \div 58$, to simulate the pedestrian traffic with impact and drag. The test was performed with 100 crampon shots (impact and drag) by the same operator in ten minutes. This test was performed manually from about 40 cm in height by letting the crampon fall without applying force. The number of shots could underestimate the wear carried out over time by the pedestrian traffic, but the hardness of steel is greater than any shoe worn, therefore, a possible release of fibers during the test can be representative. Figure 10 shows the performed test.

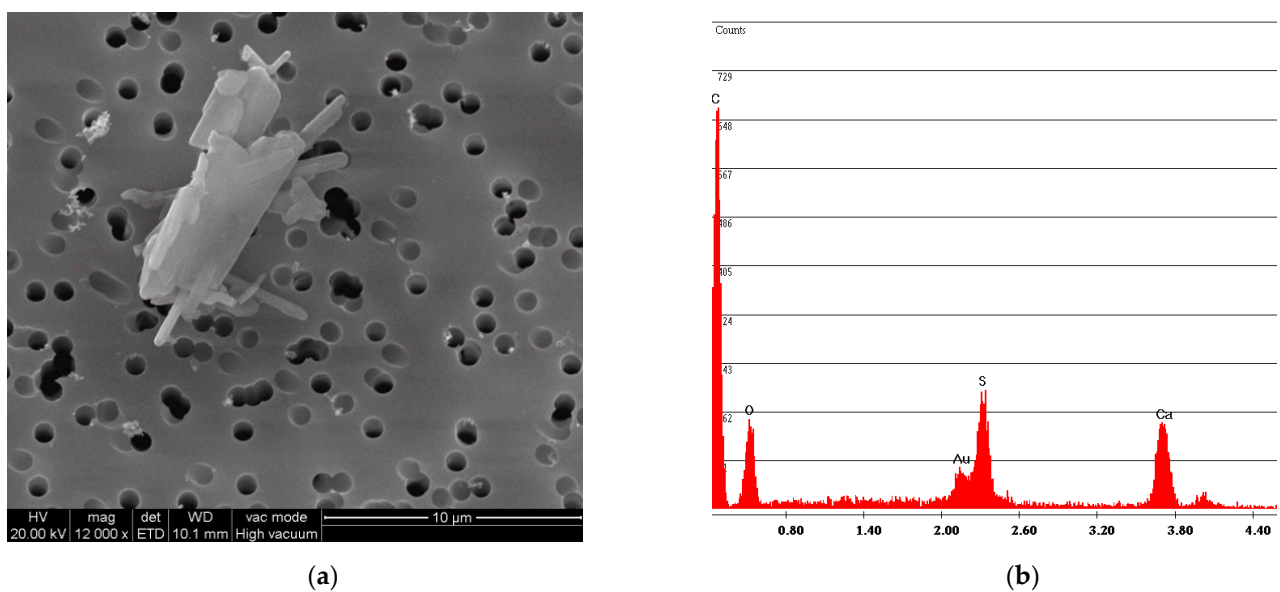
Figure 16. Sample F airborne sample of simulation for impact and drag with crampons. (a) SEM photo of part of the matrix without asbestos fibers. (b) Spectrum of the adhesive matrix.

This test was carried out with impacts and drag that simulate the trampling of the vinyl floor; this simulation did not produce fiber release. The test did not produce powder. The results obtained with Equation (1) are $C = 0$ fibers/liter for both samples. This confirms the indications given by the Italian Ministerial Decree 06/09/1994 [4], which states that there is a release of fibers only in the case of abrasion, perforation, brushing or if the vinyl floor is very deteriorated (Table 3). Figure 15 shows incorporated asbestos fibers in adhesive vinyl matrix. Figure 16 shows a piece of the adhesive matrix of the vinyl floor.
