AE propagation velocity calculation for stiffness estimation in Pier Luigi Nervi's concrete structures

AE propagation velocity calculation for stiffness estimation in Pier Luigi Nervi's concrete structures**

2 The slanted pillars of hall B: the monitoring site

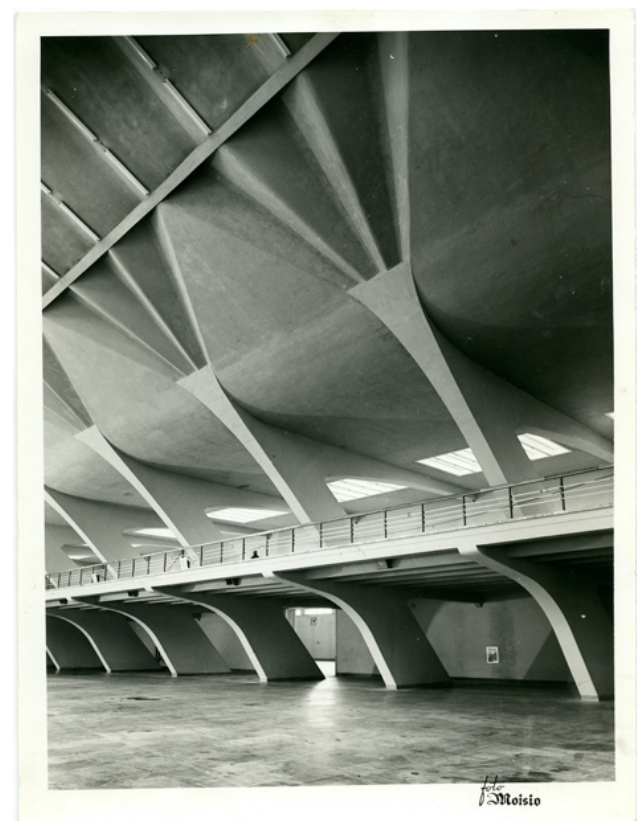
Figure 4: (a) Scheme of the various casting stages of pillars. (b) Detail of the interiors just after the completion of the hall (photo of Aldo Moisiso)

The supporting structures of the vault were instead built in four different stages, in which the concrete was poured sequentially in different months. Figure 4a shows a section of an inclined pillar reporting a scheme of the various casting stages, while Figure 4b shows a picture of the interiors just after the completion of the hall.
