Condition Assessment of an Early Thin Reinforced Concrete Vaulted System

Condition assessment of an early thin reinforced concrete vaulted system

This paper reports the direct experience acquired from an extensive experimental campaign conducted on the Paraboloid in Casale Monferrato. The study aims to be an example of how condition assessment of the structural heritage of the early 1900s, with an apparently simple geometric shape and composition, can actually contribute in understanding hidden structural complexity. Moreover, this work may provide useful information to researchers and practitioners who are approaching this specific structural typology (e.g., the industrial heritage represented by parabolic concrete silos). In more details, results are presented regarding the in-situ investigations, and the laboratory tests carried out to analyze the mechanical performance inherent to both (i) local aspects of the structure, such as the quality of the materials and connections, and (ii) global aspects, such as the modal response of the structure. Furthermore,

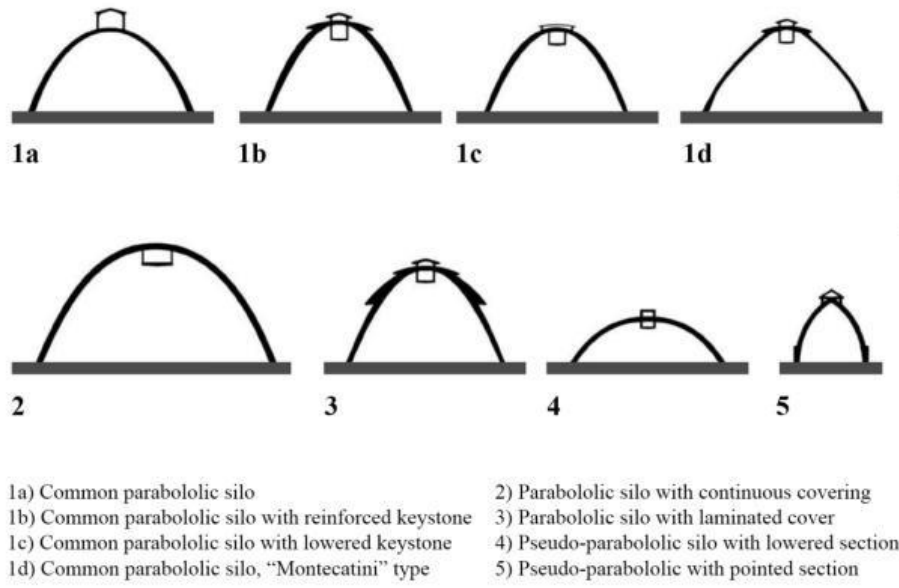
Figure 1: Scheme reporting the classification of the parabolic silos typologies gathered and classified by [8].

A thorough typological classification of parabolic silos by cataloging the various configurations of their main elements (Figure 1) was carried out by [8], and it represented a first and valuable step for the enhancement and recognition of this large heritage that has survived thanks to the local listing.

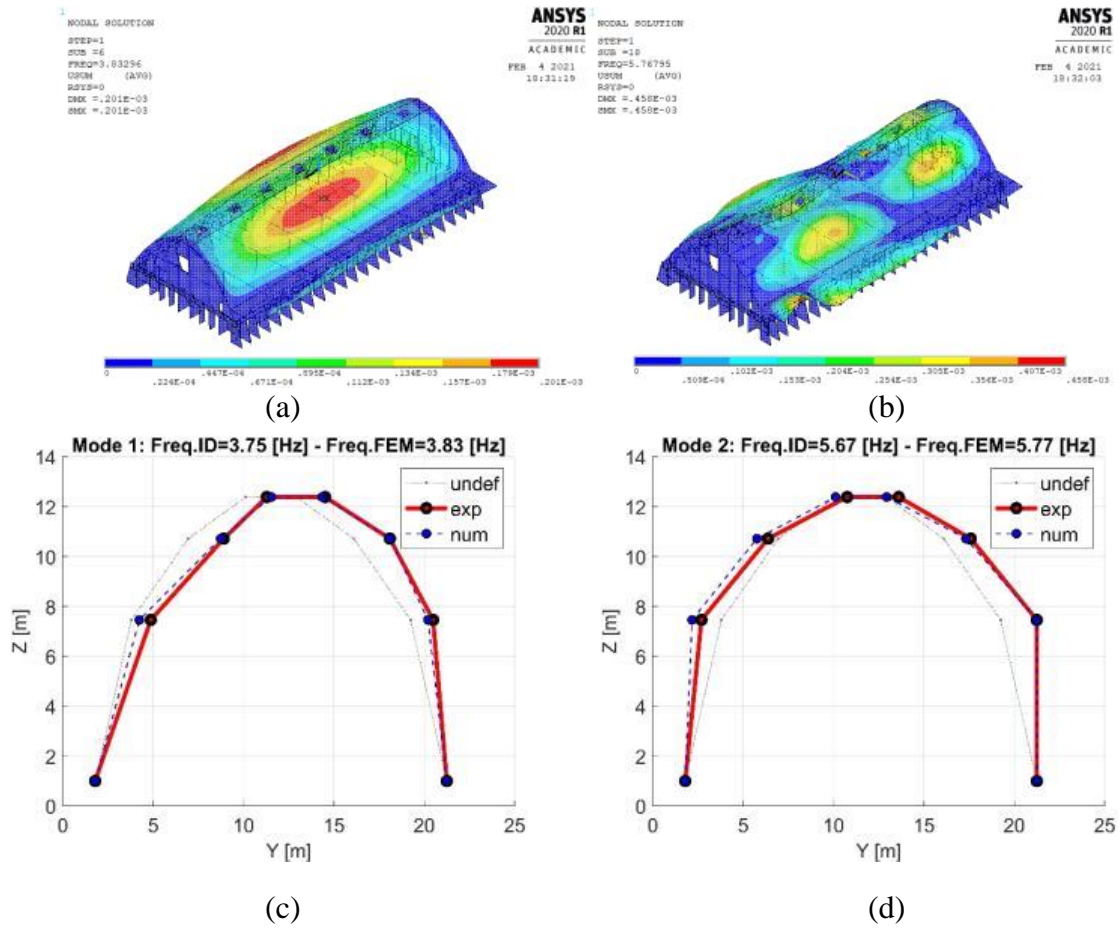
The first five modes identified were used to update the model parameters (elastic moduli) by minimizing the difference in natural frequencies and modal shapes (for details see [34]). The resulting parameter values must be considered as equivalent elastic characteristics of the entire macro-elements (for example of the entire edge curb, which would consist of edge beams and nodes) that consider not only the actual material state but also macroscopic conditions such as widespread or localized cracks.

Figure 14: First 2 updated numerical mode shapes: (a) first mode; (b) second mode; (c) first mode compared with the experimental identified; (d) second mode compared with the experimental identified.
