MIG and TIG Joining of AA1070 Aluminium Sheets with Different Surface Preparations

Abstract: In this work, AA1070 aluminium alloy sheets are joined using TIG and MIG welding after three different edge preparations. Shearing, water jet and plasma-cut processes were used to cut sheets, subsequently welded using ER5356 and ER4043 filler metals for TIG and MIG, respectively. Mechanical properties of the obtained sheets were assessed through tensile tests obtaining a relation between sheet preparation and welding tightness. Micro-hardness measures were performed to evaluate the effects of both welding and cutting processes on the micro-hardness of the alloy, highlighting that TIG welding gives rise to inhomogeneous micro-hardness behaviour. After tensile tests, surface fractures were observed employing scanning electron microscopy to highlight the relation between tensile properties and edge preparations. Fractures show severe oxidation in the water jet cut specimens, ductile fractures and gas porosities.

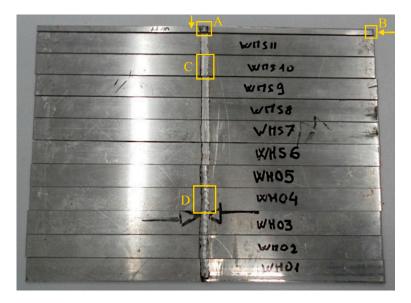
Figure 3. Sheets after waterjet cutting and MIG welding. The welded sheets were cut to obtain tensile test specimens and samples for microstructural observation and micro-hardness measures. A: Sample for weld observation and micro-hardness; the arrow indicates the side of observation. B: Sample for edge observation and micro-hardness; the arrow indicates the side of observation. C: Milled weld. D: Protruding weld.

Cross-sectional micro-hardness measurements were performed on the welded samples using a Vickers micro-hardness tester, LEICA VMHT (Leica Microsystems, Heerbrugg, Switzerland), as shown in Figure 2. The parameters applied were 200 gf and 15 s. The number of specimens and tests are reported in Table 3, while samples' production in a single welded sheet is shown in Figure 3.

Tensile tests were performed on samples shown in Figures 1 and 3.

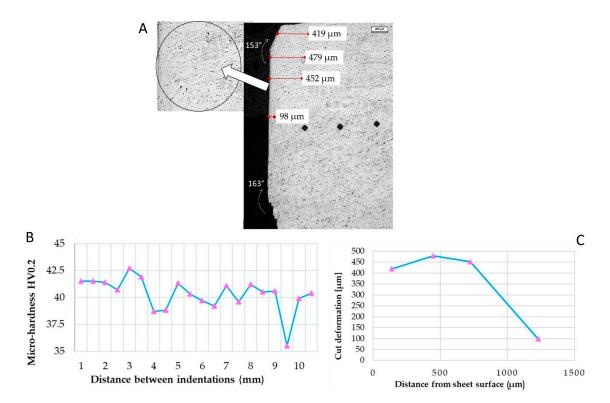
Figure 4. (A) Microscope image of the shearing cutting trace on AA1070 sheet. (B) Distortions in the first 1200 μ m were documented. (C) Micro-hardness measured along the first 10 mm starting from the cut edge. Marker: 200 μ m.

The aluminium sheets after the shearing process appear to have almost linear edges, as clearly noticeable from Figures 4A and 5. The sheet microstructure is oriented along the rolling direction (horizontal direction); after the chemical etching, the distortion of the microstructure at the edges appears evident.

Some microstructural measures were performed through image analysis software (LEICA QWin, version 3.5, Leica Microsystems, Heerbrugg, Switzerland) to evaluate the microstructural distortions. Shearing caused damage to the sheet's edges and material removal. Deformation angles were 27° (top sheet) and 17° (bottom sheet), while distortions decreased from 419 on the top to 98 μ m in the middle of the sheet (Figure 4B).

Micro-hardness measured along the edge after shearing did not show an increase caused by plastic deformation near the edge; the micro-hardness resulted almost constant along with the sheet (Figure 4B).

In terms of weldability, this configuration may affect the filler metal penetration, causing inadequate welding penetration during the welding process. On the other hand, despite the sheet edge shown in Figure 4 not being wholly planar, there was a proper welding penetration in both the welding processes (TIG and MIG). After TIG, specimens prepared by shearing resulted in the best mechanical values (along with water jet). On the other hand, mechanical tests showed similar behaviour for shearing-cut specimens and plasma-cut specimens after MIG processing.

Krinninger et al. [27] underlined that aluminium alloys' adhesive tendency (galling) is possible. Hence, the cutting surface in Figures 4 and 5 do not display the galling, while the cutting surfaces result in being relatively planar.

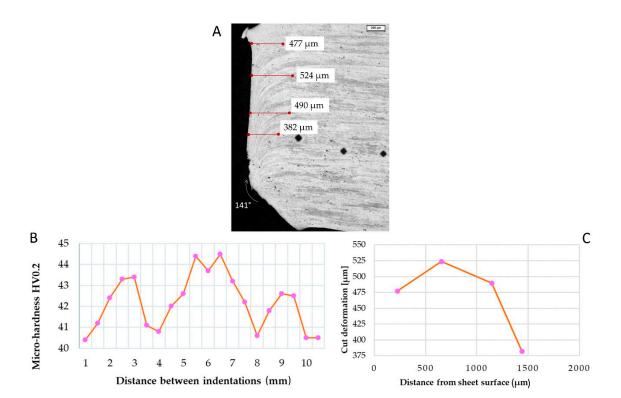
Figure 6. (**A**) Microscope image of the water jet cutting trace on AA1070 sheet. (**B**) Distortions in the first 1500 μ m were documented. (**C**) Micro-hardness measured along the first 10 mm starting from the cut edge. Marker: 200 μ m.

As for the water jet (Figure 6A), the initial distortion remained almost constant, with a measured value of 382 μm in the middle of the sheet (Figure 6C). The bottom part of the sheet showed an intense deformation and material removal; an angle of 141° was measured. Only short variations in micro-hardness were documented (Figure 6B).

In [32], Wang et al. studied the kerf taper in aluminium alloy 6061, arguing that reducing the cutting speed causes the reduction of the kerf taper. Slow cutting speeds can produce a reverse taper, as seen in Figure 6, where the cut's kerf width is wider at the bottom than at the top. The jet stream removed more material at the bottom of the sheet than at the top. The reverse taper can also occur when cutting very soft materials [33]. On the other hand, literature highlights that multipass cutting [34] may increase surface finishing by obtaining flat surfaces.

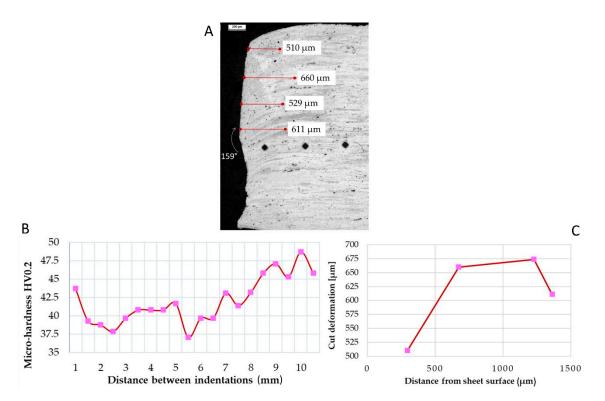
Figure 7. (A) Microscope image of the plasma cutting trace on AA1070 sheet. (B) Distortions in the first 1400 μ m were documented. (C) Micro-hardness measured along the first 10 mm starting from the cut edge. Marker: 200 μ m.

Plasma cutting (Figure 7A) caused higher specimen edge and microstructure orientation distortions. The distortion near the surface was 510 μm and at the mid-thickness 611 μm (Figure 7B).

A slight increase in micro-hardness was detected near the sheet's edge (Figure 7B).

Furthermore, significant damage was caused during the cutting process, with material removal in the lower half of the sheet, with a measured angle of 159° , while 180° was expected for a plain surface. Almost $100~\mu m$ of material was removed during the cut, causing a potential lack in penetration of the welding seam.

In the first 8 mm, the micro-hardness resulted lower, with a minimum of 37.5 HV, then micro-hardness started increasing up to 45 HV.

From the literature, plasma cutting is considered the worst in terms of microstructural modification; moreover, heat-affected zones may develop if plasma power is too high [12]. Figure 7 shows the sheet microstructure after the plasma process. High microstructural distortions were noticed in the first half-width of the sheet. A consistent material removal was observed in the lowest part of the sheet, with a measured angle of 159° (21° of deformation in respect to the planar surface). With regards to micro-hardness, the first indentation (near the sheet edge) resulted in ca. 44 HV0.2, probably caused by strain hardening, then the micro-hardness decreased. In the first 7 mm, a slight heat-affected zone was noticed, micro-hardness decreased to 37 HV0.2; away from the edge, the micro-hardness increased up to 45–47 HV0.2.

Near the edges, different cutting processes caused different effects on both microstructures and micro-hardness measured. Plasma cutting affects the micro-hardness near the edges: the first micro-hardness value was slightly higher (ca. 40 HV0.2), while in the next 7 mm, the plasma effect occurs, resulting in a HAZ (see Figure 7).

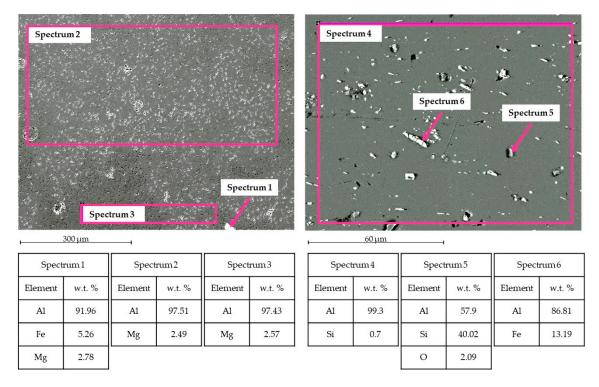
Figure 8. TIG welding analysis. Left side: SEM image and EDS in WZ. Right side: SEM image and EDS in HAZ.

Figure 8 shows SEM-EDS analysis for TIG welding. In the WM, Al and Mg were observed, as expected, in the filler metal ER5356. Some intermetallic phases were observed, for instance, the phase Al-Fe-Mg [15] in Spectrum 1. In the HAZ zone, Al-Si and Al-Fe intermetallic phases were noticed [16].

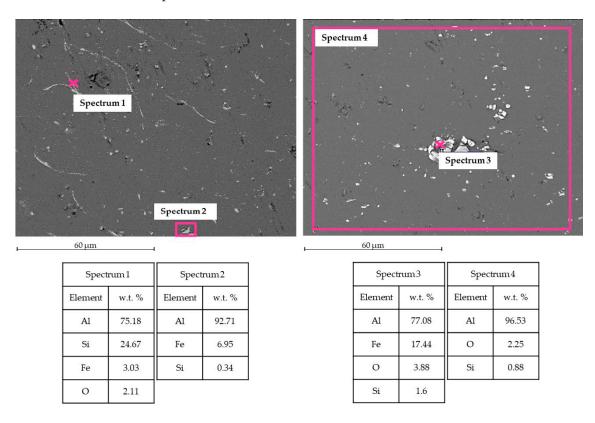
Figure 9. MIG welding analysis. Left side: SEM image and EDS in WZ. Right side: SEM image and EDS in HAZ.

Figure 9 shows SEM-EDS analysis for MIG welding. Into the WM, it was possible to observe the presence of Al and Si, typical elements for the filler metal ER4043. Some intermetallic phases are found; for instance, in Spectrum 1 and Spectrum 3, the phase

Al-Fe-Si is in the form of acicular phase β and polygonal phase α [17]. Even Al-Si and Al-Fe phases occur in the HAZ zone.

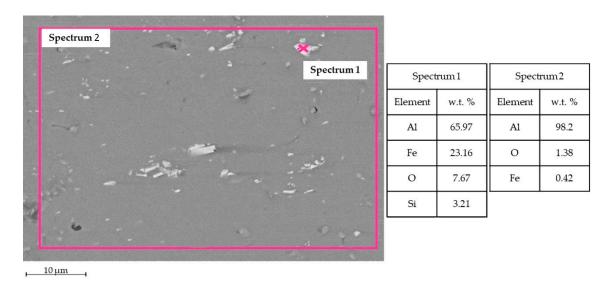
Figure 10. Base metal (BM) AA1070 H16.

The base metal contains a certain amount of Si and Fe, as shown in Figure 10. It is well known that, if Fe exceeds the solid solubility limit of 0.05 wt %, it forms intermetallic phases Al-Fe [18]. Due to the H16 starting structure, these phases show an elongated shape.

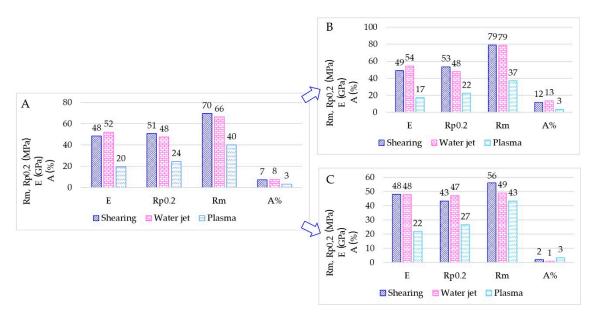
Figure 11. (A) Overall bar chart for TIG-welded sheets. **(B)** Bar charts for as-welded samples. **(C)** Bar charts for milled samples.

Results for TIG welding are summarized in Figure 11 through bar charts. The bar charts represent the average tensile properties measured (Figure 11A), the average tensile properties for the specimens as-welded (Figure 11B) and finally, the average tensile properties for the specimens having the milled weld (Figure 11C).

The average elongation at rupture A% in TIG-welded specimens is affected by the very low A% in the milled specimens. Mechanical properties observed (Rm, tensile strength; $R_{p0,2}$, yield strength) for sheared and water jet cutting appear similar.

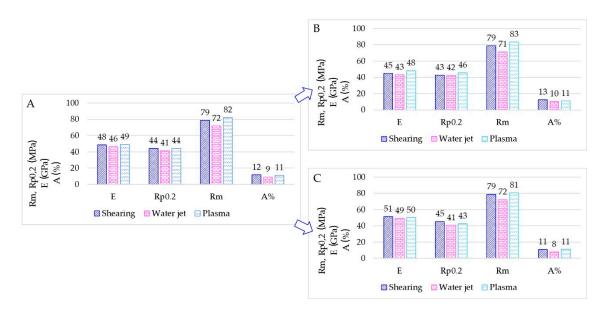
Figure 12. (A) Overall bar chart for MIG-welded sheets. **(B)** Bar charts for as-welded samples. **(C)** Bar charts for milled samples.

The average mechanical values of MIG-welded specimens are shown in Figure 12. Mechanical properties observed appear similar for each kind of sheet edge preparation, and the A% appear similar with or without the weld milling.

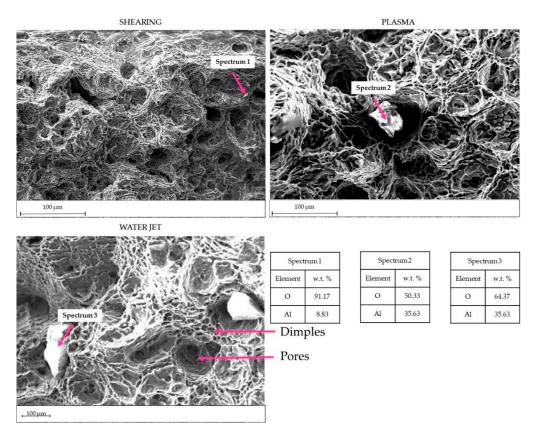
Figure 13. Surface fractures in three TIG-welded tensile specimens. Oxides were detected of variable sizes.

To assess these hypotheses, SEM observations were performed. The fracture surfaces were observed using SEM (Figure 13). Ductile fractures were noticed in all the specimens; all fractures were located in the welded part. Some welding appears non-penetrating along the entire thickness of the sheet. Furthermore, the weld seams appear rich in gas porosities [19] and in dendrites that negatively affect the mechanical strength. A high amount of oxide scale was observed, particularly in the water jet and plasma specimens (Figure 13—Spectrum 2 and Spectrum 3).

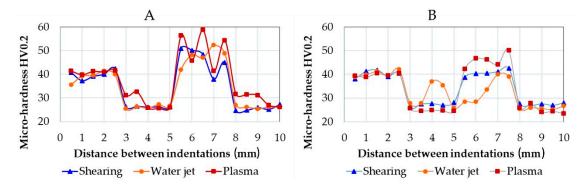
Figure 14. Graphical representation of the micro-hardness measured in TIG (A) and MIG (B) specimens.

The WM has a dilution ratio that depends on the welding process. WM comprises AA1070 base metal and ER5356 filler metal for TIG welding and AA1070 and ER4043 for MIG welding. The micro-hardness in the welded samples was measured as drawn in Figure 2, and results are shown in Figure 14. The different dilution ratios may affect the average micro-hardness. Furthermore, in the WM, the micro-hardness is subjected to a certain variation caused by defects or hardening phases. In TIG welding, specimens' plasma-cuts show some inadequate penetration and porosities. This behaviour causes a variation in the micro-hardness measured (red-square marker in Figure 14A).

Moreover, porosities inside the weld cause a decrease in hardness near the BM values. On the contrary, in MIG welded specimens, specimens after water jet cutting (orange-bullet marker in Figure 14B) show low micro-hardness in WM. This behaviour is in line with the mechanical results shown in Figure 12 (the worst in MIG welding specimens).

Overall, higher micro-hardness was noticed in TIG welding with an average value of 48 HV0.2, while in MIG welding, the average value was 40 HV0.2. This result is, in turn, affected by the filler metal. In TIG welds, the micro-hardness in WM is higher than the micro-hardness in the BM; on the contrary, in MIG welds, the micro-hardness resulted similar in the BM and the WM. Micro-hardness values are average values depending on the intermetallic phases. Considering that the number of intermetallic phases is low in alloy AA1070, hardness in BM is almost the hardness of the α -Al phase: ca. 40 HV0.2. Furthermore, the micro-hardness in the α -Al depends on the alloying elements dissolved in the solid solution [20]. Intermetallic phases detected may affect the average values: α -AlFeSi and β -AlFeSi are respectively ca. 883 HV and 765 ([21]), Al-Mg ca. 48 HV [22], Al-Si ca. 80 HV [20].
