Laboratory Test Campaign Aimed at the Analysis of an Uncommon Wear Phenomenon in a Marble Quarry

# Laboratory Test Campaign Aimed at the Analysis of an Uncommon Wear Phenomenon in a Marble Quarry

**Featured Application:** This paper presents a laboratory test campaign focused on the reduction of the wear phenomenon related to a material extracted from a marble quarry. The aim of the work is to propose a potential solution for the wear reduction pertaining to chainsaw cutting machine tools.

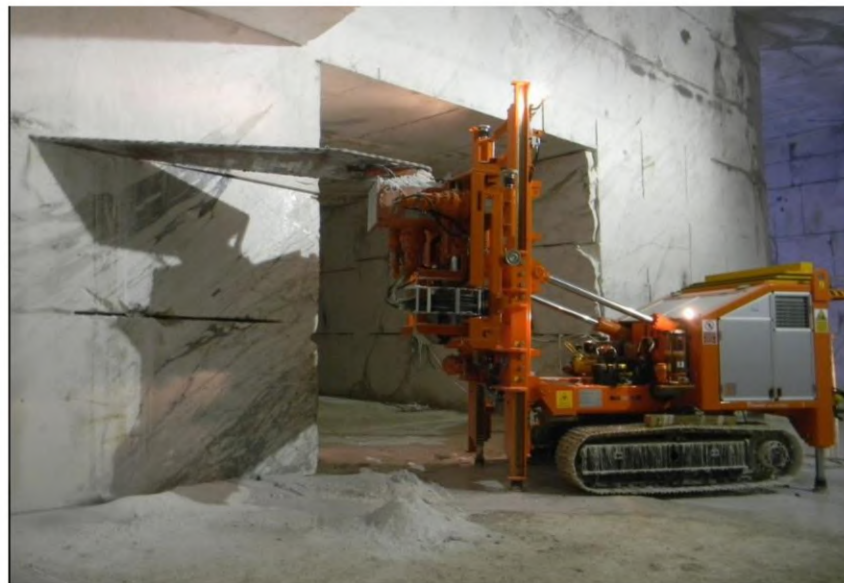
**Figure 1.** The chain cutting machine adopted in the quarry. The machine is engaged in a series of horizontal cuts to widen the underground opening (link <https://www.fantinspa.it/en/gu70rxc-tunnel-chain-saw-machine/>, accessed on 2 October 2021).

At 869 m a.s.l., where the development was planned for the expansion of the underground exploitation, the presence of grey-white marble with flint nodules was noticed. In this area, during the works started in 2018, a “sheath fold” emerged, with a siliceous marble core in entrochi, characterized by a trend of about  $350^\circ$ , immersion at NW of about  $10^\circ$ , and boudinage. Initially, this structure seemed to close quickly, while in a short space corresponding to the execution of about three development advances in the tunnel, for about 9 m in total, the core opened into a boudinage, and the structure progressed towards the inside of the cluster. The core of this structure proved impossible to cut, due to the fast wear of the tools. The machine used in marble cutting operations is the chain cutting saw (Figure 1), which has the great advantage of not requiring preliminary cutting operations. The arm operates easily, even in the presence of only one free surface. In all cases where it is necessary to perform blind cuts, the chainsaw, alone or in cooperation with the diamond wire saw, is frequently used. At the quarry, the excavation works are carried out with a chainsaw on which a 3.5 m long cutting blade is installed, equipped with guides, where a single-mesh metal chain runs (74 mm pitch, 42 mm cutting width), equipped with polycrystalline diamond plate tools. Seven sets of tool-holders are installed on the cutting chain; each series includes 12 tool holders with different cutting configurations. The tool has a diameter of 8.0 mm, a diamond layer thickness of 1.5 mm, and a tungsten carbide (WC) layer thickness of 6.6 mm, for a total height of 8.1 mm. The WC area is welded directly on the tool holder and does not contribute to the cut (made expressly from polycrystalline diamond) but represents an intermediate support between the diamond and the tool holder. Figure 2 shows a detail of the tools adopted.
