The October 2000 flooding in Valle d'Aosta (Italy): Event description and land planning measures for the risk mitigation

The October 2000 flooding in Valle d'Aosta (Italy): Event description and land planning measures for the risk mitigation / Ratto, S.; Bonetto, F.; Comoglio, C.. - In: INTERNATIONAL JOURNAL OF RIVER BASIN MANAGEMENT. - ISSN 1571-5124. - 1:2(2003), pp. 105-116. [10.1080/15715124.2003.9635197]

SARA RATTO and FRANCO BONETTO, *Geologist, Valle d'Aosta Autonomous Region, Land, Environment and Public Works Department, Cartography and Hydrogeological Asset Service, Via Promis, 2, 11100 Aosta, Italy*

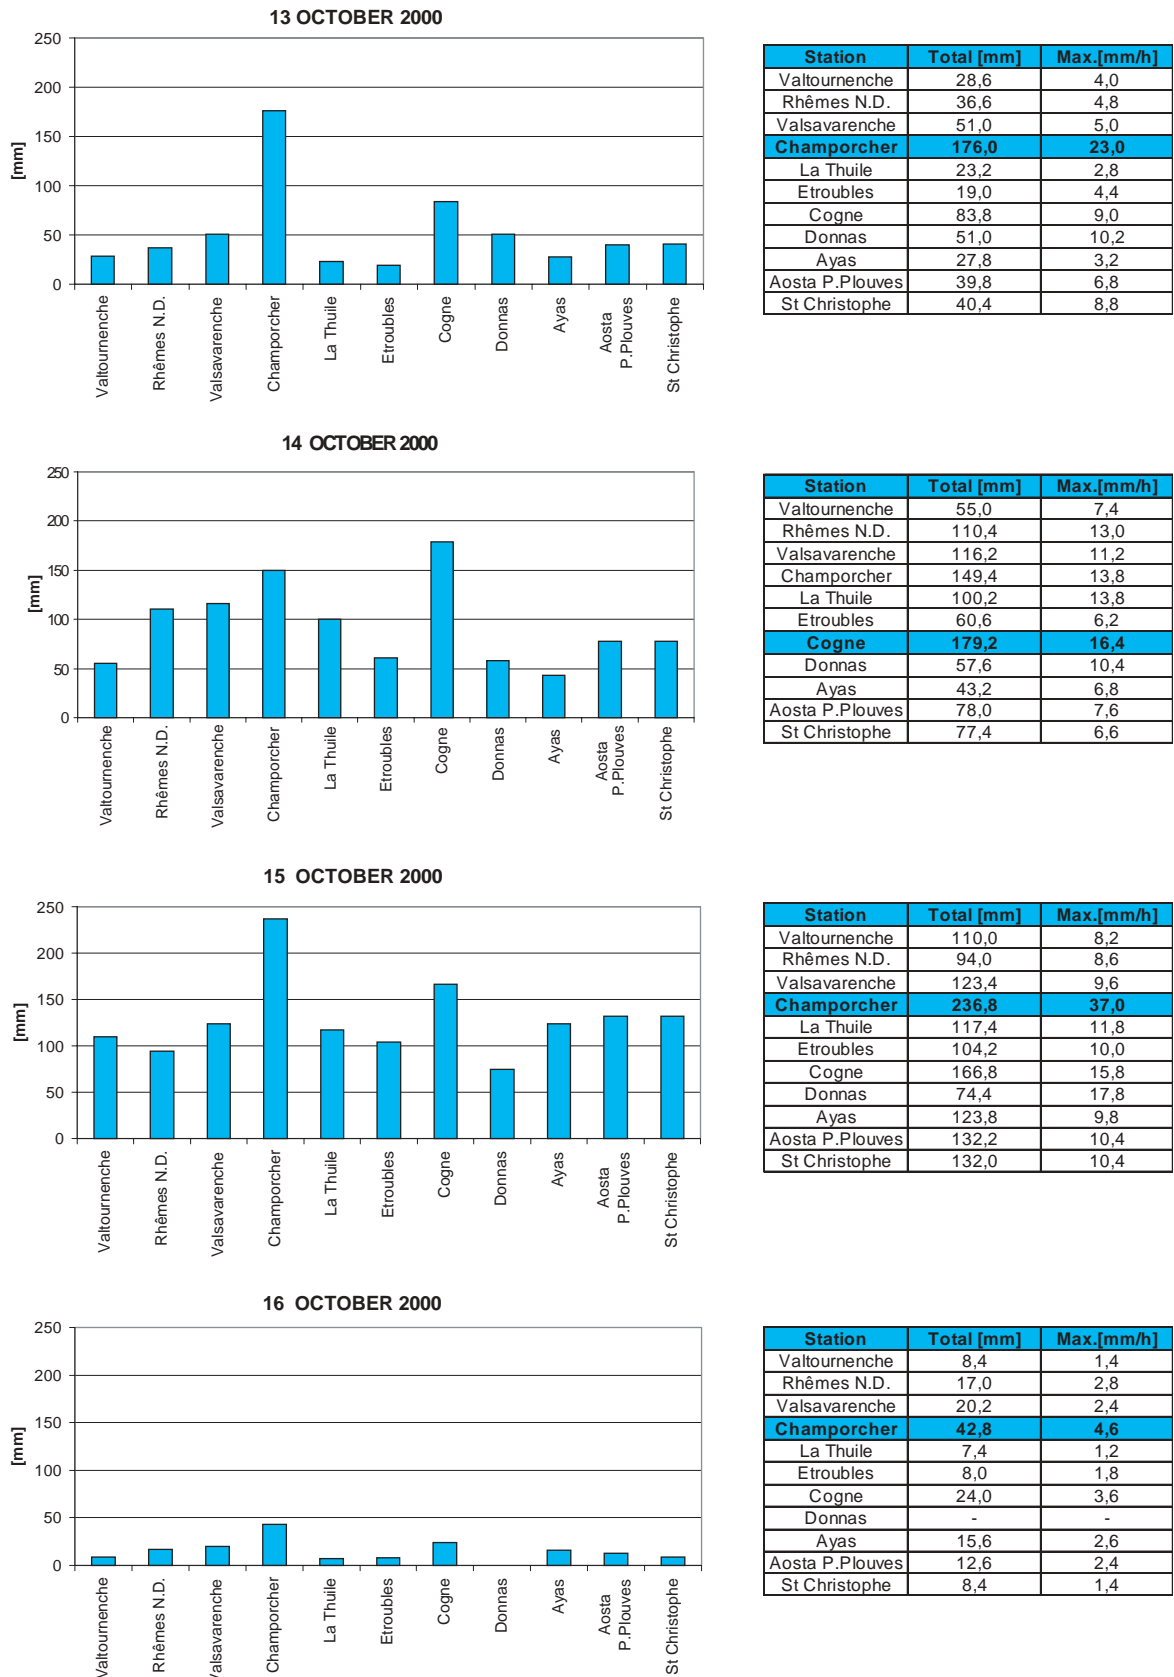
Figure 6 Daily rainfall histograms and tables.

Analysing the rainfall data showed in the tables and daily rainfall histograms of Figure 6, the following elements can be pointed out:

- Champorcher and Cogné are the stations where the higher daily rainfall has been recorded both on Friday 13th and Saturday

14th; in 6 stations out of 11 a maximum intensity of more than 10 mm/hour has been recorded;

- once again on Sunday 15th the higher rainfall recorded values are at Champorcher and Cogné stations; all the other stations (excluding Donnas that ceased its activity at 10:00 a.m. anyway recording the second higher value of hourly intensity with 17.8 mm) recorded a daily rainfall higher than 100 mm/day with a maximum intensity higher than 10 mm/hour;
- on Monday 16th the rainfalls gradually faded.

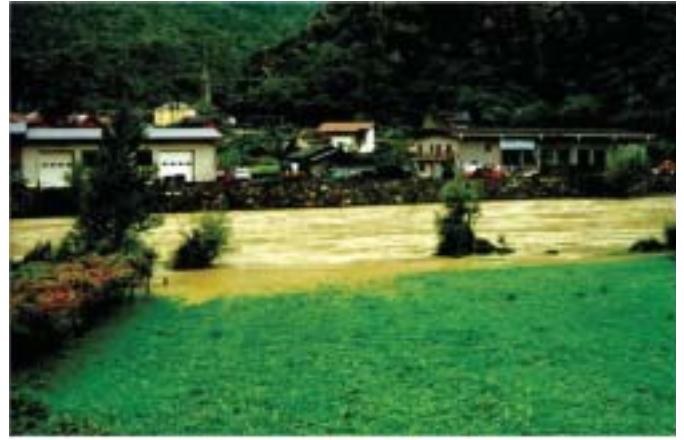
Photo 1 Hône – Dora Baltea river .

- A drastic increase of the water levels in all the regional watercourses, with the Dora Baltea river already reaching its overflow threshold levels since Saturday 14th (Photos 1 and 2).
- Debris/earth flows, landslides and soil slips activation between Saturday 14th (Cogne area) and Sunday 15th morning from 07:00 to 09:00 a.m. (in the rest of the region) (Photos 3–8).

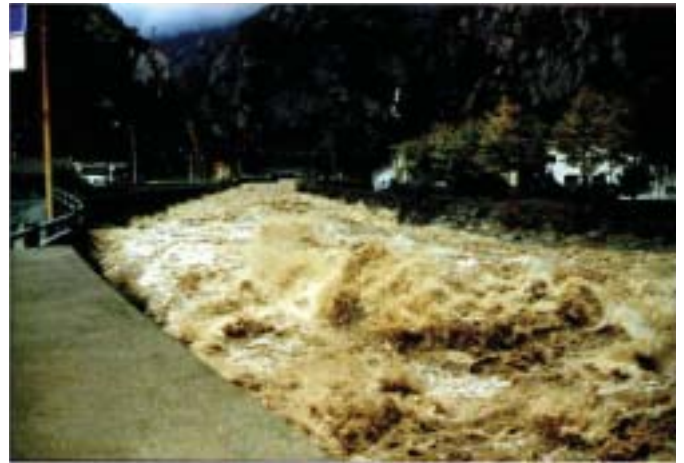
Photo 2 Hône – Ayasse torrent.

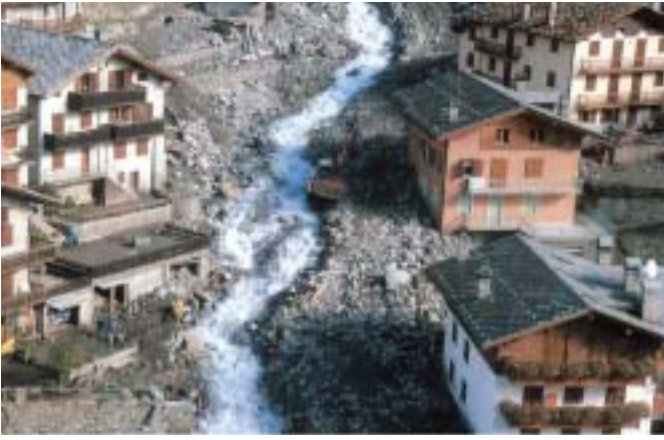
Photo 3 Cogne – Epinel Arpisson torrent. (author: local media).

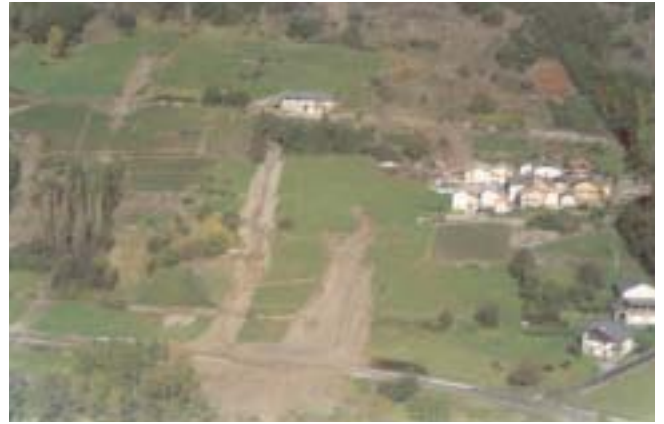
Photo 6 Nus – Soil-slip.

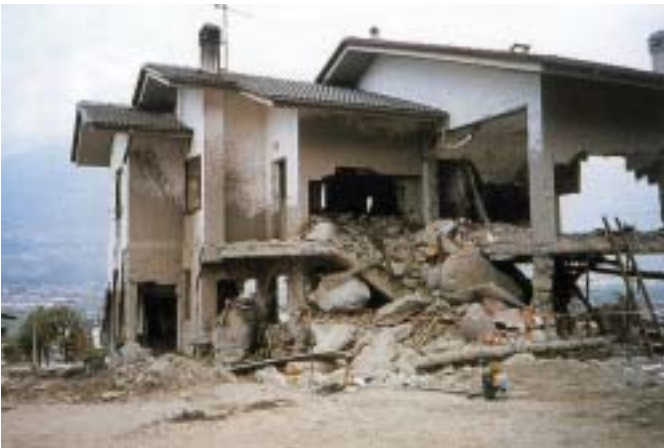
Photo 4 Pollein – Effects of debris flow (author: local media).

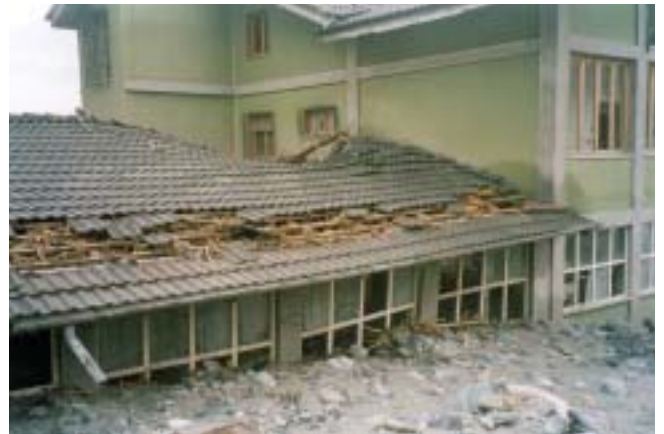
Photo 7 Nus – Solid transport of St. Barthélemy Torrent.

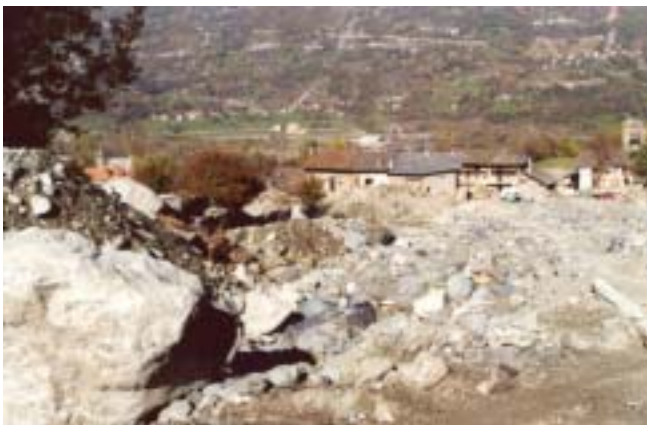
Photo 5 Fénis – Debris flow deposit.

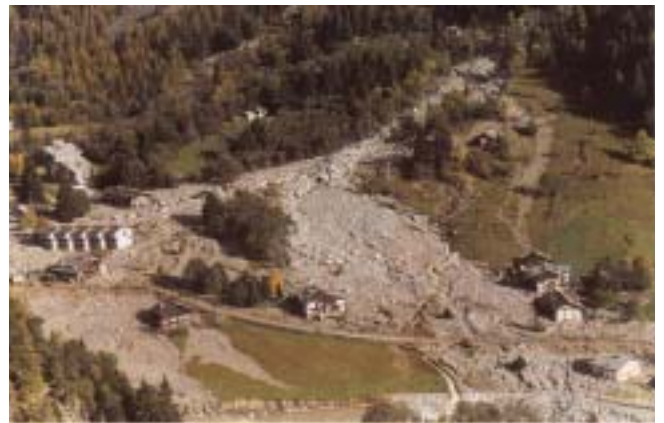
Photo 8 Gressoney-St-Jean – Debris flow.

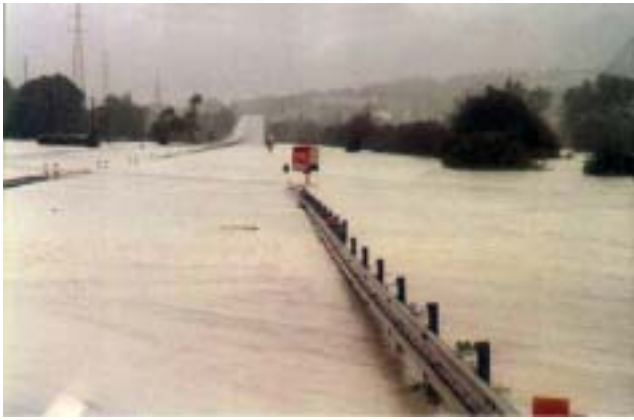
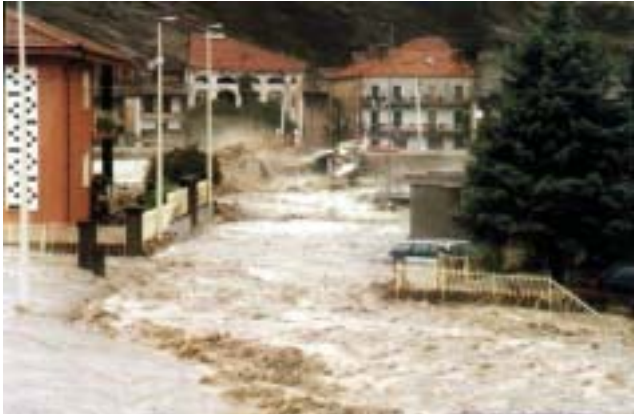
Photo 9 and 10 Hône – Donnas. Dora Baltea river flooding (*author: local media*).

- Dora Baltea river flood, even through its peak was recorded on Sunday 15th between 09:00 a.m. (central region) and 14:00 p.m (lower region) (see Photos 9–11), already caused serious damages on Saturday 14th.
- Surveys on the damages along the watercourses during the days after the flood transit (Photos 12–14).
- Activation/reactivation of landslides phenomena involving broad areas and huge volumes, some of them still developing nowadays (Photos 15–16).

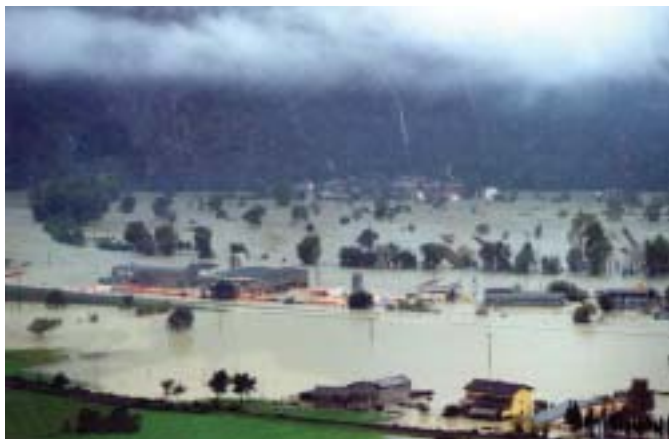
Photo 11 Donnas. Dora Baltea river flooding.

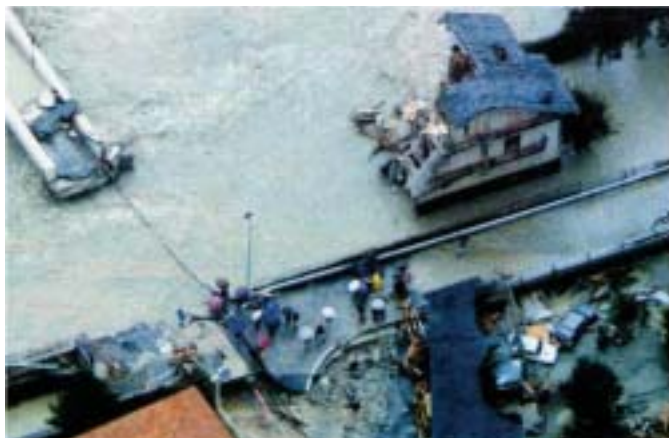
Photo 12 Donnas. Dora Baltea – Flood effects (*author: local media*).

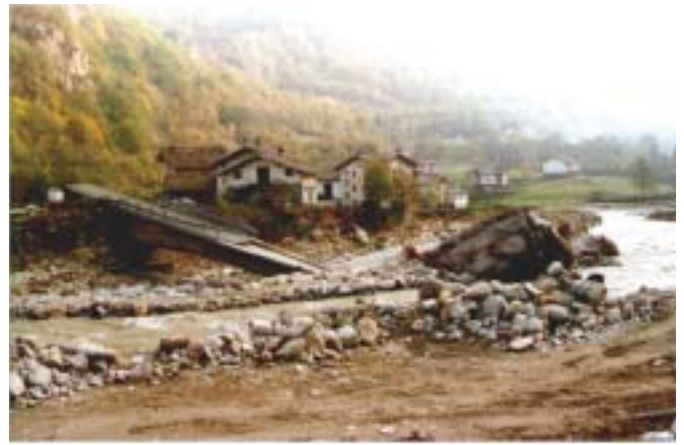
Photo 13 Issime. Lys torrent – Flood effects.

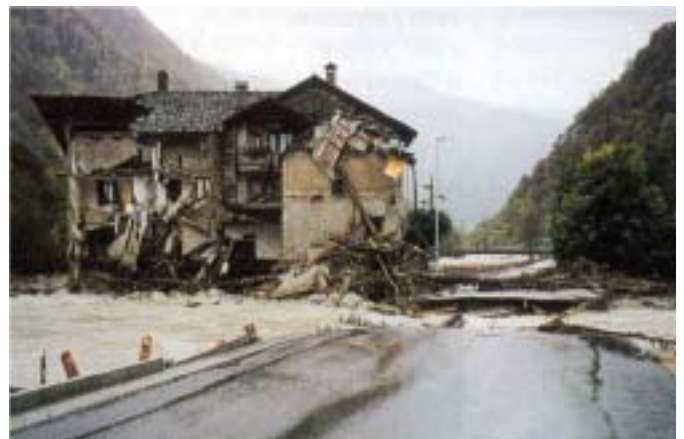
Photo 14 Gressoney-St-Jean. Lys torrent – Flood effects (*author: local media*).

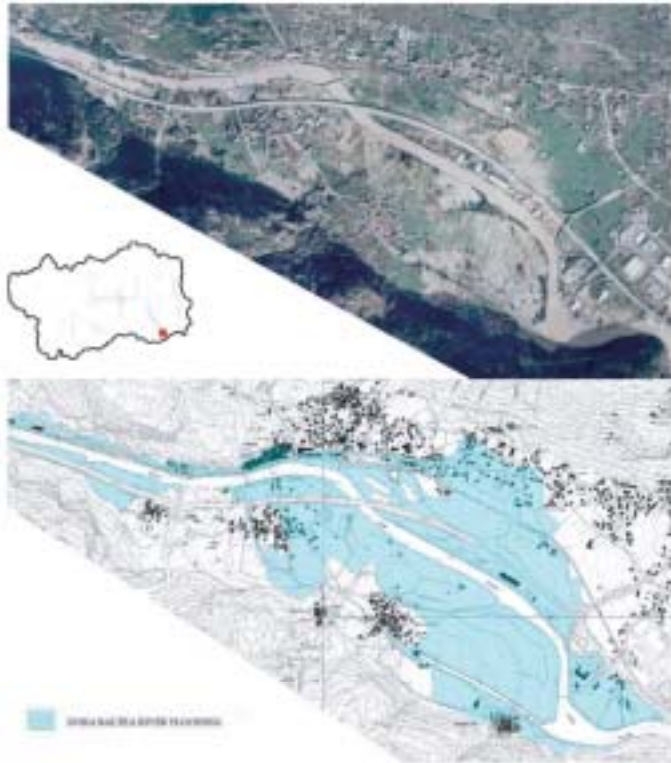
Figure 13 Donnas. Dora Baltea river flooding – comparison aerial photograph-thematic cartography.

In this way the event thematic cartography has been defined and disclosed within two months (two examples are showed in Figures 12 and 13: comparison aerial photograph-thematic cartography). On the one hand it gave a first estimate of the event's effects (Table 2), and, on the other hand, has been afterwards used as a fundamental backing element for the technical, administrative and political land planning decisions. Figure 14 shows all the areas involved by hydro-geological phenomena during the event that have been included into the thematic cartography (in the Figure are outlined the sites of Figures 12 and 13). The cartography covers approximately 2/3 of the whole region (excluding only the western part, less severely interested by the event).

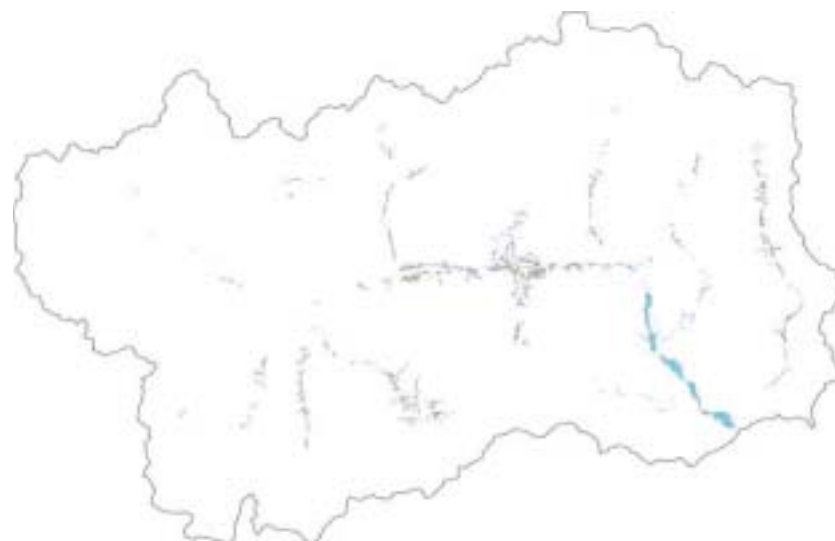
Figure 14 Areas involved by hydro-geological phenomena object of the thematic cartography.
