POPLAVA NA OBMOČJU BAČA, KNEŽAKA IN KORITNIC NÓVEMBRA 2000

FLOODING IN THE AREA OF KNEŽAK, BAČ AND KORITNICE IN NOVEMBER 2000

Flooding in the area of Knežak, Bač and Koritnice in November 2000

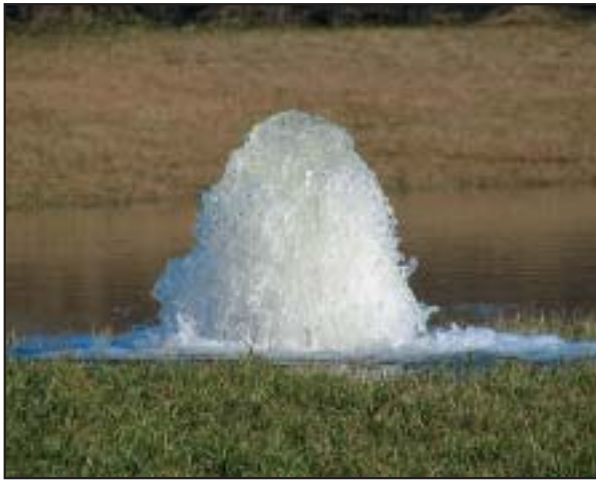
Karst groundwater erupting from a borehole in the vicinity of Bač indicates that the water table on Upper Pivka lies rather close to the surface, which causes flooding during extreme high waters (photography: Gregor Kovačič, 30. 12. 2004). Bruhanje kraške podtalnice iz vrtnice v bližini Bača kaže, da leži gladina podtalnice na Zgornji Pivki blizu površja, kar povzroča v času ekstremno visokih voda poplave (fotografija: Gregor Kovačič, 30. 12. 2004).
