Alteration of the Cultural, Religious and Architectural Heritage from Lăpuș Land, in the Context of Climate Change

Ancuța Țenter, Bety Burghele, Marin Cotețiu, Adrian Rauca, Verginica Schroder, Florin Vasile Pop and Patricia Săsăran

Keywords: cultural heritage, climate changes, wooden church, degradation

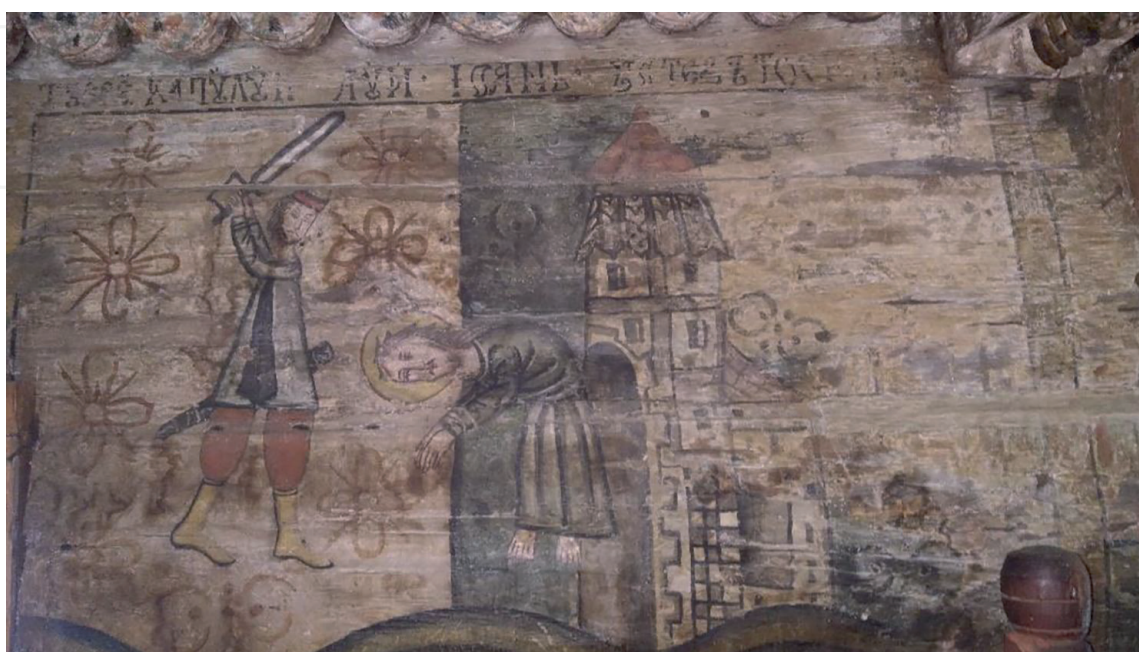
Figure 2.
Indoor painting – wooden church of “Saints Archangels Michael and Gabriel” from Rogoz.

Currently, some scenes are fragmented while others are entirely erased. The painting includes scenes from the Old and the New Testament. In the narthex, the dominant theme is that of the *Last Judgment*, where, hordes of pagans condemned to Hell are represented by figures dressed in Western clothes similar to those painted by Radu Munteanu in the wooden church in Desești (Figure 2) [24].

The painting has been restored and it is currently in a good state of preservation. Here we can talk about the patina of painting indeed. The fact that the church has received a superior classification, and the attention paid to careful care, lead to long-term preservation.

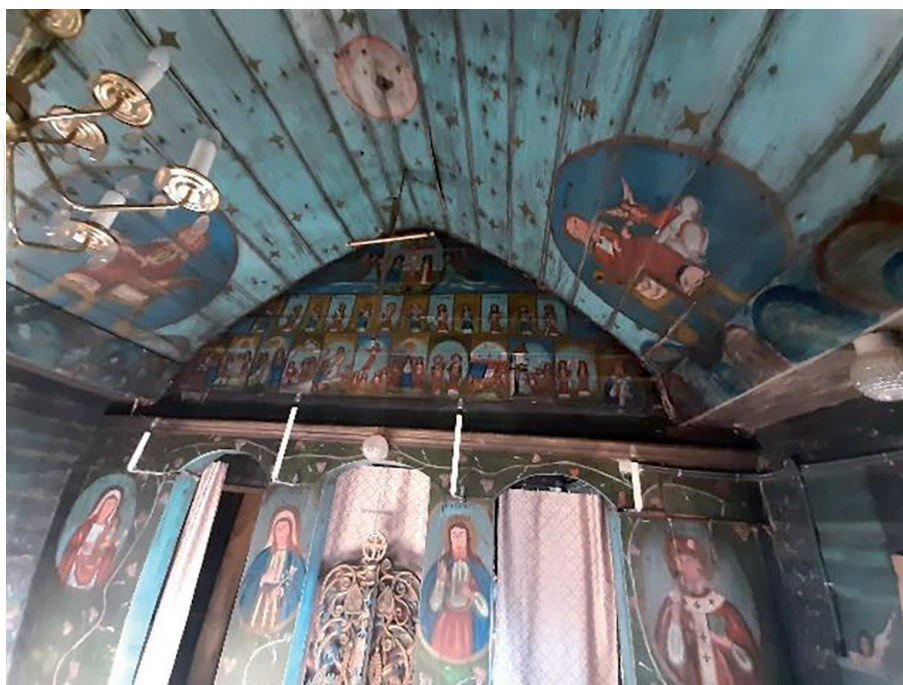
Figure 3.
Indoor painting – wooden church of “Saints Apostles Peter and Paul” from Poiana Botizii.

took place. In 1974, a period of major modernization in that area, electric lights were introduced, which continue to function until today (**Figure 3**).

Located on top of a hill overlooking the village, surrounded by the cemetery, the church is an imposing presence, with a length of about 17 m and a width of about 5 m. It is built of oak wood, following a ship-type plan, with beams joined in a dovetail. The wooden soles are placed on stone vaults, which form a solid foundation. The upper beams, by extension, form consoles, on which a hipped roof is placed, covered with *draniță*. Through the additional extension – the awning that was intended as a place of entry – will become a narthex. This greatly increases the nave while the altar remains at its original dimensions. Above the nave, in the middle of the roof, rises the tower formed by a single plank section. Currently, the church is in good condition, but if no measures are taken, the wood caries will start working because winters with high frosts have been replaced with mild winters, without snow, which led to the formation of cavities in certain parts of the building material.

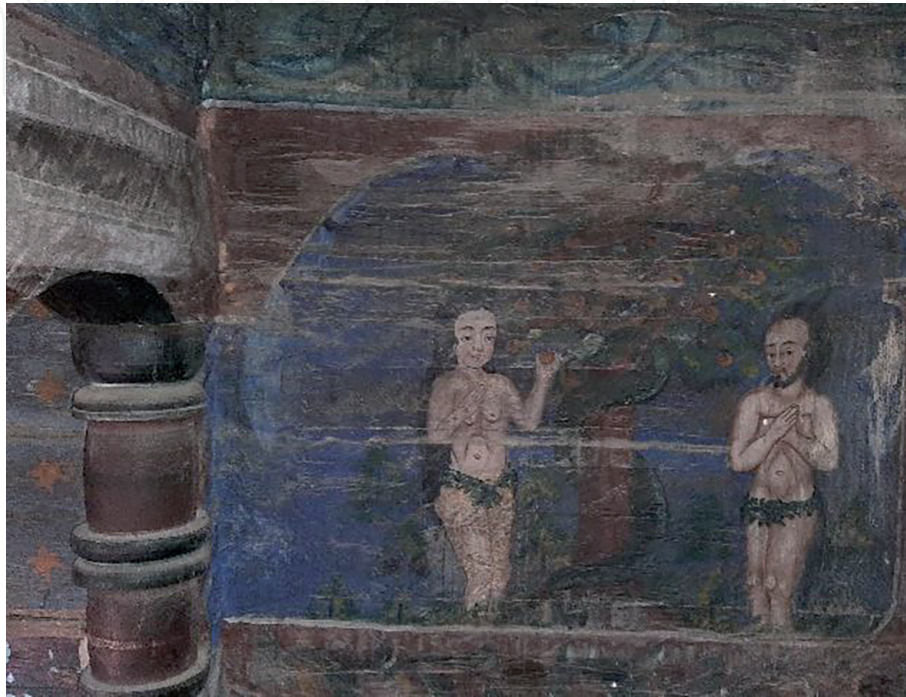
painted in the narthex, according to tradition, and the scenes of *The seven-headed dragon* and *Death with Adam's head and shins*. On the walls of the nave, we find biblical faces and scenes: *Adam and Eva in Heaven*, scenes from the Passions (**Figure 4**). The half vault and the vault are painted with faces: *Saint Mary*, *Saint Alexander*, *Saint John*, and the *Evangelists* (**Figure 5**).

Figure 4.
Adam and Eva in the garden of haven – wooden church of “Saints Archangels Michael and Gabriel” from Stoiceni.

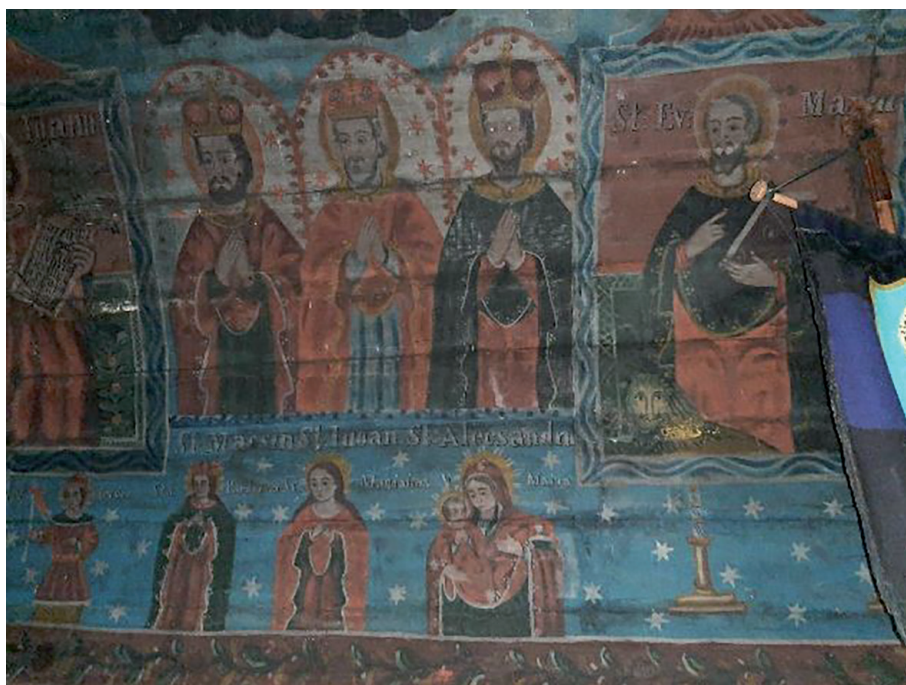
Figure 5.
Half-vault painting – wooden church of “Saints Archangels Michael and Gabriel” from Stoiceni.

The interior painting is in very good condition, taking into account the normal aging. Perhaps one reason for this good preservation would be the fact that the

roof is covered with galvanized metal sheets, which led to better protection of the interior environment. One other hypothesis would be the geographical location. The bell tower rises above the roof. Unlike the body of the church, the tower is covered with *draniță*. If the roof would be rebuilt to include the original roofing stile (*draniță*), perhaps it might have a chance of a superior heritage framing.

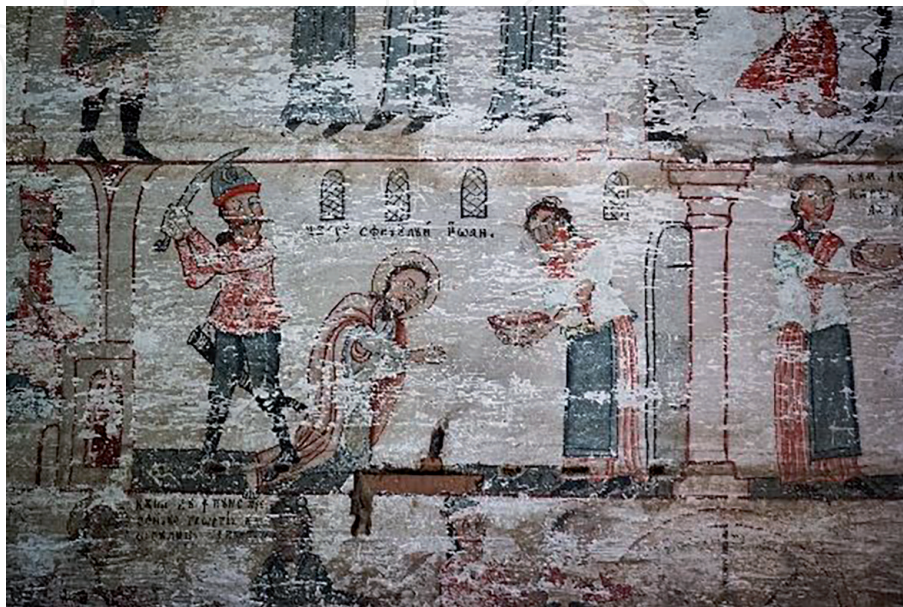
Figure 6.
The beheading of St. John the Baptist – wooden church of “Saints Archangels Michael and Gabriel” from Ungureni.

“When it was vlet from Christ 1782 made this church the ununited” is engraved inside the church, above the entrance door leading to the narthex. It is a medium-sized church, also placed on a hill, in the center of a village spread over a considerably large area. The planimetry is the most common, with a narthex, nave, altar, and an entrance located on the western side of the narthex. It is built of massive ash wood beams. The beams at the top form consoles with rich ornamentation at the ends. The narthex is ceilinged (it has a built-in ceiling) and the nave and narthex have a semi-cylindrical vault. The interior of the church has been painted in its entirety. There are no historical data regarding the master painter, who remains unknown until today. The church is altogether well preserved, even if the painting is quite altered, to the point of being entirely erased in many places. Its state of conservation is mostly due to its maintenance and attentive care paid by the local community (**Figure 6**).

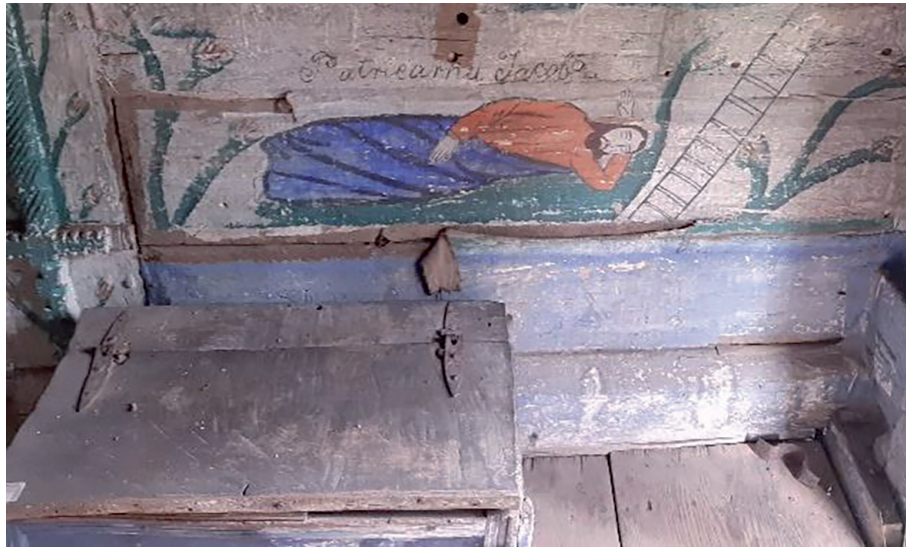
Figure 7.
Jacob’s dream – wooden church of “Saints Archangels Michael and Gabriel” from Vima Mică.

Vima Mică. The *Cross of Jerusalem* is carved around the entrance door to greet the parishioners. Inside, we can read the inscription from 1854 with the announcement that the roof was “shingled”. It consists of narthex, nave, and altar. The bell tower has a frustoconical helmet that ends at the top with a cross with three arms and a crescent. The roof has two more small towers. The painting inside is of extraordinary beauty, in light blue tones, which gives it a unique value. In 1902 an unknown painter partially restored the painting (according to local sources). At the entrance to the narthex, we are greeted by the *Tree of Life* and an old chest above which is painted a scene that urges you to reflect: *Jacob’s dream* (Figure 7).

The door is also decorated in a special style. The scenes from Passion on the western wall are very well preserved compared to the opposite wall and vault where the painting shows signs of deterioration. When passing between the nave and the narthex, the walls at the joint is in a severe degradation state, which gradually led to the alteration of the painting. The intact painted scenes appear clearly and have a high chance to be saved for perpetuity (Figure 8). There is a file pending for the rehabilitation of the church. The wooden structure and the roof are to be rebuilt and consolidated.

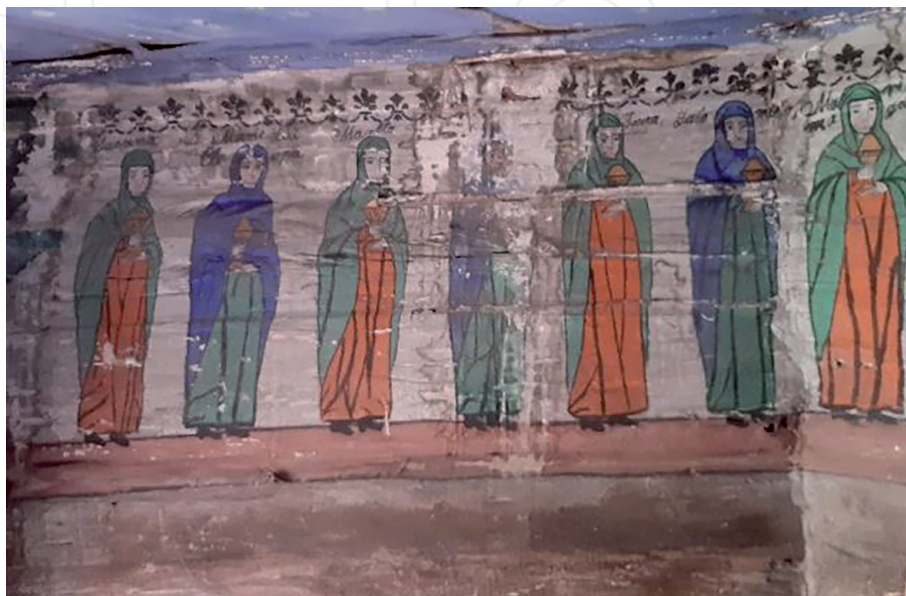
Figure 8.
Myrrh-bearing women – wooden church of “Saints Archangels Michael and Gabriel” from Vima Mică.

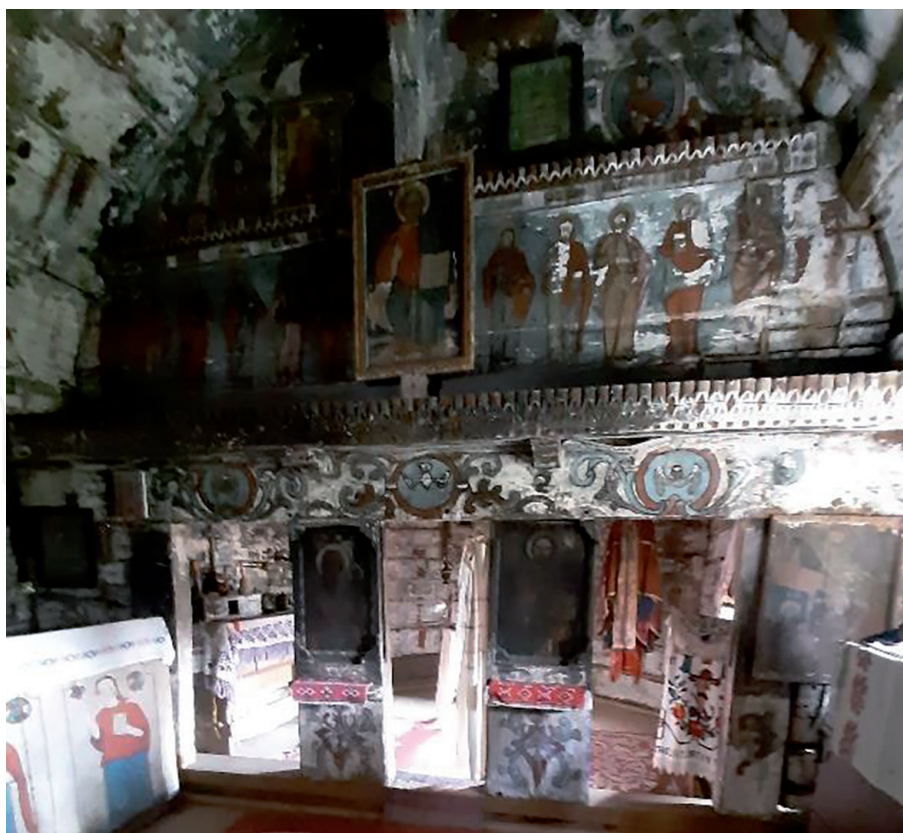
Figure 9.
Indoor painting – Iconostas – wooden church of “Saints Archangels Michael and Gabriel” from Răzoare.

The painter “*Petre Diul (Deacon, n.n.) from Preluca*”, signed the royal doors in 1759, which is why the interior painting is also attributed to him. Unfortunately, the state of advanced degradation of the painting does not give us an optimistic image of the future of this church. The careful care of the caretakers will not solve the severe degradation state that affects the wooden structure, with serious damage to the altar, while the hardly visible painting left has a great chance to be lost under the patina of time.

The entrance to the underground galleries of a non-ferrous mine use to be at a very short distance from the church. We hypothesize that the long years of mining exploitation, with heavy traffic and underground works, weakened the wooden structure of the church, which implicitly led to the deterioration of the indoor painting (**Figure 9**).

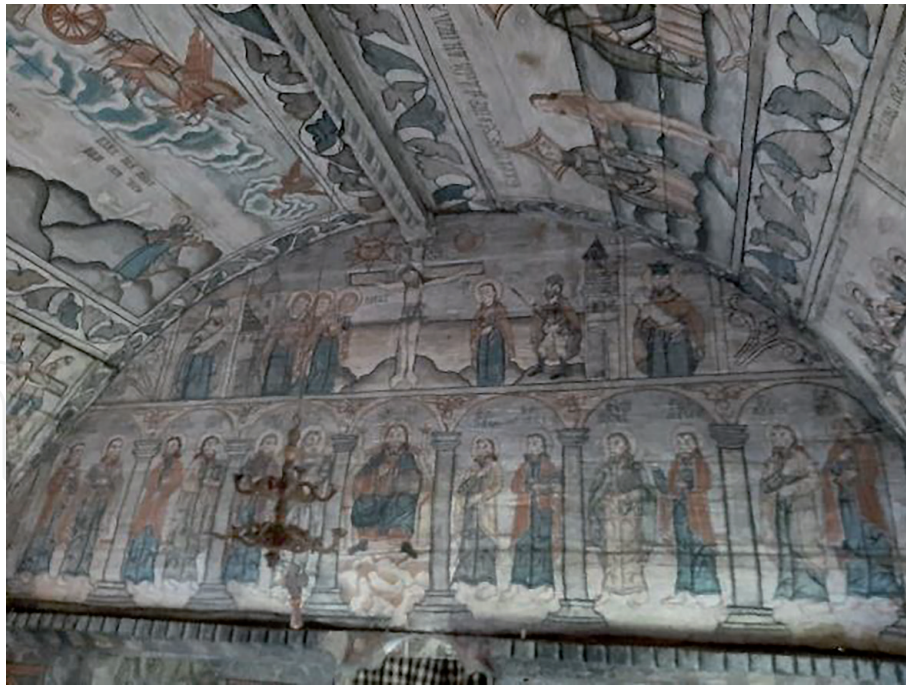
Figure 10.
Indoor painting – Libotin’s wooden church of “Saints Archangels Michael and Gabriel”.

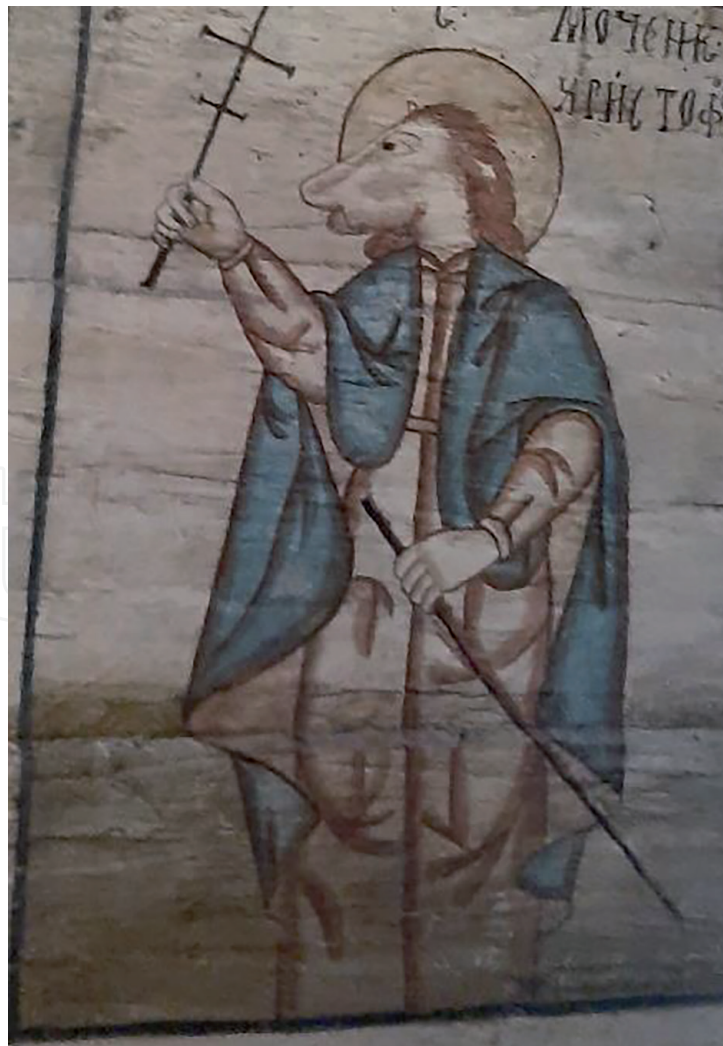
The interior walls of the church preserve the old painting that presents biblical scenes. The semi-cylindrical vault of the apse and the ceiling of the narthex have been restored, and the semi-cylindrical vault of the nave presenting a restored representation of the first chapters of *Genesis* and the *Ascension of Elijah* (**Figure 10**). This church had the benefit of having its painting restored. Amongst its painting, we can find a unique representation of *Saint Christopher*, that few people are aware of **Figure 11**.

Figure 11.
Saint Hristofor – wooden church of “Saints Archangels Michael and Gabriel ” from Libotin.

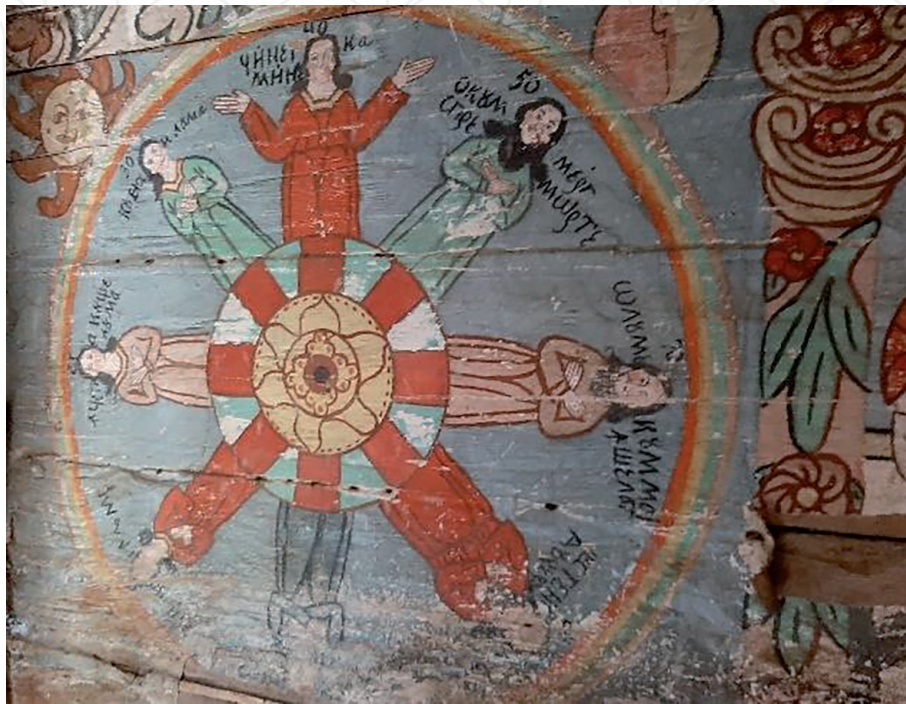
Moon, while on the eastern wall is represented the *Last Judgment* and the cycle of the *Wise Virgins* and the *Mad Virgins* (Figure 12).

Figure 12.
The wheel of life – wooden church of “Saint Dimitrie” from Larga.

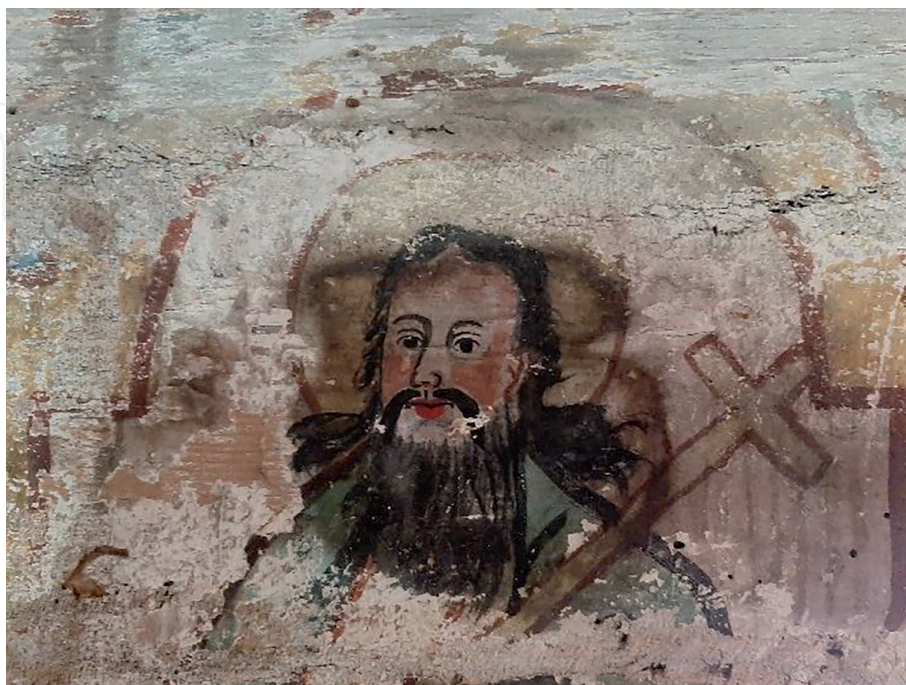
Figure 13.
Saint on the wall – the wooden church of “Saint Dimitrie” from Larga.

The northern wall of the nave is painted with saints in vaulted frames and scenes from the New Testament and the Passion. The iconostasis is in an advanced state of degradation, yet the faces of *St. Anthony* and *St. Euthymius* can still be identified. The altar preserved some scenes and figures of saints but equally degraded. The face of a Saint with a cross stands out on the southern wall, through the altered painting (Figure 13).

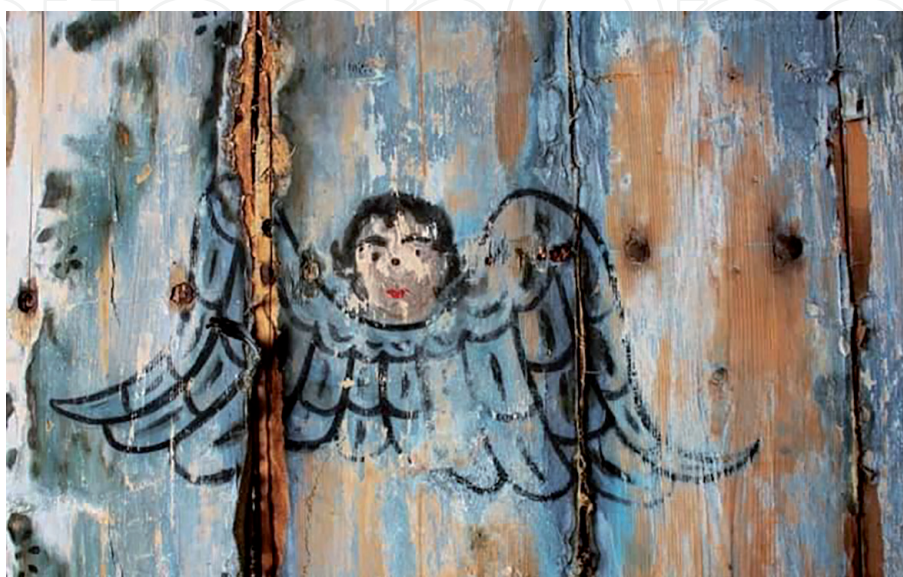
Figure 15.
Angel – wooden church of “Saints Archangels Michael and Gabriel” from Drăghia.

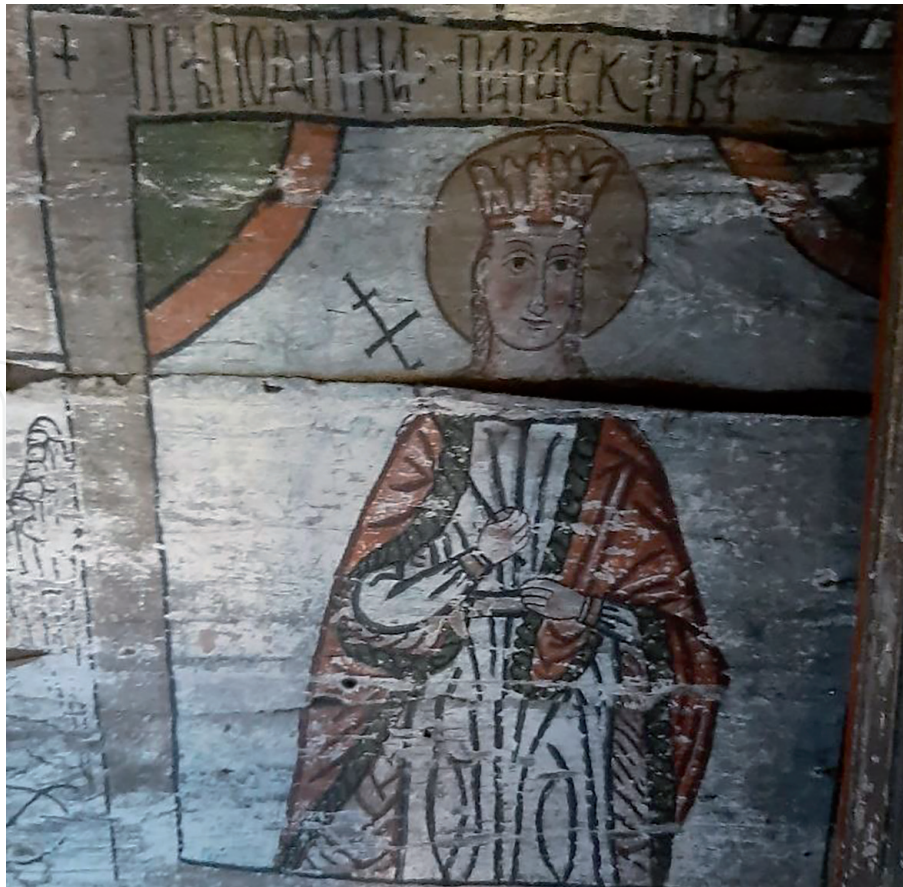
It is a medium-sized construction, built of oak beams on a stone foundation. The entrance, without a porch, is made through the southern part directly in the narthex followed by the nave and the altar. A beautiful strip, with the rope of life carved in wood, surrounds the church. In 1930, the shingle roof was rebuilt with a *draniță*, covering an extension of the *Table of the Elders*. The church tower is covered with tin sheets. Indoor we can find a beautiful painting, relatively well preserved, with the framed faces of male and female Saints (**Figure 17**).

Figure 17.
Saint Paraskeva – wooden church of “Saints Archangels Michael and Gabriel” from Dobric.

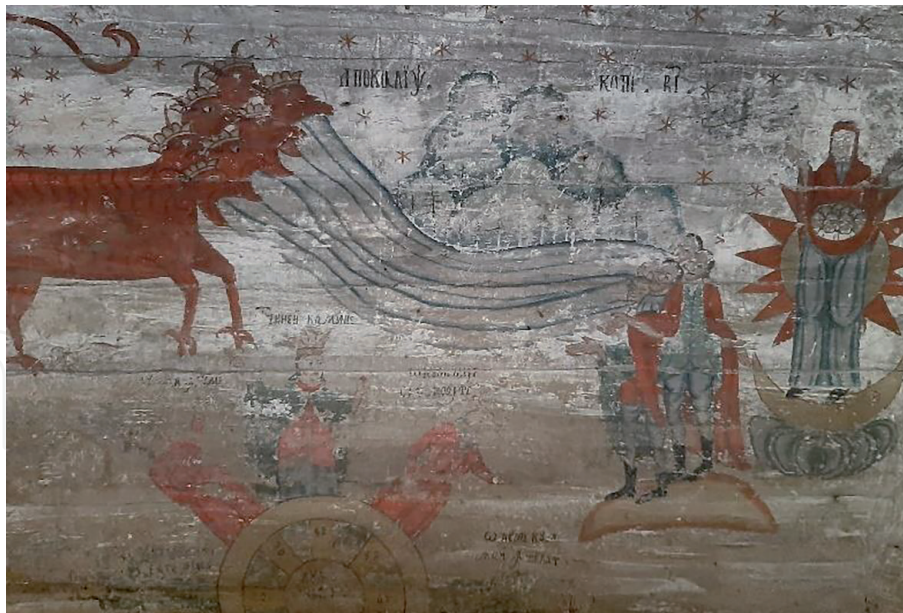
Entire scenes are preserved in both the narthex and the nave, such as the *Wheel of Life* and scenes inspired by Revelation (Apocalypse). The vault and the joint areas suffered bad weathering. The chances of conservation for this church remain uncertain (**Figure 18**).

Figure 18.
The wheel of life and the Revelation (Apocalypse) – wooden church of “Saints Archangels Michael and Gabriel” from Dobric.

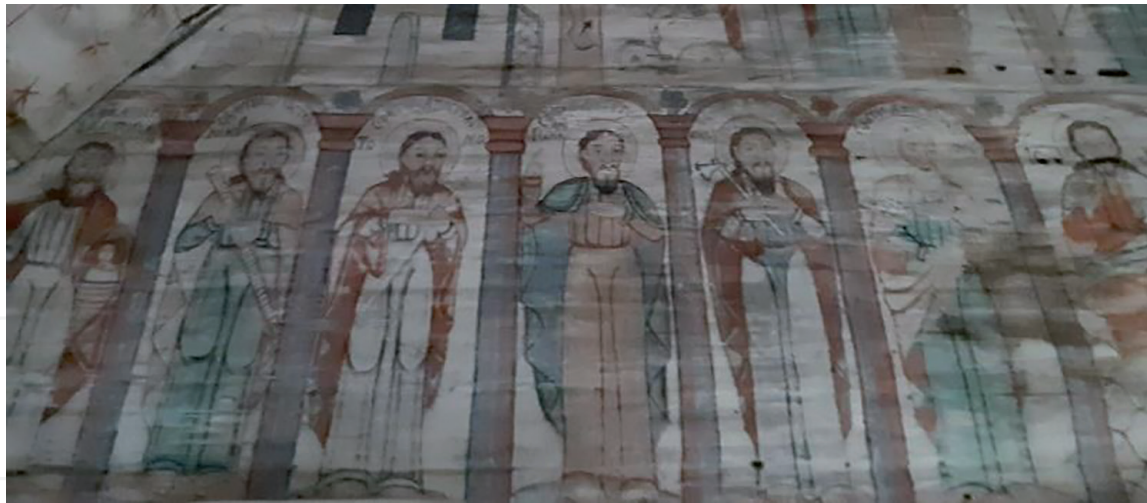
Figure 19.
 Iconostasis – wooden church of “Saint Elijah the prophet” from Cupșeni.

“This saint... too the high emperor... Francis first bishop... being... and prot... the ununited place John... 1823.” It is of medium-small dimensions, with a porch, narthex, nave, and altar. It stands out through the staircase that goes up to the tower, its steps being hollowed out in a single tree trunk. It is covered with wooden shingles, and the bell tower is massive and square-shaped. The interior painting in the narthex is almost completely destroyed, half of the ceiling and a wall has been rebuilt. In the altar, the

painting is likewise compromised. The paintings of the apostles on the iconostasis are hardly preserved, showing an increasingly pale coloristic over time (**Figure 19**).

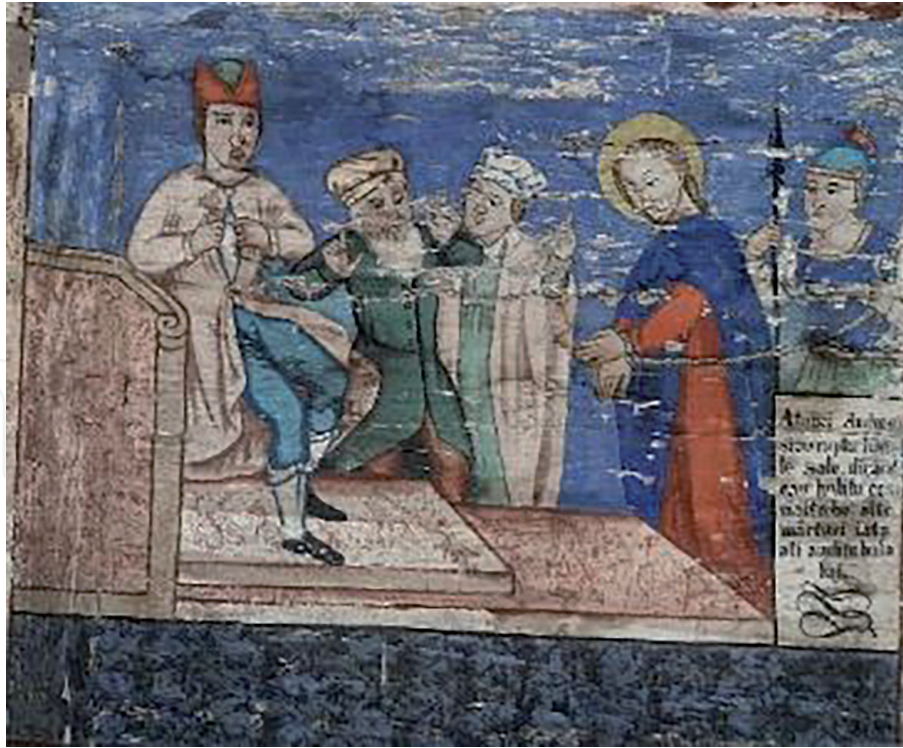
Figure 20.
Inside painting – wooden church “Saints Archangels Michael and Gabriel” from Jugăstreni.

wood, keeping the same typical architecture. The date of construction is between the 18th and 20th centuries. They are located on plateaus or hills of the villages from Lăpuşului Land. Being later put to use, they receive electricity and plastered indoor walls, which has led to better preservation over time. Some of them were painted on the inside plastered walls or on the wooden vaults, keeping with the spiritual charm of the area. An eloquent example is the painting, with a beautiful patina, from the wooden church of “Saints Archangels Michael and Gabriel” from Jugăstreni (**Figure 20**).
