Article in *Journal of Coastal Research* · May 2022

# Managing Saltwater Intrusion and Agricultural Practices along the Boğaçay River, Turkey: Effects from Excavation and Land Source Pollution

Muhammed Ernur Akiner<sup>†\*</sup> and Časlav Lačnjevac<sup>‡</sup>

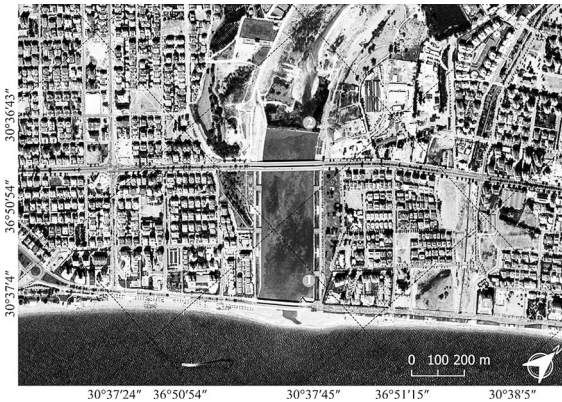
Figure 2. Two sampling locations, No. 1 and No. 2, were chosen based on the seawater reaches 700 m from the beach, with No. 1 being at the channel outflow and No. 2 being beyond the reach of the seawater (No. 1, 36°51'14\"N, 30°37'34\"E; No. 2, 36°51'28\"N, 30°37'14\"E).

Measured data for this research were obtained from the State Hydraulic Works (DSI) monitoring program for the Boğaçay stream discharging into the Mediterranean sea (DSI, 2019). Samples were transported in a cold box (4°C) and analyzed within 24 hours (ISO 5667-2, 1991; ISO 5667-3, 1994; ISO 5667-6, 1990). Then each parameter was tested in the laboratory. Applied test methods were ion chromatography for TKN and nitrate nitrogen; the stannous chloride method for total P; and 5-day incubation for 5-day biochemical oxygen demand (BOD<sub>5</sub>). According to Turkey's surface water quality management regulations (SWQMR) (MFWA, 2012), water quality classes are shown in Table 1. Samples were collected at two measuring points. The measuring points were selected considering the seawater entering 700 m from the shore. Point number 1 was at the outlet from the channel, and point number 2 was chosen from beyond the seawater's reach (Figure 2).

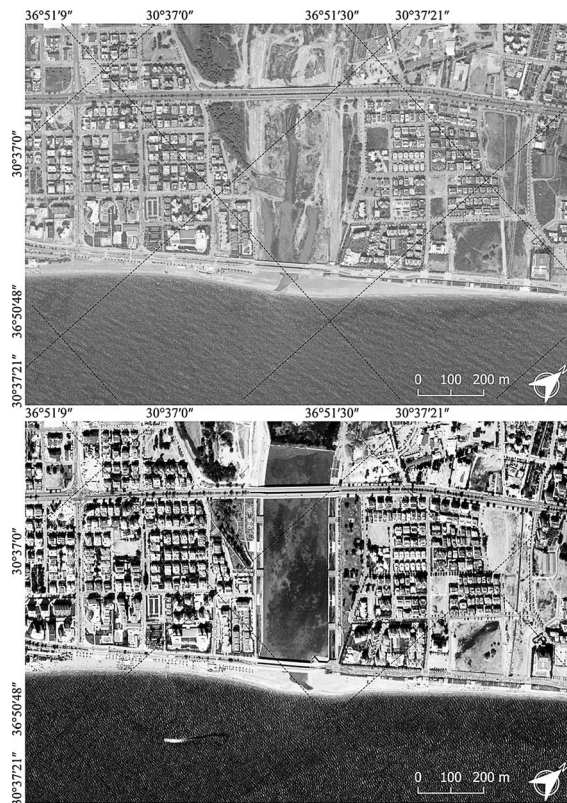
Figure 3. Satellite imagery from October 2017 (upper figure) and August 2019 (lower figure) reveals coastal erosion that occurred since the dates fall between the before and after the river bed excavation within the scope of the Boğaçay project implementation.

Previously, river estuary water was all fresh. After the project implementation, salinity became a problem in the Boğaçay aquifer and wells because of the arrested salt wedge. The Boğaçay River has two endemic freshwater fish species: *Capoeta antalyensis* (Antalya barb) and *Alburnus baliki* (Antalya bleak) (Küçük and İkiz, 2004). These are at risk of disappearing because of the threat of saltwater intrusion. The freshwater source of Konyaaltı, groundwater, is open to pollution. The Boğaçay River prevents Konyaaltı Beach from negatively affecting littoral transport by continuously discharging the sediments to the Mediterranean Sea. As a result of this project, the river was prevented from meeting with the coast, and the shoreline eroded rapidly. The coastal line receded up to 25 m due to wave erosion. The eroding shoreline between October 2017 and August 2019 was detected through satellite photography.

The most damaging impact of the so-called Crazy Project was visible at the world-famous Konyaaltı Beach. The project causes the river estuary to act as an artificial dam. Within two years, the sediment cycle was interrupted. According to the results of this research, the shoreline was retracted up to 25 m.

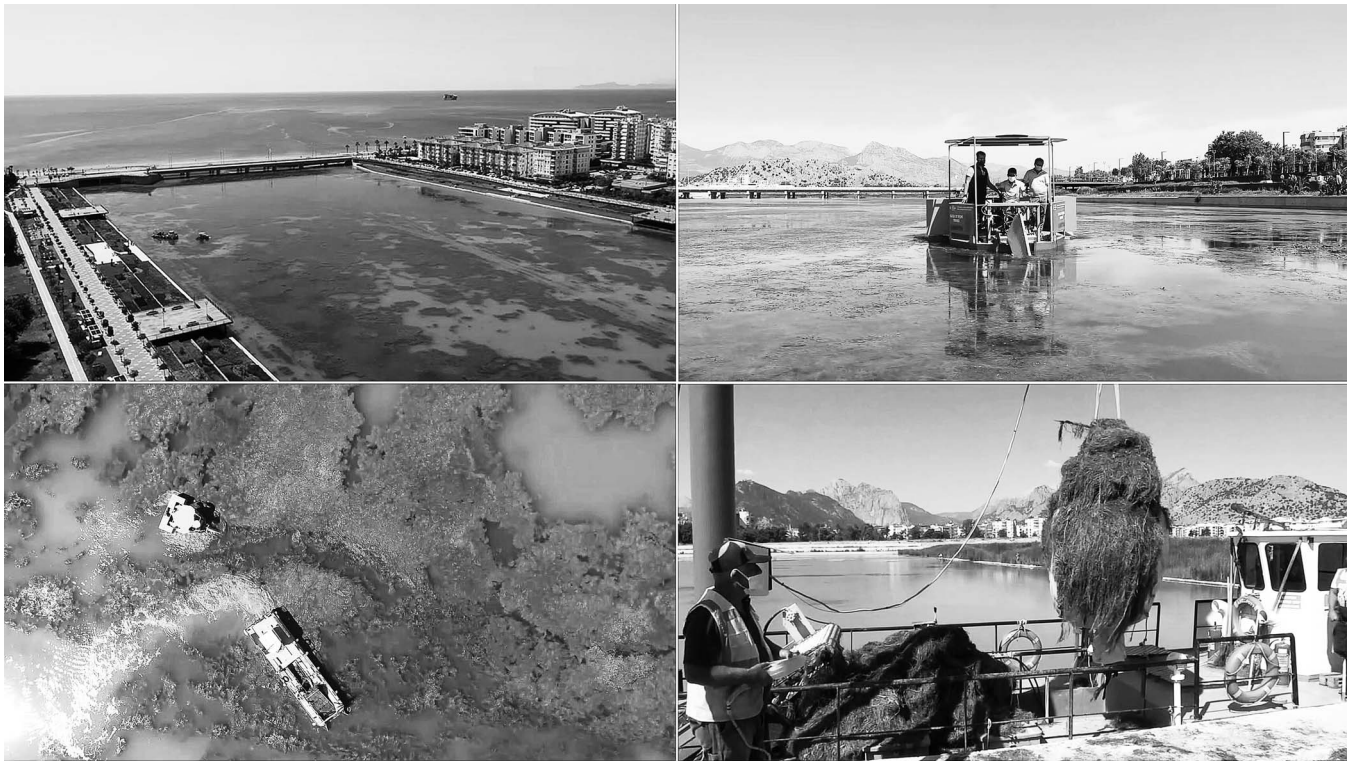
Figure 4. Periodic harvesting activity by the municipality to remove excessive moss that produces odor and unpleasant visual pollution owing to the deteriorating water quality caused by the Boğaçay project.

Boğaçay, where the waters coming from the karstic structure of the Taurus Mountains in Antalya merge at Konyaaltı Beach and pour into the Mediterranean, is covered with moss. The water coming to Boğaçay, where the bed elevation level was lowered, mixes with the fertilizers left from the surrounding agricultural areas, and algae occur in the freshwater that cannot reach the sea as easily as before the Crazy Project. The global warming that is threatening water resources today, as well as the observed global climate change, causes an increase in the seasonal average temperature, a change in the water level, and a decrease in the oxygen level in the water, which negatively affects the life in the water. Current studies in the literature indicate that global warming will be one of the most significant negative factors affecting global water quality in the future (Radhapyari *et al.*, 2021; Valipour, Bateni, and Jun, 2021). Saltwater intrusion acts as a catalyst in the formation of bad odors and appearance of algae with the warming of the water with hot air. When the saltwater, which enters from the sea and stratifies at the bottom due to the density difference, meets the algae growing in freshwater, decay begins. Negative results of the project are seen in Boğaçay as of May 2021. As a temporary solution, growing grass is cut from the bottom and harvested (see Figure 4). Despite the costly cleaning efforts, human intervention has caused the ecological balance to deteriorate and the water quality to decrease. In short, expensive systems such as mobile ventilation systems may be required to increase oxygen and maintain the ecosystem.
