Oxidation of austenitic stainless steels in PWR primary water

Abstract:

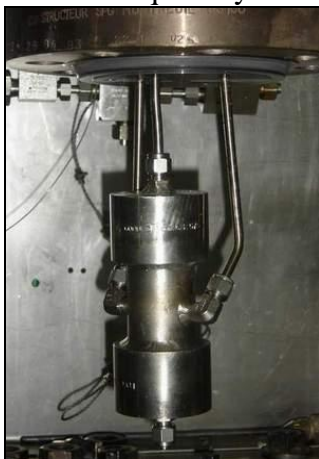
Figure 2 – Capsule for short exposure to primary water. Figure 3 – Evolution of the temperature during testing in capsule.

A short exposure test was carried out in a specifically designed capsule placed in an autoclave (Figure 2). A specimen was introduced in the capsule, after tensile pre-deformation at room temperature (specimen 1171-13, 304L, heat T2575, strained to 40%). The test in primary water at 320°C lasted 6h (2h heating and 4h at 320°C), then a rapid decrease of temperature was obtained by the injection of cold pure water in the capsule (Figure 3). After testing, thin foils were cut to quantify the surface oxides.

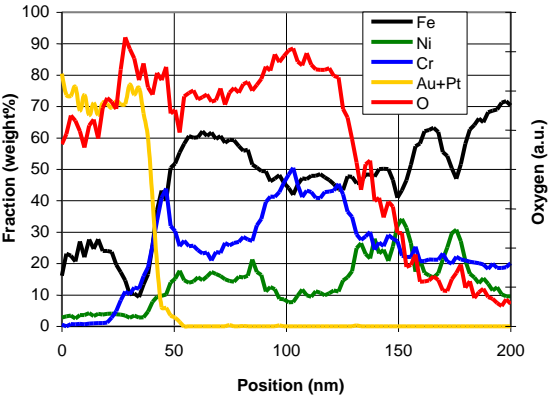
Figure 7 – EDS profile. Site 1A at the surface of specimen 1594-T112-06 (304L).

Figure 7 is an EDS scan corresponding to the previous site (at the location of the remaining gold grid). Oxygen content is plotted in arbitrary units, while Fe, Cr, Ni and Au+Pt contents are plotted in weight %. O and Ni contents slightly increase within the 200 nm – 130 nm depth range. Conversely, Fe content decreases and Cr content does not change. It can be noticed also that Ni maximum correspond to minima in Fe and O content. This observation suggests that only a limited fraction of Ni (noble element) is affected by oxidation, contrary to Fe and Cr.

The important decrease of the Fe content indicates that oxidation essentially affects Fe. Within the range 130 nm – 90 nm, Fe and Cr contents are equivalent (45%) and significantly higher compared to Ni content (10%). Therefore, a significant Cr enrichment is observed in this inner oxide layer. It can be assumed that Fe diffusion is more effective than Cr diffusion in this layer. Within the range 90 nm – 45 nm, the oxide is essentially composed of Fe (60%), even if Cr (25%) and Ni (15%) are present. This outer oxide layer is probably essentially composed of Fe spinels. The total thickness of the oxide is approximately 150 nm, including 40 nm of Cr-rich oxide.

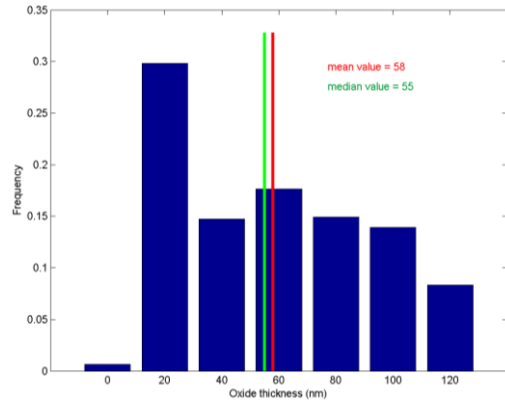
Figure 17 – Distribution of the thickness of the rich-Cr inner oxide layer formed at the surface of specimen 1171-13 on site 3
