# Application of ultrasonic tomography to characterize the mechanical state of standing trees (*Picea abies*)

Loic Brancheriau, Ghodrati Ashkan, Philippe Gallet, Patrice Thaunay,  
Philippe Lasaygues

Loic Brancheriau, Ghodrati Ashkan, Philippe Gallet, Patrice Thaunay, Philippe Lasaygues. Application of ultrasonic tomography to characterize the mechanical state of standing trees (*Picea abies*). *Journal of Physics: Conference Series*, IOP Publishing, 2011, 353, pp.1-13. <10.1088/1742-6596/353/1/012007>. <hal-00721362>

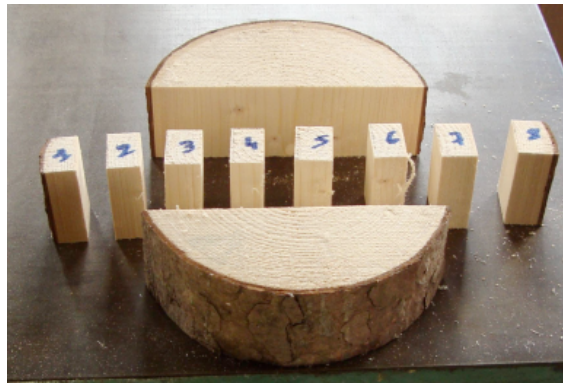
**Figure 1.** Sampling pattern for moisture content determination (dimensions of the small samples: 2x3x5 cm<sup>3</sup>).

The first log was cut in two disks of 5 cm thick and one disk of 15 cm thick. These disks were sampled in the middle area of the log to avoid cracks due to wood drying and to have high moisture content. The disks of 5 cm thick were used to determine the mean moisture content and also the moisture content profile along the radius (Figure 1). The moisture content was determined before and after the ultrasonic tests. The samples of Figure 1 were weighted then dried in an oven (103°C) during 48 hours then weighted again. The Equation 1 was used to compute the moisture content.

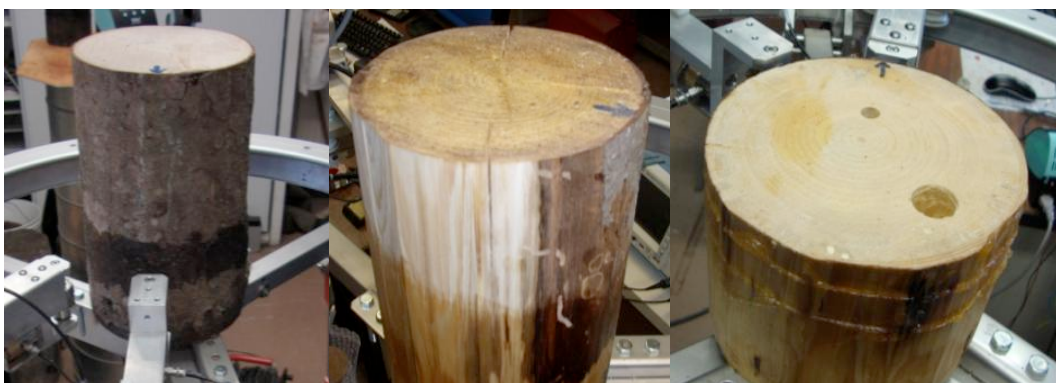
**Figure 2.** Tomography tests on the first log (from left to right: bark, debarked and drilled with two holes of diameter 1 cm and 2 cm).

The disk of 15 cm thick was tested in tomography with 3 states of the sample: bark, debarked and drilled (2 holes of diameter 1 cm and 2 cm, see Figure 2). The tomography tests were made with two repetitions and an angular step of 30° to estimate the measurement uncertainties and with an angular step of 10° for tomographic imaging.

The mean moisture content was 23% before the tests and 21% at the end of the experiment. The moisture content profile along the radius was presented at the Figure 7. The difference in moisture content from the pith to the bark was 5% before test and 10% after test. Despite the presence of the plastic film on the logs and on the disks, the wood samples tested were not in a green state and the natural drying effect increased while testing (phenomenon important after debarking). Small cracks appeared at the periphery of the disks due to drying (Figure 2, right image).

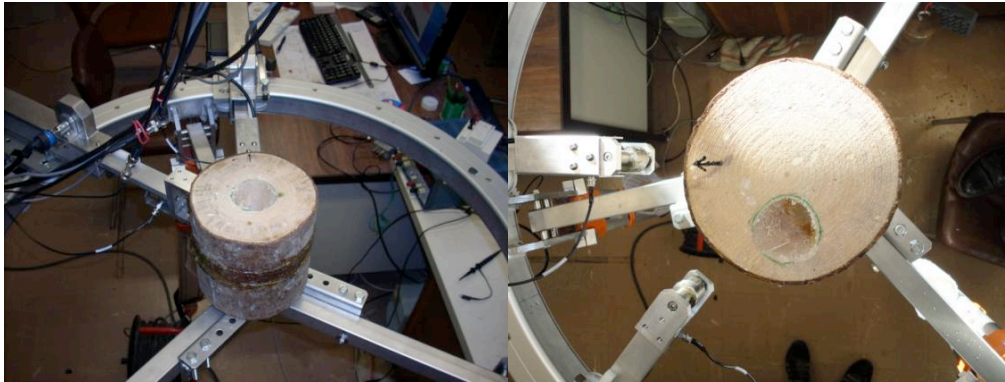
**Figure 3.** Tomography tests on the two disks of the second log (hole diameter of 5 cm).

The second log was cut in two disks of thickness 15 cm. These disks were sampled in the middle area of the log. In each disk a hole of diameter 5 cm was drilled, one in the middle and the second off-centered (Figure 3). These two disks were tested in tomography with an angular step of  $10^\circ$ .

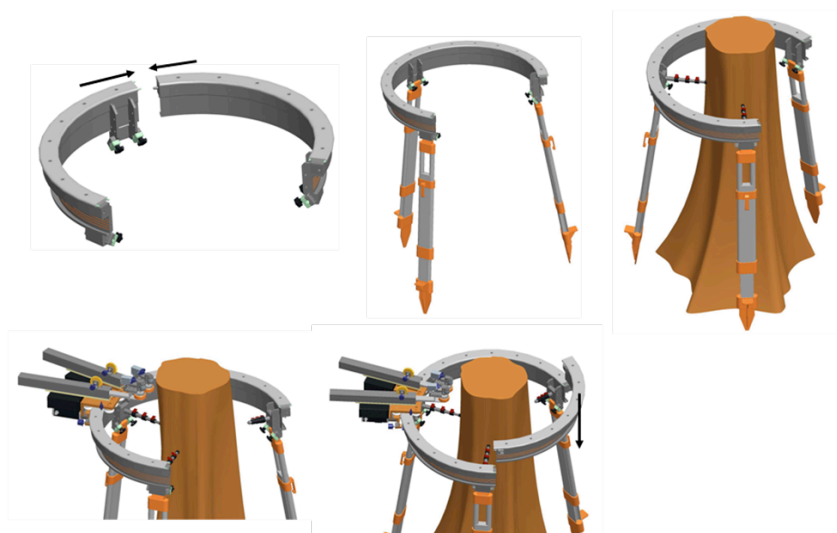
**Figure 4.** Mounting steps of the ultrasonic tomograph.

The ultrasonic tomograph consisted in an aluminium ring supported by a tripod (Figure 4) [3]. To be able to test small disks, a specific support was added and mounted between the tripod (Figure 3). This device was designed to test standing trees. Thus, the height of the ring can be adjusted from 1 m to 1.6 m but the typical height is 1.3 m. If the apparatus is mounted on a trunk (Figure 4) the two parts of the ring are first assembled, and then the tripod is fixed. The apparatus is then placed against the trunk using two narrowing elements. Each probe is mounted on a trolley and these trolleys are slipped within the ring. Finally, the last part of the ring is fixed and the third narrowing element is applied.

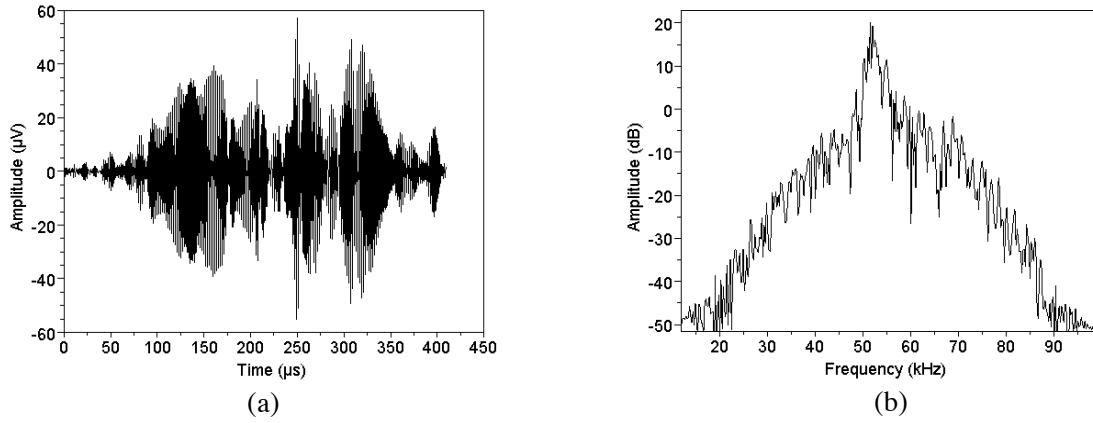
**Figure 5.** Ultrasonic signal filtered by a Morlet wavelet at 55 kHz with a bandwidth of 20 kHz (a) and associated Fourier transform (b).

MHz. The duration of acquisition was set to  $410 \mu\text{s}$ . The output signal was previously filtered by a Morlet wavelet at 55 kHz with a bandwidth of 20 kHz for denoising (Figure 5).

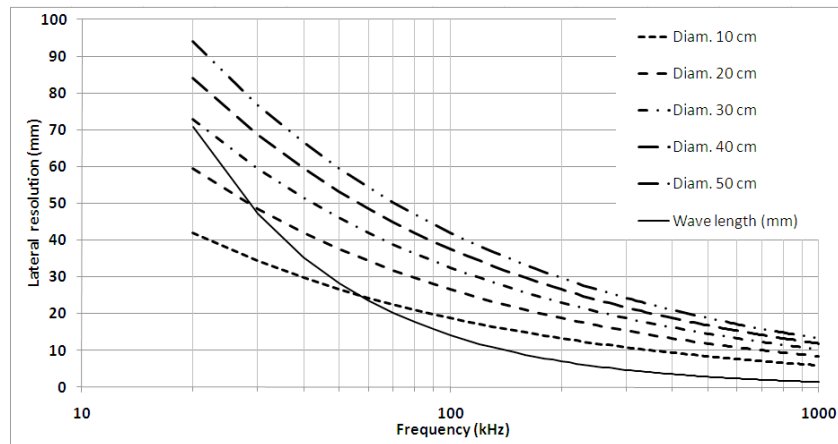
**Figure 6.** Lateral resolution and wavelength as a function of the frequency and according to the sample diameter (the acoustic wave speed was set to 1400 m/s).

The theoretical upper limit of the number of computed pixels was 450 (mesh of  $39 \text{ mm}^2$ , Equation 4). The physical resolution was however about 26 mm (axial resolution: wavelength) and 31 mm (lateral resolution: Fresnel zone, Equation 5, Figure 6). This resolution led to a mesh of  $806 \text{ mm}^2$ ; the images were thus 2D smoothed by a blackman filter of the wavelength size (the errors induced by the use of the modified Shepp-Logan filter was also highly reduced). It was important to highlight that the redundancy of the information ( $39 \text{ mm}^2$  compared to  $806 \text{ mm}^2$ ) allowed to decrease the effect of erroneous experimental values in the imaging process.

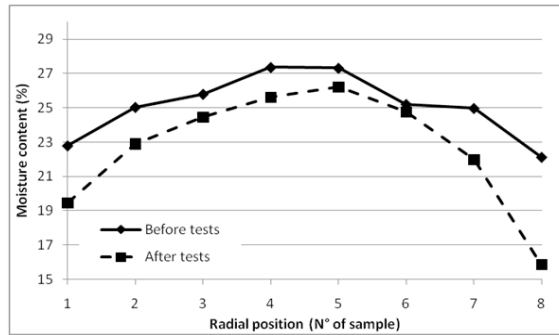
**Figure 7.** Moisture content (%) according to the radial position before and after the ultrasonic tests (samples from the first log).

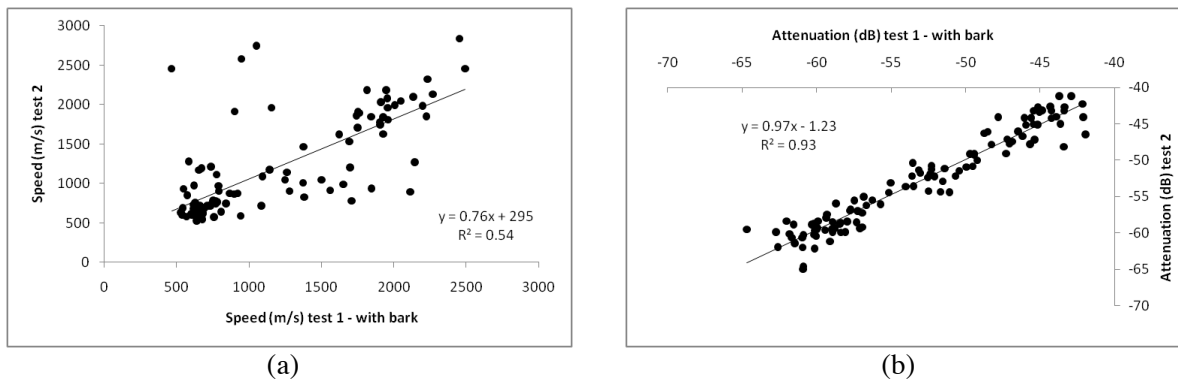
**Figure 8.** Relationship between the two repetitions for (a) speed and (b) attenuation (disk with bark,  $N=108$ ).

Two tomography tests were made with an angular step of  $30^\circ$  (108 acquisitions) on the same disk (with bark, debarked and drilled). The results were shown at the Figure 8 only for the disk with bark because the trends were very similar after debarking and drilling. Significant linear relationships were found for the speed ( $R^2 = 0.54$ ,  $F = 105$ ,  $p < 0.001$ ,  $N = 108$ ) and for the attenuation ( $R^2 = 0.93$ ,  $F = 1373$ ,  $p < 0.001$ ,  $N = 108$ ). The presence of outliers in the scatter plots of speed (Figure 8, a) was caused by errors in the travel time estimation. The standard error of the speed determination was thus  $\pm 420$  m/s. The attenuation had a low measurement error compared to the speed estimation with a standard error equal to  $\pm 1.7$  dB.

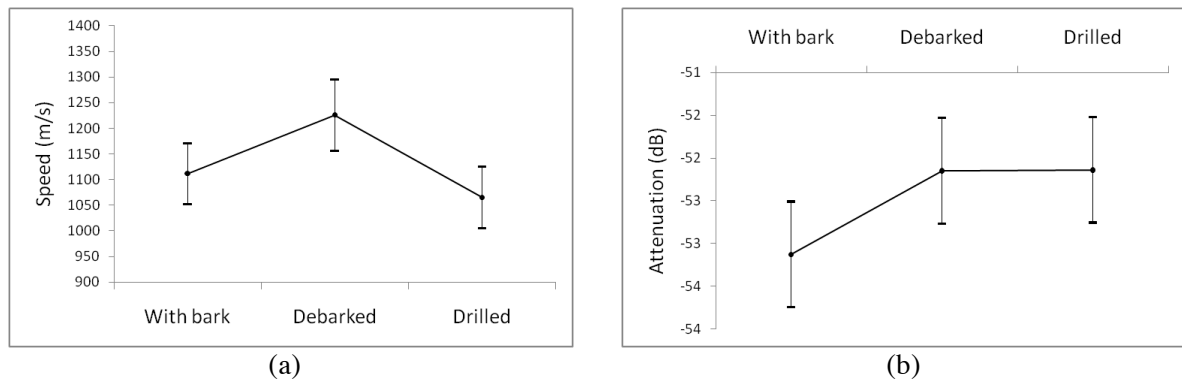
**Figure 9.** Means and standard deviations of speed (a) and attenuation (b) computed on 108 acquisitions for the disk with bark, debarked and drilled.

Mean comparisons were made to study the effect of bark and holes on the ultrasonic parameters (Figure 9). The number of acquisitions was 108 with an angular step of  $30^\circ$ . The statistical tests were firstly a Student's t-test on paired samples (Table 1).

The results of Table 1 were secondly completed by non-parametric Wilcoxon tests (valid when the normality assumption was not satisfied or the sample size was too small). The Wilcoxon tests agreed with those of Student's t for attenuation but did not confirm the Student's t results for speed (Table 1). The mean attenuation measured on the disk with bark was thus significantly different with the one after debarking. The mean attenuation was higher with bark than without bark. No significant difference was found between the mean attenuation of debarked disk and of drilled disk. Concerning the speed measurements, differences existed between disks with bark, debarked and drilled but the probability values were too high to be absolutely affirmative (Figure 9 and Table 1).

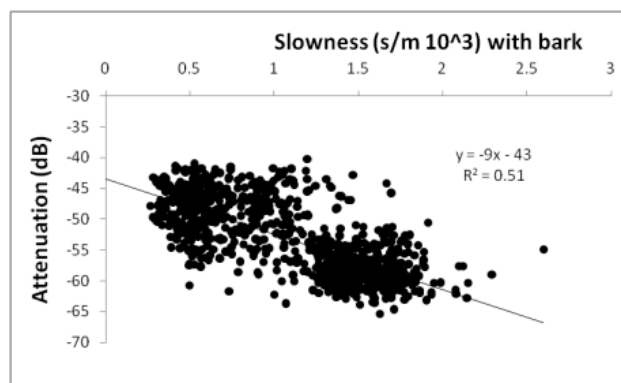
**Figure 11.** Relationship between slowness and attenuation for the disk with bark (N=900).

The Figure 11 showed a scatter plot between slowness and attenuation for the disk with bark. A significant linear relationship was found with a  $R^2$  equal to 0.51 ( $F=933$ ,  $p < 0.001$ ,  $N=900$ ). The attenuation increased when the slowness increased or the speed decreased. However, the degree of fit should be read with care because the Figure 11 clearly showed two populations (associated with the distributions of the Figure 10). Outliers were also visible due to the uncertainty on the slowness determination; but they were not associated to particular positions of the probes.

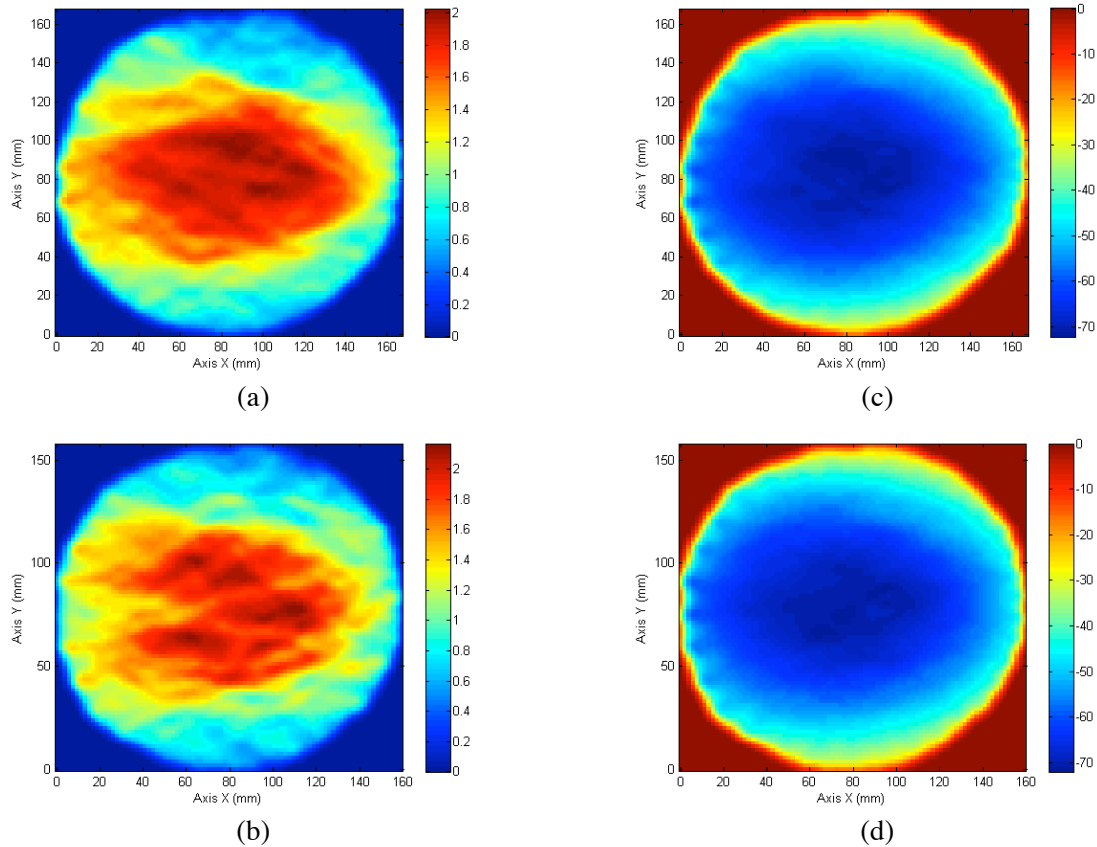
**Figure 12.** Tomographic maps of slowness ( $10^{-3}$  s/m) (a, b) and attenuation (dB) (c, d) for the disk of the first log, with bark (a, c) and debarked (b, d).

The computed maps of slowness and attenuation for the first log with and without the bark were presented at Figure 12. The images were displayed in 87x87 pixels and based on a 10° angular step (900 acquisitions). There was no visible effect of the presence of the bark on the outlines of the maps (Figure 12). This phenomenon was due to the low thickness of the bark (3 to 5 mm) compared to the wavelength (26 mm) added with the smoothing effect of the 2D filter.

The Figure 12 showed however two different areas from the pith to the periphery. These areas were highlighted at Figure 13 where the paths were drawn if the slowness was lower than  $1.2 \times 10^{-3}$  s/m and if the attenuation was upper than -51 dB. The periphery was thus characterized by a higher speed and a lower damping than the ones of the pith. The inverse phenomenon was observed by Socco and interpreted as an effect of the wood anisotropy [14]. The shorter paths (periphery) were more influenced by the tangential behavior of wood, while the radial behavior had a more important effect for longer paths (center). However, the radial velocity of wood is known to be upper than the tangential velocity. In this specific case (Figure 12), this observation was explained by the transition from juvenile to mature wood coupled with the effect of the moisture distribution (Figure 7).

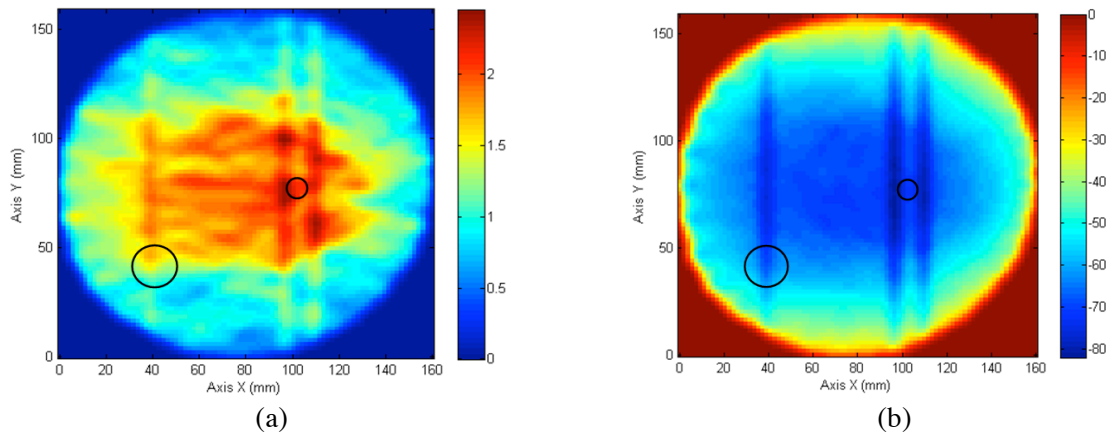
**Figure 14.** Tomographic maps of slowness ( $10^{-3}$  s/m) (a) and attenuation (dB) (b) for the drilled disk of the first log. The black circles indicate the positions of the drillings.

The tomographic images obtained for the drilled disks of the two logs were presented at Figure 14 and Figure 15. The effect of the holes was visible on the maps by areas with a high slowness and also a high damping. This observation was valid even for the hole which diameter (10 mm) was the half of the wavelength (26 mm). It seemed that the position of holes in the disk had an effect on the reconstructed pattern; the holes closed to the pith were characterized by two elliptic patterns at the difference of those closed to the periphery. The shape of the patterns associated with the holes was not a circle but an ellipse and several hypotheses were advanced: the anisotropy was not taken into account, some cracks due to natural drying occurred, the reconstruction procedure was not well adapted for missing data (the dimension of the probe supports not allowed to scan the total angular area but only  $250^\circ$  for each projection), the mounting of the probes (Figure 5, right image) induced back waves which altered the received signals. These hypotheses will be investigated in a future study to improve the tomographic process.

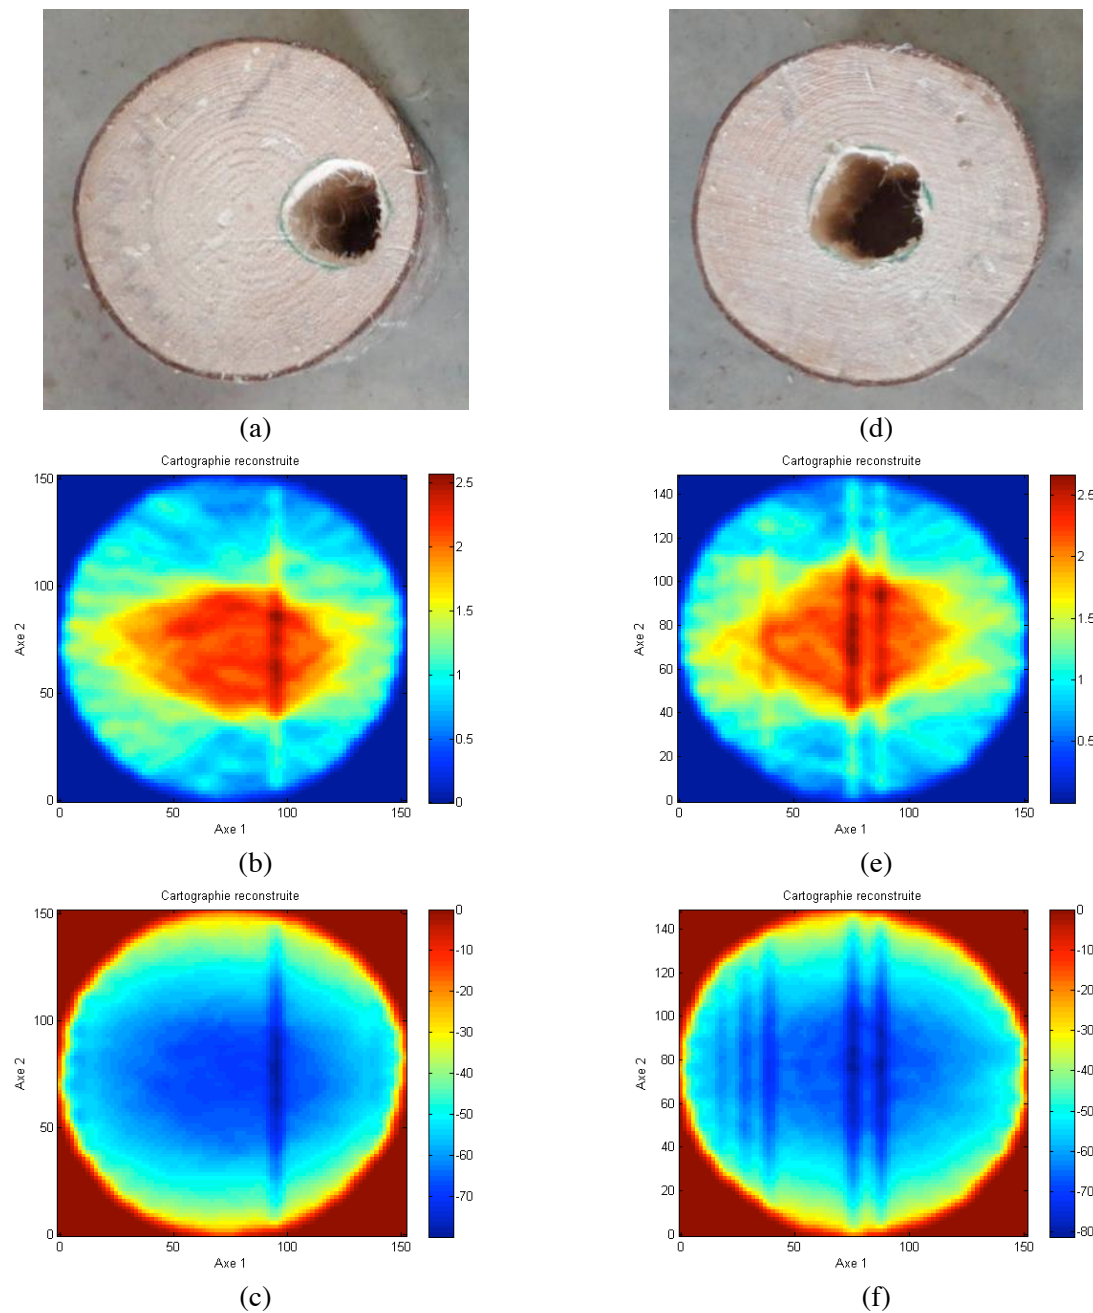
**Figure 15.** Tomographic maps of slowness ( $10^{-3}$  s/m) (b, e) and attenuation (dB) (c, f) for the two disks of the second log (a, b).
