Impact of storage induced outgassing organic contamination on laser induced damage of silica optics at 351 nm

Abstract: The impact of storage conditions on laser induced damage density at 351 nm on bare fused polished silica samples has been studied. Intentionally outgassing of polypropylene pieces on silica samples was done. We evidenced an important increase of laser induced damage density on contaminated samples demonstrating that storage could limit optics lifetime performances. Atomic Force Microscopy (AFM) and Gas Chromatography -Mass Spectrometry (GC-MS) have been used to identify the potential causes of this effect. It shows that a small quantity of organic contamination deposited on silica surface is responsible for this degradation. Various hypotheses are proposed to explain the damage mechanism. The more likely hypothesis is a coupling between surface defects of optics and organic contaminants.

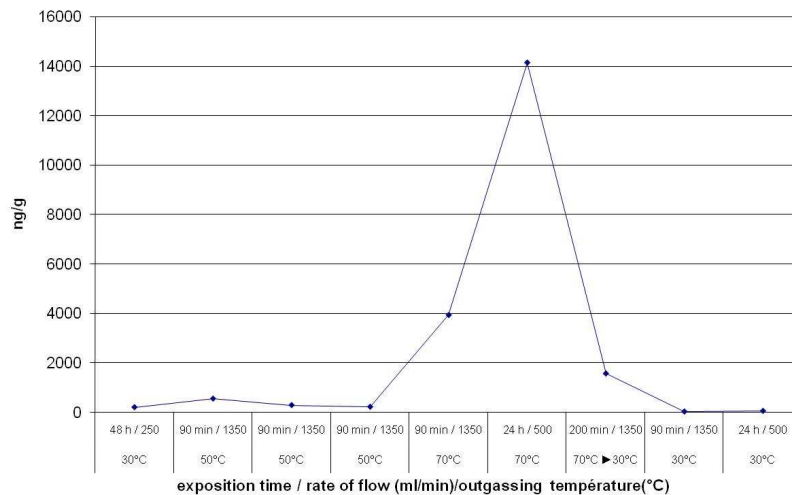
Fig. 1. Outgassing rate of polypropylene at different temperatures, flow rates and durations

The amount of outgassing species increases with the duration and the temperature. Maximal outgassed quantity is measured around 70°C. The outgassing rates of major

molecules measured at 70°C during 24 h and at 30°C during 48 h corresponding to the first and sixth points of Fig. 1 are given in Fig. 2.

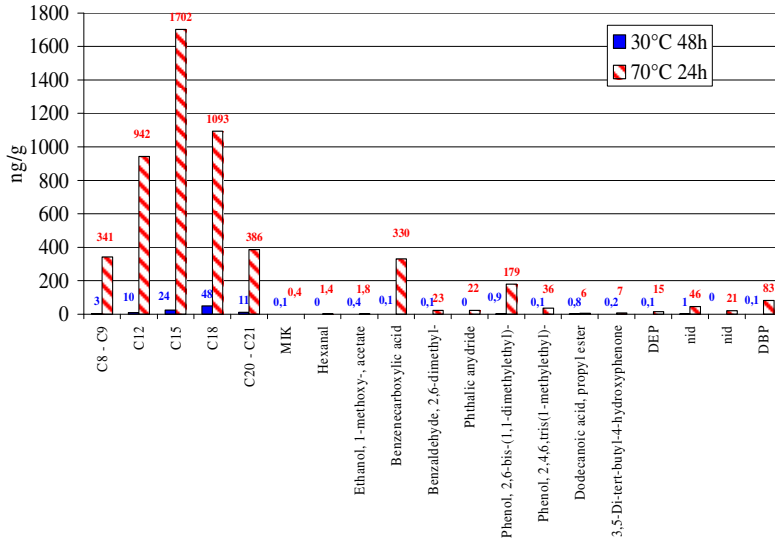
Fig. 2. Outgassed species at 70°C during 24 h by the selected polypropylene

The detected compounds were measured during the whole duration of the outgassing cycle. The alkanes and alkenes come probably from decomposition of other higher molecules. Dibutylphthalate and diethylphthalate are esters of phthalic acid and are mainly used as plasticizers, substances added to plastics to increase their flexibility. The other molecules are measured at the beginning as well as at the end of the outgassing cycle; consequently, they probably come from NPP material and not from a surface contamination of the analyzed NPP sample. Moreover, outgassed species at 70°C and at 30°C are similar. It means that an outgassing at 70°C during 24 h can be equivalent to an outgassing at 30°C during many days which is representative of a long term outgassing such as optics storage conditions. Consequently a temperature of 70°C during 24 h was chosen for the outgassing contamination phase.

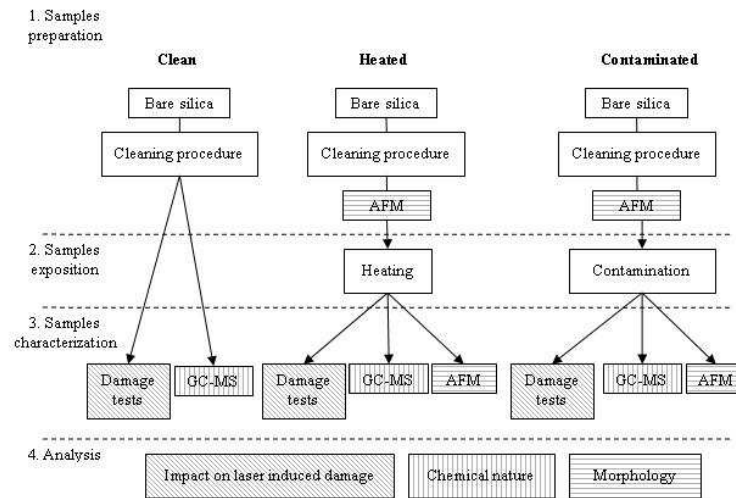
We used plano-parallel Corning 7980 fused silica polished samples. An experimental protocol detailed in Fig. 3, was used for contamination, for laser damage tests and for characterization. Preliminary, samples were cleaned using an automated cleaning procedure in a spray system machine with RBS 50 soap followed by an ethanol drag wipe. At this step, all bare samples exhibit the same laser induced damage density as typical clean LMJ optics, that is to say approximately 0.1 damage/cm² at 351 nm, for 10 J/cm², and 3 ns pulse length. The contamination process is then carried out in the following way: the sample to be contaminated is placed in a clean glass box with 60 g of NPP. Silica sample and NPP in the glass box are then put in an oven programmed to do a cycle consisting in a rising slope of 6 h to 70°C followed by a stage of 24 h at this temperature and an abrupt return at ambient temperature during 15 min to help condensation of the outgassed species on the silica surface. To avoid any external contamination and guaranty the repeatability of the contamination process, glass box and NPP sample are cleaned in a washing machine with L51 soap followed by an ethanol cleaning prior to contamination experiment. To evaluate the impact of NPP outgassing, each contaminated sample is compared with a reference clean sample. Nevertheless, as the contaminated phase includes a heating cycle, a second reference sample is used; it is cleaned with the previous procedure and is heated with the previous temperature cycle without NPP in a similar glass box. These references were used for the following samples characterization

Fig. 3. Experimental protocol

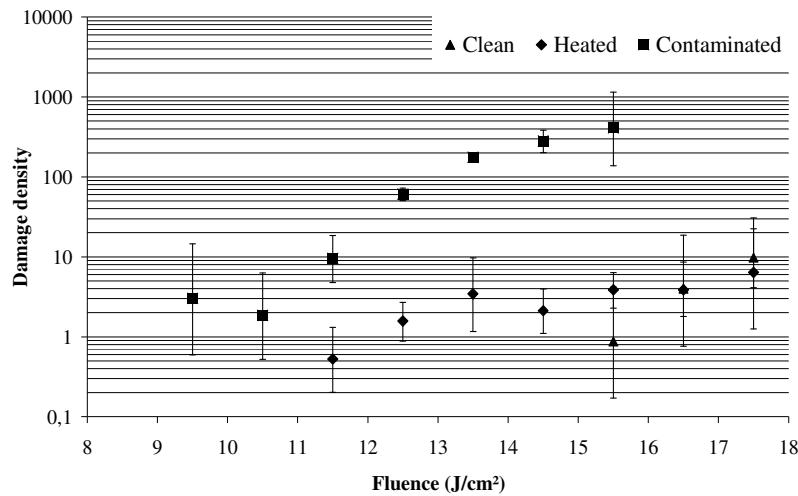
Laser induced damage tests have been made on several clean, heated, and contaminated silica samples. The total surface tested is about 100 cm² for each type of sample. Results are presented on Fig. 4. Firstly, damage tests reveal that clean and heated samples are similar. It demonstrates that the outgassing protocol without NPP has no effect on damage density. Laser damage tests on clean sample did not generate damage at fluences below 14 J/cm². Secondly, the impact of NPP outgassing is significant. Indeed, from 11 J/cm² to 14 J/cm², damage density is increased by a factor of 5 to 200 on contaminated samples.

Fig. 4. Laser induced damage tests of clean, heated and contaminated silica samples

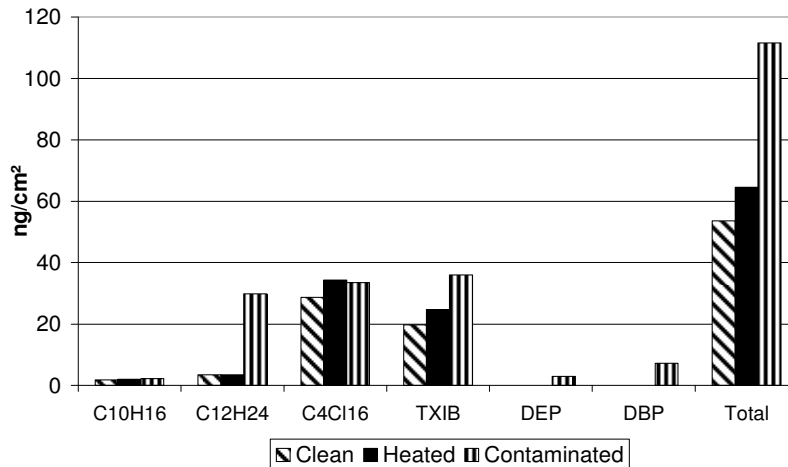
Fig. 5. Chemical species measured by GC-MS on clean, heated and contaminated silica samples

The amount of each molecule measured is expressed in terms of mass per unit surface. Comparison of clean, heated and contaminated samples demonstrates that contamination carried out with NPP increased global amount of contaminant by a factor of 2. NPP contamination induces an additional contamination of diethylphthalate (DEP), dibutylphthalate (DBP) and $C_{12}H_{24}$. Additional GC-MS measures on contaminated samples confirmed this increase of a factor 2 compared with clean or heated sample. Other condensable molecules were found; which demonstrated that this mode of contamination generate a mixture of various condensable molecules on silica surfaces.

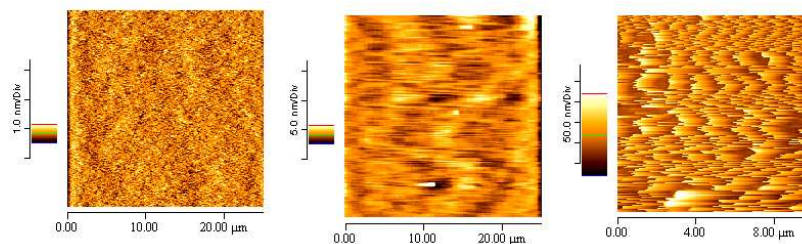
AFM measurements were made to determine the morphology of the contaminant layer. The measurements after cleaning and after contamination with NPP were compared. The same areas were analyzed each time. After cleaning, as shown on Fig. 6a, all samples exhibit a root mean square roughness of 0.1 nm with a standard deviation of 0.01 nm; which is conform to manufacturer's roughness specifications. Then, we performed the same measures after contamination. As showed on Fig. 6b, on the contaminated sample, streaks appear on the picture. AFM manufacturers warn that these streaks are artifacts related to a tip contamination [19]. They appear especially in location where there are sharp features and edges on the sample surface such as scratches or digs.

Fig. 6. AFM picture of bare silica samples after cleaning (a) and after contamination (b) – solvent spread on a fused silica sample (c)

These artifacts are relevant of a tip problem; the tip can be charged with liquid when scanned over the surface. To be sure that these artifacts are linked to the presence of liquid on the surface, a surface with a droplet of solvent deliberately deposited on it with a micro syringe, was measured. As shown on Fig. 6c, the presence of many streaks demonstrates that this behaviour of the tip is linked with the existence of a liquid film. Nevertheless, as this kind

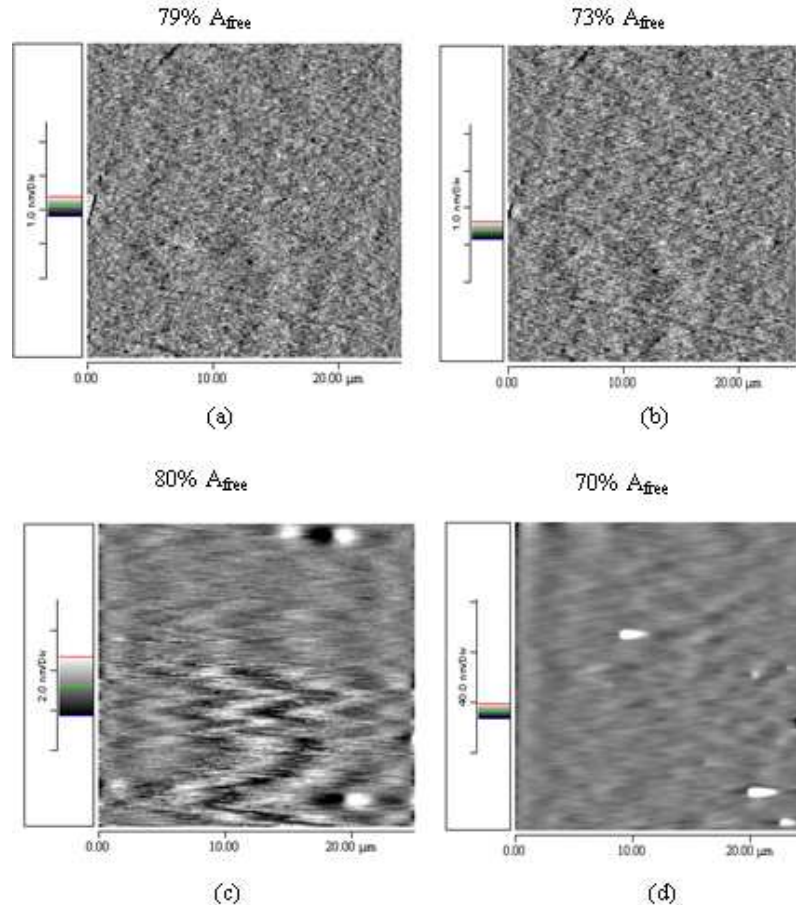
of pictures can also be attributed to the fact that the approach of the tip is not effective, complementary experiments were performed. AFM images of clean silica samples and contaminated ones were made with different set point amplitude values (Fig. 7). For 79% or 73% of the free amplitude, respectively images a and b of Fig. 7, clean bare silica surface is well distinguishable. We found the same root mean square roughness certified by the manufacturer. On contaminated samples, for low forces (80% of the free amplitude, Fig. 7c) the tip generates streaks and for higher force (70% of the free amplitude, Fig. 7d), the silica surface is still not apparent. Indeed, at the end of the measure, after the withdrawal step, the natural oscillating amplitude of the tip has decreased of about 20 nm and a shift of natural frequency was noticed. In normal conditions, the natural oscillating amplitude and frequency come back to the ordered values at the end of the withdrawal.

Fig. 7. AFM picture of bare silica samples after cleaning (a and b) and after contamination (c and d) for different set point amplitude values

In a similar experiment, imaging droplets, Pompe [20] noticed various behaviors for trace and retrace signal as well as amplitude and resonance frequency shifts of the cantilever, depending on the chosen set point amplitude value. It was attributed to the instability of the cantilever motion against the attractive capillary forces. For small set point, a permanent liquid bridge between the tip and the liquid drop is formed. This liquid bridge is likely to alter our AFM measurements.

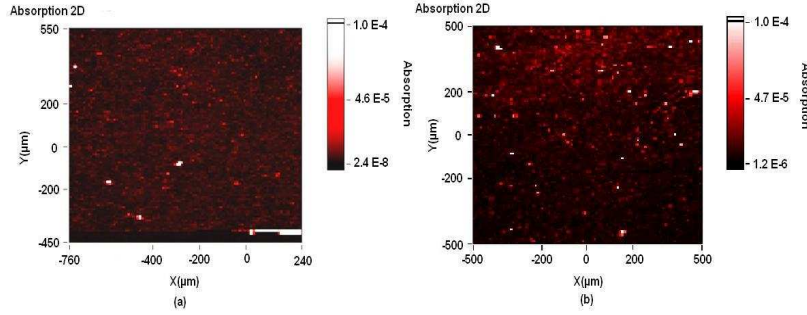
The measurements were made on various areas of the sample and two times for each kind of sample. The same result has been found each time, which indicate that the signal is independent of the liquid contamination morphology. An example of experimental measurement results is given in Fig. 8

Fig. 8. Absorption mapping of clean (a) and contaminated (b) samples obtained by photothermal deflection with a sampling step of 20 μm

For the clean sample, a mean value of $2.93 \cdot 10^{-5}$ with a standard deviation of $4.08 \cdot 10^{-6}$ was measured; for the contaminated sample, a mean value of $1.95 \cdot 10^{-5}$ with a standard deviation of $9.43 \cdot 10^{-6}$ was measured. The difference between the clean and the contaminated sample is not significant showing that contamination does not affect absorption mappings. This technique is not adapted to measure such absorption. Furthermore, the more absorbing points visible are due to micrometer sized particles on the sample. We must outline that Palmier demonstrated that particles cannot be linked to damage in similar conditions (polished fused silica samples damage tested at 351 nm) [22,23].
