The environment effect on operation of in-vessel mirrors for plasma diagnostics in fusion devices

THE ENVIRONMENT EFFECT ON OPERATION OF IN-VESSEL MIRRORS FOR PLASMA DIAGNOSTICS IN FUSION DEVICES

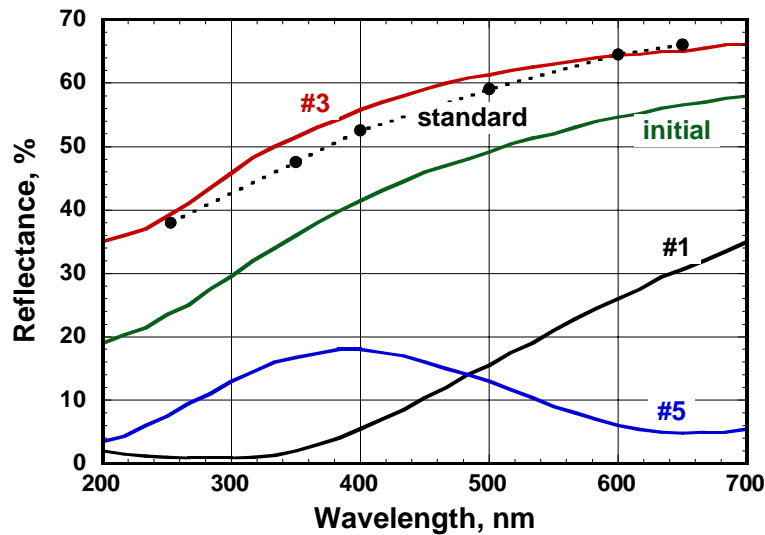
Fig. 3. Spectral reflectance of SS mirror samples before (marked as “initial”) and after exposure inside the LHD vessel (curves marked as #1, #3, and #5). Solid points show the typical spectral reflectance of a SS mirror subjected to cleaning by low temperature deuterium plasma after polishing and washing in an ultrasonic acetone bath.

The reflectance of mirrors #1 and #5 dropped strongly as a result of appearance of the contaminating films. From spectral dependence of reflectance one can conclude that the film on sample #5 is thicker than on the #1 sample. At the same time, the reflectance of sample #3 increased significantly and became close to what is usually observed when after rinsing in a

After rinsing in the ultrasonic bath the samples are cleaned by low temperature plasma of an ECH discharge in deuterium, as shown by solid points (the curve “standard”). This effect is connected with not full cleaning of all three mirrors before they were installed inside the LHD vessel from contamination by some organic film appeared due to rinsing samples in acetone. This initially existed film was fully cleaned from sample #3 due to plasma impact but became over coated by new films (to be immured) at samples #1 and #5. The high level of reflectance for mirror sample #3 measured after exposure samples in LHD was supported by very high quality of surface as follows from profilometry measurements (Fig. 4) and analysis of the SEM photos (not shown).

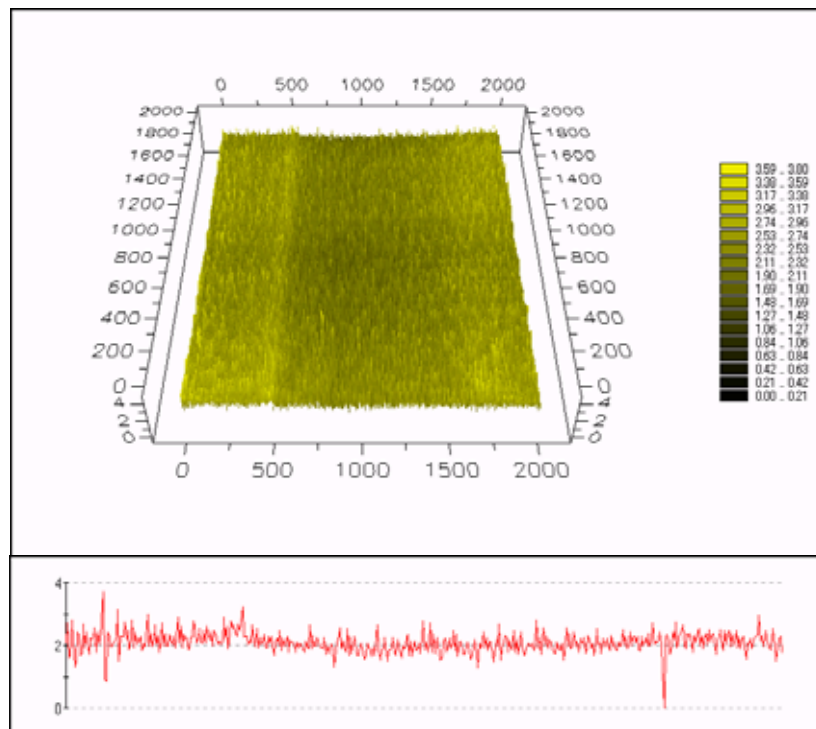
Fig. 4. Results of profilometry measurement of the surface morphology of the sample #3 after exposing in the LHD.

The mirror placed in the nearest location to the hot plasma became to be cleaner than it was initially. The full erosion of this sample found by measurement of the surface profile did not exceed $0.15\mu\text{m}$. Such small net erosion seems surprising if one takes into account the long time of glow discharge conditioning and large number of working discharges. Probably the balance between sputtering by CXA during working discharges and by plasma ions during conditioning, on the one side, and contaminant deposition, on the other side, was almost zero, only with minor preponderance of sputtering erosion over deposition.

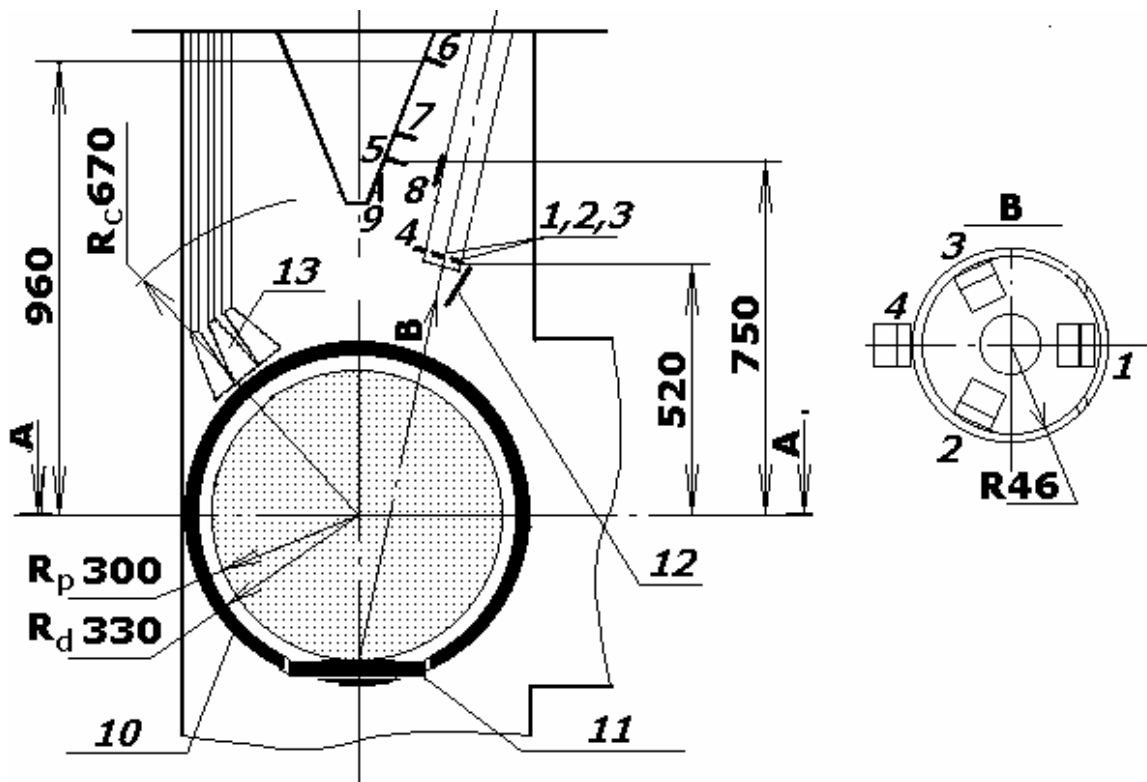
Fig. 5. The layout of experiments in T-10.

1-9 – mirrors (note, mirror #7 is in the shade of mirror #5), 10 - ring carbon based limiter, 11 - movable graphite limiter, 12 - shutter, 13 – ECRH antenna. R_c – radius of toroidal magnetic coils; R_p – plasma radius; R_d – radius of ring limiter.

Polished mirror samples of SS316 (10×10 mm² and 20×20 mm², 4 mm thick) were used for experiments. They were exposed in diagnostic port of limiter section of T-10 at different distances from plasma as shown in Fig. 5 [6].

Thin SS shield protected a part of each sample with ~ 0.1 mm gap between shield and mirror surface. Samples fixed in 1-3 positions were shutter-protected during vacuum vessel (VV) conditioning. The positions of mirrors 1-6 were frontal to plasma. Besides, in 2003 mirrors 8-9 were placed edgewise to plasma and one mirror located in frontal position, 7, was shadowed by sample 5.

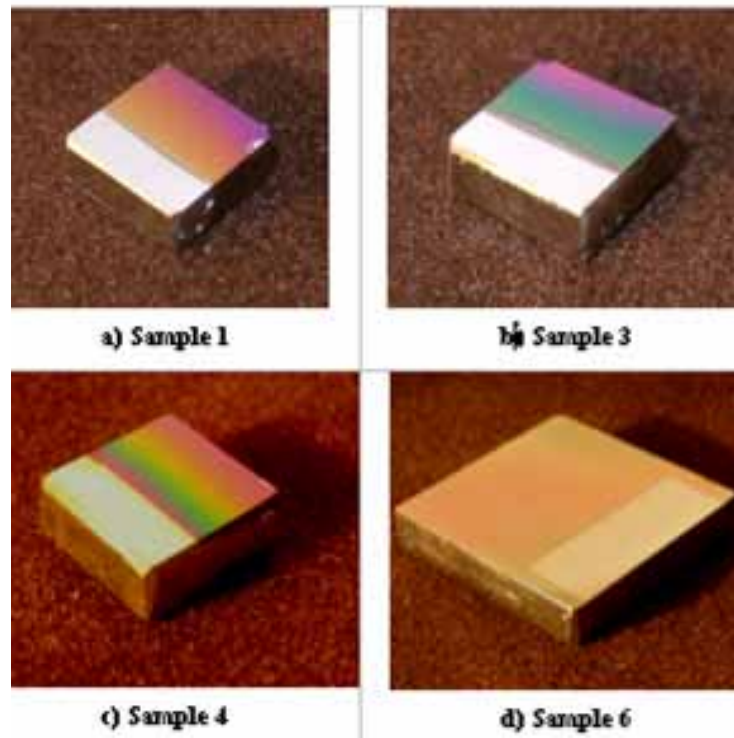
Fig. 6. Photos of samples after finishing the 2002 year campaign. Lighter parts of mirrors were closed during whole exposure time. The deposit has quite homogenous, fine-dispersed structure. On mirrors protected by shutter during conditioning it grew with the rate 0.2 nm/s in 2002 and 4 nm/s in 2003.

looked shining and smooth and the color of deposits varied from golden-crimson to violet-green. The screened parts of mirrors practically did not changed by sight, Fig. 6. The deposits not only decrease the reflectance of mirrors but also distort the spectrum of reflected radiation because of interference phenomenon.

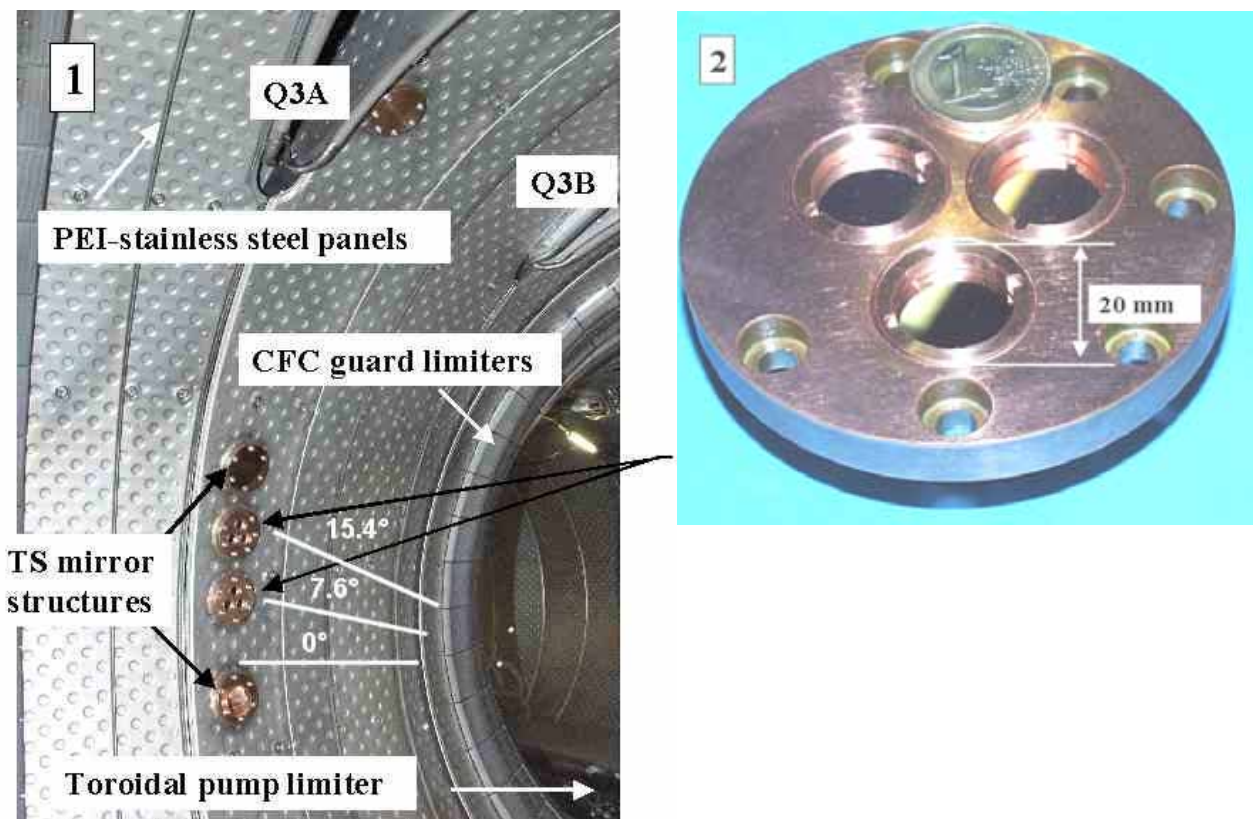
Fig. 7. Mo, SS and Cu mirror samples assembled in CuCrZr ring holders and fixed on Tore Supra vessel wall at high field side.

The mirror samples of 22 mm diameter and 4 mm thickness have been installed on the high field side of the TS plasma vessel. They were located at $\theta = 7.5^\circ$ and 15° out of the equatorial plane (Fig. 7) and positioned roughly 140 mm from the LCFS. The reflecting surface of all mirrors were oriented parallel (not inclined) to the toroidal field direction. The mirror assembly allowed contact cooling via the first wall steel panels. 2D- thermohydraulic finite element calculations of the mirror sample assembly showed temperatures not exceeding $\sim 150^\circ\text{C}$ for a typical “Gigajoule” operation scenario (~ 1 MW radiated plasma power loss during 36 s of pulse length).

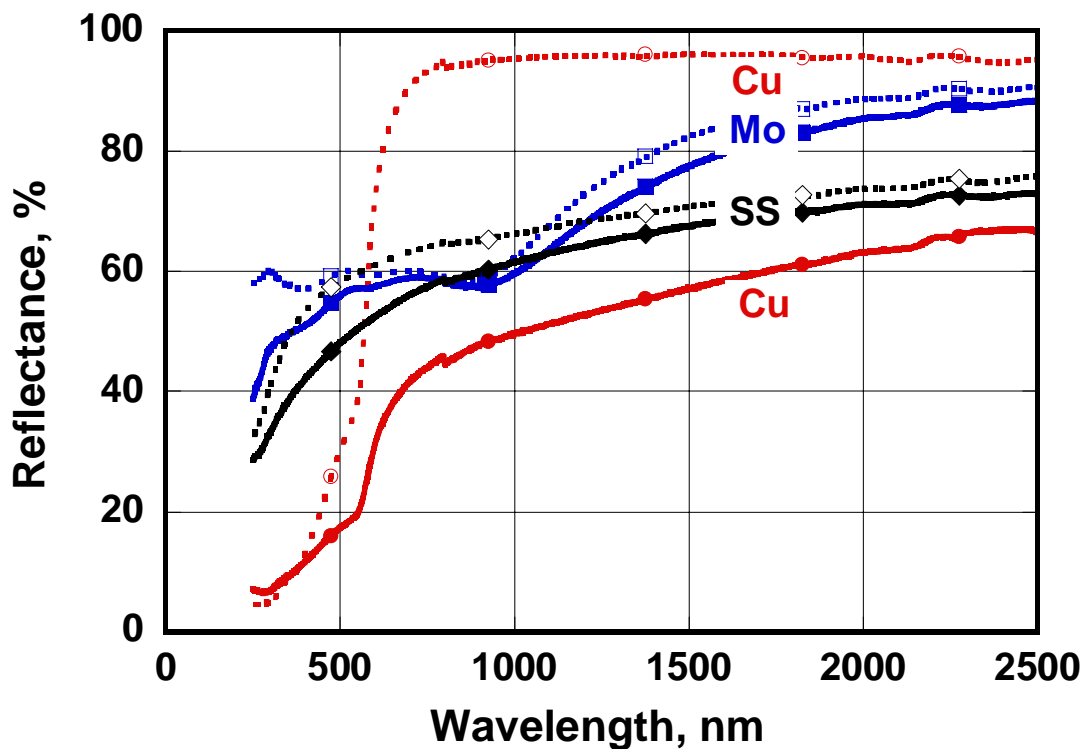
Fig. 8. Reflectance of mirror samples before (dotted lines) and after (solid lines) exposure inside Tore Supra.

Total and diffusive reflectance values were measured before and after exposure in the Tore Supra tokamak by means of a spectrophotometer ($\lambda=250-2500$ nm) and significant change of reflectance was observed for all samples, but especially for Cu, as Fig. 8 shows. From measurements by con-focal microscopy the surface roughness of the Cu mirror samples after exposure increased by factor 7 and a net erosion profile depth amounted $\sim 2.8 \mu\text{m}$, while the surface roughness of the sc Mo samples did not change with a net erosion profile depth only $\sim 0.12 \mu\text{m}$.

It was found that all exposed mirror samples became not only eroded but also coated with some deposited layers what is the main reason for change of the total reflectance.

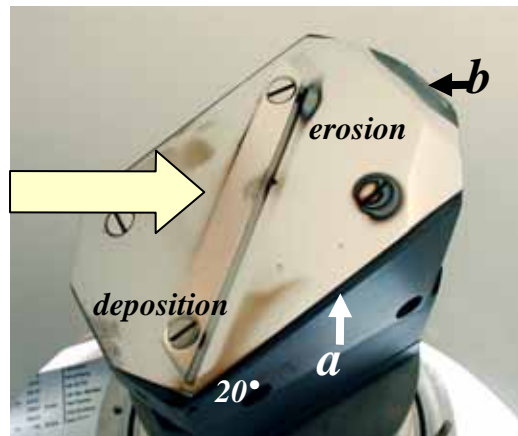
Fig. 9. Photograph of the mirror holder after exposure in the erosion dominated zone. The large mirror (a) is mounted 20° inclined on the graphite carrier, the small mirror (b) on the rear side perpendicular to the toroidal direction.

Polycrystalline mirrors from molybdenum were placed in the SOL plasma of TEXTOR [10]. The photograph in Fig. 9 shows the experimental set-up and the appearance of mirrors after exposure. One large mirror (115mm x 74mm) was fixed inclined at 20° to the toroidal fluxes. The mirror was partly protected by an aluminium bar which created a shadow. Outside the shadow some deposition becomes visible. One small mirror was placed for comparison at the rear side of the holder perpendicular to the toroidal direction. All mirrors were polished mechanically and had optically been pre-characterized.

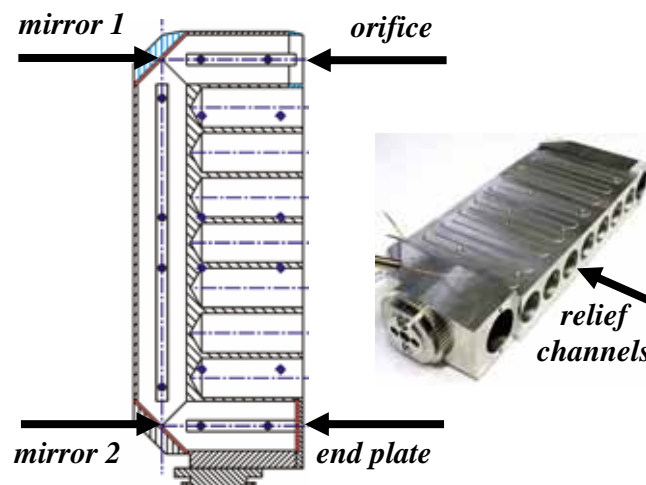
Fig. 10. Periscope system with mirror 1 (closest to the plasma), mirror 2 and the end plate. The tubes (35mm) are wrapped inside with exchangeable steel foils fixed at the wall by bars. The photograph shows the stainless steel body without end plate. Relief channels reduce weight.

The set-up of a periscope-like system on TEXTOR simulates the ITER diagnostic ports transmitting the plasma radiation to further distant sensors. Two plane mirrors were installed in tubes facing each other at a distance of 275 mm. The mirrors are oriented 45° with respect to the line of sight. The orifice (35 mm diameter) is oriented perpendicular to the toroidal direction.

The second end was closed with a polished end plate as is shown in Fig. 10. The SOL fluxes hit the first mirror under 45°. Carbon transport inside and deposition can be investigated after dismantling of the system. The deposition patterns on exchangeable steel foils wrapped inside the tubes complete this information. The stainless steel body can be heated up to about 500°C. Mirrors made from TZM (99% Mo, 0.1% Zr, 0.5% Ti) were used for the pilot experiment. The edge closest to the plasma was kept at 25 mm from the LCFS and the system exposed to 89 (partly neutral beam heated) plasma pulses ($n_e = 1.5$ to $4.5 \times 10^{19} \text{ m}^{-3}$) with a total plasma exposure time of 1047 s. The temperature was 150 °C.

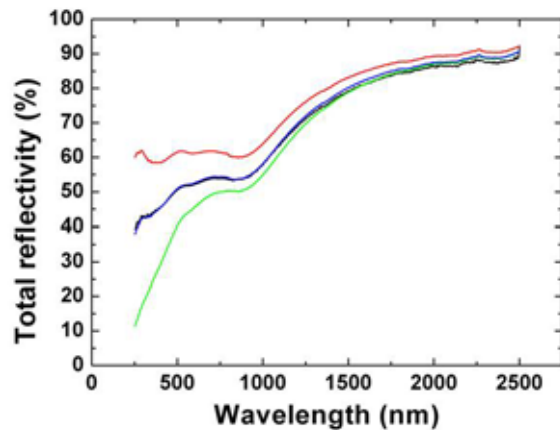
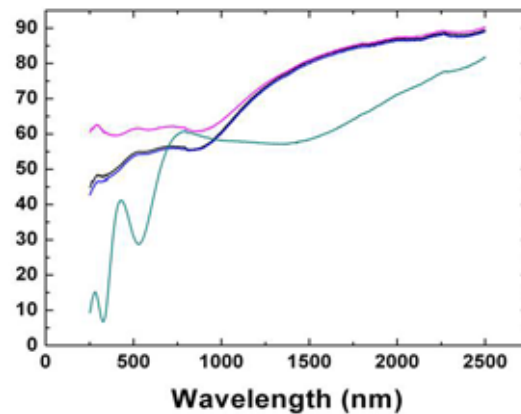
Fig. 11. Total reflectivity R_{tot} depending on wavelength measured on the molybdenum mirrors before and after exposure in a protected area (1) and after exposure in the deposition (2) and erosion (3) area. The mirrors (a) were exposed for 197 s in the erosion dominated zone (edge at LCFS+8mm) and (b) and for 312 s in the deposition dominated zone (edge at LCFS+25mm).

space resolution of ≈ 10 mm. Fig.11 shows examples for the wavelength dependence of the total reflectivity R_{tot} found on the two large mirrors. The central curves (1) represent the total reflectivity measured before and after plasma exposure at a location protected by the aluminum bar. The lines stay below the values given for polycrystalline molybdenum in literature [11]. As soon as deposition begins (curve 2 in Fig.11a) the reflectivity decreases by absorption in the film (thickness ≈ 30 nm). The drop is most pronounced in the UV region and levels off in the IR. In addition to absorption, the reflectivity can be distorted significantly due to destructive and constructive interference in thicker deposits. The example (curve 2, Fig. 11b) was measured on the mirror plate exposed deeper into the SOL (LCFS+25mm) where carbon deposition dominates and a film up to about 220 nm thickness was formed.

Surprisingly, an increase of R_{tot} was measured on surface areas which suffered from net erosion (curves 3). The increases are similar, independent whether the target mirror was exposed near the plasma edge (Fig. 11a) or deeper into the SOL (Fig. 11b). This increase is most pronounced ($\Delta R_{\text{tot}} \approx 10\text{-}20\%$) for short wavelengths and almost vanishes (1-3%) beyond about 1500 nm.

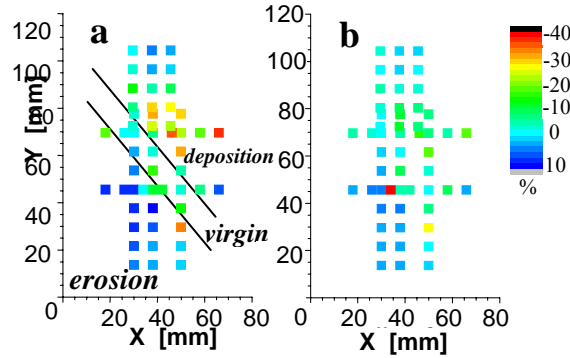
Fig. 12. Differences $\Delta R_{\text{tot}} = R_{\text{after}} - R_{\text{before}}$ given in colours at different surface locations for $\lambda=250$ nm (a) and 500nm (b). The co-ordinates x and y cover the mirror dimension (74mm x 115mm).

exposure the local changes were much larger. Fig. 12 shows the N differences $\Delta R_{\text{tot}} = R_{\text{after}} - R_{\text{before}}$ measured on the mirror exposed at LCFS+8mm. The differences are highest for $\lambda=250$ nm (a) and achieve more than +12% (dark blue) in the eroded part of the mirror, while reductions of -30% (deep red) occur in areas covered with deposits. In protected or shadowed areas ΔR_{tot} is in the scatter range ΔR observed before exposure (blue green). For increasing wave lengths (b) the changes are less pronounced. The intensity of the diffuse reflected light has also been measured at the identical locations, but contributes little since the differences do not exceed about $\pm 2\%$ on this mirror plate.

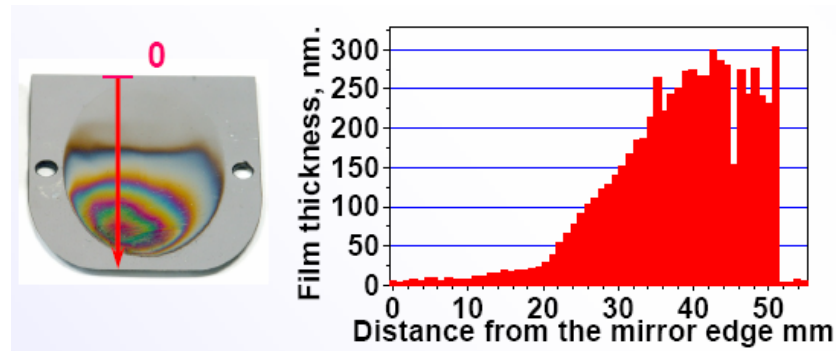
Fig. 13. The thickness of carbon-based film deposited on the mirror #1 of the periscope system.

Mirror #1 exposed in the periscope for 1047 s showed a radial decaying deposit with a maximum thickness of about 300 nm, Fig. 13, as follows from electron probe micro-analysis (EPMA). The thickness corresponds to a deposition rate of about 0.4 nm/s (inclination angle 45°). Although the deposition rate on mirror 1 is high, no detectable deposition was found on the following mirrors and walls.

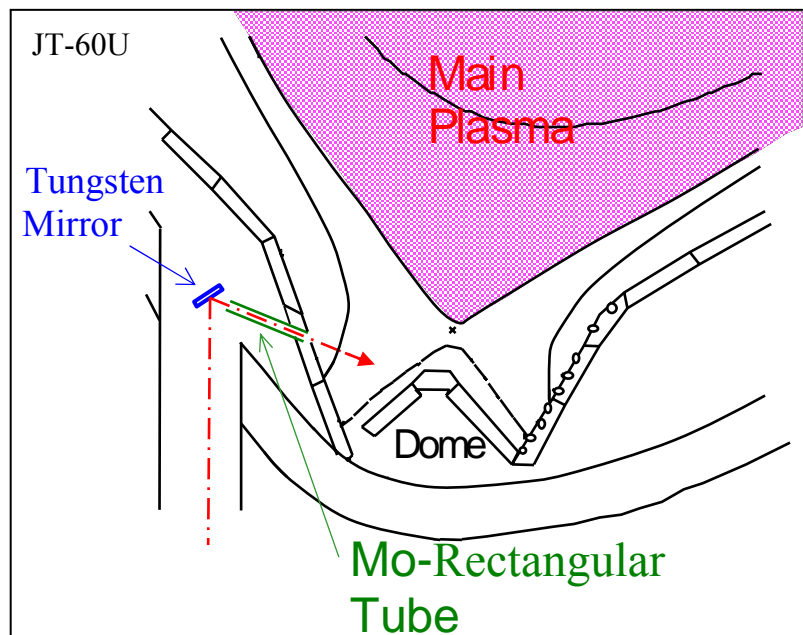
Fig.14. Disposition of W mirror for measurement of VUV and UV radiation emanating by the divertor plasma in JT-60U.

In JT-60U, a tungsten plane mirror was installed near the divertor to measure impurity lines emitted in the divertor with a vacuum ultra violet (VUV) spectrometer.

magnetic field line. The temperature of the mirror is around 300 °C since the vacuum vessel of JT-60U is 300 °C during the operation. The normal pulse length of JT-60U is about 15 sec. Under the condition, the reflectivity degradation of the mirror is not serious. VUV spectral lines can be observed with good S/N ratios after ~ 4000 shots of JT-60U.

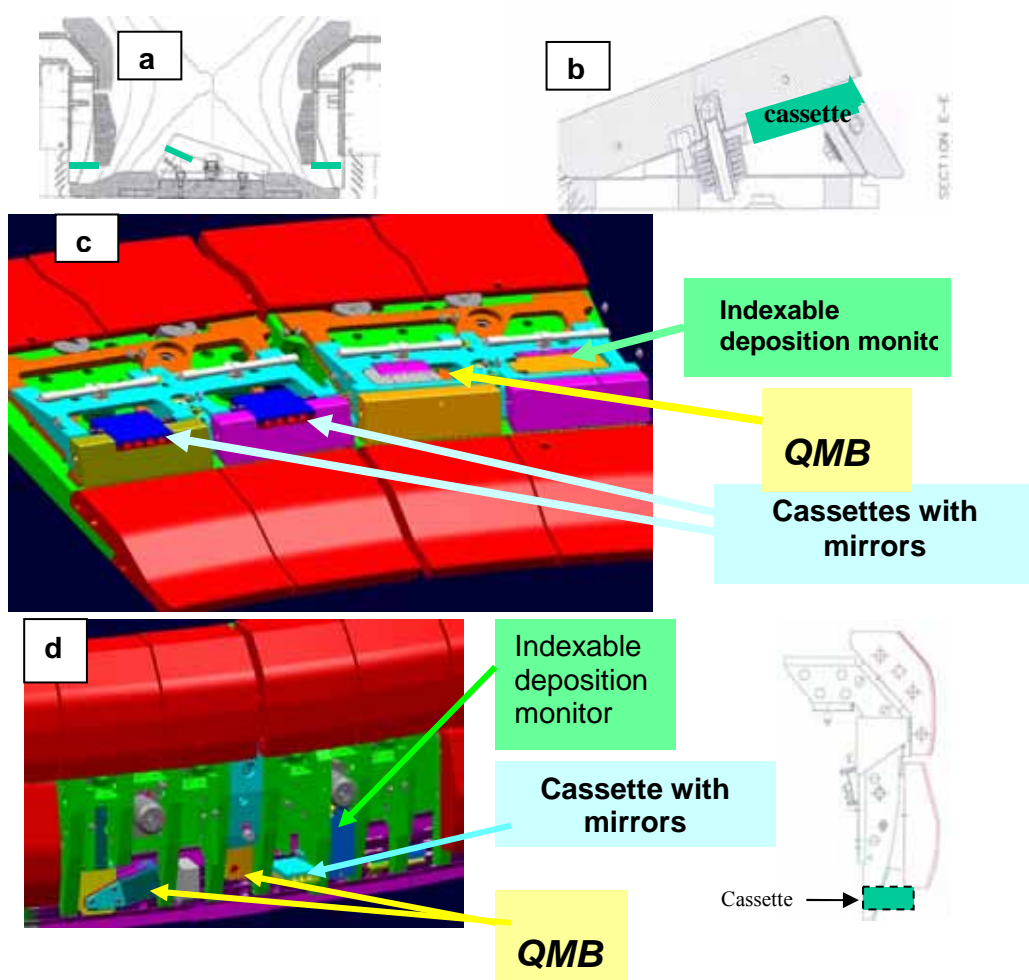
Fig. 16. (a) Divertor cross-section with a mirror cassettes (green boxes) in the inner, the outer carrier and below the load bearing plate (LBP made of carbon fibre composite); (b) base divertor module with a cassette; (c) location of several devices for monitoring the deposition mounted in the base divertor modules [Load Bearing Plate is removed]; (d) location of tested mirror and other deposition monitors in the inner divertor.

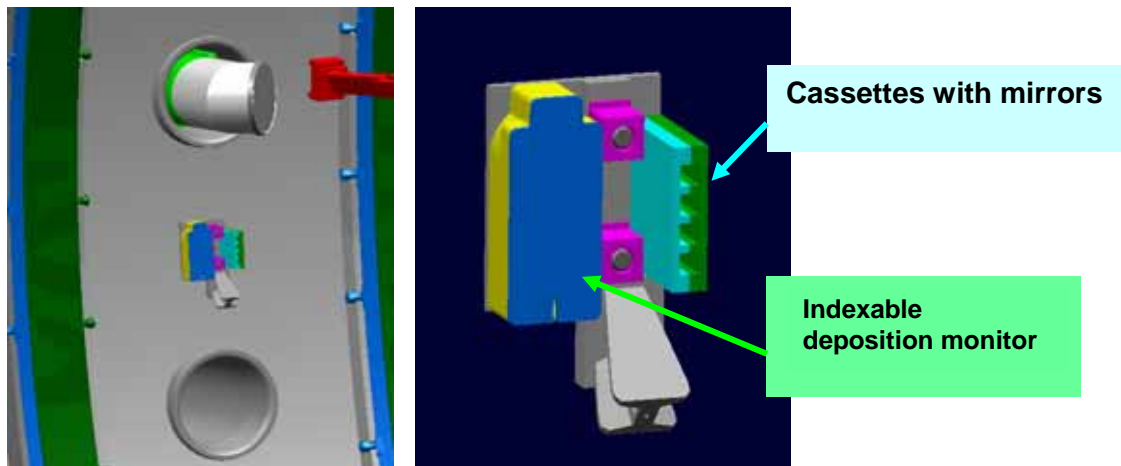
Fig. 17. Tested mirror and other deposition monitors in the main chamber wall mounted a clip (wall bracket) compatible with remote handling.
