The Morphometric 3D Reconstruction of run over accidents

Case example: morphometric 3D reconstruction of a run over accident involving an agricultural vehicle and a cyclist

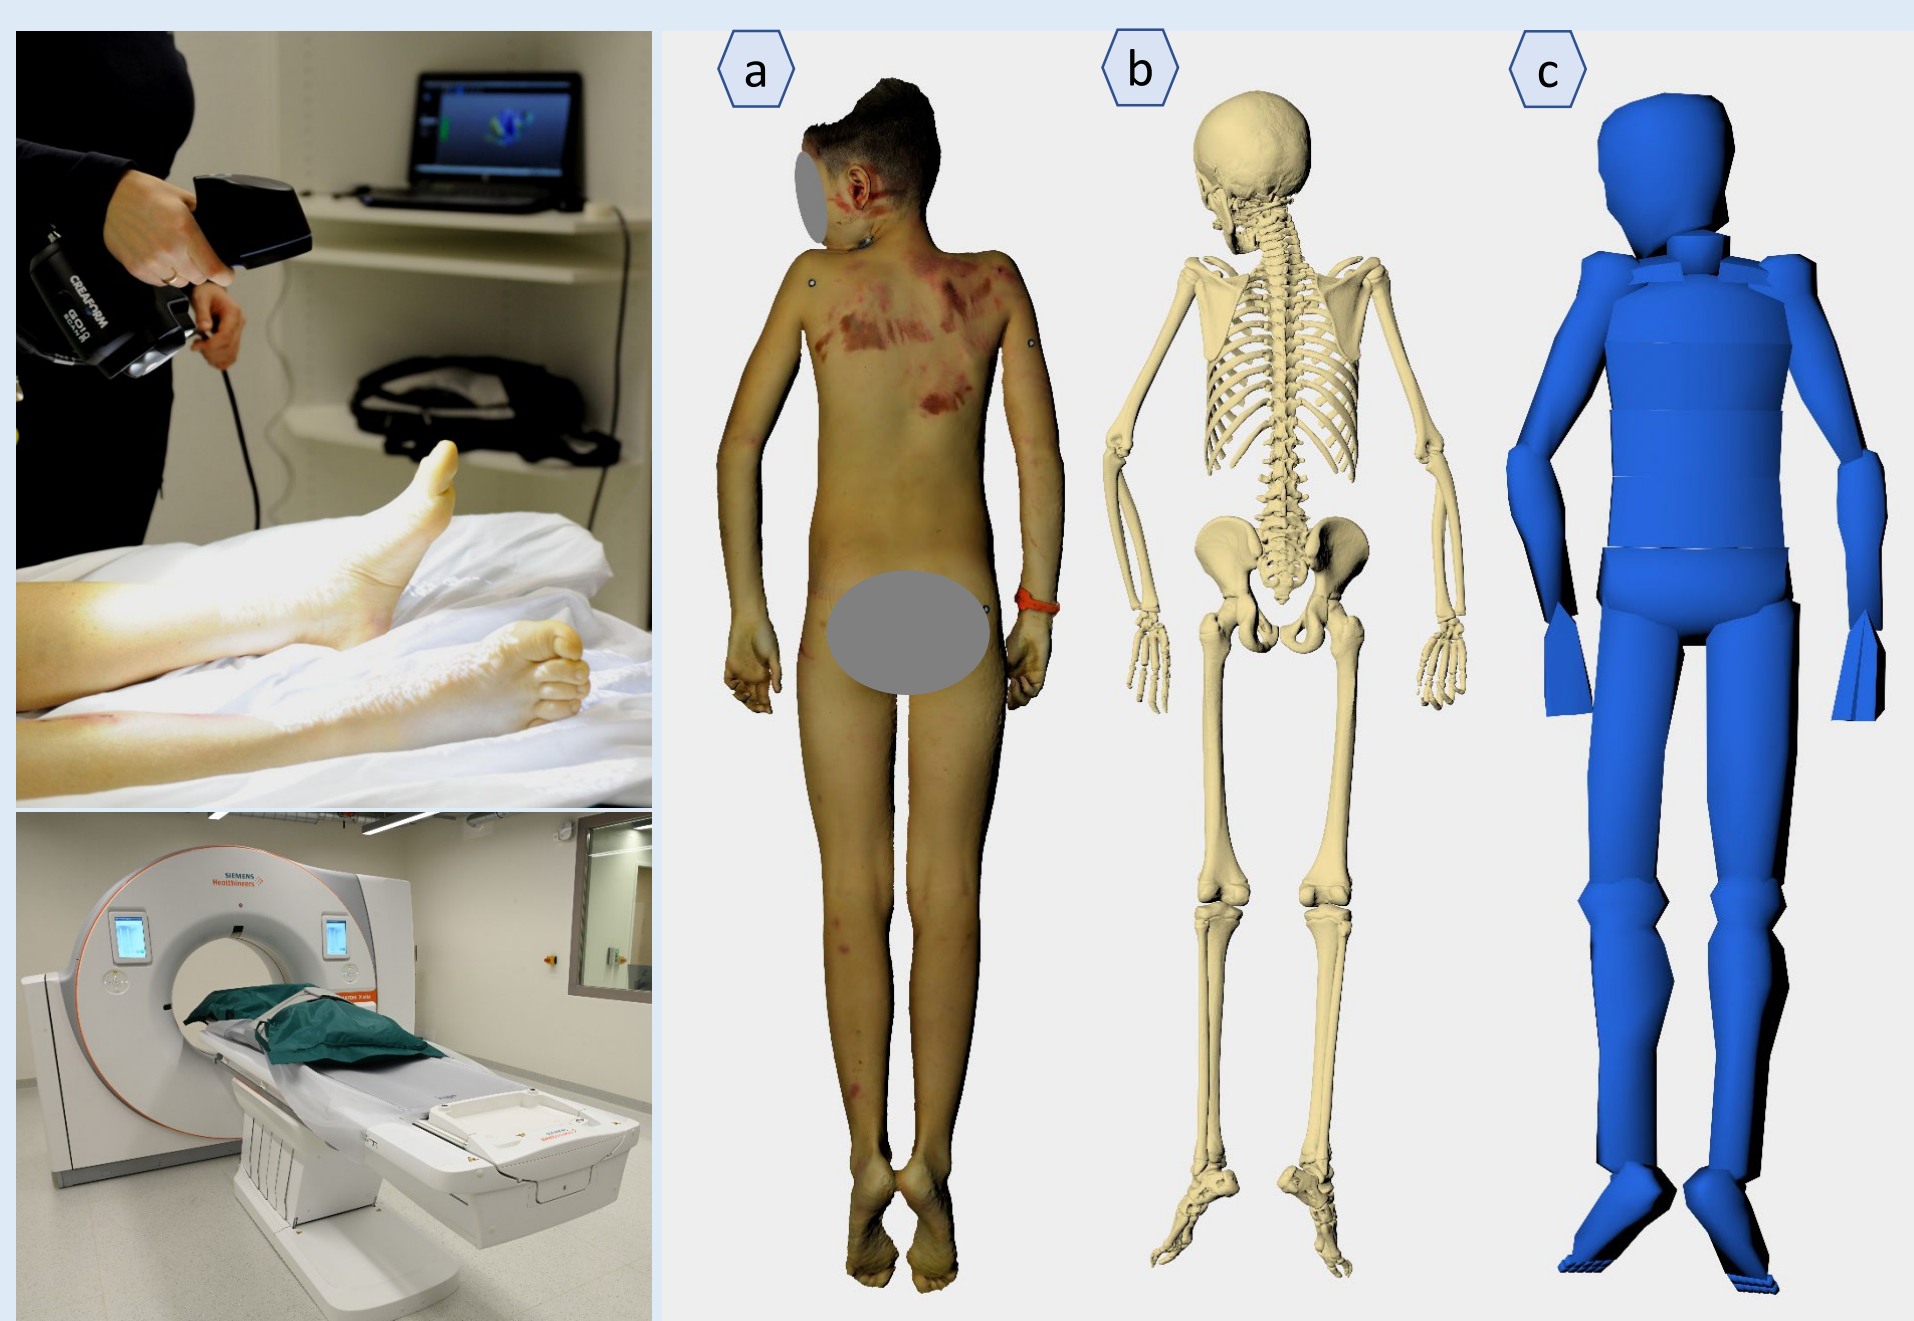
The deceased is documented using **photogrammetry and structured-light scanning** (a) as well as **computed tomography** (b). Based on this data, an individually adapted **computer body model** (c) is created.

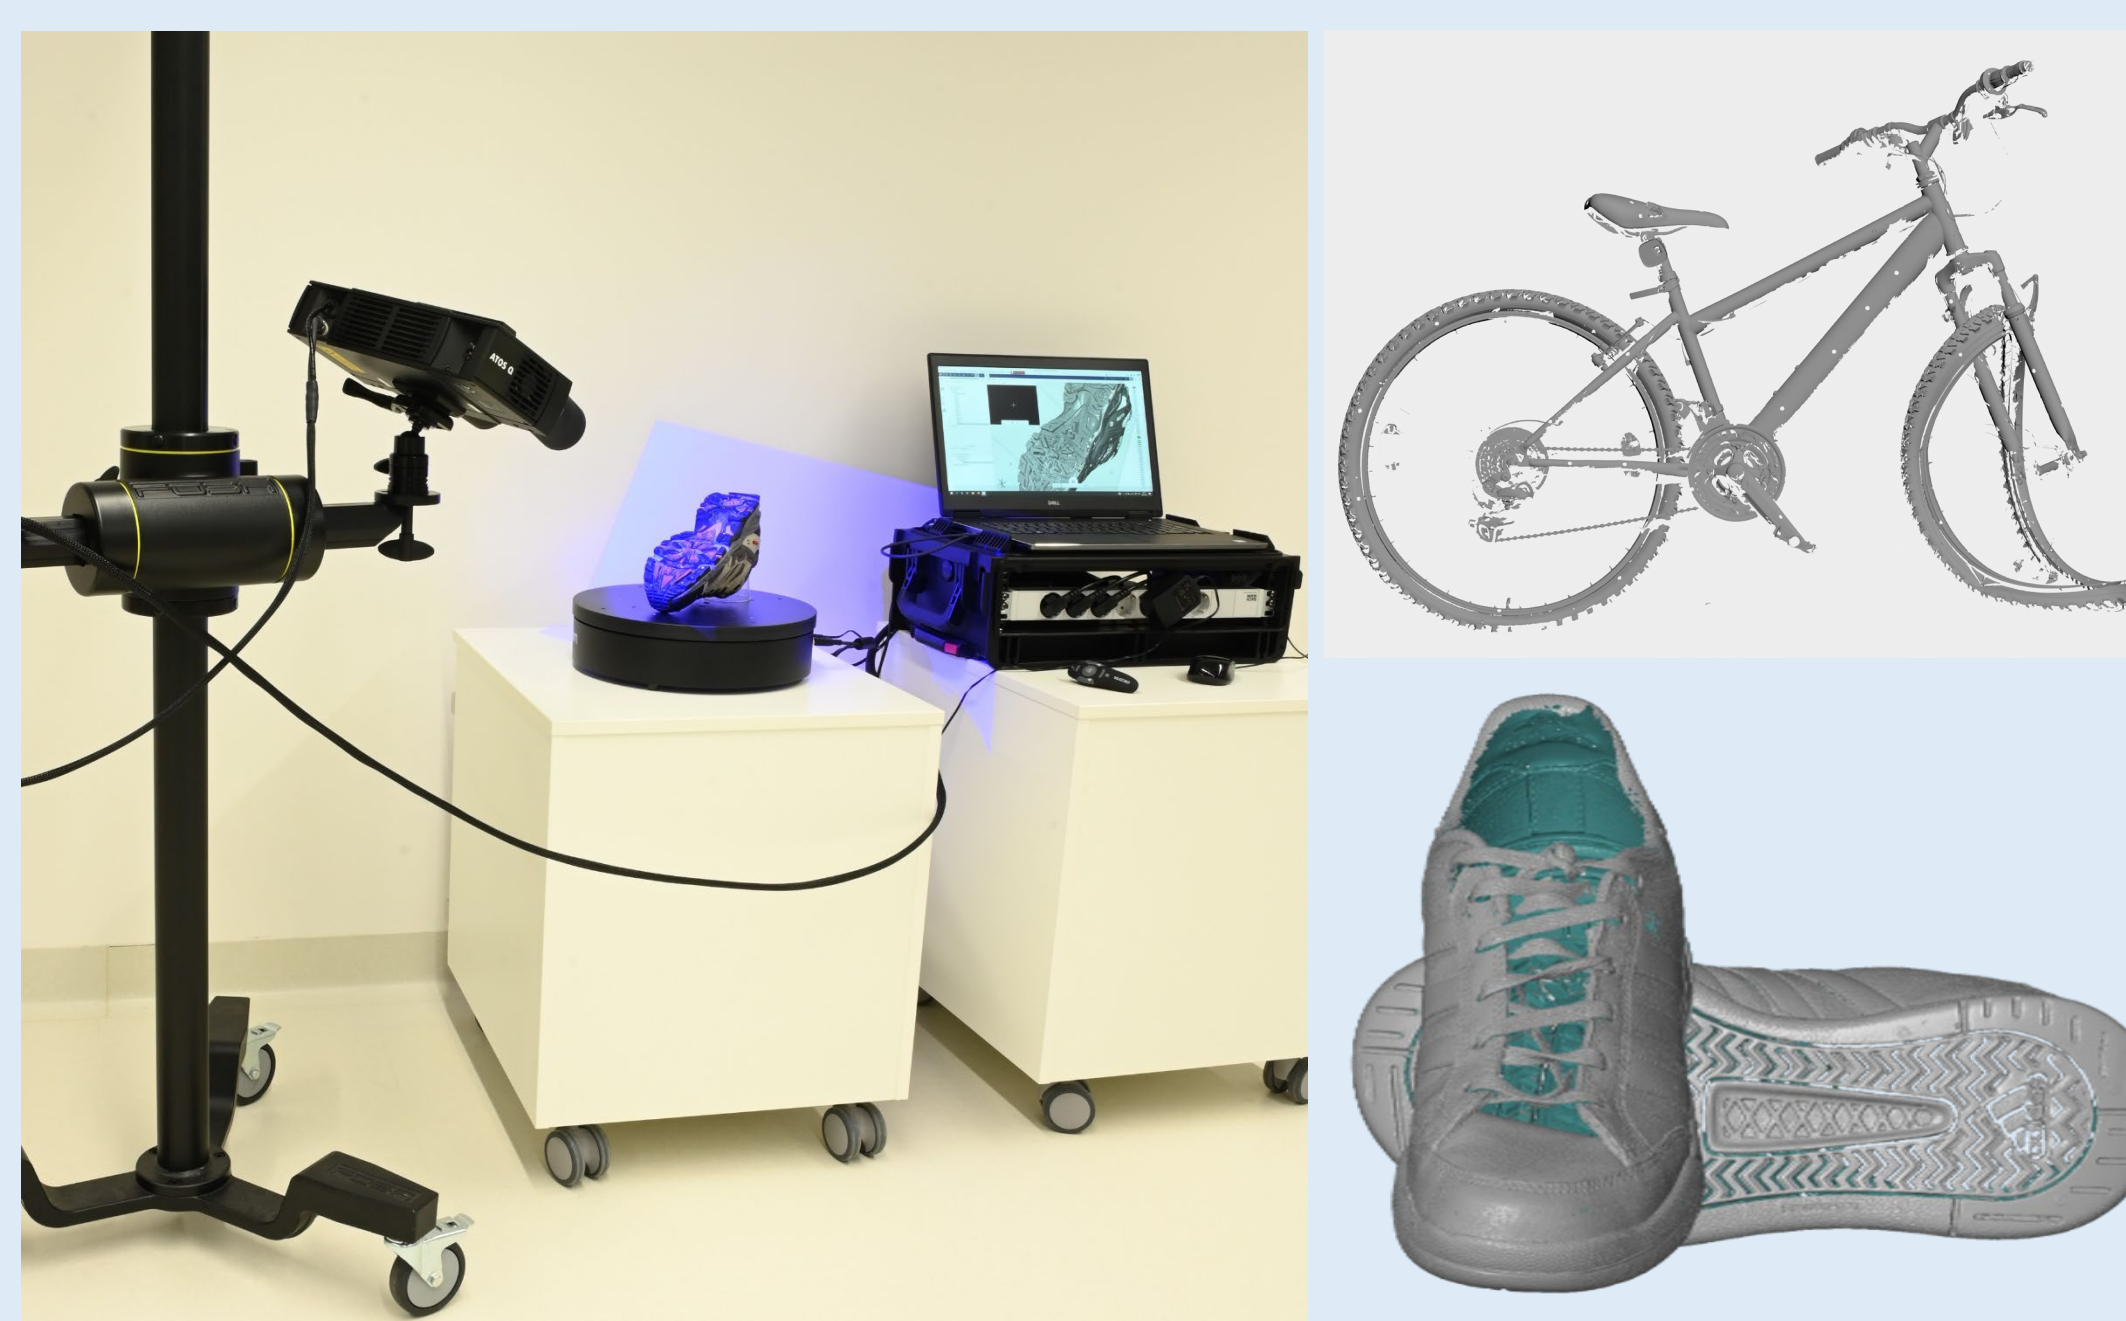
Medium and small objects such as bicycles and shoes are documented by means of **structured-light scanning** using various systems adapted to the object size and required level of detail. Standard 2D photo documentation is still a matter of course.

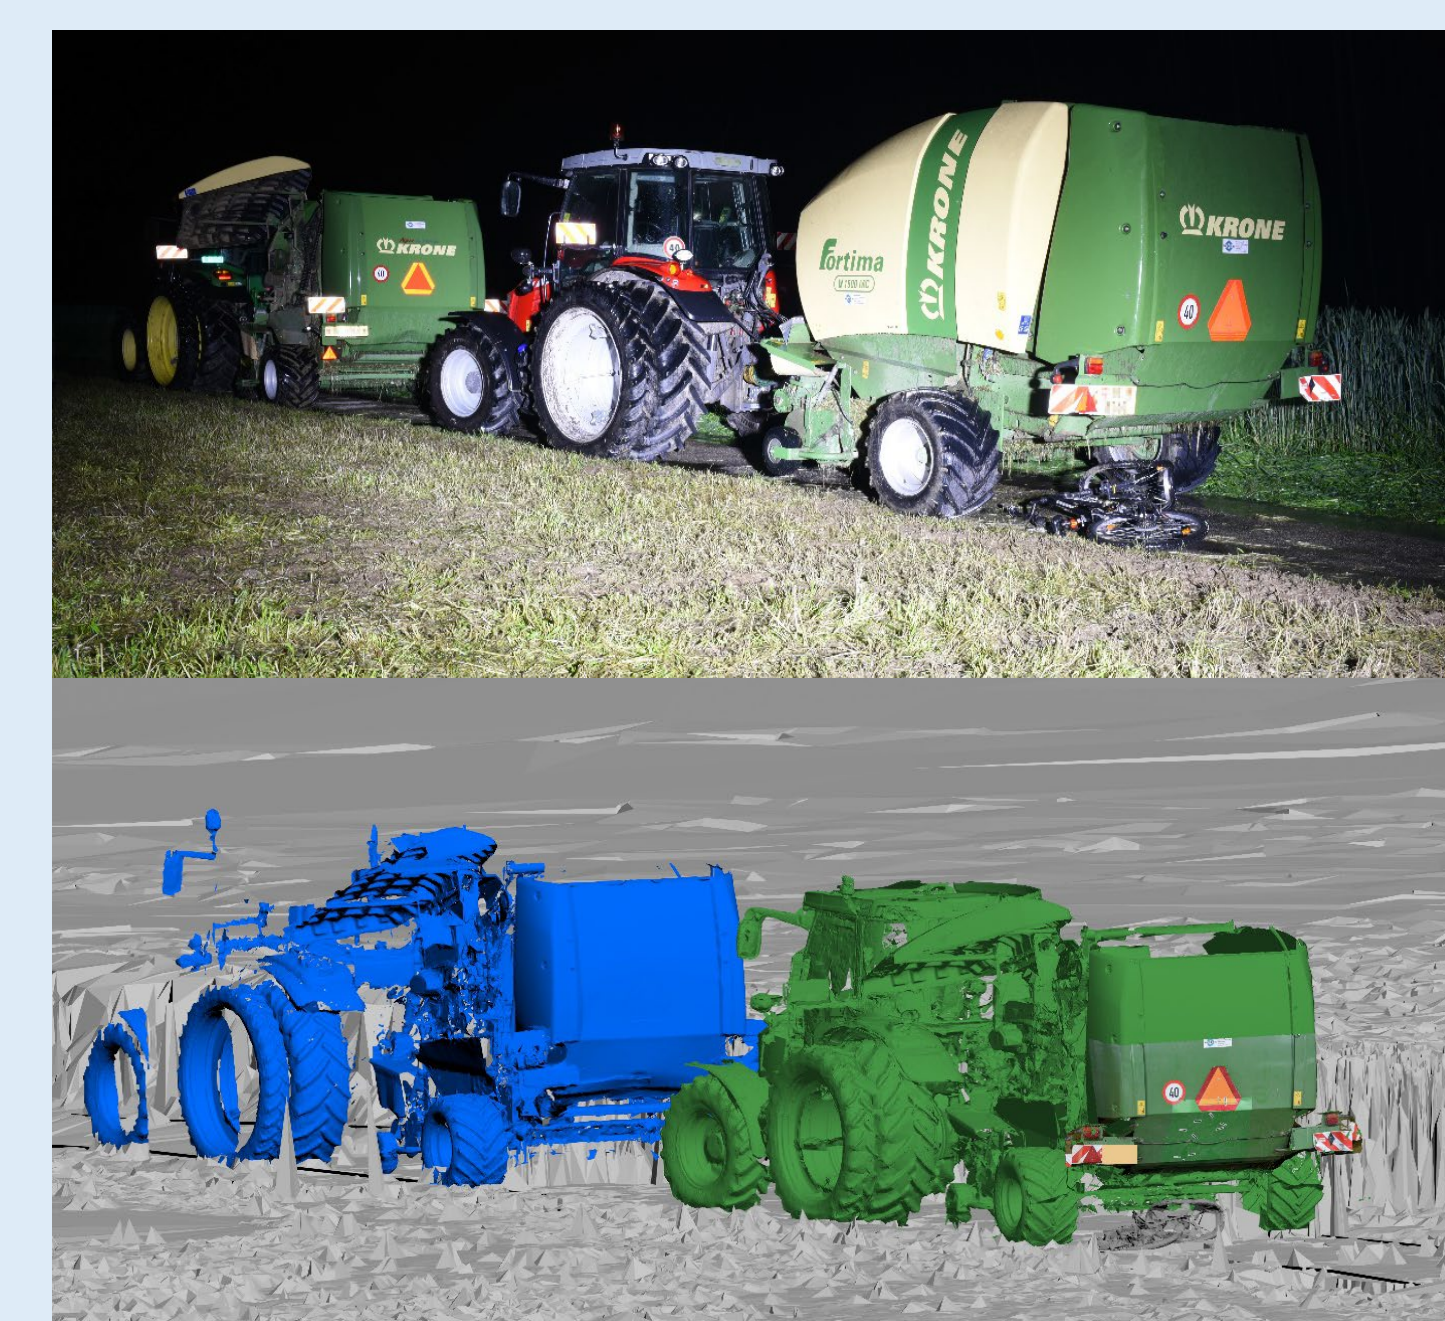
The accident site and large objects such as agricultural vehicles are documented using **laser scanning and photogrammetry**.

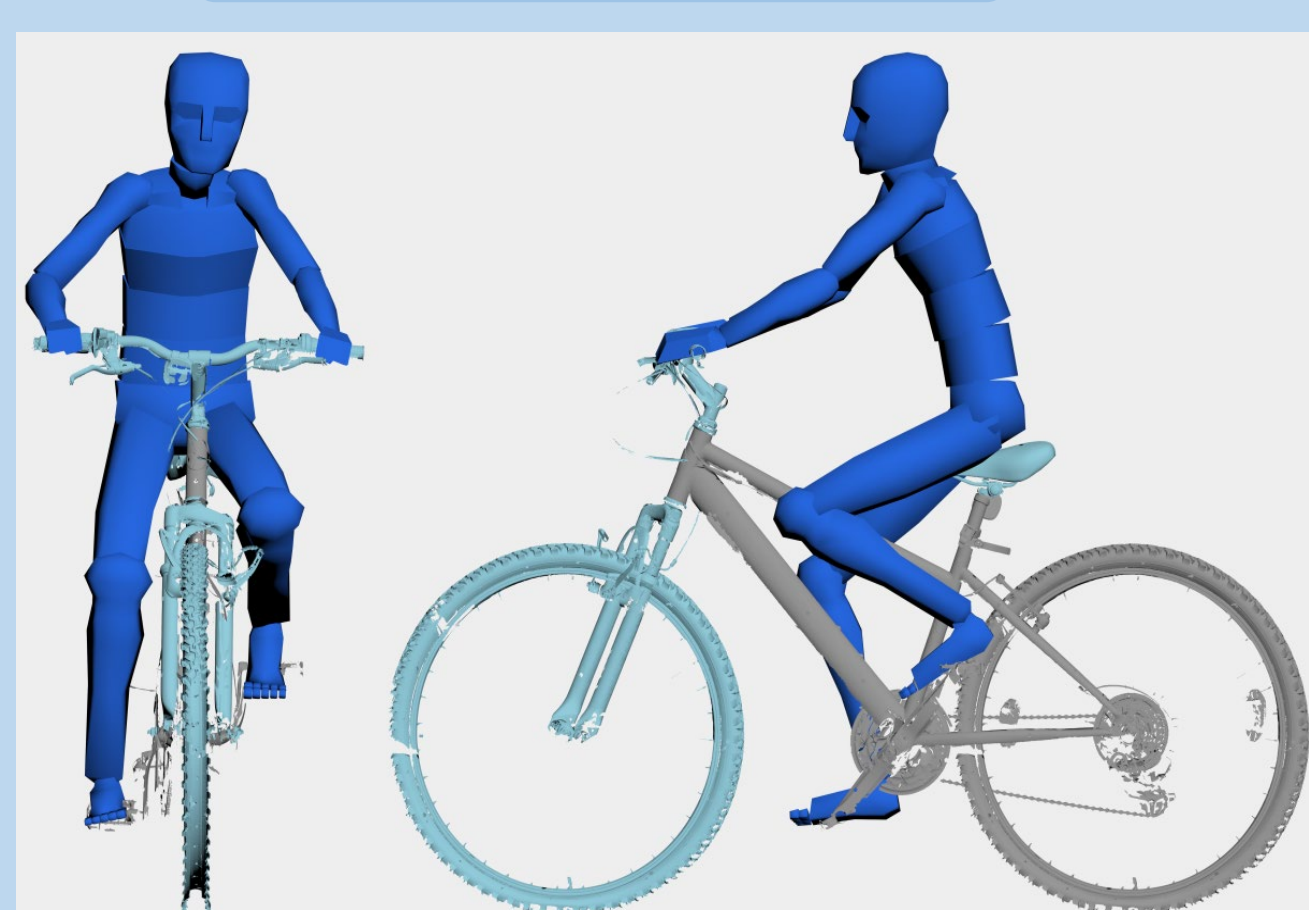
The computer body model was positioned riding the virtually reconstructed bicycle.

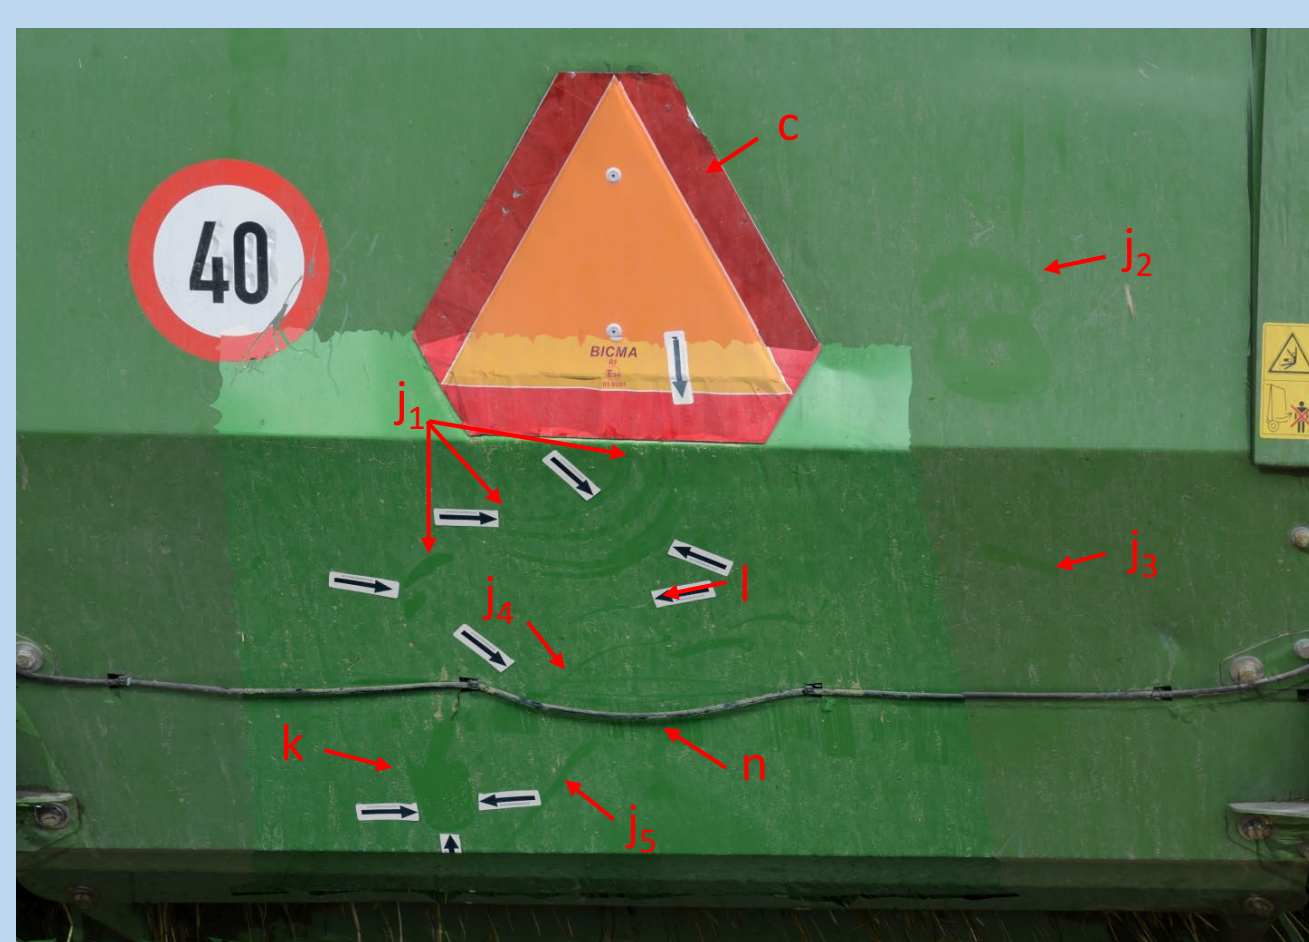
The true-to-colour 3D model of the rear of the agricultural vehicle shows patterned traces.

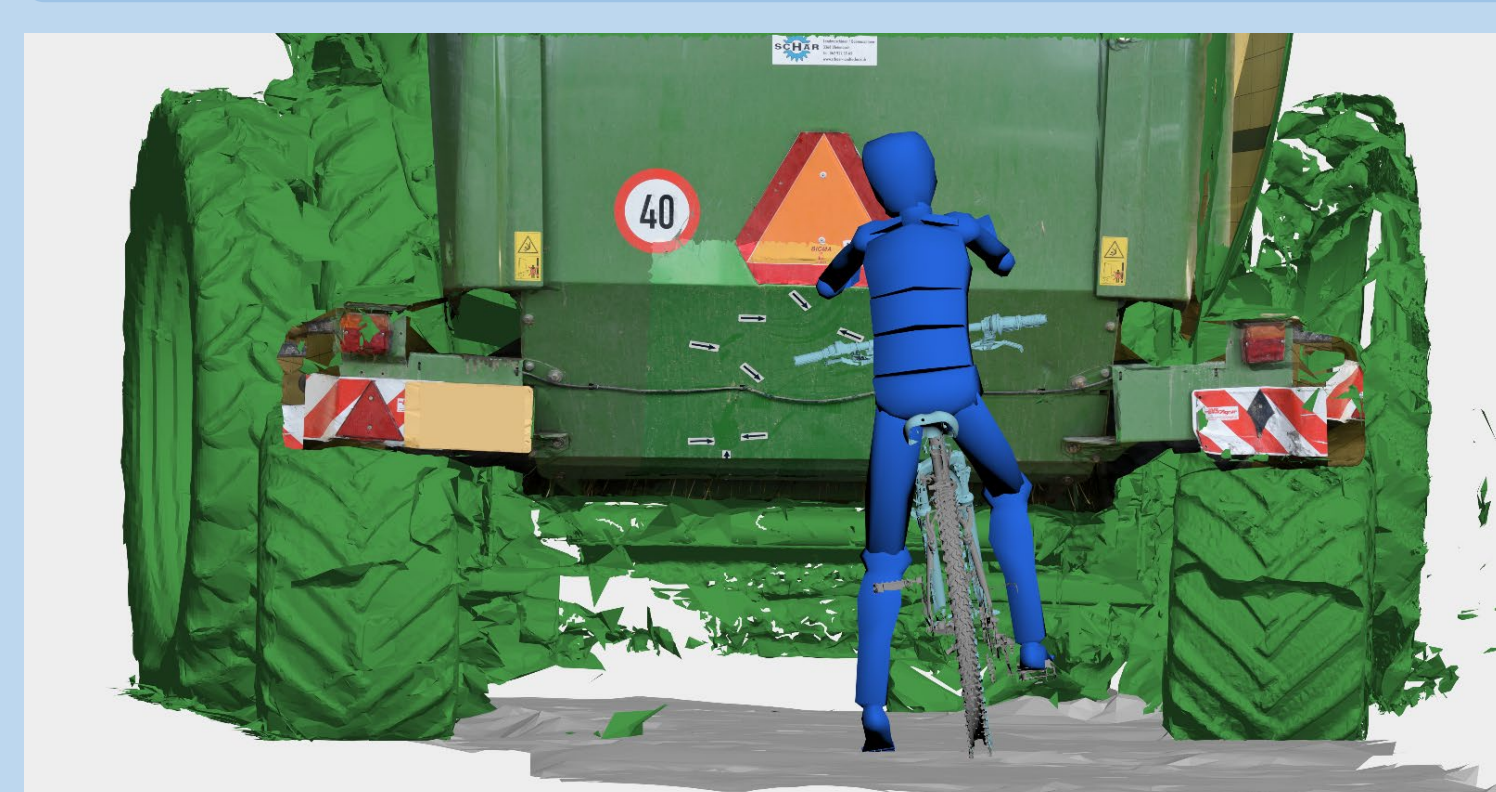
Based on the traces at the rear of the agricultural vehicle, the most probable first contact position of the cyclist was reconstructed.

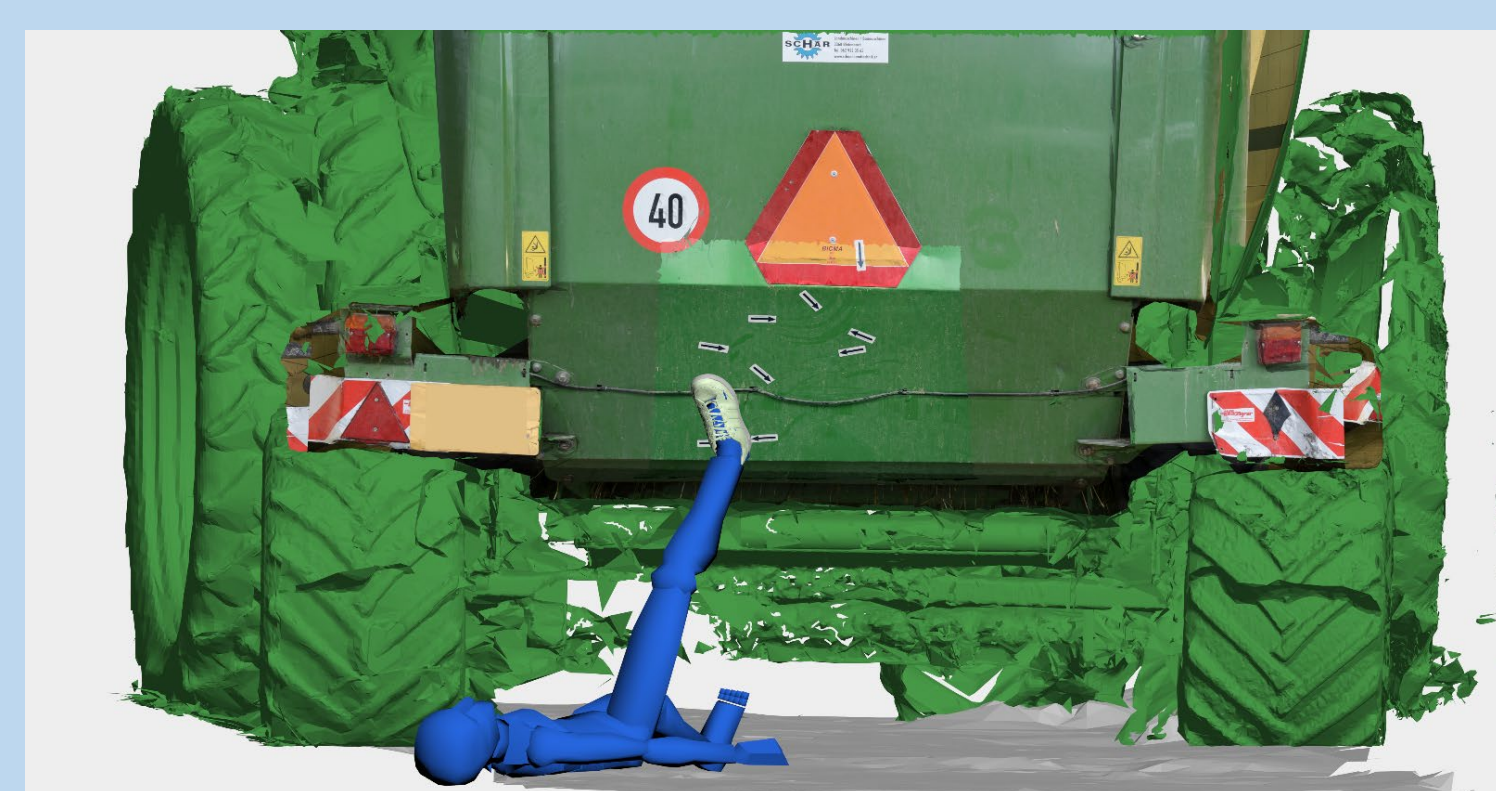
Most probable position of the victim at the time of the formation of footprint at the rear of the agricultural vehicle by the sole of his right shoe.

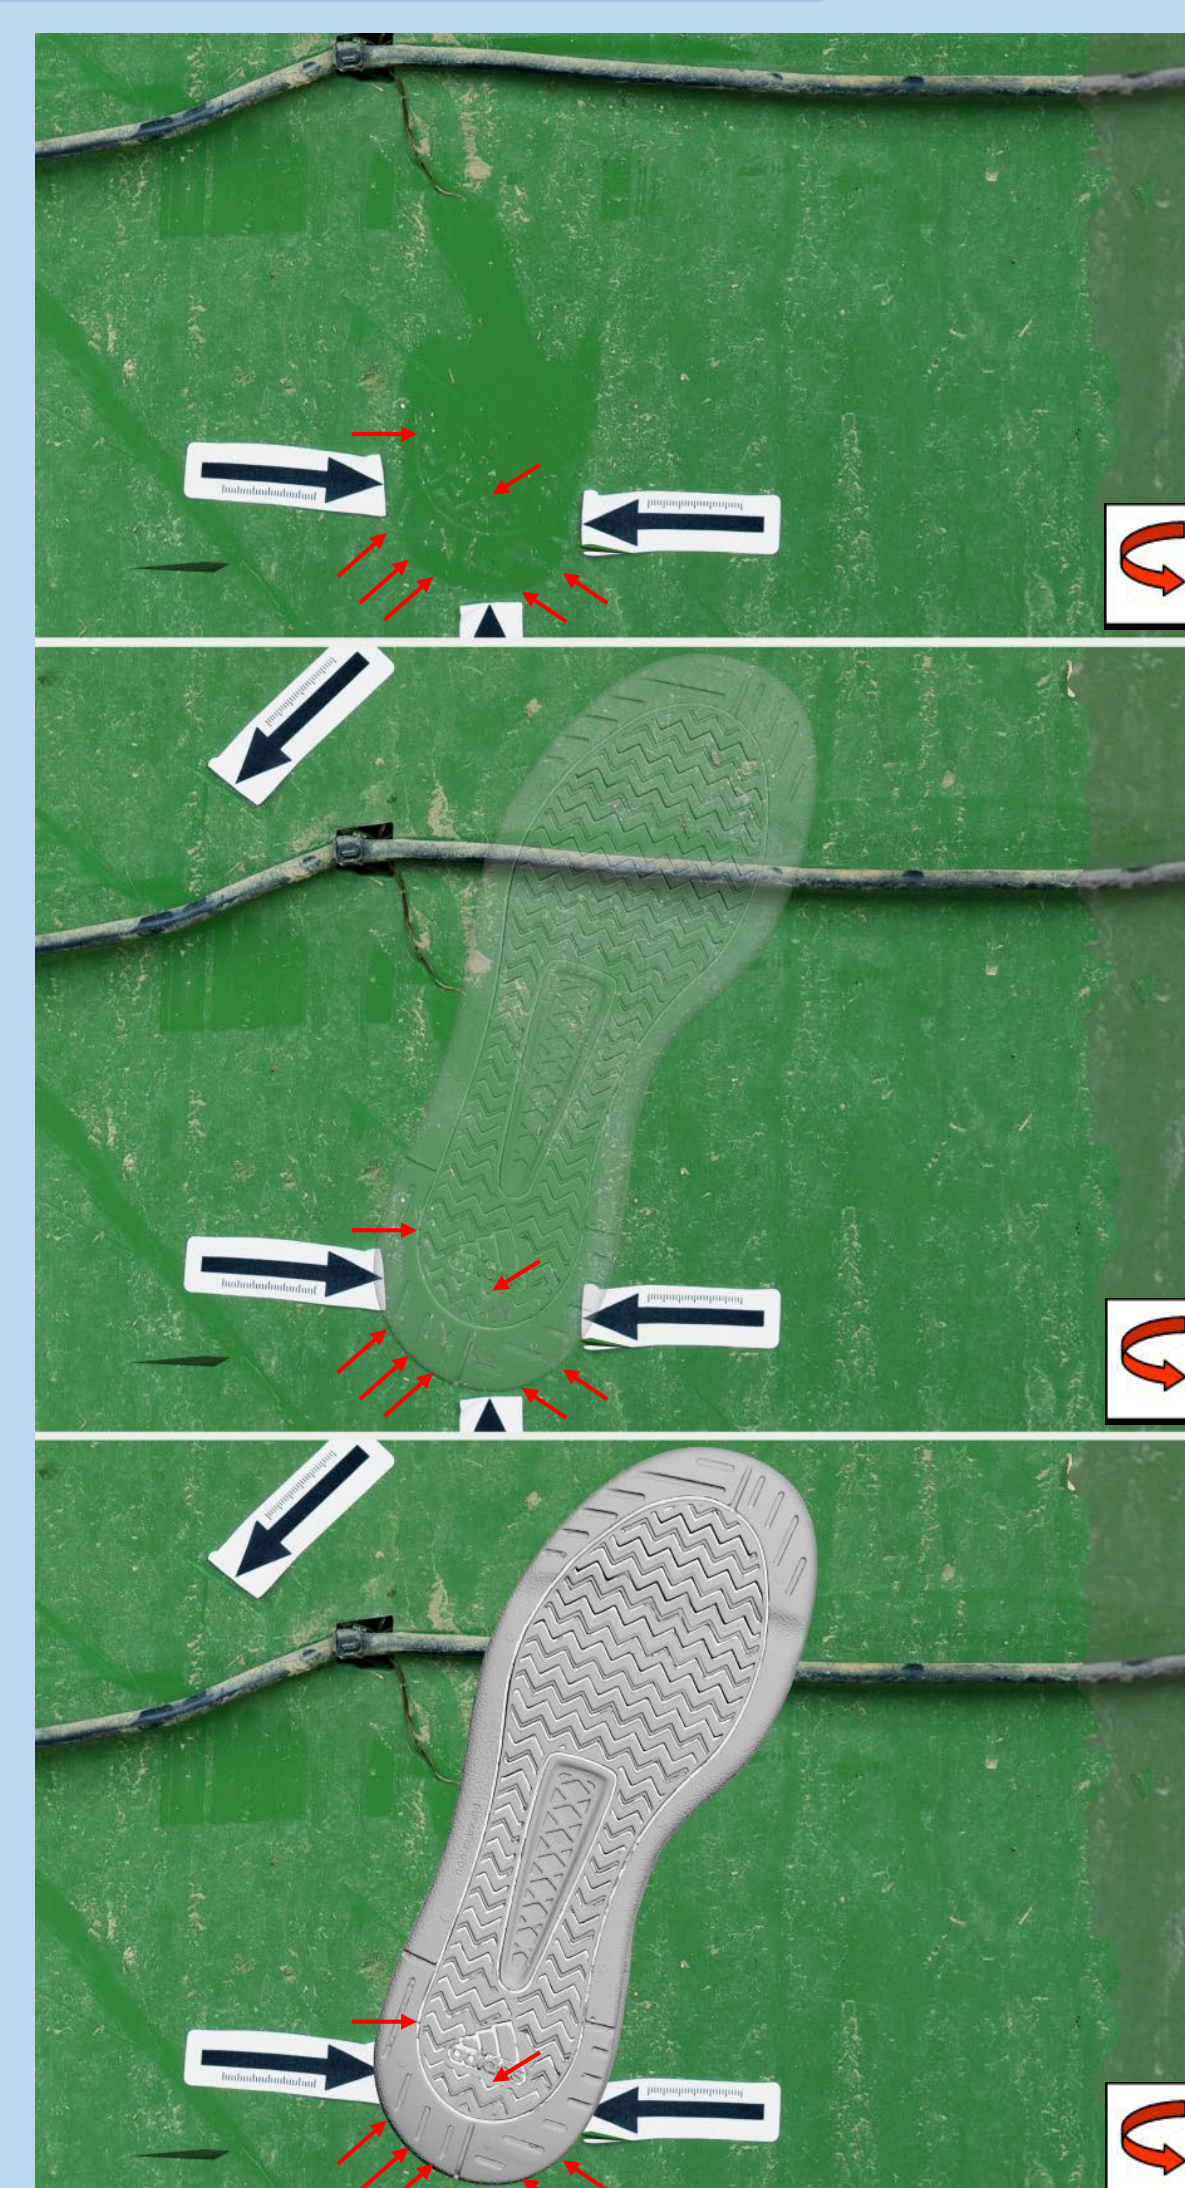
Geometric comparison of the footprint and the shoe sole. The red arrows point to the individual matching characteristics.

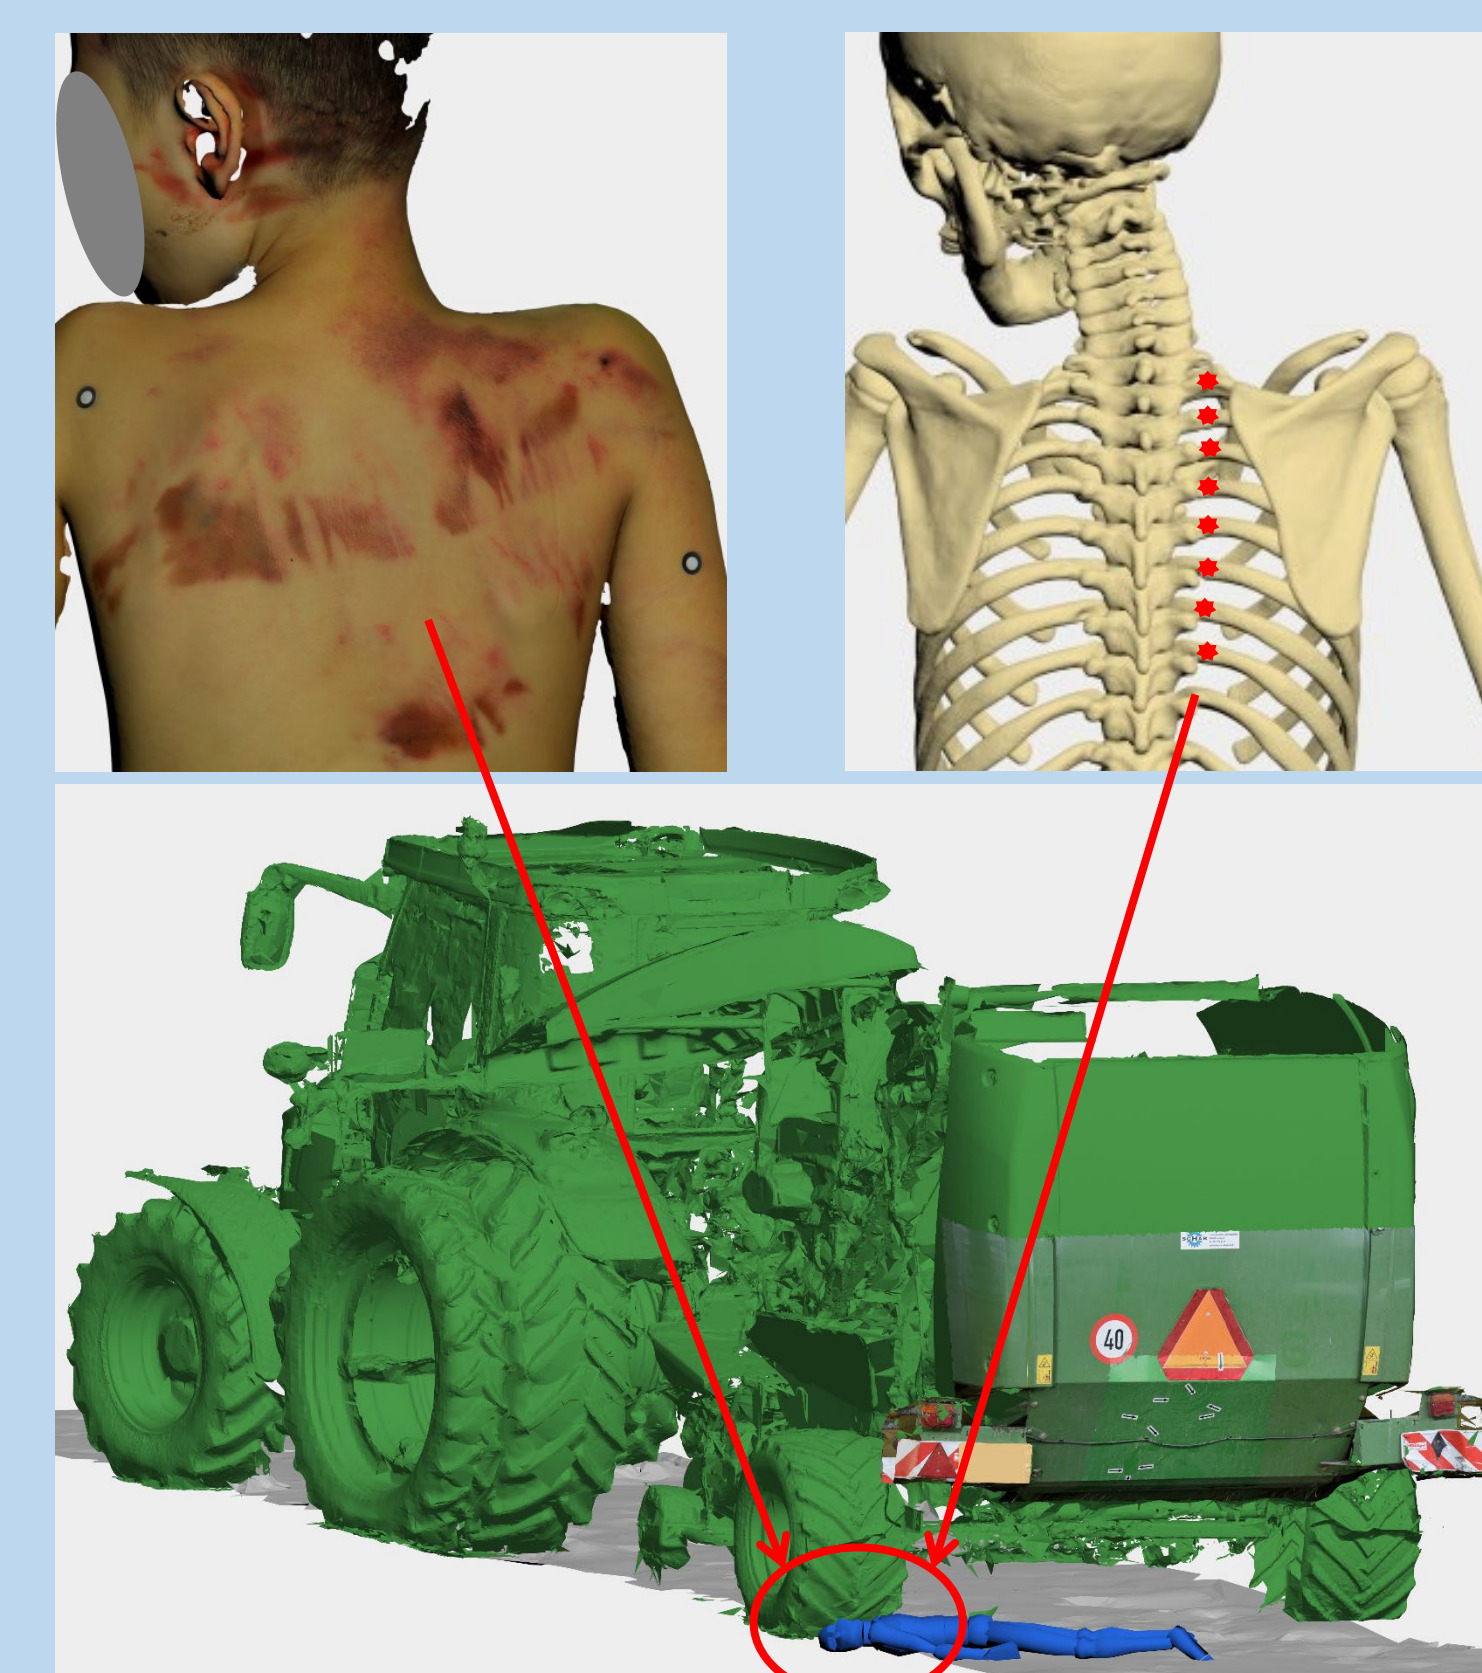
The geometric comparison of the tyre tread with the patterned skin injury behind the ear and on the back show that the most probable course of action is the following: The agricultural vehicle reverses and runs over the cyclist who is lying on the ground. The transverse hinge fracture and the broken ribs mirror the width of the tyre.
