Marginal gap and fracture resistance of implant-supported 3D-printed definitive composite crowns: an in vitro study

Original article

**Objectives:** To compare the marginal gap and fracture resistance of implant-supported 3-dimensional (3D) printed definitive composite crowns with those fabricated by using 3 different millable materials.

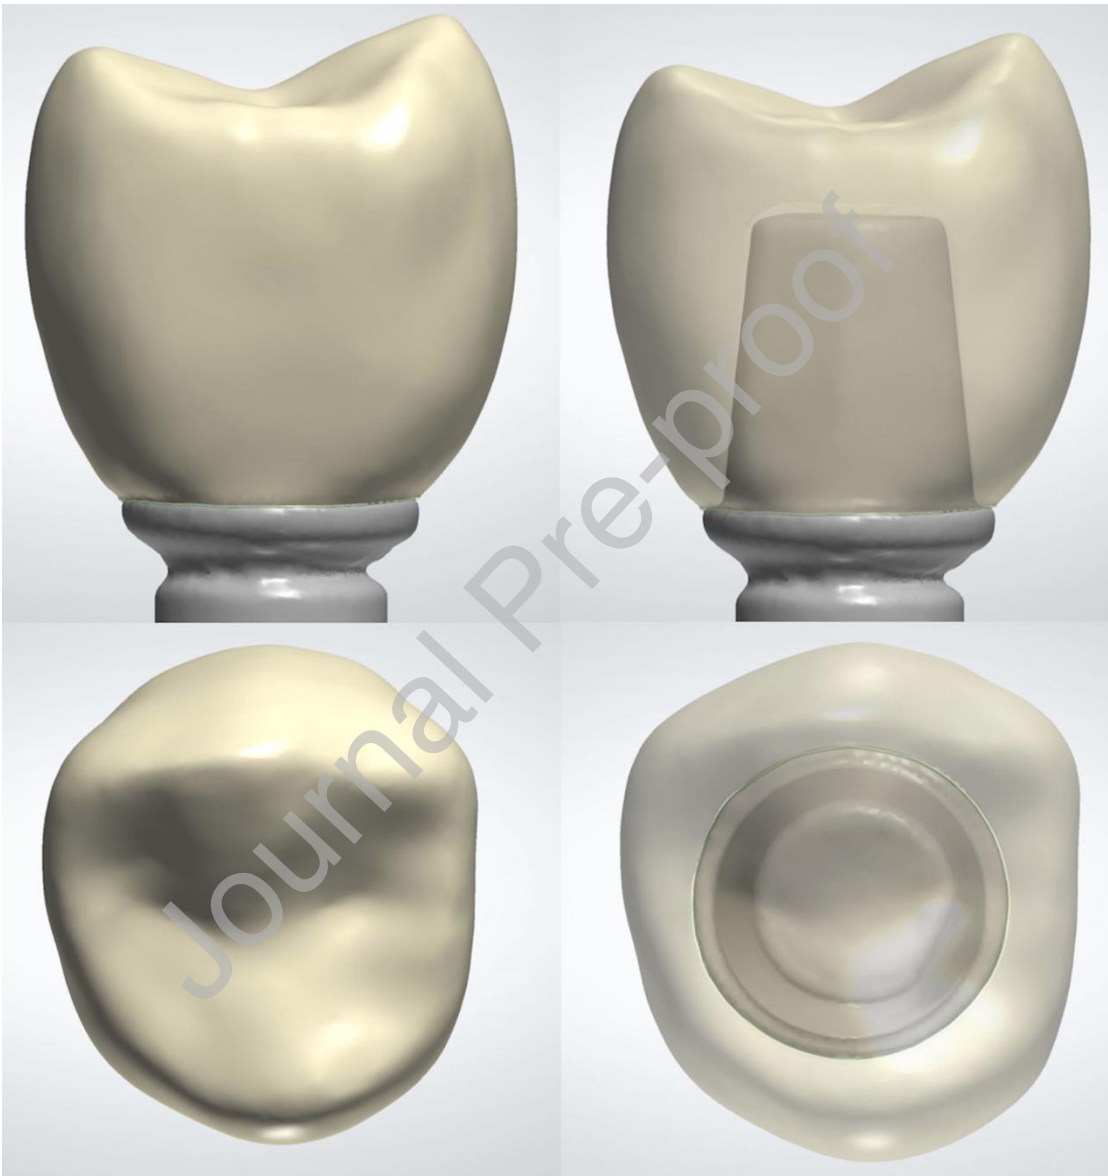
**Figure 1.** Proximal and occlusal aspect of the crown design

A prefabricated abutment ( $\phi=5.5$  mm,  $h=5.5$  mm, and 1.5 mm of gingival height, EZ Post Abutment; Megagen Implant, Daegu, Republic of Korea) was screwed to an implant replica ( $\phi=4.3$  mm,  $h=12$  mm, Megagen Implant, Daegu, Republic of Korea) and was digitized by using a laboratory scanner (E4 Lab Scanner; 3Shape, Copenhagen, Denmark). A full contour maxillary first premolar was designed (Dental Designer; 3Shape, Copenhagen, Denmark) in standard tessellation language (STL) format (Figure 1). The height of the crown was 9 mm from the buccal aspect and 8.5 mm from the palatal aspect, while the thickness of the restoration was 2 mm in the proximal surfaces, 2.5 mm in the buccal and palatal surfaces, and the minimum occlusal thickness was 1.5 mm. The cement gap (the distance between the margin of the abutment and the restoration) used was 25  $\mu\text{m}$ , while the extra cement gap (cement spacer) was set to 50  $\mu\text{m}$  [25]. In addition, drill radius was set to 650  $\mu\text{m}$  and drill compensation offset was set to 660  $\mu\text{m}$ .

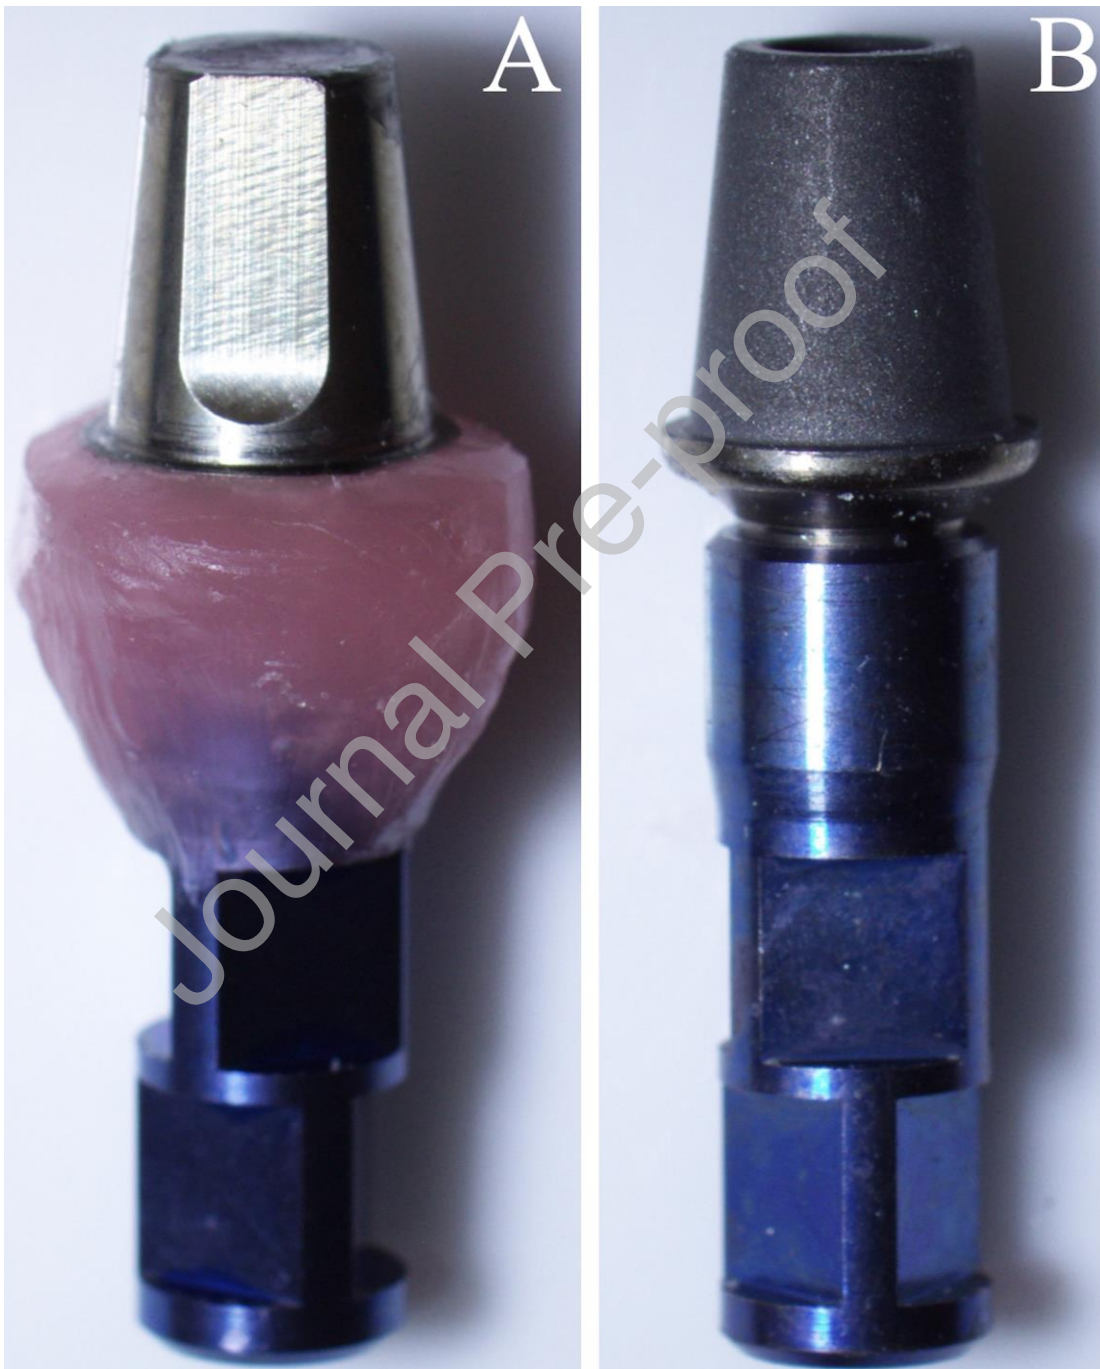
**Figure 2.** Pretreatment of the standard abutment (A: Isolation of the margins; B: After sandblasting)

Crowns were then pretreated either with airborne particle abrasion (Rotaks Sandblasting Machine; Rotaks Dent, İstanbul, Turkey) or hydrofluoric etching gel as per manufacturers' recommendations for adhesive cementation (Table 2). After isolating the abutment margins with wax, the abutments were sandblasted with  $50\mu\text{m Al}_2\text{O}_3$  from 10 mm for 60 s (15 s per surface) at 1 bar (Figure 2) [27].

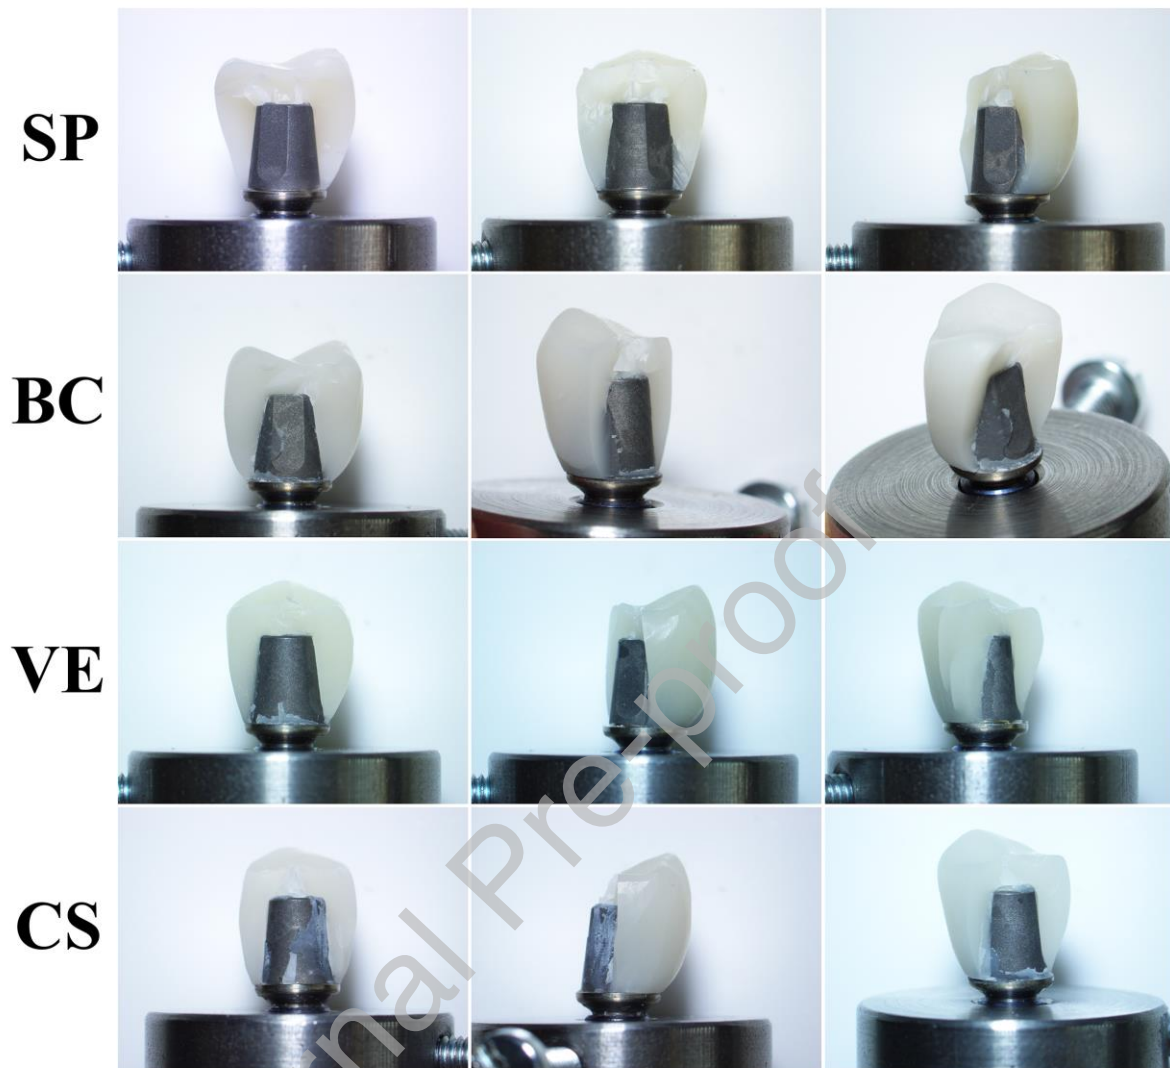
**Figure 4.** Crown fractures observed in each group

Table 5 summarizes the descriptive statistics of the fracture resistance data. One-way ANOVA showed that the differences among the test groups were nonsignificant ( $df=3$ ,  $F=1.589$ ,  $P=.209$ ). In addition, all crowns showed non-repairable fragmented crown fractures with at least one part of crown remaining on the abutment. However, no damage was observed in any of the abutments or prosthetic screws (Figure 4). Figure 5 illustrates the representative SEM images of the tested materials for fractographic analysis. Fractured SP, BC, and CS surfaces showed similar topography, which was characterized by dominant hackle and arrest lines. However, VE surfaces were relatively smoother when compared with the other materials tested.

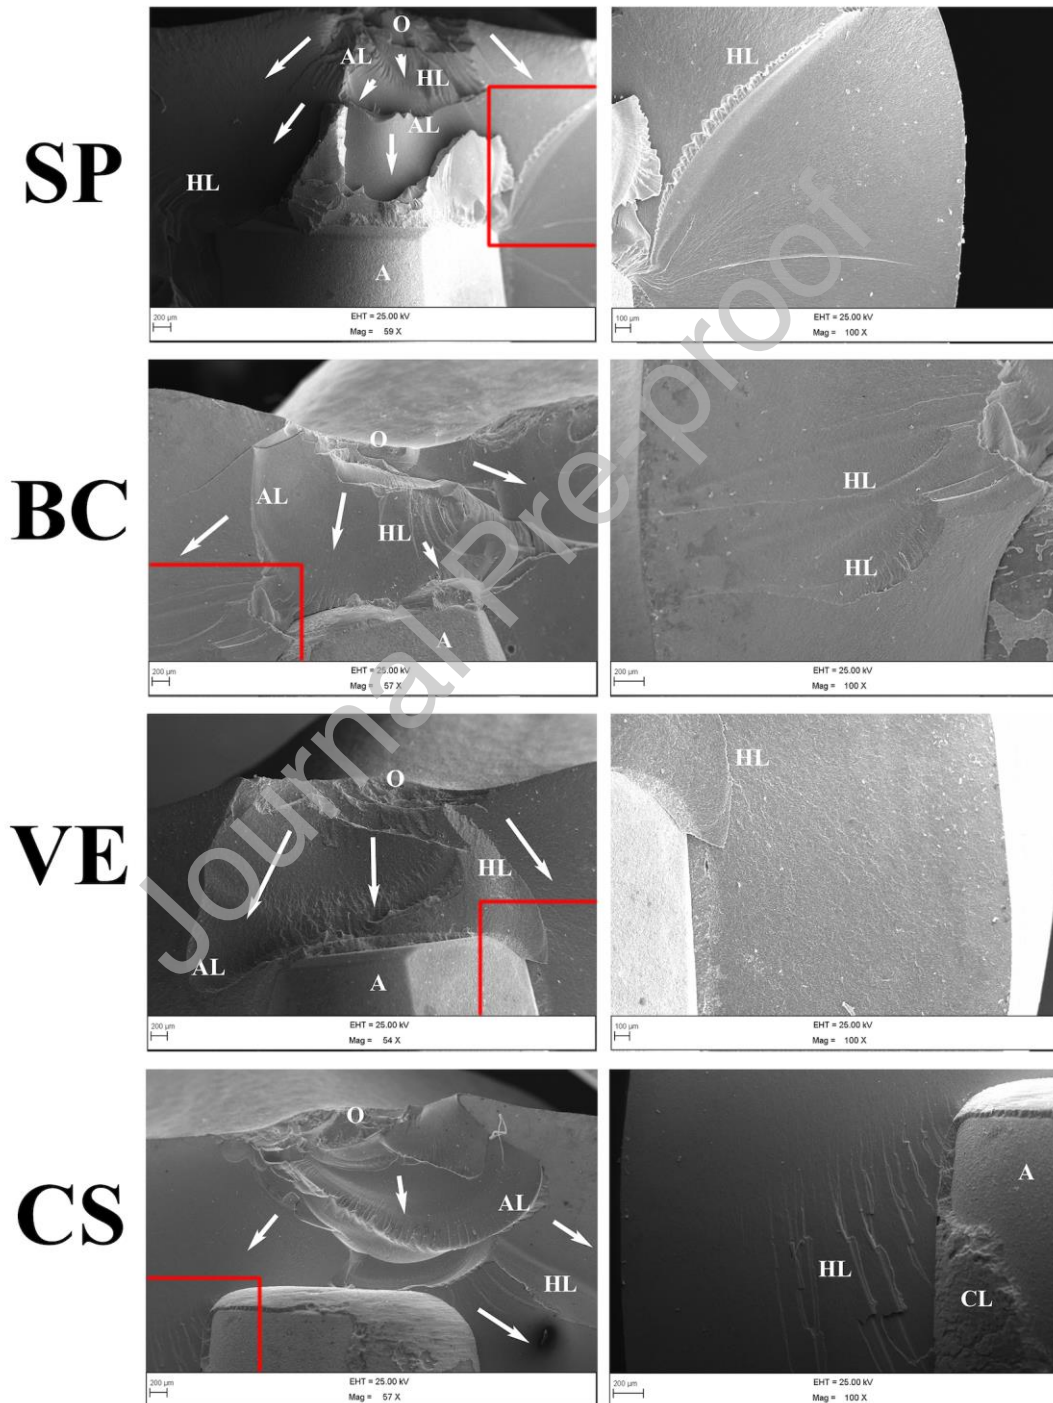
**Figure 5.** Representative SEM images of fractured specimens (A: Abutment; AL: Arrest line; CL: Cement layer; HL: Hackle line; O: Origin of fracture; White arrows: Direction of crack propagation). Images on the left have magnifications ranging from  $\times 54$  to  $\times 59$  and images on the right have  $\times 100$  magnification. SEM images on the right depict magnified images of red squares on the left.

It is possible to enhance the mechanical properties of a restorative material through advancements in fabrication processes as they are related to the material's distinct matrix and filler arrangement [21, 22]. The materials tested in the present study contain fillers of different ratios. Even though non-repairable crown fractures were seen in all specimens, SEM images showed that VE had a different fracture pattern due to non-complex crack propagation and the presence of main deformation being dominant at the occlusal region. Except from this area, the incidence of hackles was considerably low compared with the other materials. This could

be associated with VE's chemical composition that comprised of higher amount of ceramic than the other materials as well as its higher elastic modulus. Considering this finding, it can be speculated that VE might have a different fatigue behavior in clinical use, which should be corroborated with in vivo findings. Nevertheless, no significant differences were found among the fracture resistance values of the materials tested, which may be attributed to the absence of aging or to the adequate occlusal thickness of the restorations. Zimmermann et al's [18] study substantiates the results of the present study as 1.5 mm-thick VE, BC, and CS crowns were reported to show similar fracture resistance values after thermomechanical aging. Moreover, the authors [18] showed that none of the 0.5 mm-thick VE crowns survived the thermomechanical aging and 1 mm-thick BC crowns endured statistically higher loads than VE crowns of same thickness. Contrarily, Rosentritt et al [17] showed that VE resisted higher fractural loads than CS, which was corroborated by another study [9].
