University of Surrey

A Study of Damage Accumulation in a Knitted Fabric Reinforced Composite

**A thesis submitted to the University of Surrey
in partial fulfilment of the requirements of the degree of
Doctor in Philosophy**

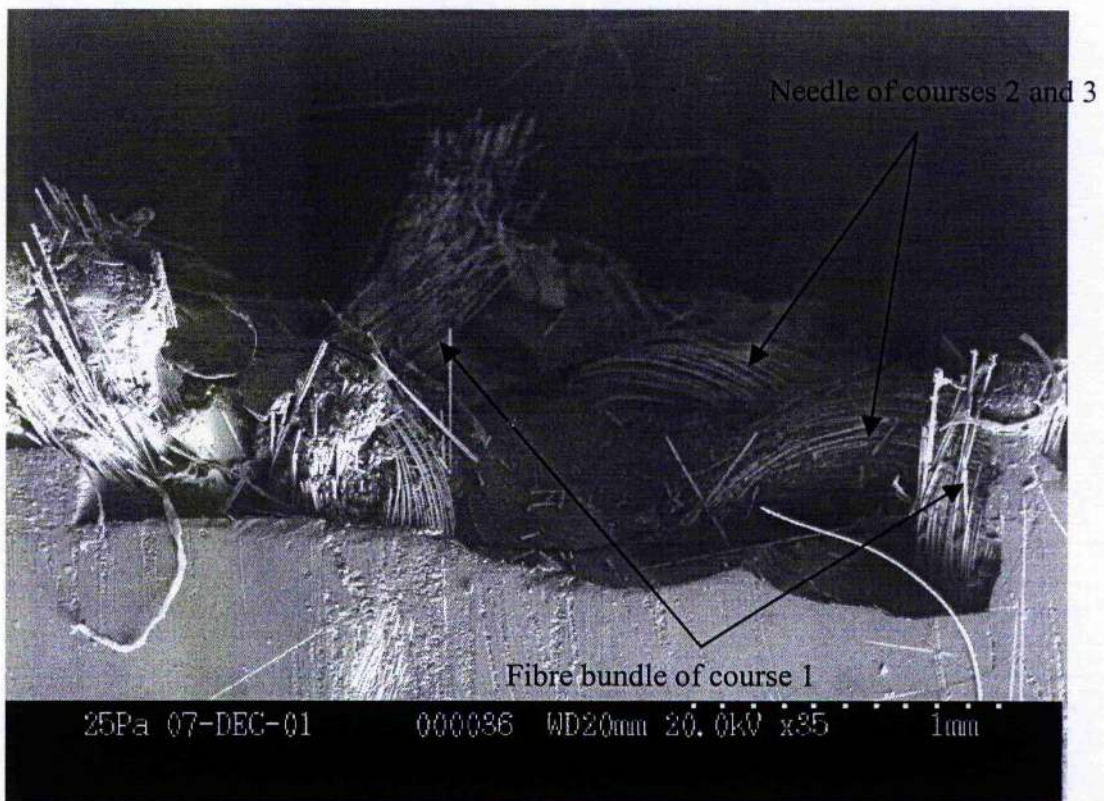
Figure 4.23.- Fractured surface of single layer sample tested in the 0° (wale) direction.

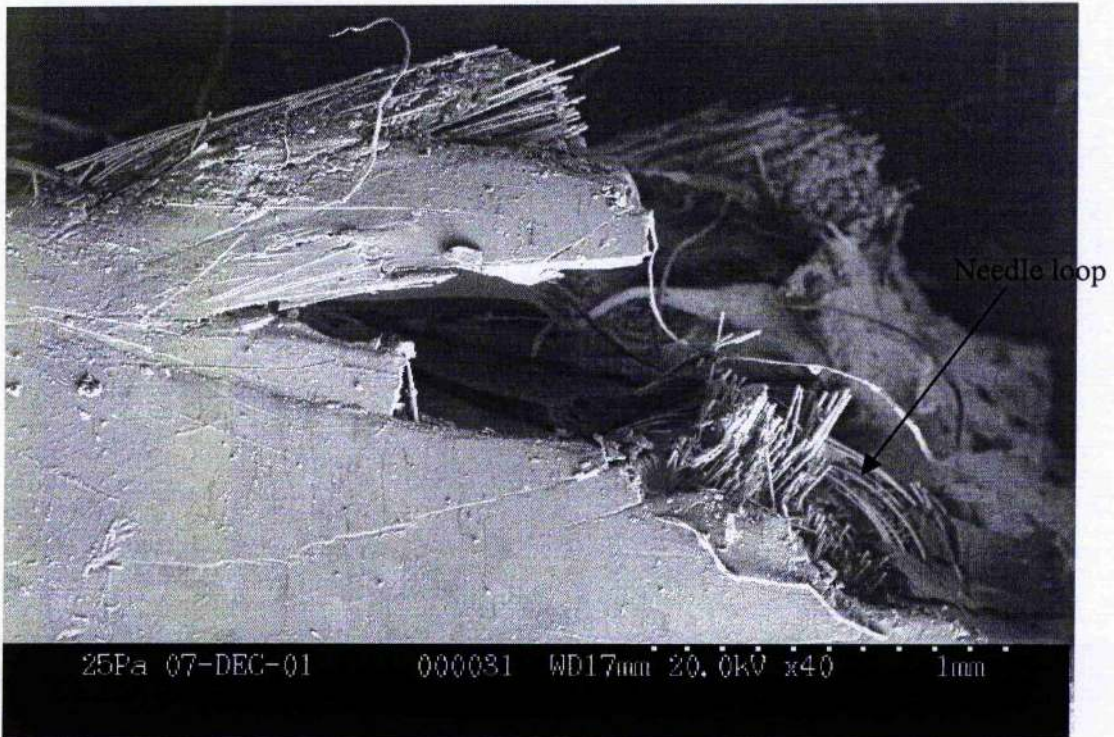
Figure 4.24.- Fractured surface of single layer sample tested in the 30° direction.

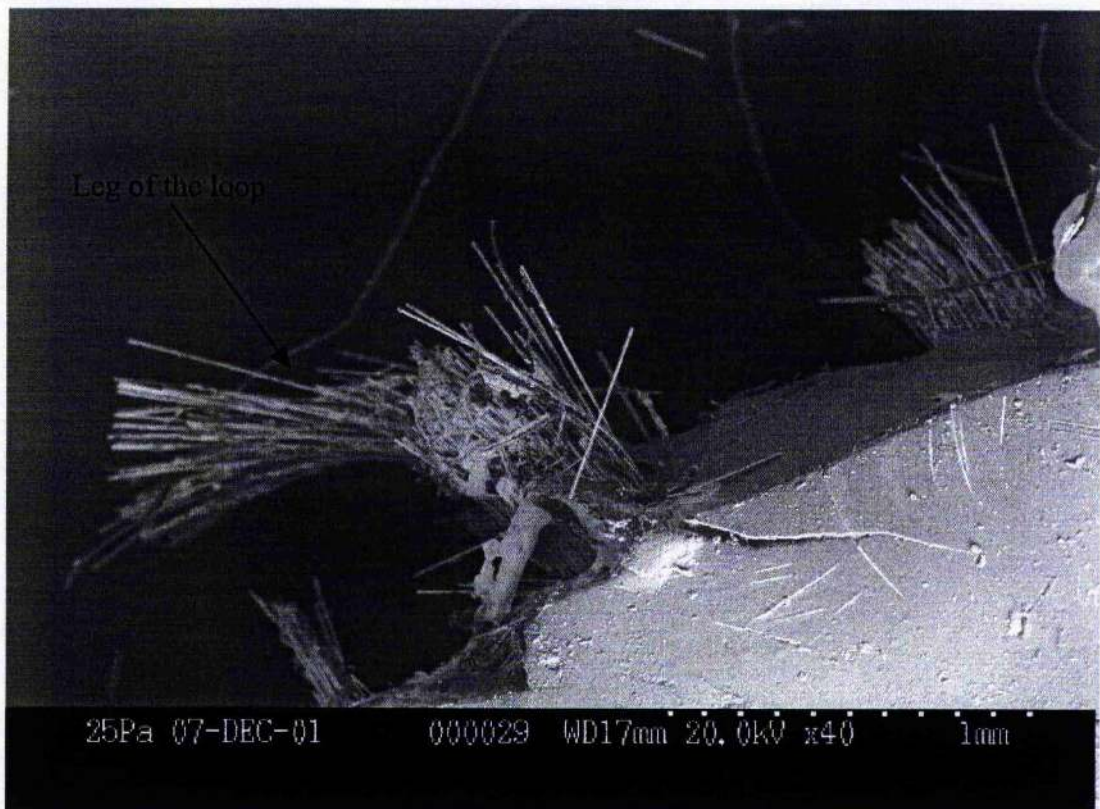
Figure 4.25.- Fractured surface of single layer sample tested in the +45° direction.

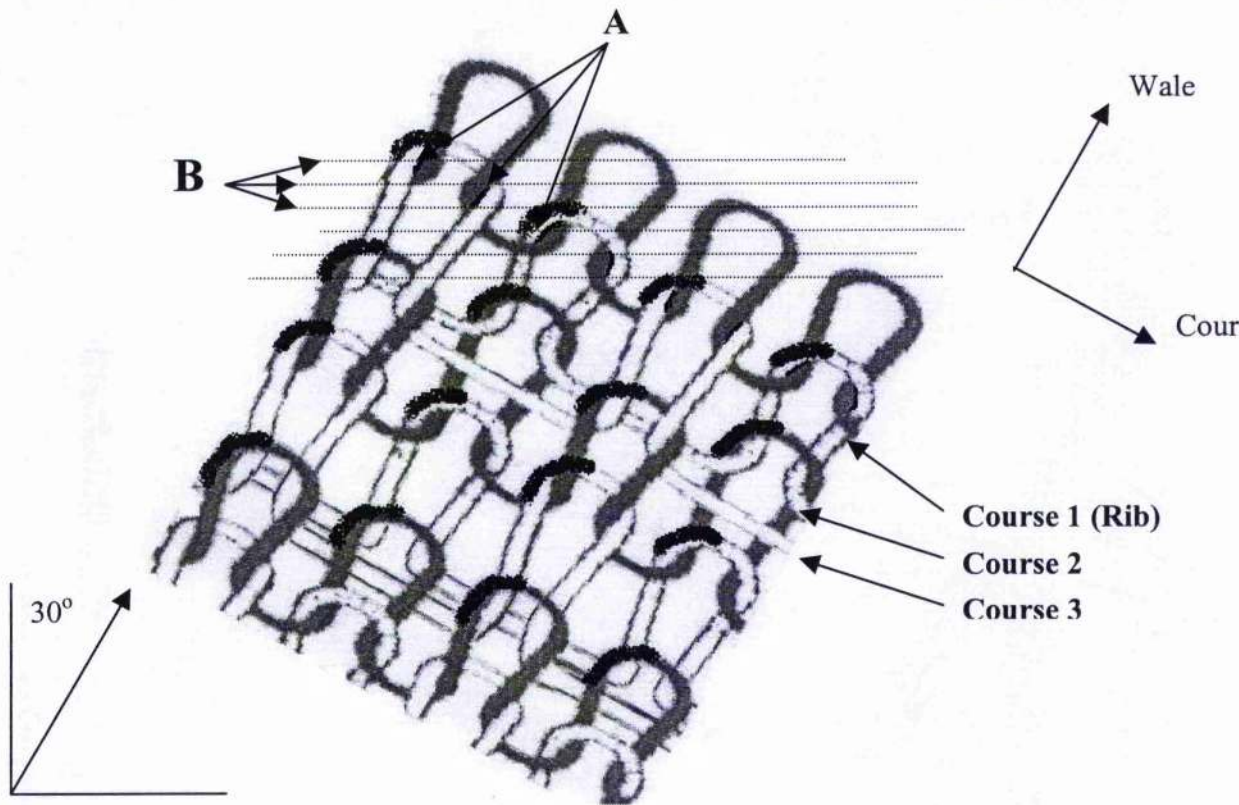
Figure 4.46.- Schematic diagram showing crack development for the model sandwich laminate with the fabric layer in the 30° direction.

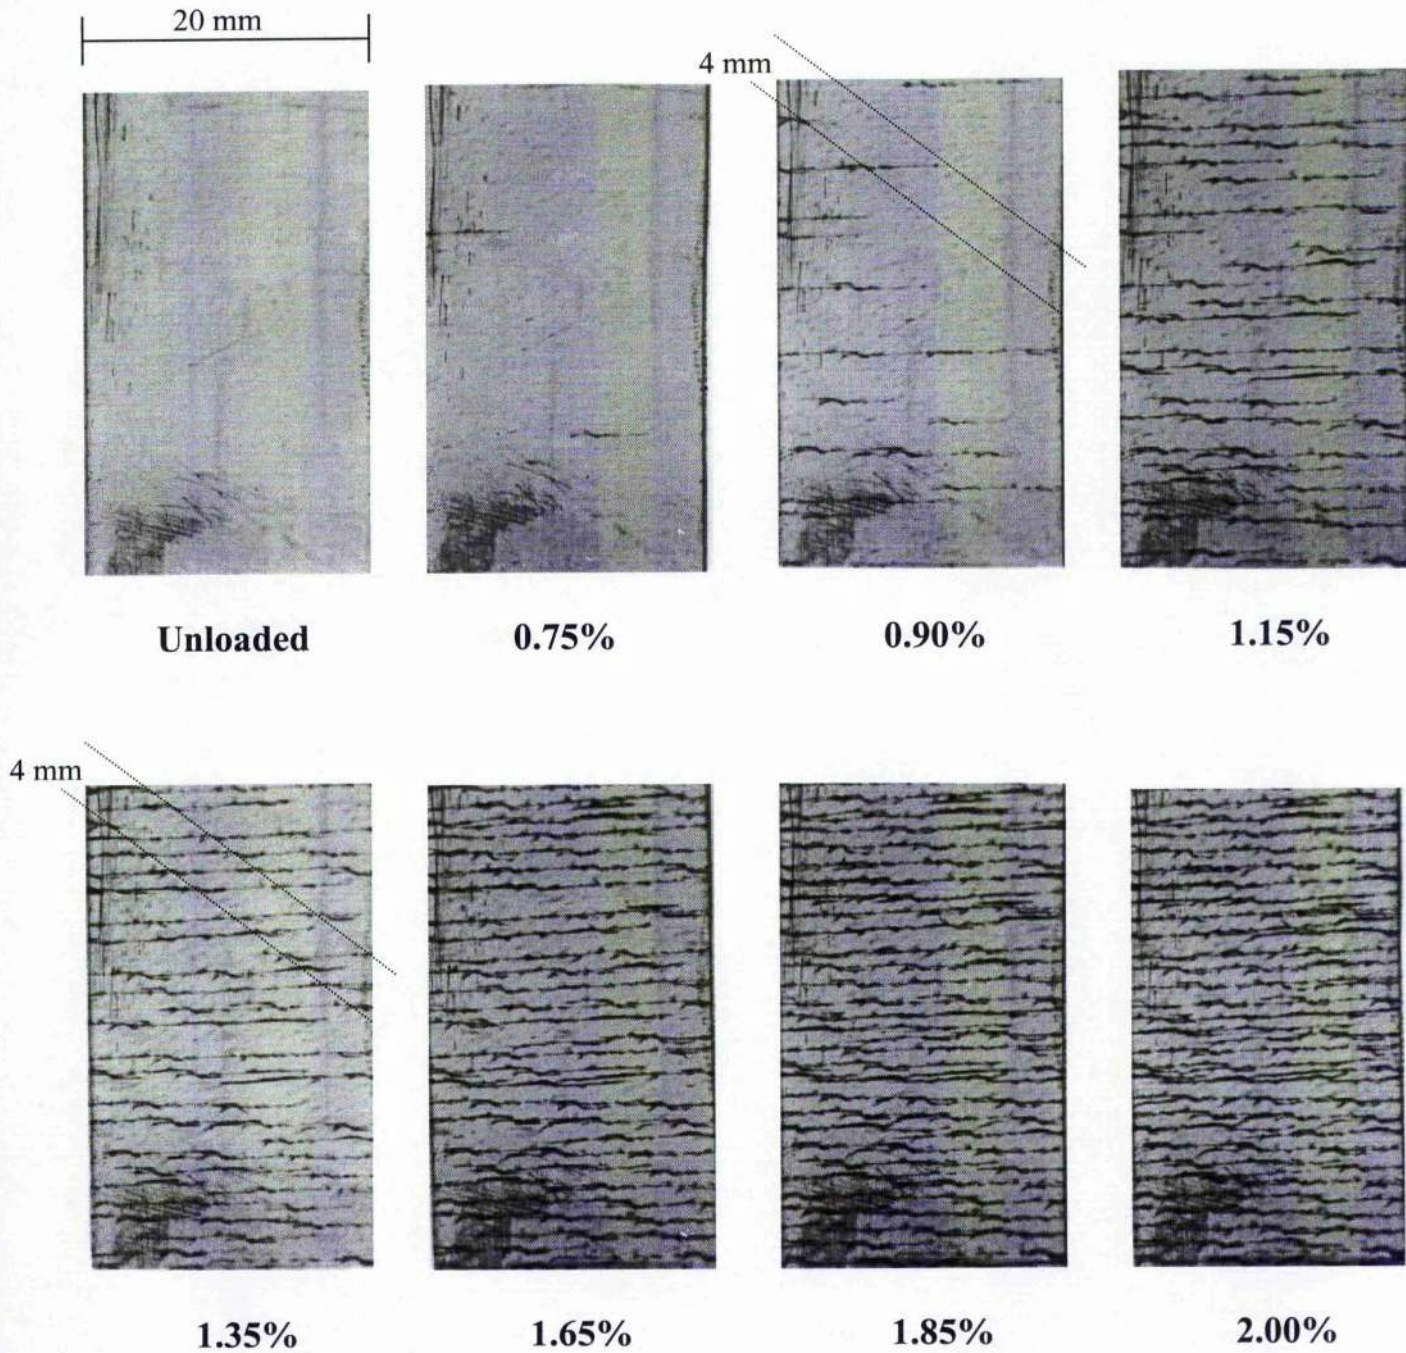
Figure 4.52.- Crack development for the model sandwich laminate with the fabric layer in the $+45^\circ$ direction. Applied strains are indicated.

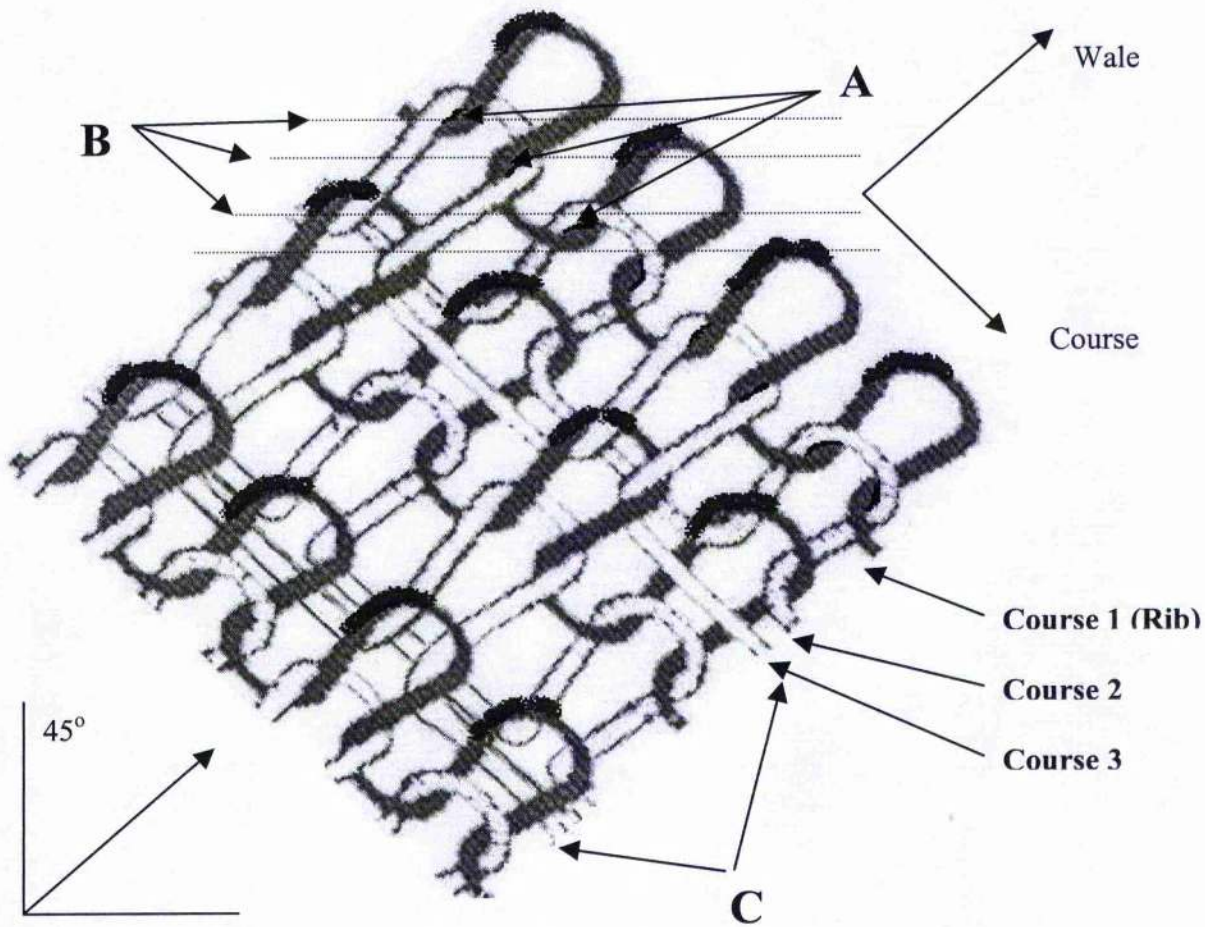
Figure 4.53.- Schematic diagram showing crack development for the model sandwich laminate with the fabric layer in the +45° direction.

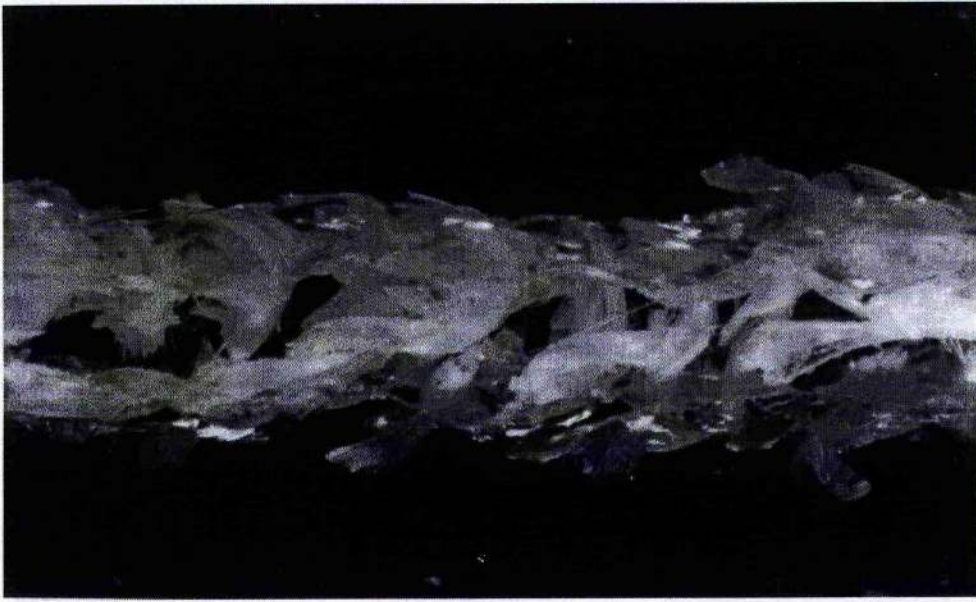
Figure 4.84.- Fracture area in (a) wale direction and (b) course direction

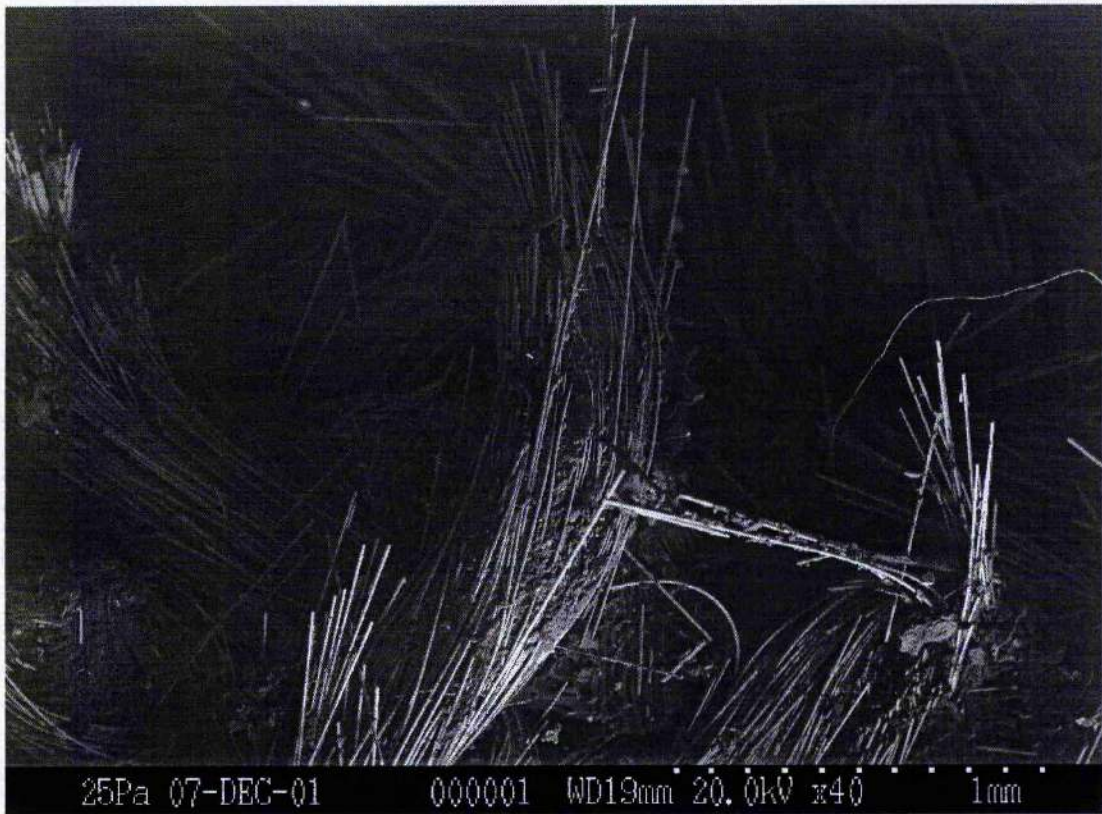
Figure 5.25.- Fractured surface of RTM sample tested in the -45° direction.

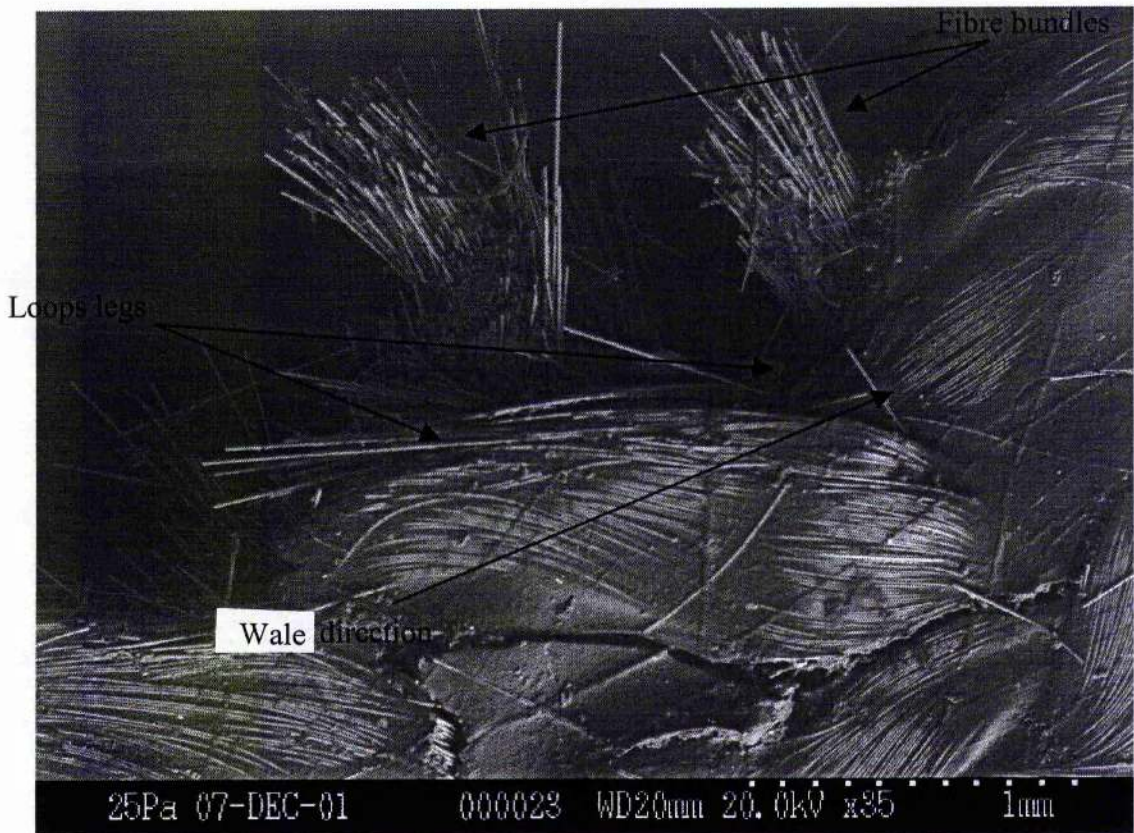
Figure 5.31.- Fractured surface of RTM sample tested in the 60° direction.
