STUDIES ON THE ENVIRONMENTAL STRESS CORROSION  
CRACKING OF MODEL EPOXY-GLASS COMPOSITES.

A thesis in part fulfillment for the degree of Doctor of  
Philosophy of the University of Surrey. April, 1983.

The stress corrosion cracking of model epoxy-glass  $0^{\circ}/90^{\circ}/0^{\circ}$  crossply and  $0^{\circ}$  unidirectional composites in aqueous sulphuric acid has been studied. Specimens, in the form of coupons cut from laminates were tested under conditions of uniaxial tension at constant load, whilst partially immersed in an acidic environment. Two different modes of failure, which resulted in fracture were observed. In the "so-called" Mode I failure, fracture occurred within that part of the composite immersed in the acid, whereas in Mode II, it occurred in the unimmersed part. Both failure modes were observed for crossply and unidirectional composites. In unstressed  $0^{\circ}/90^{\circ}/0^{\circ}$  specimens a third failure mode (Mode III) was observed, in which the damage took the form of transverse and longitudinal cracking of the unimmersed part.

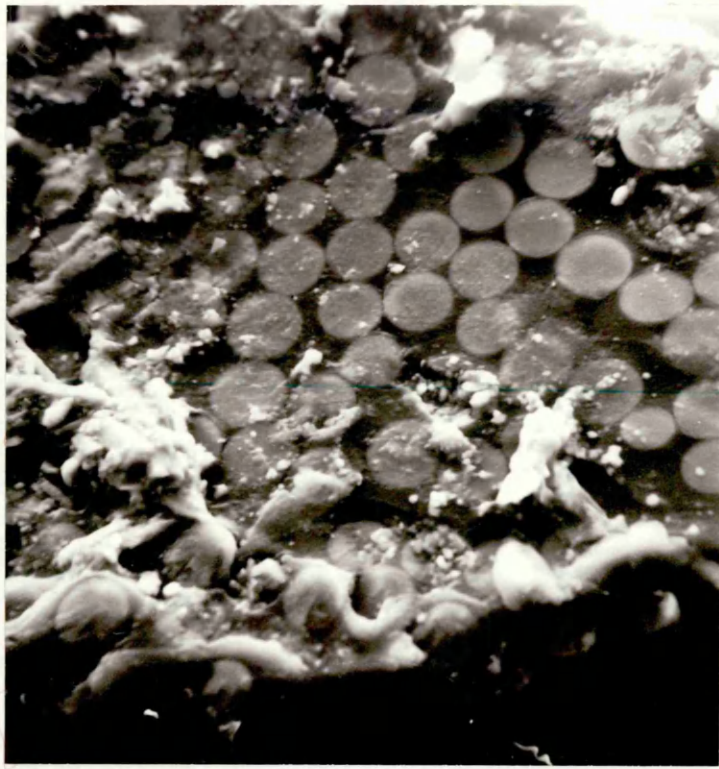
Figure 3.26 Stress corroded nucleation region from a Mode I failure, the lower micrograph shows partial debonding of the fibres.

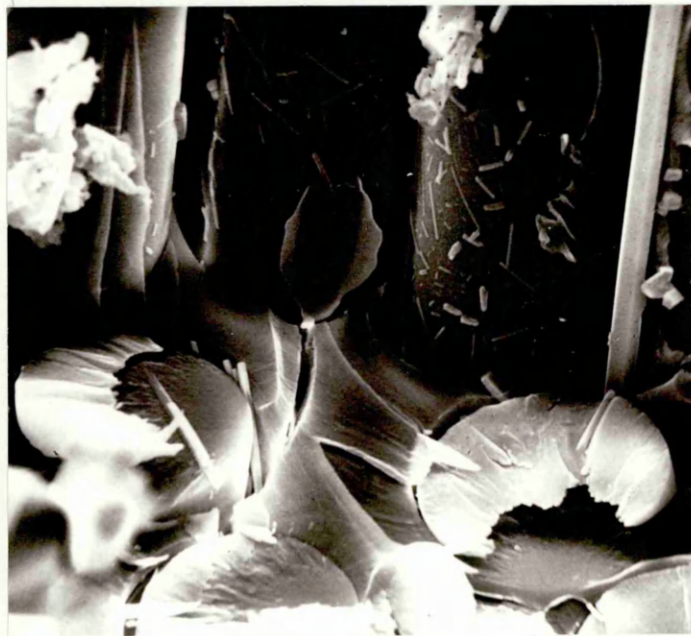
Figure 3.28 Micrograph showing glass segments produced when bifurcation of the fracture crack occurs in the glass fibre.

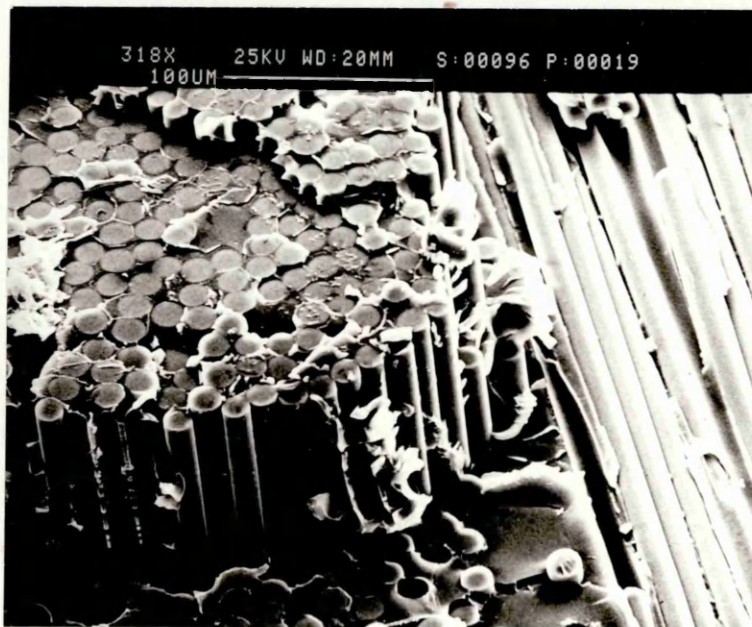
Figure 3.30 Mode II fracture surface showing steps.

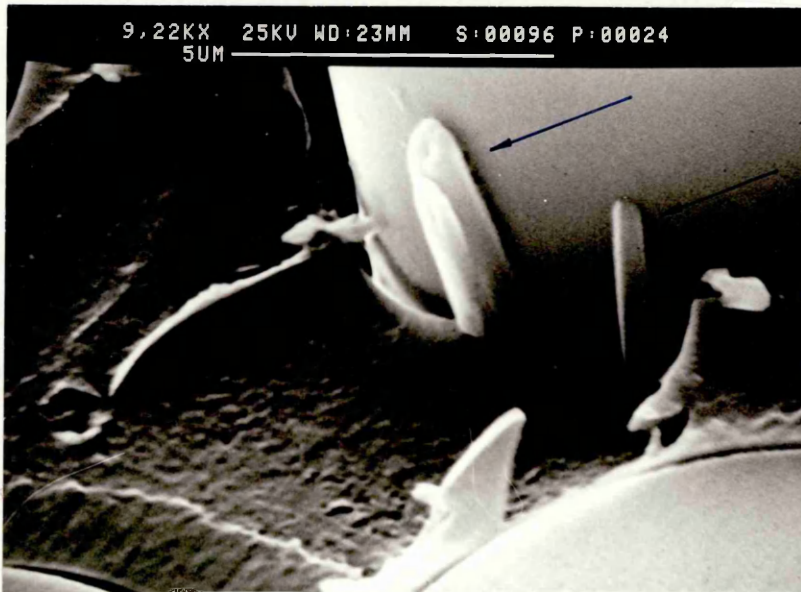
Figure 4.23 Material (crystalline) found at the fibre matrix interface in a Mode II failure fracture surface; shown arrowed in the micrograph.
