Effects of Dissimilar Metal Coupling, Potential  
Distribution, and Temper Condition on  
Galvanic Corrosion of 5086 Aluminum Alloy in  
Synthetic Seawater

NPS-69PS-78-001

January 1978

Technical Report No. 5  
To the Office of Naval Research  
Contract No. N00014-77-WR-70215  
NPS 036-120

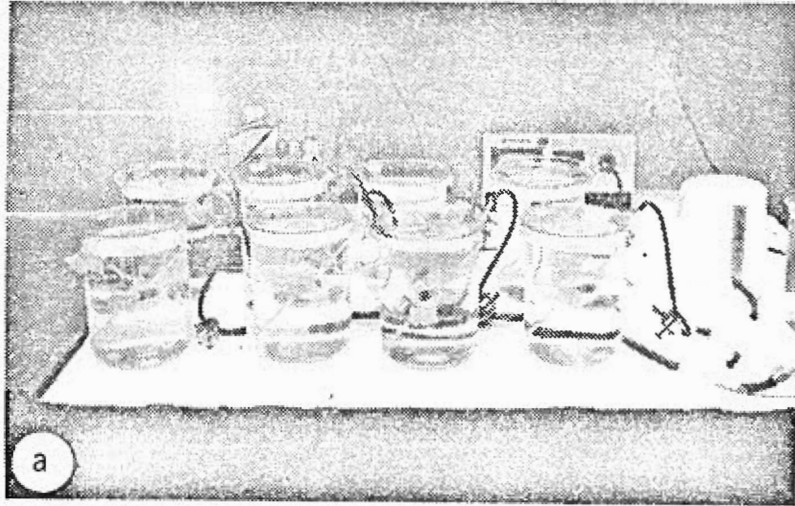
Figure 2: (a) Experimental equipment used for exposure of galvanic couples  
(b) Mounting equipment used to form proximate galvanic couples  
Shown are torque wrench, sample coupons, mounting ring, and final mounted couple.

The primary purpose of these exposures was to deploy various proximate, planar, bimetallic couples in synthetic seawater in order to subsequently study corrosion product morphology and distribution. The anodic member of the proximate couples was in all cases one of the three temper types of 5086 Al, while the cathodic member was one of the three other metals (steel, brass, or titanium). Testing was accomplished by mechanically mating the two metals in such a way that a reproducible and crevice-free interface was produced. The samples were so designed that they could subsequently be examined in a scanning electron microscope (SEM) without disturbing their corrosion product formations. In the design of all test procedures, the guidelines set down in National Association of Corrosion Engineers Standard TM-01-69 were carefully followed (15). The exposure apparatus consisted of an array of 1000 ml beakers (Figure 2) each filled with 1000 ml of synthetic seawater prepared according to Kester et al (16).

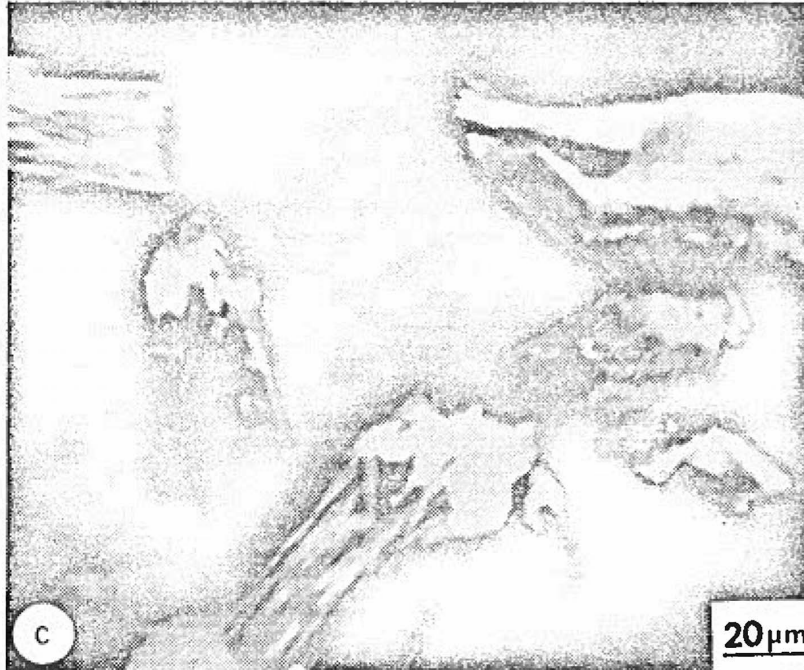
Figure 14: Precipitate formations occasionally found on cathodic members of proximate couples, shown here for brass/5086-H32 couples in aerated synthetic seawater: (a) exposed two weeks, 230X, (b) exposed eight weeks, 110X, (c) same, 550X, (d) calcium x-ray distribution image of same area.

Another interesting structure observed on cathodic surfaces, which will be described as "corn husk" formations, is shown in Figure 14. Unlike the features mentioned earlier, these features were found on only a few of the samples; analysis of these features using the energy-dispersive X-ray analyzer (Figure 14cd) reveals that they are a calcium compound, devoid of Al. However, the surface of the metal upon which they stood is covered with an Al compound.
