The Acoustical Performance Analysis of Bilkent Amphitheater: Proposal for Acoustical Renovation

The 4000 seat multi-purpose Bilkent Amphitheater is a semi-closed amphitheater with a volume of 90,000 m³, designed to serve the University's and the city's educational and artistic activities. At the beginning, the amphitheater was designed only for open-air performances. Afterwards it was decided it would be roofed with a tensile membrane in order to protect the spectators from atmospheric effects. However, the covered amphitheater was turned into a resounding and a problematic place with a reverberation time of more than 6 s. when the hall is unoccupied. Acoustical interventions were implemented, but these have not been sufficient in decreasing the number of problematic echoes and dead spots. This paper analyzes the hall by means of assessing the fundamental acoustical parameters for both speech and music. Parameters such as reverberation time, early decay time, clarity, definition, lateral fraction, strength and speech transmission index were calculated by the aid of ODEON Room Acoustics Program simulation software Version 6.01. It was observed that most of the parameters are out of

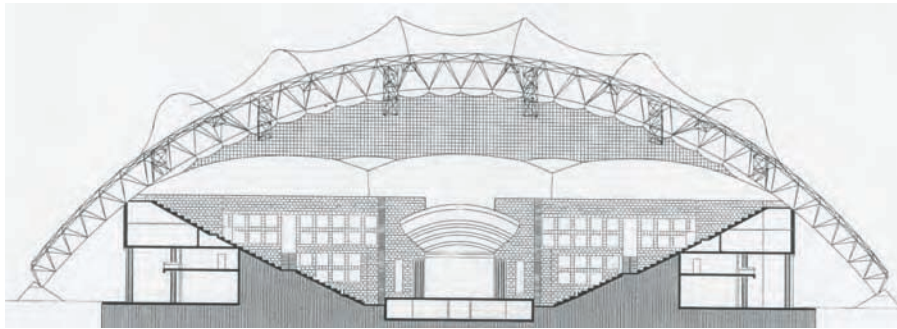
Figure 2: Section view of Bilkent Amphitheater.

Similar to those Roman theaters of the Antiquity, the Bilkent Amphitheater has in plan a semicircular shape [7, 8]. It has a radius of 48 meters corresponding nearly 100 meters in diameter and 18 meter height approximately from the stage to the top of the main arcade at the back of the seating area (Figure 1 and 2). The amphitheater is built in reinforced concrete and all surfaces of the walls and staircases are clad with travertine plates. The front and inner face of main arcade at the back of the seating area is smooth unpainted concrete. The columns of this area are also clad with travertine, which are stripped vertically. The stage is partially covered with travertine, whereas the movable part that forms the pit is wooden floor on joists. The wooden canopy over the stage has a cavity filled with mineral wool.

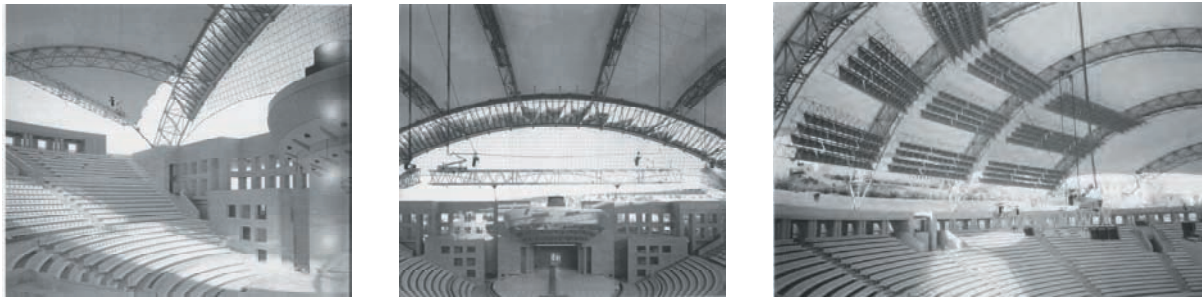
Figure 3: Interior views from Bilkent Amphitheater.

- Reorienting the fabrics hanged on acoustical bridges; the rigid roof membrane and its shape cause the primary defects including sound foci and uneven distribution of sound. The previous precaution against the reshaping of the membrane includes hanging more absorbent materials underneath. However, the sound absorption properties and the orientations of the fabrics are not satisfactory for the acoustic correction of the hall. The roof construction is slightly convex in the cross section, whereas it is closing to a perfect arc in the longitudinal section. The present acoustical fabrics are hanged on parallel to this convex section, whereas the problematic section that causes sound focuses is the opposite one. In this study, the first suggestion accordingly is hanging these absorption fabrics parallel to the concave section, as the concave surfaces focus sound, and are poor distributors of sound energy. In Figure 8, the re-arranged absorption fabrics in between the steel trusses could be observed, while Figure 3 is picturing the current condition. The uneven distribution of

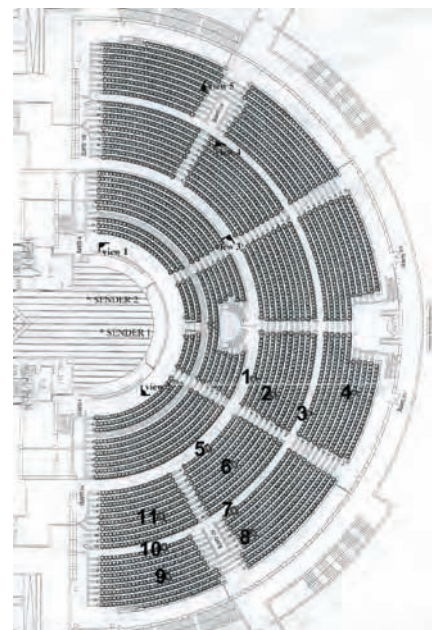
Figure 4: Selected source and receiver locations for the unoccupied hall, for the real-size measurements.

3382 in terms of equipment [10, 11]. The MLSSA configuration was; 64 K samples-sequence, samples frequency 20 kHz and bandwidth 5 kHz. The microphone was a Bruel&Kjaer type 4006 omni directional microphone. Microphone and loudspeaker height was 1.2 m above ground. Measurements were made for two different source and eleven receiver locations (Figure 4).

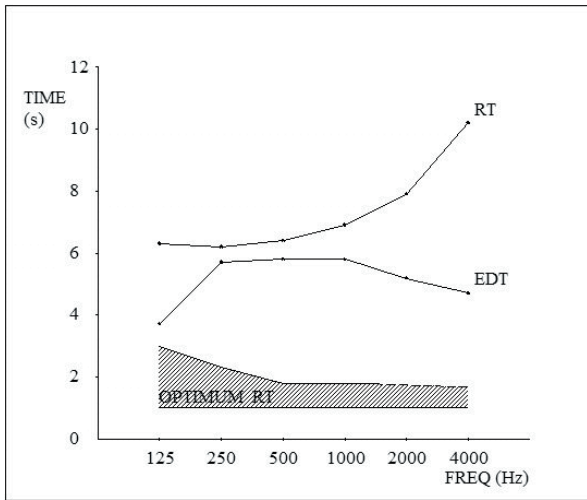
125 Hz	250 Hz	500 Hz	1 kHz	2 kHz	4 kHz
RT(s) _{real}	6.33	6.22	6.48	6.86	7.97	10.17
EDT(s) _{real}	3.75	5.26	5.82	5.87	5.16	4.73

Figure 5: Measured values for RT_{real} and EDT_{real} for frequencies from 125 to 4000 Hz, shaded area: optimum RT for multi-purpose [12, 13].

The Figure 5 shows that the EDT_{real} values are lower than the RT_{real} ones. While the mid frequency values are much closer to each other, it is obviously seen that at lower and especially at higher frequencies there are big differences between the two parameters. However, it should not be higher than $\pm 10\%$ for the conditions of good acoustics. The big differences of EDT_{real} from RT_{real} imply bad distribution of sound in the room, whereas the value to be smaller than the RT_{real} implies that there are surfaces that direct the early reflections on to the audience. A hall to be considered as good, generally has to have EDT_{real} 0.5 s higher than RT_{real} at mid frequencies. The RT_{real} graph with higher values at high frequencies implies that there are surfaces, which are highly reflective at high frequencies and clearly the main reason for the focuses around the hall. The different values at the EDT_{real} with an average minimum of 3.75 s and an average maximum of 5.87 s is caused by the remoteness of the surfaces in this large hall, as the EDT_{real} is chiefly depends on the room geometry and distinctness of the absorptive and the reflective surfaces [14, 15].

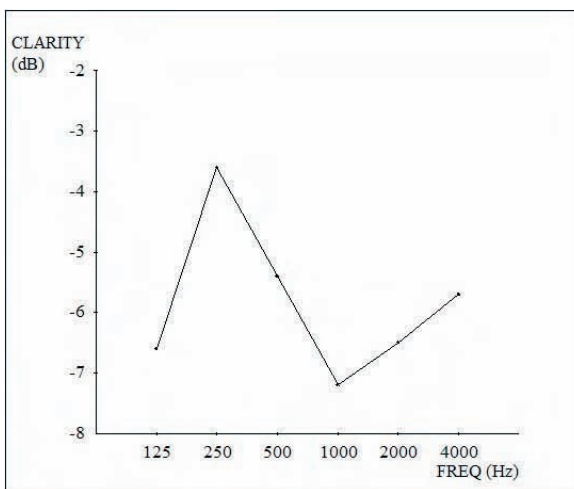
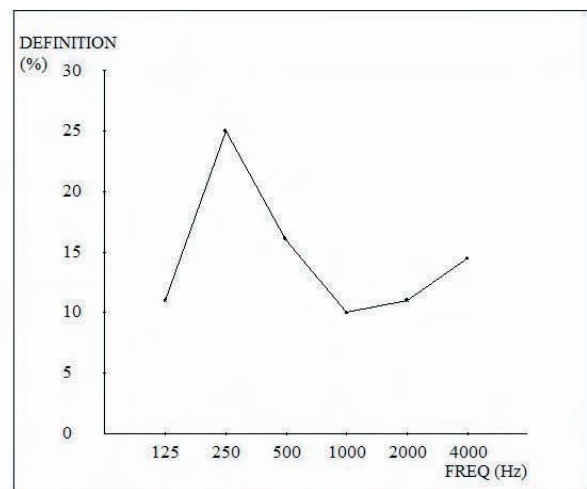
125 Hz	250 Hz	500 Hz	1 kHz	2 kHz	4 kHz
$C80$ (dB) _{real}	-6.62	-3.56	-5.39	-7.18	-6.56	-5.75
$D50$ (%) _{real}	12	25	17	10	12	14

Figure 6: Measured $C80_{real}$ and $D50_{real}$ values for frequencies from 125 to 4000 Hz.

The abrupt jumps of the values including both the rises and falls at specific points are illustrating an inefficient clarity for the overall condition of the hall. The clarity values appear to be best at mid sides that are closer to the limit value, while it is worst at the central part of the mid tiers among the others. On the other hand, the results show that none of the seating points of measurements is in the acceptable range for clarity. The definition illustrates one of the worst distributions of the sound throughout the hall. It is below % 20 in most of the seating places (Figure 6).

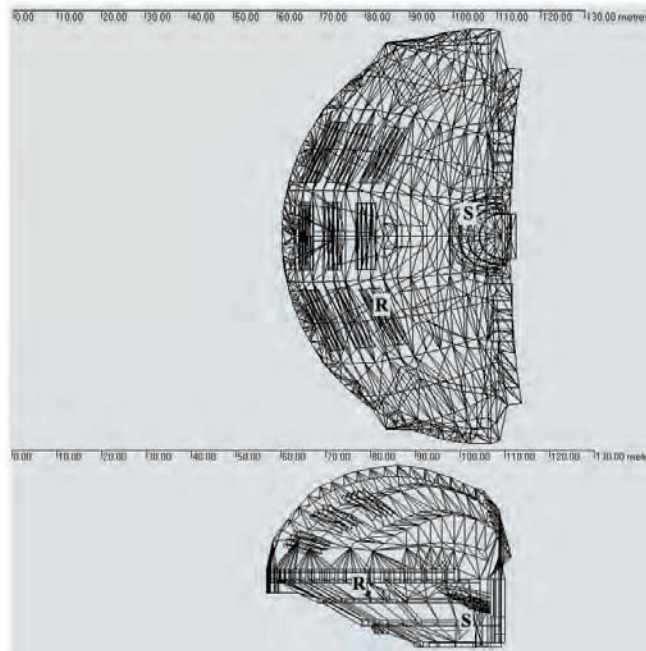
Figure 7: Plan and side view of source and receiver locations for the fully occupied condition of the hall, from the computer simulation.

A typical point is chosen for demonstrating the echo problem from the present condition of the fully occupied hall. At this receiver location (Figure 7), impulse response is observed from the reflectogram. The unwanted reflection can be observed from the Figure 13. The time interval between the direct sound and the reflected sound with similar energy in between 60 and 70 ms, which signifies an echo. It is known that a speech signal that has an energy nearly as much as the direct sound is perceived as an

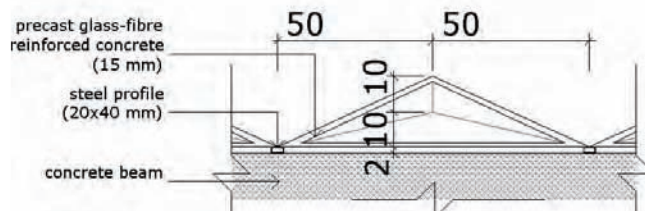
Figure 9: Partial plan view from the fragmented beam surface.

- Fragmenting the semi-circular beam of the back arcade; diffusing wall surfaces are important for the good distribution of sound among the hall. The concave surfaces cause focusing and echoes [19]. The back arcade is one of these concave surfaces. The suggestion for the arcade is principally breaking up the front beam into smaller scattering surfaces, than the geometrically focused reflection will turn into a diffuse reflection. The diffused pattern could be formed by the material called Glass-fiber Reinforced Concrete (GRC), which is widely used in the exterior facades of the buildings due to its durability against atmospheric effects. The surfaces of the material could also be given different textures which is especially important in the case of Bilkent Amphitheater, as with the textures on the concrete the scattering and accordingly the diffusivity could be increased. The concave beam is fragmented in every 1 m portion. Each element of GRC with a width of 1 m, length of 0.75 m, depth of 0.01 m at the bottom and 0.02 m at the top. It has an inclination towards the audience about 8° and anchored to the beam by a steel frame carcass at the back of the GRC. This fragmentation of the beam could be observed in detail from Figure 8 and 9.

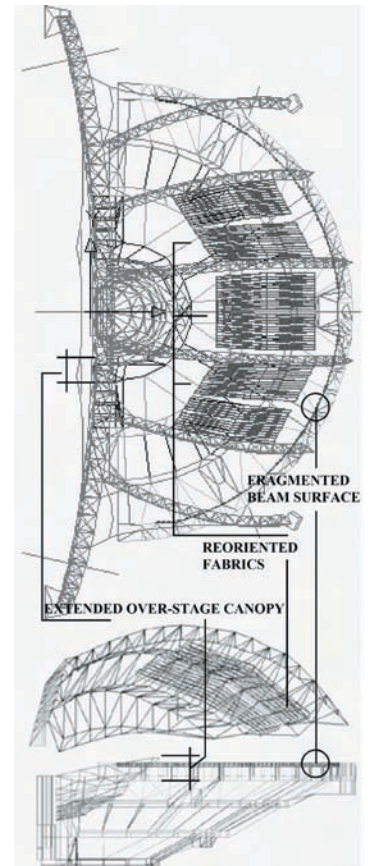
Figure 8: Plan and section view for the renovated hall.

- Extending the over-stage canopy; the designer should concern with getting reflections to the most distant seats with the aid of the reflectors above the stage, not only to the front of the stage. In a space as large as this it is expected a quieter sound at seats remote from the walls. The uniformity and the minor risks of low sound levels could be obtained by the careful orientation of the stage reflectors. Analysis of Bilkent Amphitheater proves that, the central front seats are rated as best throughout the hall, whereas the back seats especially the side backs are worst among the others. Looking at the maps of different parameters the zone of better acoustical quality in the central front is clearly selected (see Appendix). The perimeter of this circular zone is mostly due to the dimension and orientation of the over-stage canopy. Extending this over-stage canopy through sideward and forward, as the limits of the backstage permits, the zone of better acoustical quality is supposed to be expanded (see Appendix). The extended canopy could be observed from the plan and section views in Figure 8.

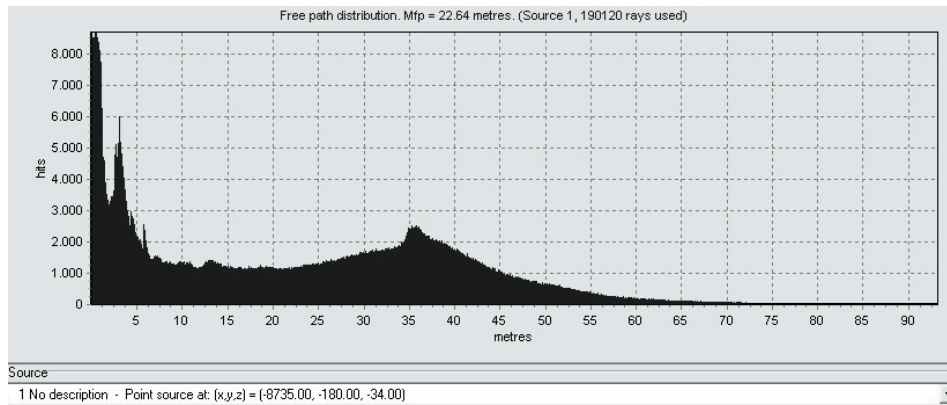
Figure 10: Free path distribution graph for fully occupied hall.

The global estimation results show that the reverberation time (RT_{pres}) of the hall for mid frequencies is 3.05 s. The value is higher than the limits of optimum reverberation times. The free path distribution graph is much alike the unoccupied hall, so there are jumps in the first five meters which is caused by the reflected sound at the closer seating area

by the large cut surfaces of the ceiling membrane. The later reflections are characterized by a dense pattern and a smooth decay in the level of reflections. The unsmooth decay of the free path distribution graph is indicative of a poorly diffused sound field (Figure 10).

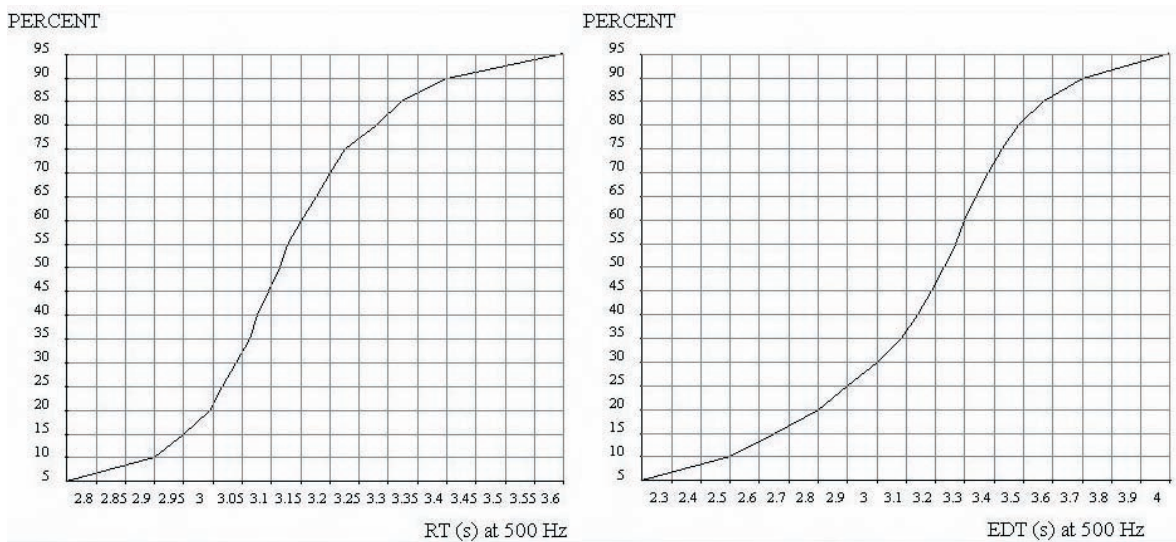
Figure 11: RT_{pres} and EDT_{pres} cumulative distribution graphs.

The uneven distribution of the RT_{pres} results is observed in the present (fully occupied) hall (see Appendix-M1). The results are ranging from 2.8 to 3.6 s according to the cumulative distribution function, whereas 3.6 s is covering the 95% of the hall for 500Hz. This value is much higher

than the required measure, especially for the speech activities. The focuses of the sound is less than the unoccupied case due to the audience absorption, however the echoes are still in disturbing amounts (Figure 11). The early decay time measures are ranging in between 2.3 to 4 s, while 95% of the values are around 4 s for 500Hz. Analyzing the map from Appendix-M1, it is found that the values are better in the front tiers especially at the mid fronts and rising towards the back tiers. Besides the focuses all over the hall, the highest values occur at the backsides. These mid frequency values for the EDT_{pres} are also higher than the maximum limit of the optimum range. Being a part of the uneven distribution of sound in the hall, the focuses that are observed all through the hall, are not the only defect. There are also dead points in compare to the live areas at the hall with reverberation times lower than 1s that are in some cases adjacent to the focus points (Figure 11).

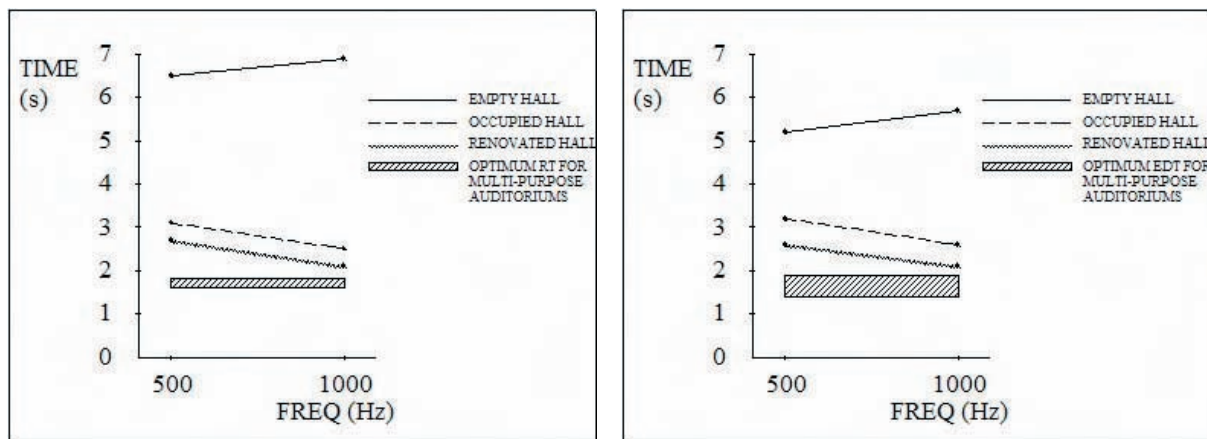
Figure 12. RT and EDT values for empty, fully occupied and renovated hall.

The reverberation times for renovated hall are collected from the global estimation calculations. The first improvement is in the mid frequency reverberation time (RT_{ren}) that has priority in the assessment of the parameter. The mid frequency reverberation time for the renovated hall, when the hall is in use, is 2.60 s whereas it is 3.05 s in the hall with its present condition (Figure 12). The parameter is still some higher than the upper limits for the concert use but acceptable for liturgical music. It is decreased by 15%. The second issue is the improvement in the warmth or bass ratio of the hall, which is one of the discussed subjective criteria for music use. The bass ratio, which is the average RT_{ren} at 125 and 250 Hz divided by RT_{ren} at mid frequencies, is 1.13 for the present hall and 1.21 for the renovated hall. As the lower limit is 1.2 for music performances, the renovated hall is satisfying the criteria [20]. Looking at the overall distribution throughout the hall, it is observed that the field becomes much even. The problematic spots with excessive reverberation times implying echoes and sound focuses are halved, and are seen in the much fewer locations throughout the hall (see Appendix-M2). Coming to the EDT_{ren} graphs of the renovated hall, the range is decreased to 1.75 to 3.3 s from 2.3 to 4 s for 500 Hz. This is corresponding to a 17% decrease with some seats in the optimum range, whereas almost none of the seats of the present hall are in the acceptable range for the parameter (Figure 12). The distribution for the EDT_{ren} is much dependent on the geometry and the distance from the reflective surfaces, so it is expected that the parameter will show a higher variety when compared to the reverberation time (RT_{ren}).

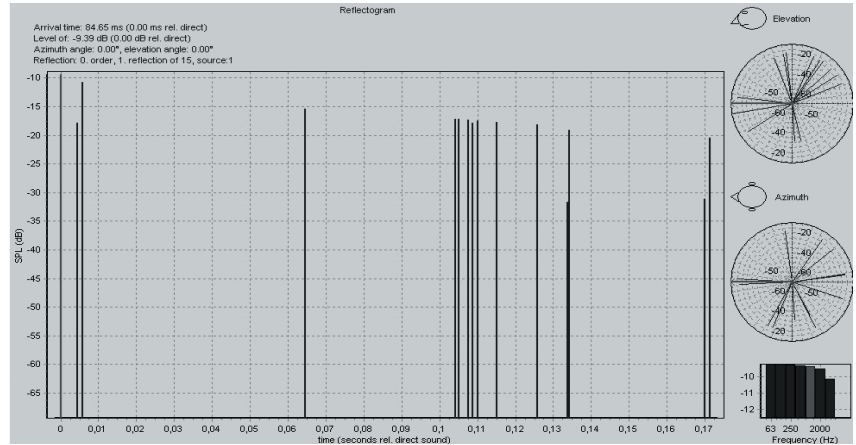
Figure 13: Reflectogram for a typical receiver point, for the present condition (fully occupied) of the hall.

echo, when the time interval between the direct and reflected sounds are greater than 50 ms [12]. The same receiver point with an echo in the present condition of the hall is checked for the renovated hall as well. When the impulse response is observed from the Figure 16, it could be seen that the time interval between the direct and reflected sound with a similar sound energy is dropped under 50 ms. The value illustrates an improvement in terms of echo formation.

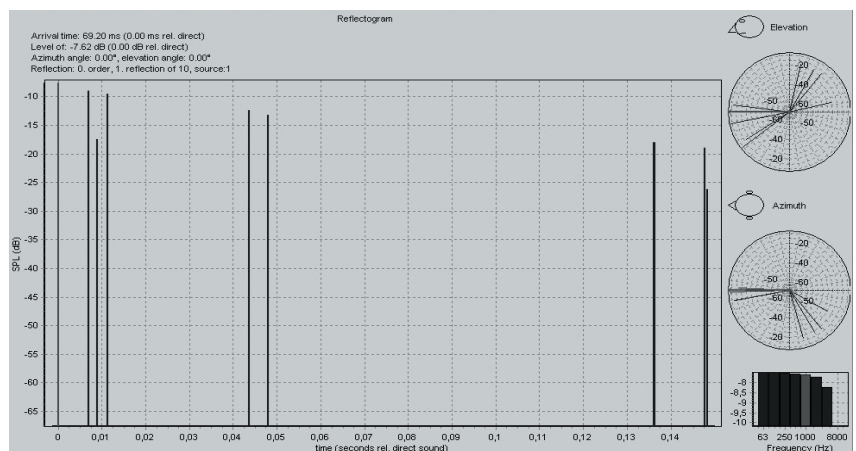
Figure 14: Reflectogram for a typical receiver point, for the renovated hall.

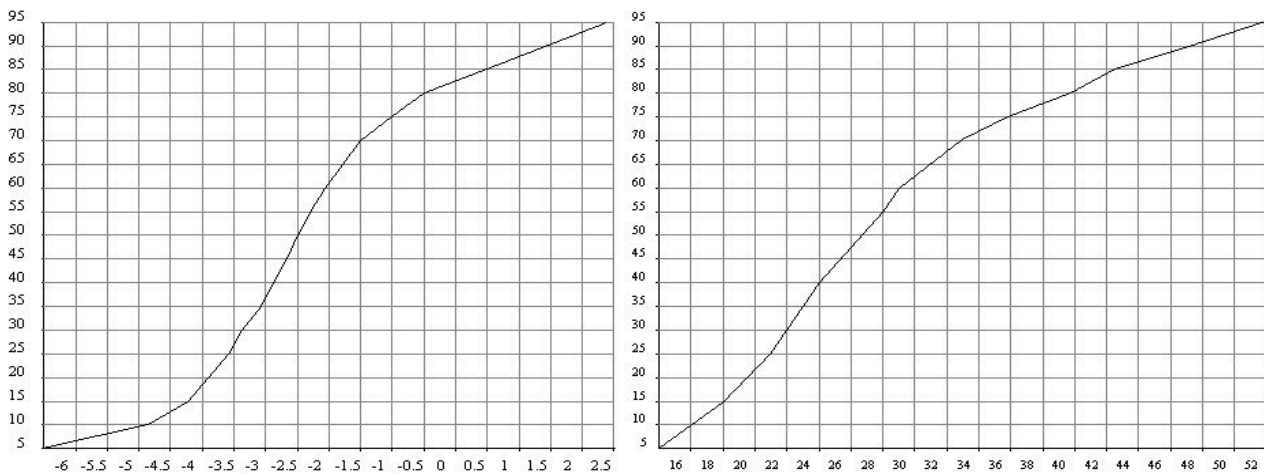
Figure 15: $C80_{pres}$ and $D50_{pres}$ cumulative distribution graphs.

The clarity cumulative distribution maps and graphs of the present condition of fully occupied hall picture that the values are ranging in between -6 to 2.2 dB, which is including both the acceptable and unacceptable measures for 500 Hz (Figure 15). Analyzing the maps it is concluded that the better values are at the front tiers and at the center of the mid tiers. However, the excessive values including both the lowest and highest measures could be seen throughout the hall apparently at some specific points. These peaks of low and high values are sometimes very closer to each other as in the case of center rows of the mid tiers (see Appendix-M5). The definition illustrates one of the worst distributions of the sound throughout the hall. This implies that the intelligibility of the details of speech, besides the sensation of details in music is insufficient for much of the places. The values are ranging in between % 14 to 55 for 500 Hz with 55 at majority, which shows that most of the places are out of the

optimum range. The values are much higher than the required ones at the front tiers, whereas it reaches to the acceptable values at some places of the mid and back tiers. The uneven distribution is the most important cause for making the parameter not convenient for both speech and music performances (Figure 15).

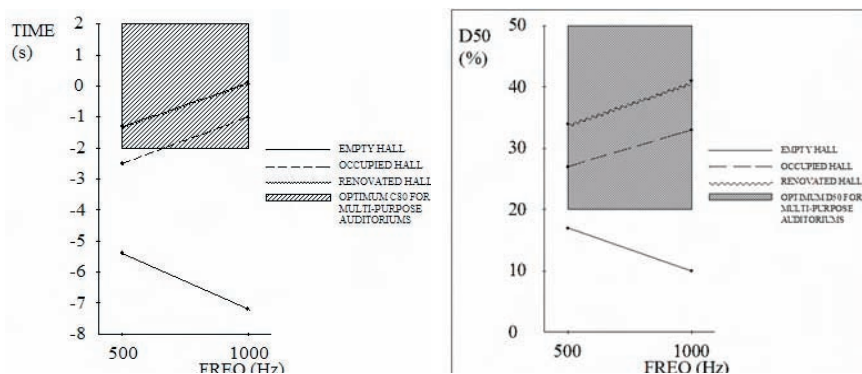
Figure 16: $C80$ and $D50$ values for empty, present (fully occupied) and renovated hall.

The clarity values of renovated hall are changed from -6 to 2.2 dB to -4 to 2.8 dB for 500 Hz. The ratio of the seats that are falling into the optimum range, especially for the music is increased significantly. The $D50_{ren}$ is ranging from % 20 to 60 in the renovated hall, while in the present hall it is from % 14 to 55 for 500 Hz. None of the seats is falling below the lower limit in the renovated hall, and it becomes especially better for the music performances. The better values for both the clarity and the definition are due to the extended canopy, which is providing increased level of early reflections (Figure 16).

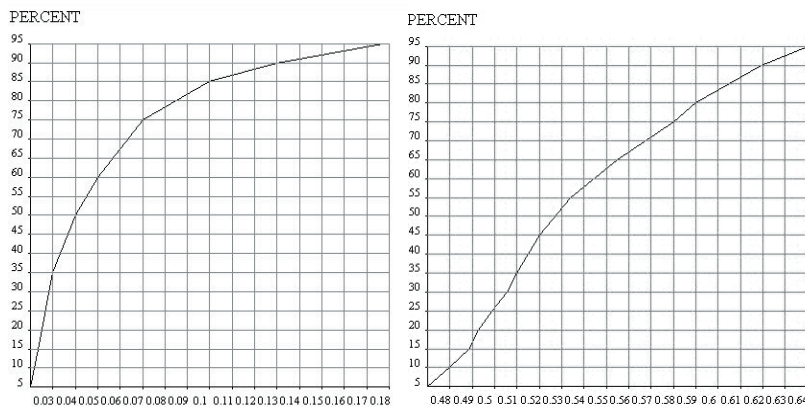
Figure 17: $LF80_{pres}$ and STI_{pres} cumulative distribution graphs.

From Figure 17, it can be observed that the $LF80_{pres}$ values are ranging in between 0.02 to 0.17 for 500 Hz. Examining the distribution maps and graphs, it is found that the $LF80_{pres}$ values of the present condition of the fully occupied hall in general is smaller than 0.15 in both frequencies. This is not sufficient for the concert halls as for other activities as well. The better places throughout the hall considering the $LF80_{pres}$ are back and front tier sides, and the back rows of the mid sides (see Appendix-M9). The STI_{pres} values are ranging from 0.48 to 0.63, which are corresponding to the fair class for the parameter in general. The results to some

extent are better than the unoccupied hall, which is again related to the audience absorption mostly at the higher frequencies (Figure 17). The maps illustrate that the value is best at the front tiers corresponding to the good class, and in very few points at the mid first row, it is classified as excellent. The sides of the mid tiers are classified as fair, and these areas are better than the centre of the mid tiers. At the back tiers the values continue to drop and in some parts, mostly at the mid parts of the last two rows, it is evaluated as bad and unacceptable for STI (see Appendix-M11) [21].

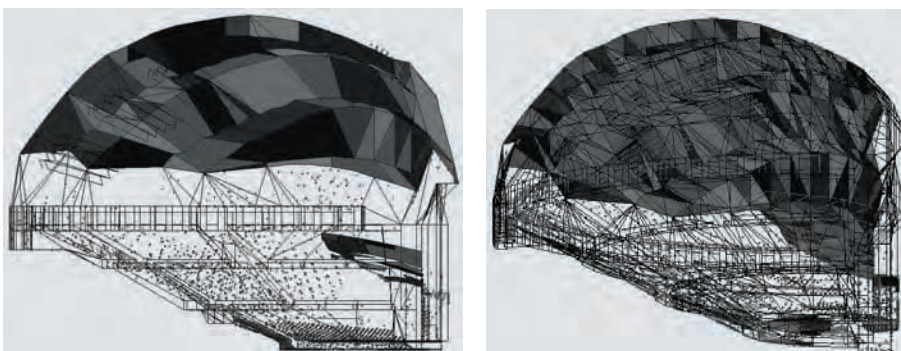
Figure 18: Reflector coverage view for present and renovated hall in order.

the sound energy at a specific point. If the sound cannot be reflected to the seating areas adequately, the direct sound might be insufficient at the places especially which are far from the stage. The reflector coverage display of the simulation is exemplifying that, the sound is mostly reflected to the first tiers followed by the center rows of the mid tiers at the present condition of fully occupied hall. On the other hand, the frequency of the dots which can be seen from the Figure 18 is decreasing through the upper tiers and becomes very scarce at the sides of the mid and the back tiers. This proves that the reflectors are not designed properly for the sound to be carried all over the seating area equally and sufficiently. This is also caused by the fan-type plan at which the area is increasing through the back seats and consequently the density of the sound reflected from the diffusers is being lessened. In order to compare with the present hall, the reflector coverage for renovated hall is also observed. Figure 18 illustrates that the sides of the mid and back tiers have denser reflected sound when compared to the present condition, which is deficient of sound at these seating locations.

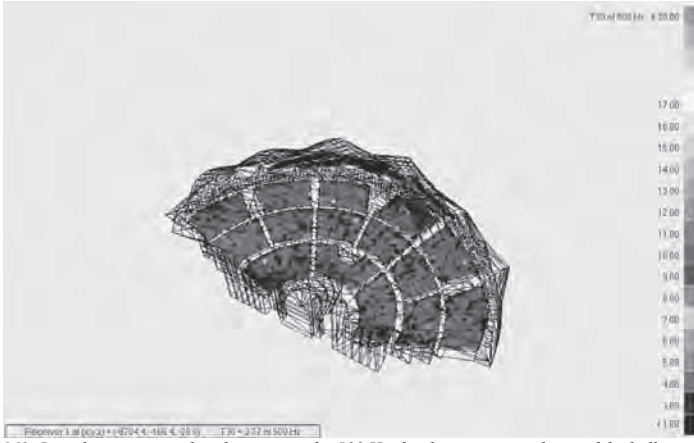
M1: Reverberation time distribution map for 500 Hz, for the present condition of the hall.

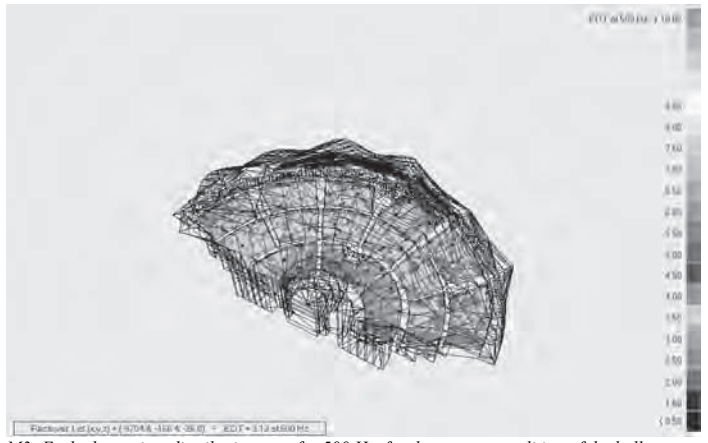
M3: Early decay time distribution map for 500 Hz, for the present condition of the hall.

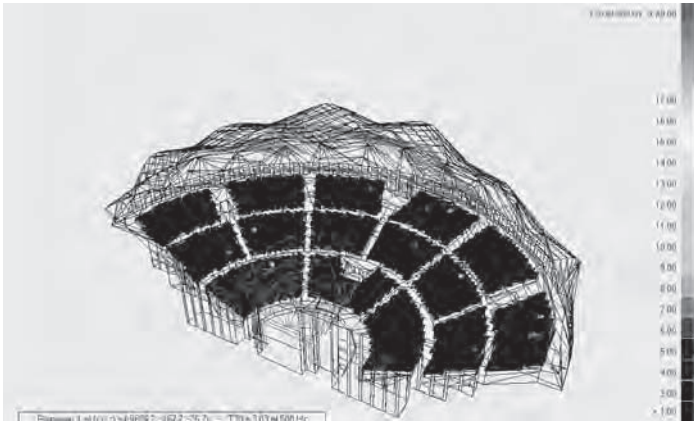
M2: Reverberation time distribution map for 500 Hz, for the renovated hall.

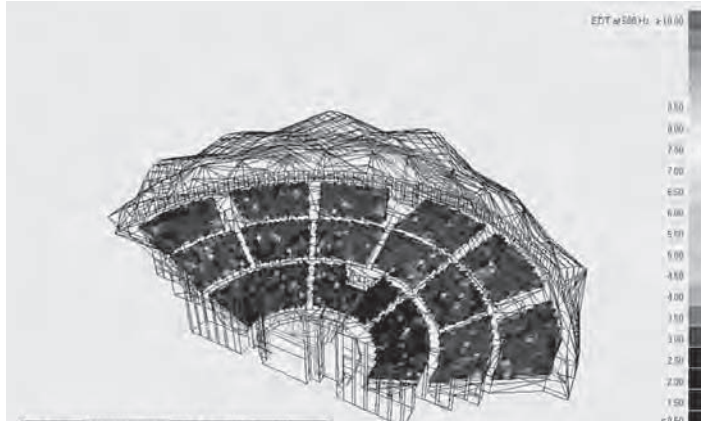
M4: Early decay time distribution map for 500 Hz, for the renovated hall.

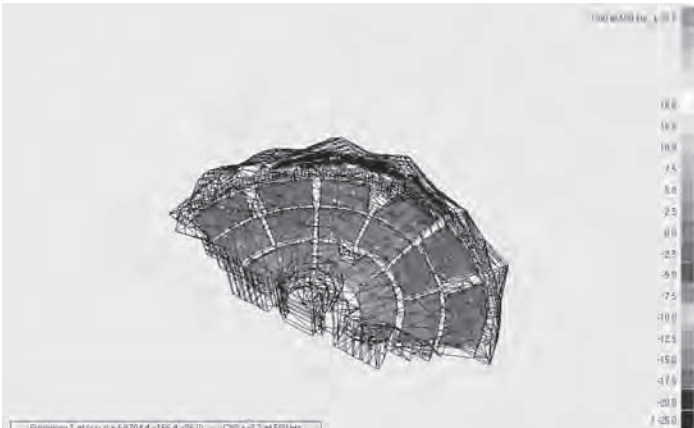
M5: Clarity distribution map for 500 Hz, for the present condition of the hall.

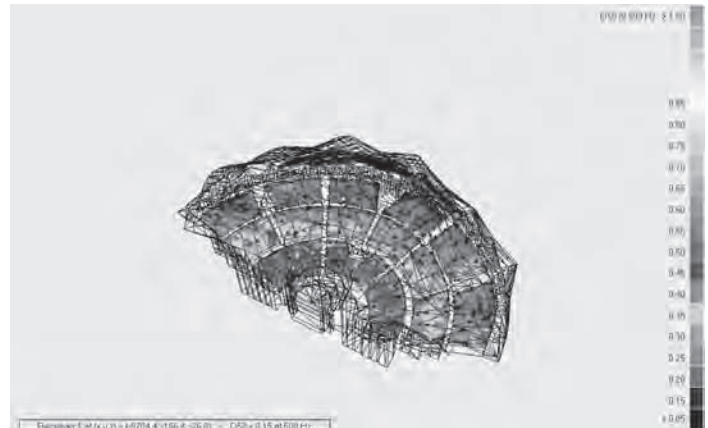
M7: Definition distribution map for 500 Hz, for the present condition of the hall.

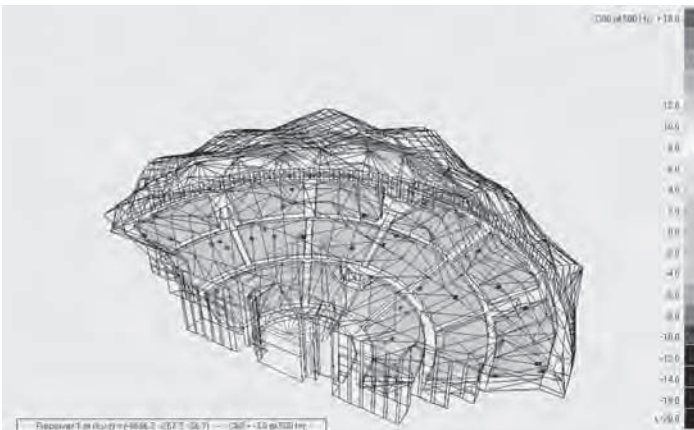
M6: Clarity distribution map for 500 Hz, for the renovated hall.

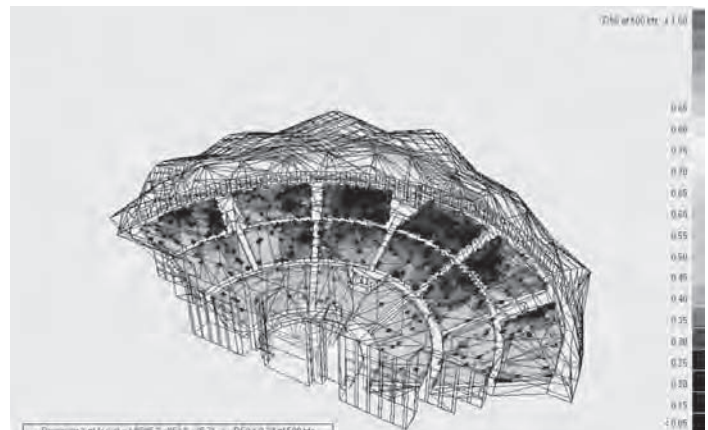
M8: Definition distribution map for 500 Hz, for the renovated hall.

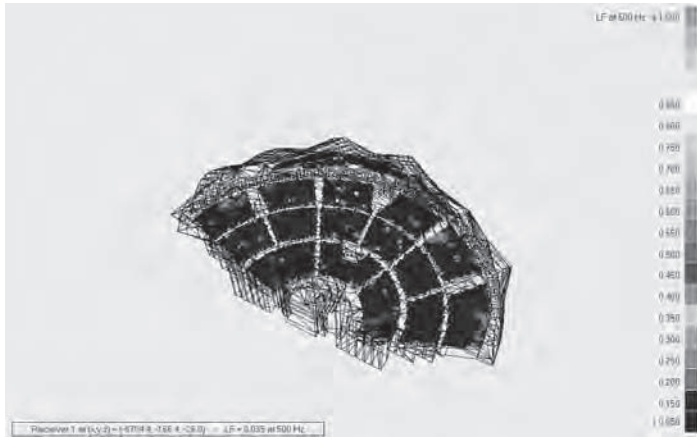
M9: Lateral fraction distribution map for 500 Hz, for the present condition of the hall.

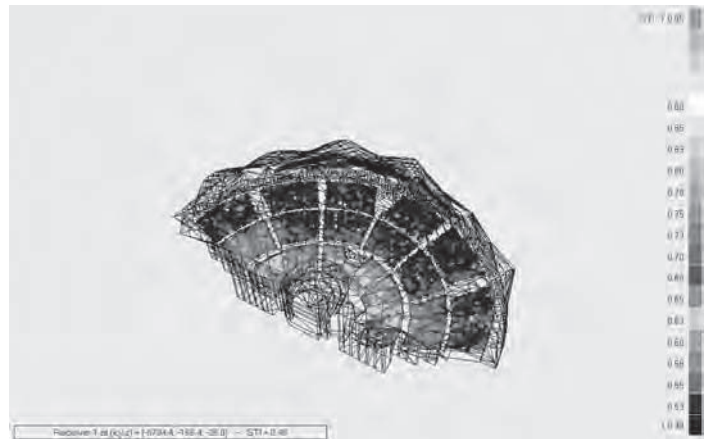
M11: Speech transmission index distribution map, for the present condition of the hall.

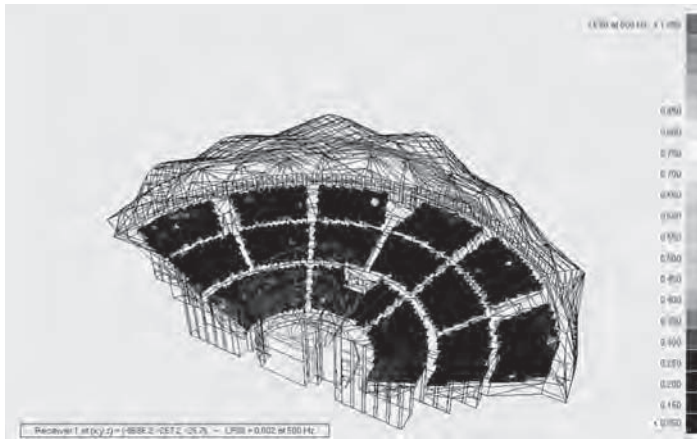
M10: Lateral fraction distribution map for 500 Hz, for the renovated hall.

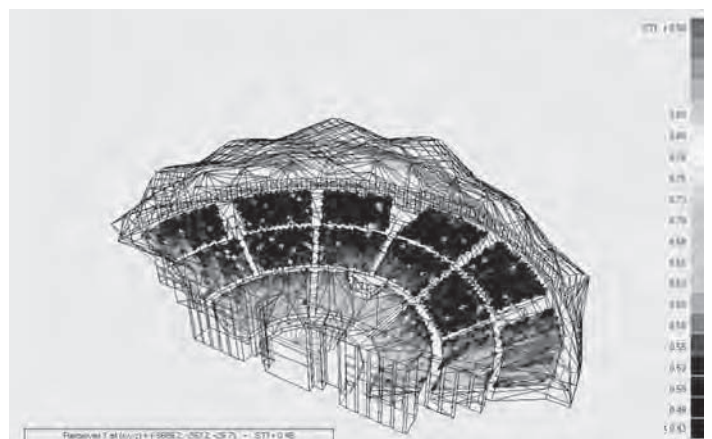
M12: Speech transmission index distribution map, for the renovated hall.

In the renovated hall, $LF80_{ren}$ is raised at the upper end of the range from 1.7 to 0.22 for 500 Hz. The maps obviously show that the areas with better values at the side rows extend through the central seats, which is most likely due to the enlarged canopy in this case as well (see Appendix-M10). STI_{ren} is comparatively better than the other parameters in the present and renovated hall, but as there are many problematic spots when observed from the reverberation time distributions the tolerable values of STI_{ren} become masked. Again, in the renovated hall, the values are ranging from fair to good class. There is some increase at the upper limit from 0.64 to 0.68. This time the reverberation time distribution is better than the present hall, and so the STI_{ren} is less deteriorated (see Appendix-M12).

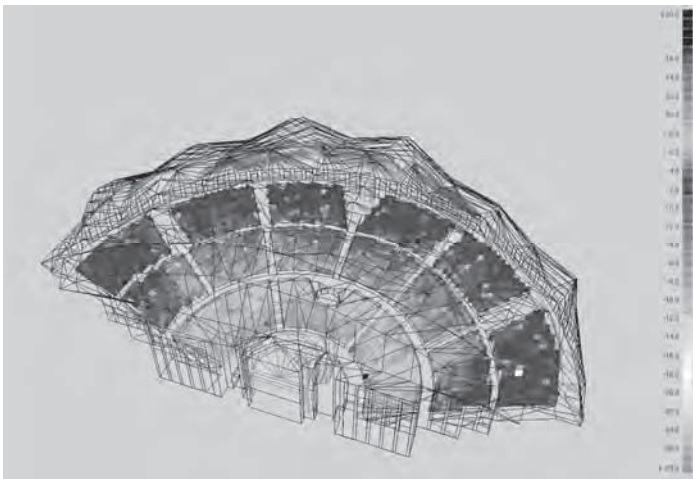
M13: Strength distribution map, for the present condition of the hall.

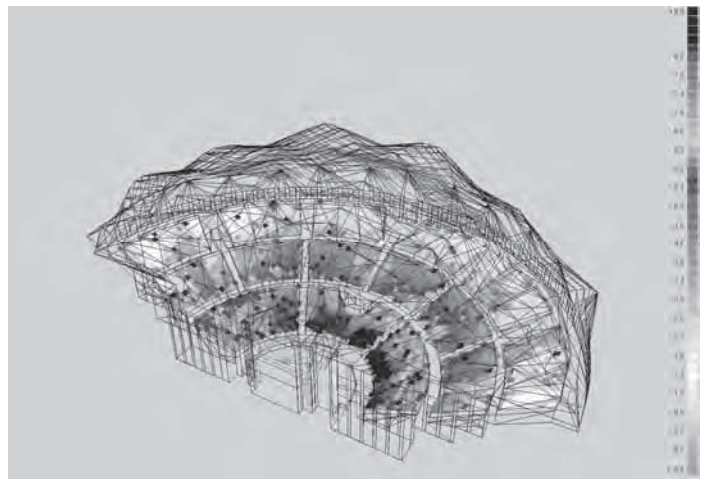
M14: Strength distribution map, for the renovated hall.

the present condition of fully occupied hall, it is obvious that the G_{pres} values decrease at the mid sides and the decrease continue at all over the back tiers, certainly worst at the back sides. The parameter is satisfactory at front tiers with values higher than 3 dB. The maps and graphs of renovated hall illustrate that the front tiers and the mid tiers except the mid sides are falling into the acceptable range, which is greater than 3 dB. The results are closer to the present condition (see Appendix-M13).
