USING REAL-LIFE CASES TO TEACH STUDENTS ABOUT ELECTRIC BURNS

Part II Secondary burns, including arcing burns

Sarosh Patel, Navarun Gupta, Buket Barkana, and Lawrence V. Hmurcik

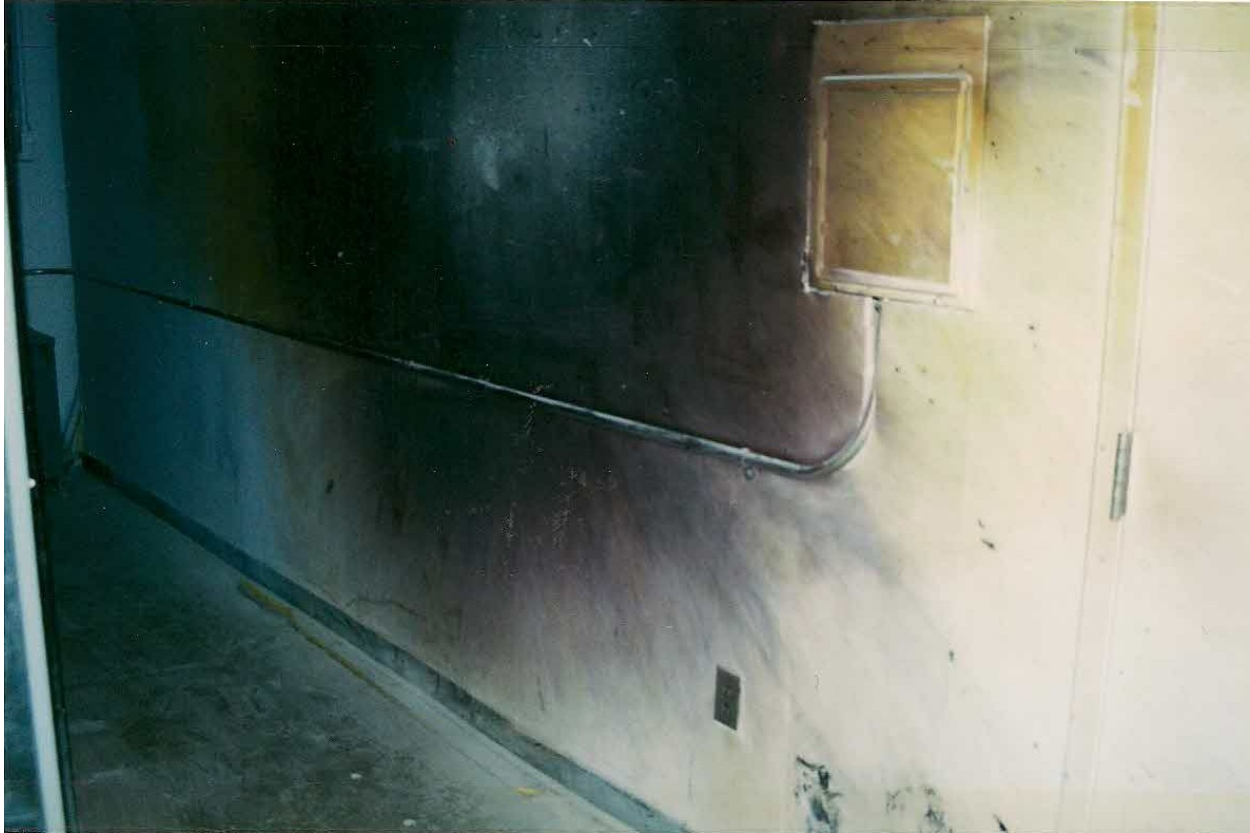
Figure 2: Steel and steel vaporized on to wall (black and purple). Copper (orange) vaporized on to wall also.

There was such a surge in power at the panel where Mr. Fixit was working that copper and steel (1/8 inch thick) vaporized into a plasma. Figure 2 shows the plaster wall facing the power panel. Black colors are due to plastic and steel being vaporized. Orange colors are due to copper vaporization. Just to be clear. The copper and steel did NOT melt. They vaporized. Not only did the vapor coat the wall surrounding the panel, it also coated Mr. Fixit. He was burned over 90% of his body. He was in the hospital for 6 months in intensive care. The electric burn he received had nothing to do with making contact with the electric source, since it was an arcing burn. It just

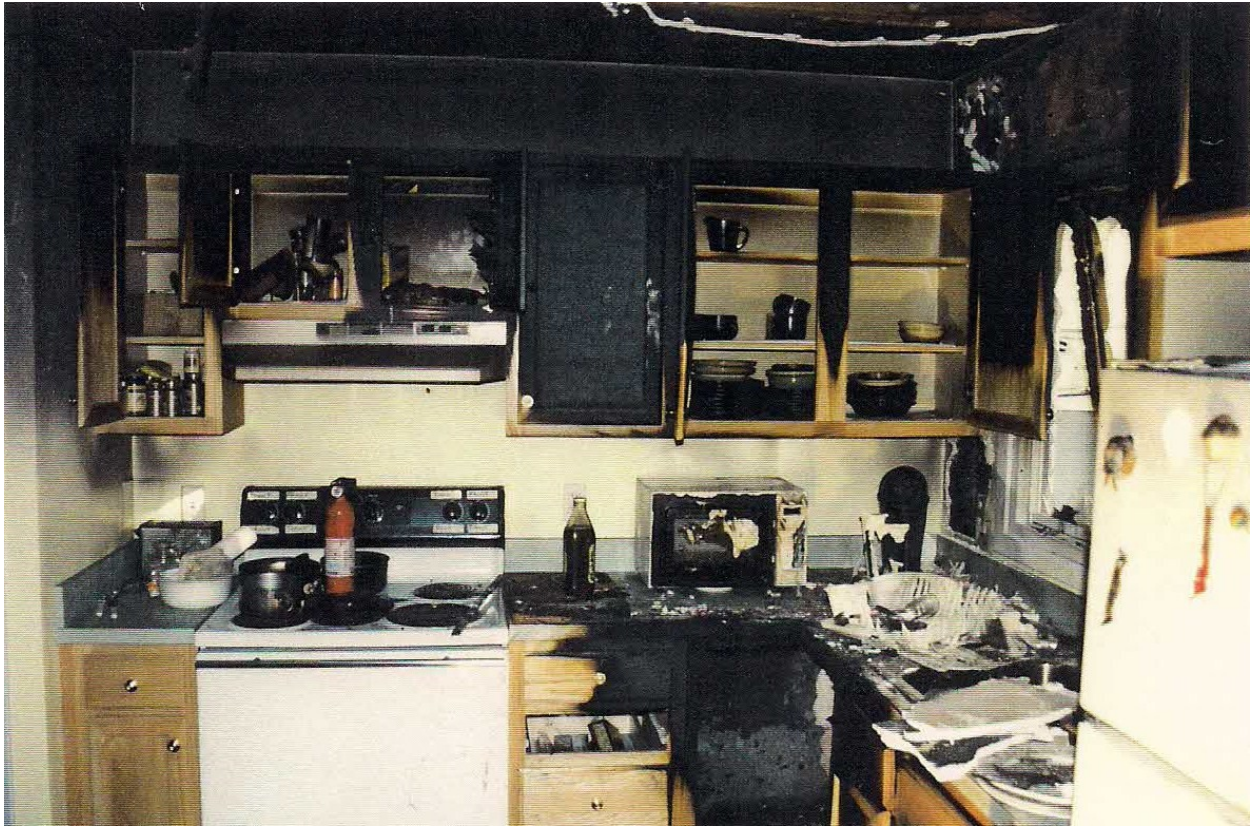
Figure 4: Damage of fire caused by fridge wire under microwave cabinet was small. However, the owner died of smoke inhalation. NOTE: fire extinguisher on top of stove, un-used.

The fire itself was small. One row of wall cabinets was damaged. A microwave oven underneath the cabinets was lost. The refrigerator was slightly blackened but functional, except for the cord leading to it. See Figure 4. The investigation found that a #12 gauge wire was run under the cabinets to the refrigerator. See Figure 5. Typically, the fridge drew 10 amps. The wire could safely carry 20 amps. Yet, the cord was the site of the ignition of the fire. How can the cord have gotten hot enough to ignite a fire when the current was only half the rated maximum? Or to put

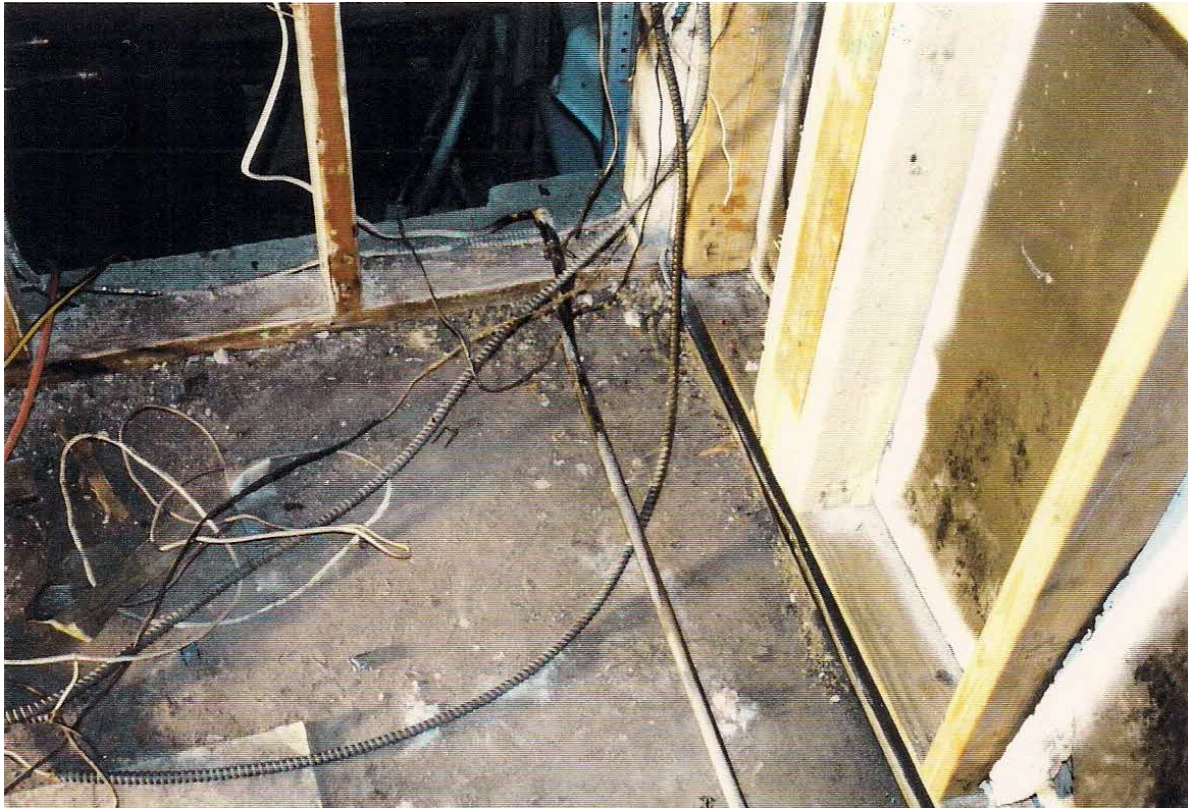
Figure 5: Fridge wire (long straight wire) was found as the point of ignition for the kitchen fire.

The cord started the fire due to the phenomenon of pyrolysis. The term pyrolysis has several definitions, especially in the subject of Chemistry. See [6]. For our purposes, it means a “slow burn”. We are used to thinking of the flashpoint of burning. For paper and most wood and wood products, ignition is at 451 degrees Fahrenheit. Temperatures under this value are considered too cool to burn or too cool to ignite a burn. In pyrolysis, a high temperature (but lower than the ignition temperature) heats up the material, and in the process it makes it more easily combustible by breaking down its structure. The process can go on for hours or weeks or even months. At some point the wood will ignite, and the temperature of ignition is lower than the normal value (451 F). When the wire was run from the far wall to the refrigerator, the kitchen cabinets were placed directly on top of them. This is sloppy carpentry on the part of the contractor, since it required extra steps in leveling the cabinets. The cabinets essentially flattened the copper wire. But apart from the sloppy carpentry, there was the additional problem of heat build up. The wire made intimate contact with the base of the wood cabinet. Over time, this wood came closer to the ignition point. After 3 months the wood ignited into a fire.

It should be pointed out that the NEC has a rule regarding the contact of cabinets and wire run in this fashion [2, 3]. The contractor must “notch” the bottom base of the wood cabinets. The wire

can then run under the cabinets with a layer of free air surrounding it. Any heat built up can then be easily dispersed, even in areas where air flow is stagnant.

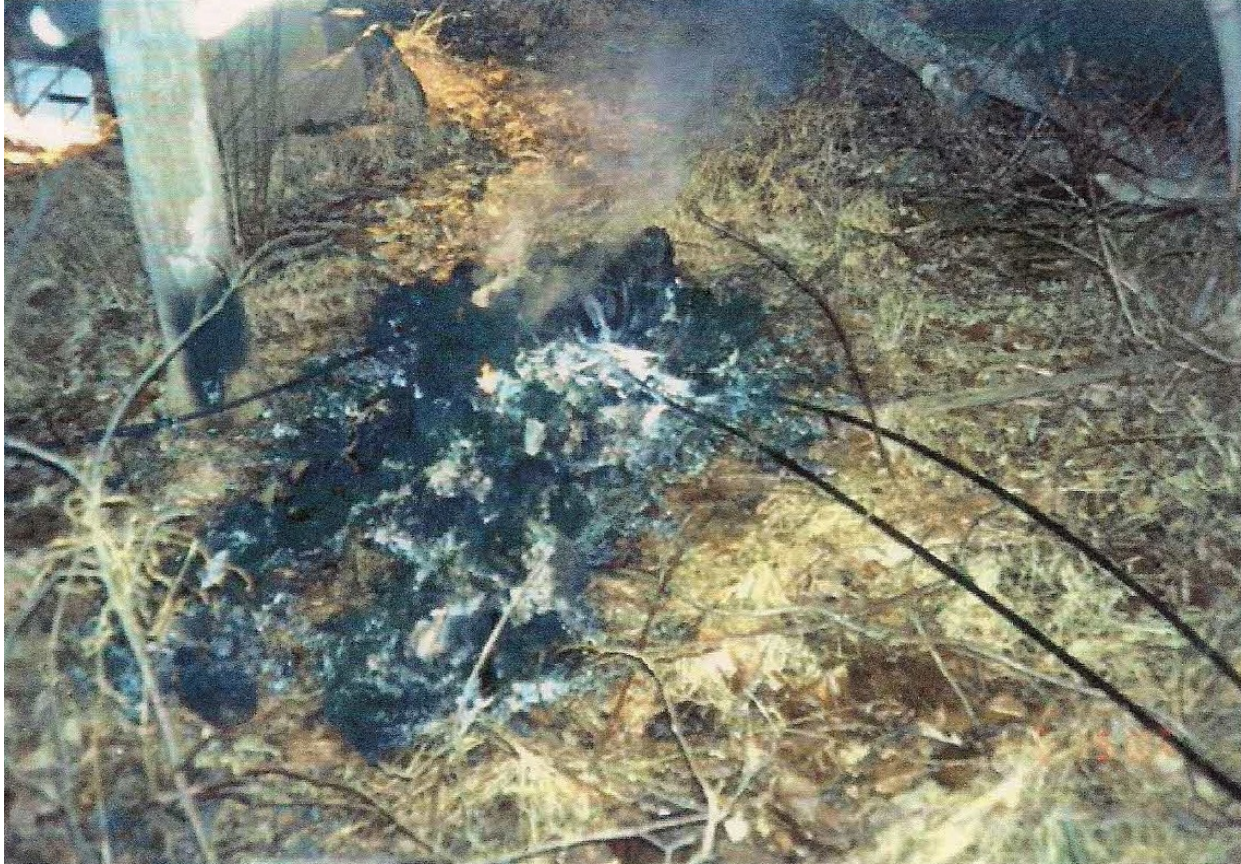
Figure 6: Body of the man burned by 5000 Volt power line falling on him.

The police/fire/first-aid crews find the homeowner or what is left of him. He is on his property in the woods, one hundred yards from the house. He is burned so badly that most of his bones are showing. Positive identification can only be made later from dental records. There is a 5,000 volt power line broken but lying on top of the man. See Figure 6. Before the rescue crew can approach, they must tell the power company to kill power to the line. There is a series of poles (aka telephone poles or power poles) from the main road. They are on the owner's estate leading through the woods to the guest house and from there to the main house.

There was one theory that seemed to make the most sense, given the bizarre circumstances and the lack of hard evidence. A tree breaks and falls on the power line. The power line is accompanied by several other wires, including a phone wire and another wire from the cable TV company. A tree is weakened by disease and age and falls. It lands on the power bundle. But the wires do not break. They support the tree. There is a break in the junction box from the tension of the tree on the wires. The house loses power. The homeowner calls the electrician. While waiting, the homeowner sees smoke in the woods. He goes to investigate. Even though the tree is supported by the wires, the power wire is broken at the junction box and at that point there would be sparking and smoke as the live line made erratic connections to ground. The owner gets close to get a better look. At that point the power wire snaps. In the fashion of a whip it springs out and lands on the homeowner. Note: the two low power cables (phone/cable TV) did not snap. They just stretched more and more as the full weight of the tree came to rest on them. They were still connected from pole to pole (though bowed in the center) when the rescue team arrived. See Figure 7. The homeowner may have been electrocuted as well as burned. There is no way to tell. The outer body was so badly burned, that death could have been by electrocution or burning or both. See Figure 6. Figure 7 shows the fallen tree, the snapped power wire, and the overly stretched TV/phone wires.

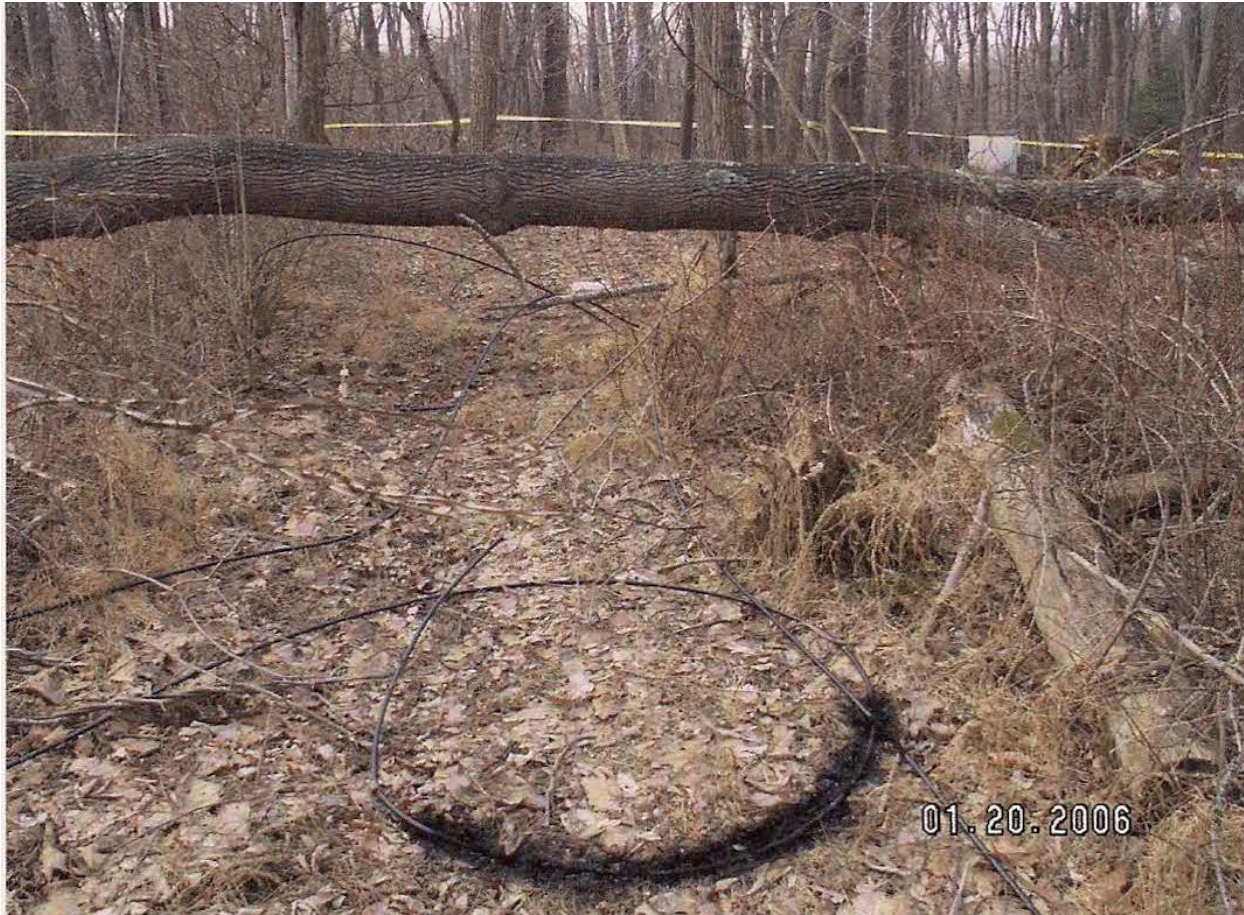
Figure 7: Fallen tree with broken power lines and stretched cable lines.
