# Real Life High Voltage Accident Cases – Teaching Electrical Safety

**Abstract** – We discuss the engineering principles of Hi-voltage (any voltage above 600 volts). We cite 4 examples that typify some of the problems facing the Engineer and technician working with Hi-voltages, including geometry considerations, the need to follow proper protocol and the laws (both scientific and political) governing Hi-voltage. Poor design considerations in capacitor construction is the first case we consider, as well as the lack of proper protocols in discharging same. In the second case, a warning can be made that one should never get too close to a Hi-voltage line, unless the power is cut. In the third case, following simple rules in measurement of an unknown voltage could avoid a serious accident. In the fourth case, a high voltage shows up in a low-voltage circuit. These unfortunate cases are used as teaching tools to impart details of electrical safety in common industrial setting.

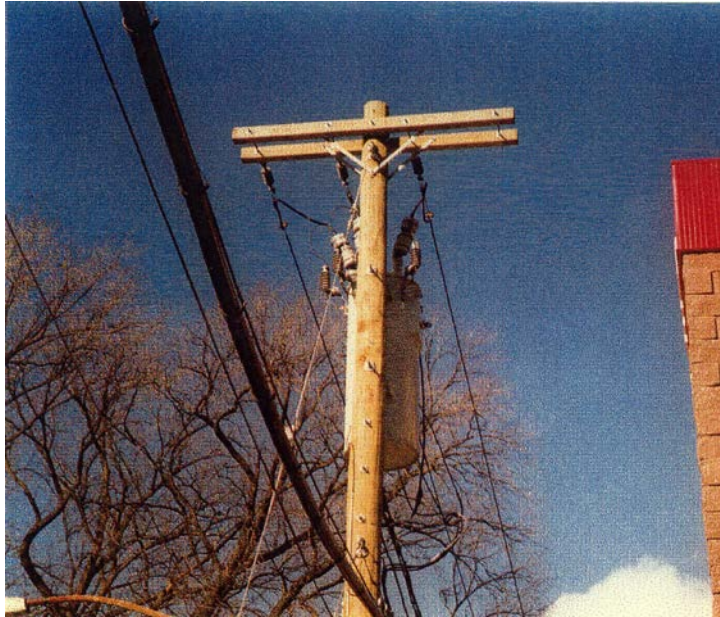
A sign hanger is working on the outside wall of a building housing a factory in New York. The contractor has his worker go up in a bucket boom (aka cherry picker). The contractor is licensed by the city. His project is near a power line that feeds power to the factory. The voltage in the power line is 13,000, 3-phase. A transformer on the pole converts this to 220/120 volt at 3-phase, and sends this in to the factory. The worker is very successful in completing the work on the outside wall. He finishes over 90% of the sign. Then, suddenly, he slumps over in the lift bucket. He is being electrocuted via asphyxia [2, 8, 34]. He can not breathe. A co-worker is located on the roof of the factory at the same level as the first worker. He reaches out toward the bucket to grab the first worker. But then, the co-worker suddenly is struck with muscle pain and burned over the greater part of his stomach. Electricity is now forming 2 circuits. It leaves the pole, travels through the air, and goes into the first man. At this point, the electricity splits. Some of it leaves the first man by his upper torso and enters the second man who is grounded by contact with metal capping at the roof ledge. The electricity also leaves the first man at various points on his body and enters the bucket of the boom which is in contact with ground. The truck that supports the boom has metal feet placed down on the flat sidewalk for added mechanical strength. Later, after the truck is moved, there are burn marks on the sidewalk where the feet were placed in contact with the sidewalk. This is proof that electricity went through the boom to ground.

Figure 2. Telephone pole with 3-phase 13,000 Volt power cable near building (right) where accident occurred.

Simply stated, the sign hanger was too close to the power source. His boss (a licensed sign hanger) failed to measure the proper and safe distance to keep from the power line. Alternatively, his boss could have contacted the power company to shut off the power, and he did not. The power company had the power wires close to the factory because the wall nearby was a non-maintenance wall, i.e. there was no indication of any activity that was to be carried on near that wall. As an example, a wall with a door or window is a maintenance wall. It would be expected that people would be entering the door or standing near an open window. Similarly, after the sign was installed, it too became a maintenance wall. But these facts should have been reported to the power company before the sign was placed.

Contact the power company before you work near a hi-voltage line (any line with voltages of 600 volts and up). Alternatively, if you are using a boom or ladder or scaffolding, it is always a good thing to isolate it from ground. However, this might not be something that is always practical in the field.

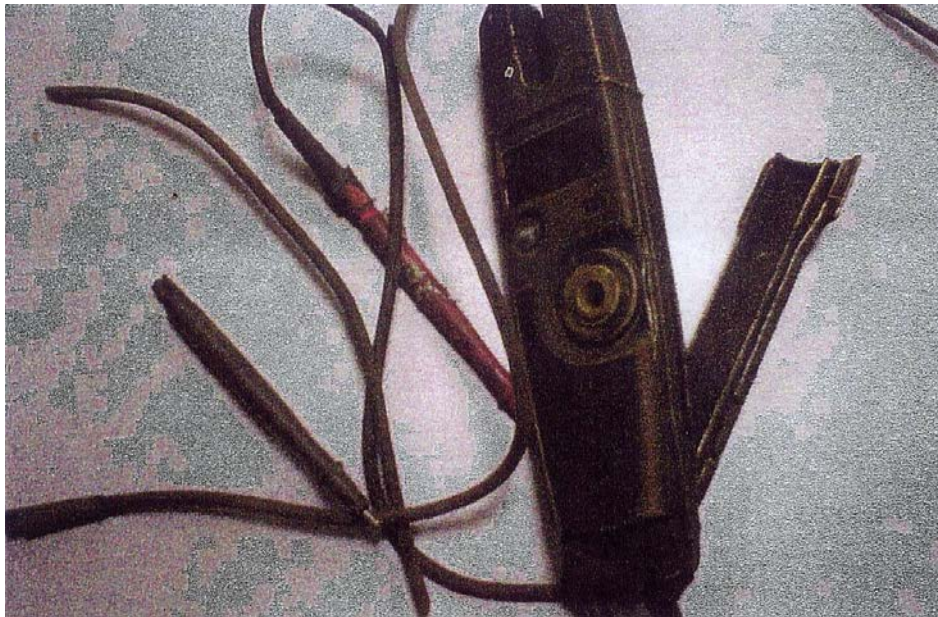
Instead of hooking his meter leads between ground and one leg of the 3 phases to measure 2300 volts, our Master Electrician hooks his two meter leads across two different phases. This is a shortcut. By doing so, he can cut his testing time in half; if the voltage is proper, he can verify 2 phases with one measurement. But this is dangerous, if the voltage is unknown.

Figure 3. Bright yellow fluke multi-meter is badly blackened (burnt) as a result of measuring 4000 Volts.

A voltage of approximately 4000 volts spans the electrician's meter. Note: for any two phases in a 3 phase system, the phase-to-phase voltage is the single phase voltage (2300) multiplied by the square root of 3, or approximately 4000 volts. This large voltage causes a massive current to travel into the meter. The meter is instantly burned and on fire. The current does not stop there. It continues to travel into the electrician's work gloves and into his hands and chest. He is severely burned. Eventually after a very long illness, he will die. Note: his work gloves are rated at 800 volts – they are safe for low voltages but they are not safe for high voltages.

Follow the proper protocol when measuring any unknown voltage. Do not assume that your measurements are safe for the voltage you think you are measuring. Always tell yourself things like “suppose this voltage is much higher” or “suppose the label on the voltage is wrong”. Also, note that many electricians now use proximity voltage testers to assess power of an unknown source. See [1, 14]. These often fail to tell the exact voltage of the source, but they can determine the order of the voltage as being very low or simply low or high or very high. But these testers are incredibly safe in that there is NO need to actually touch or sample any electricity from the circuit under test.

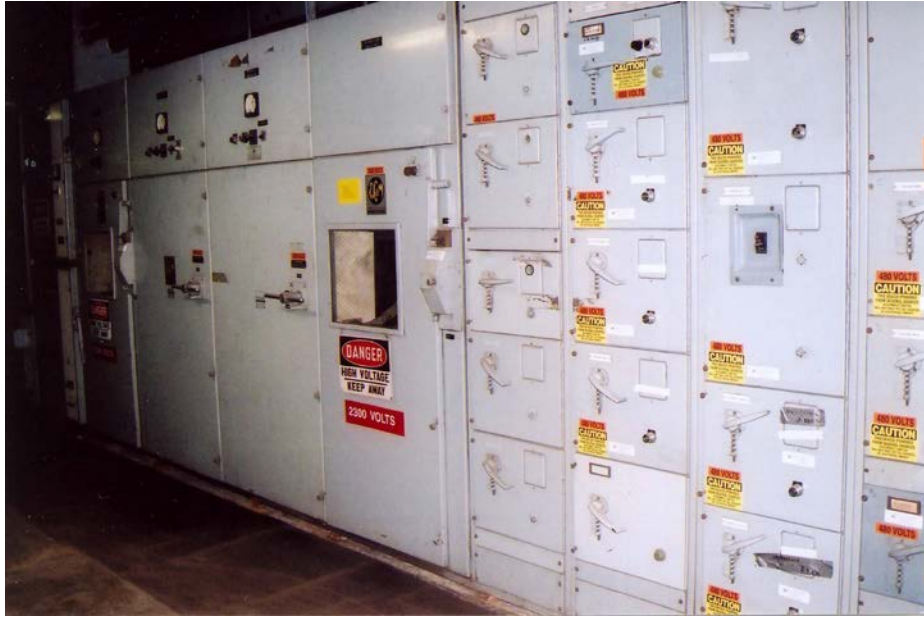
The power from this source is fed into the warehouse and into one particular closet, almost identical to dozens of other electrical closets near it. Of the 300-plus electric closets, this is the only one that is high voltage. There is a large sign on this closet that reads: "Danger 2300 volts". There is a small sign (about one inch square) that reads the same thing. The closet is locked with a padlock. This dangerous voltage obeys the Lock-Out-Tag-Out protocol enforced on all dangerous voltages.

Figure 4. A sampling of the more than 300 electrical closets at a very large food warehouse in New Jersey.
