IMPACT OF FIRE ON STEEL REINFORCEMENT OF R.C.C STRUCTURES

**Master of Technology
in
STRUCTURAL ENGINEERING**

**Department of Civil Engineering
National Institute Of Technology
Rourkela
2007 - 2009**

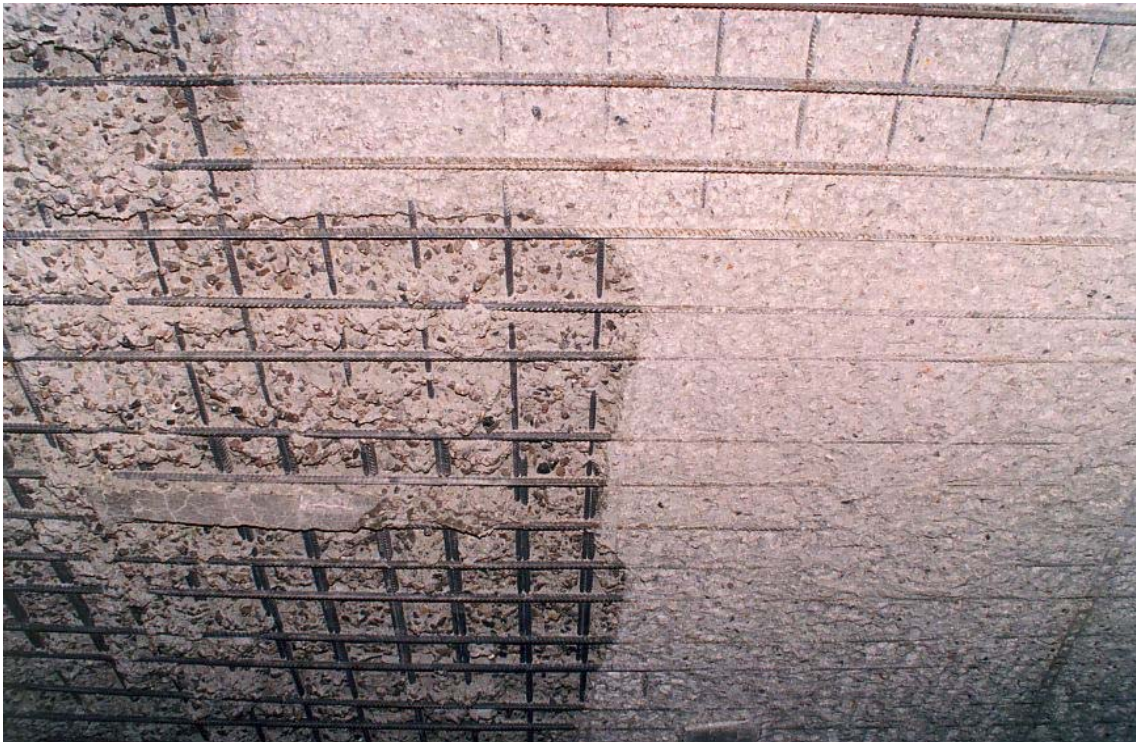
Fig 1.1: fire damaged slab

1. Most of the structures were repaired. Of those that were not, many could have been but were demolished for reasons other than the damage sustained.
2. Almost without exception, the structures performed well during and after the fire.

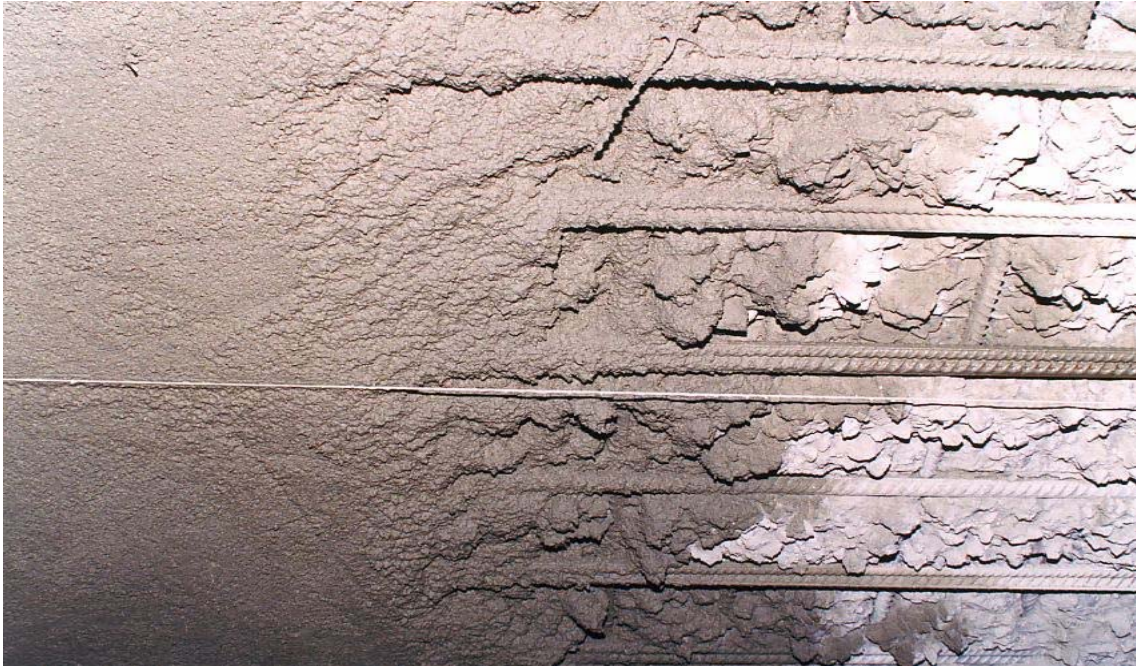
Fig 1.2: concreting of fire damaged slab

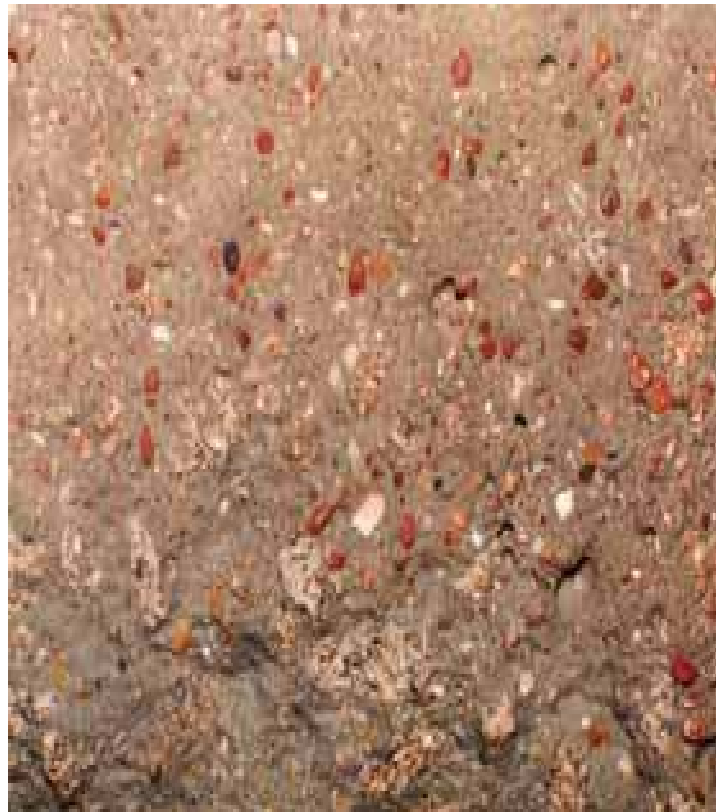
Fig 1.4: Color change in the concrete due to elevated temperature

The color of concrete may change as a result of heat due to fire may and may give an idea of the maximum temperature attained. A correlation between the decolouration due to fire and a possible temperature attained is available in technical report no.33:assessment and repair of concrete structures by concrete society, U.K. Due to fire decolouration takes place and the possible change in concrete is normal, pink, whitish grey and puff.

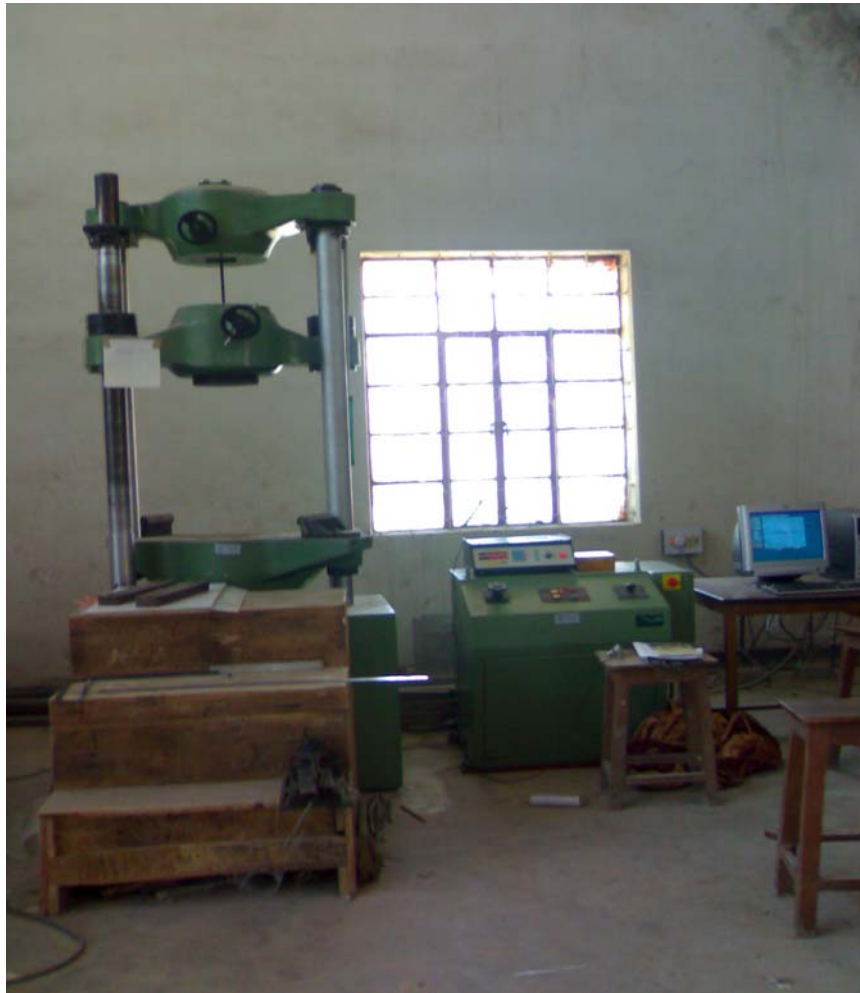
Fig 2.1: UTM testing setup

The 12mm steel bar is cut to a length of 40 cm and gave a gauge length of 60mm. The specimen is fixed on the machine and the required data on the computer is given. Test is conducted at a load rate of 300 kg/min for all the specimens. An extensometer is fixed to the specimen during the test to read the elongation. The data of the test is noted in computer during the test by default s it is setup. The graph of load versus deformation and load versus elongation is drawn on the computer. After the test all the other parameters like ultimate load, maximum extension in mm, area in mm², ultimate stress, elongation in percent, reduction in in area, young's modulus, yield stress, .1% and .2% proff stress and many other parameters can be observed.

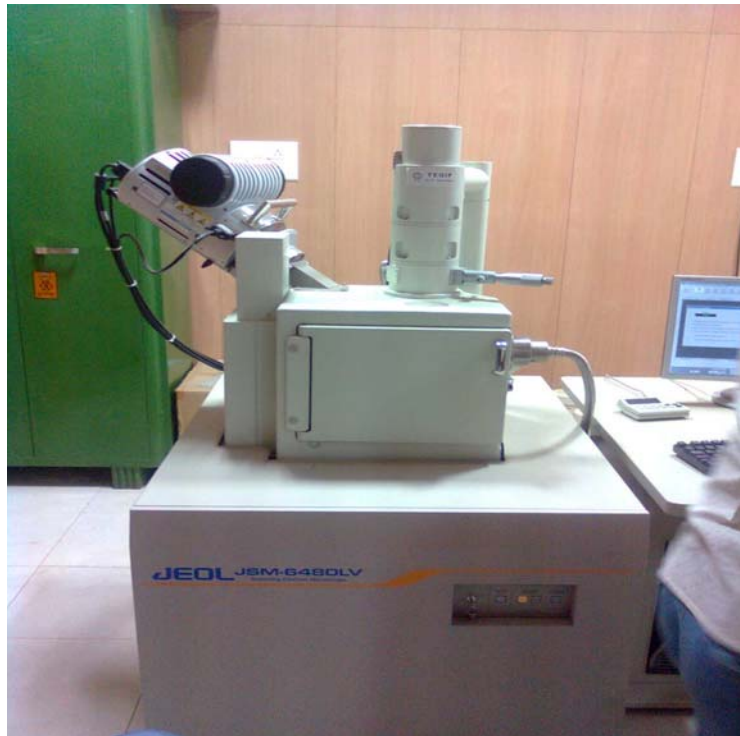
Fig 2.3: Setup of SEM

Scanning Electron Microscopy has done by JSM- 6480LV at magnification of 5 microns (x5000) and 10 microns (x1000). The specimens are made in a size of 12mm diameter and 10mm length. Before testing the specimens are to be finely polished in all the edges and neatly cleaned with acetone for the clear view of the grain size and grain structure.

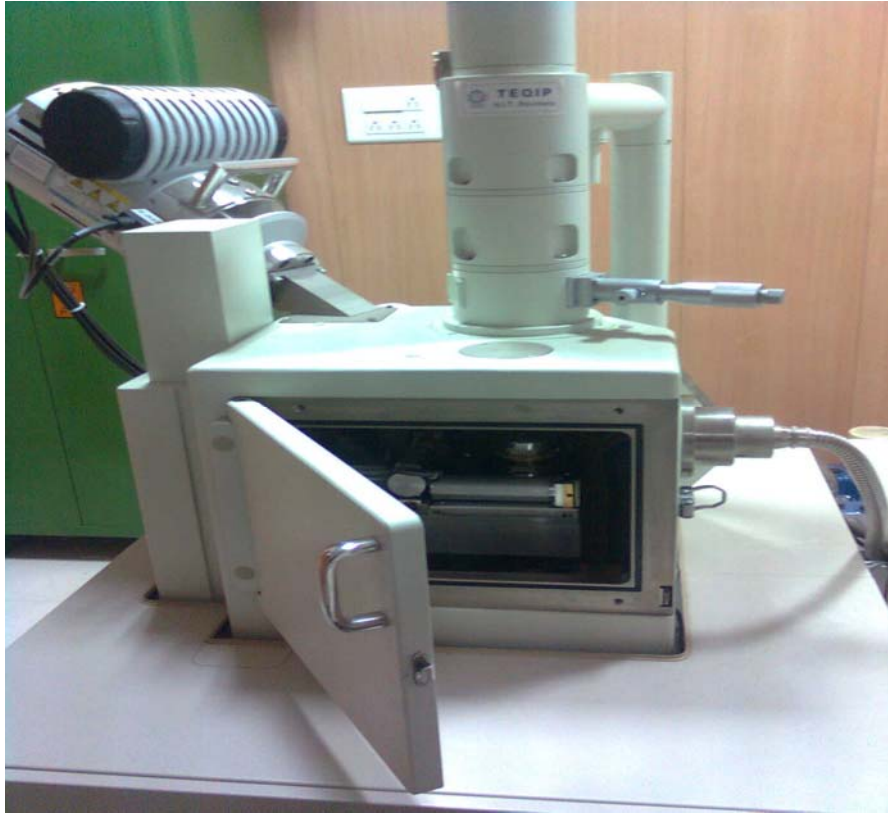
Fig 2.4: Inner view of SEM

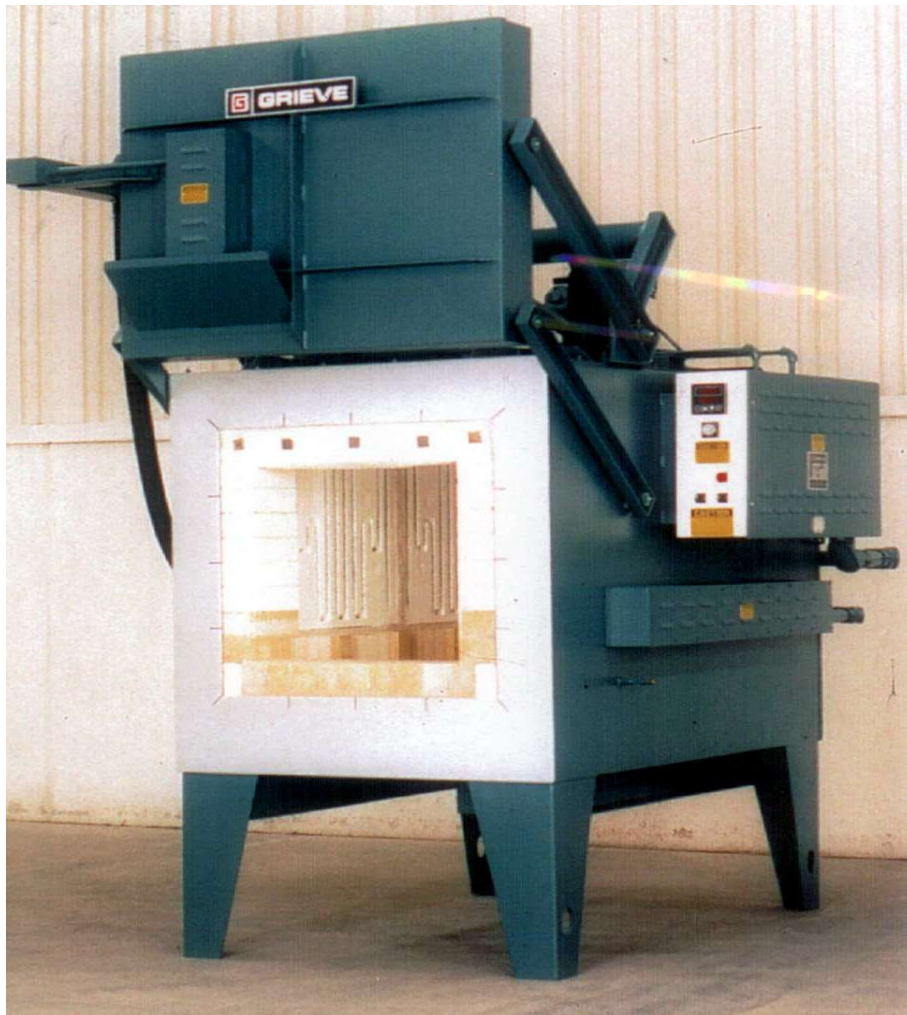
Fig 2.6: Electric furnace

The electric furnace is used to heat the specimens. The maximum temperature attained in this furnace is 1000°C. The inner depth of the furnace is 45mm. initially the furnace is heated to the required temperature by switching on it and when the required temperature is attained then 6 specimens put inside with the door closing tightly so that no air enter inside. The specimens are kept for a duration of 1 hour inside the furnace and later 3 specimens are quenched in water for rapid cooling and the other 3 are kept aside for atmospheric time. The 3 specimens which are quenched in water are removed after 15 minutes. Each time 6 bars are kept at temperatures of 100°C, 300°C, 600°C, 900°C and the same is repeated.

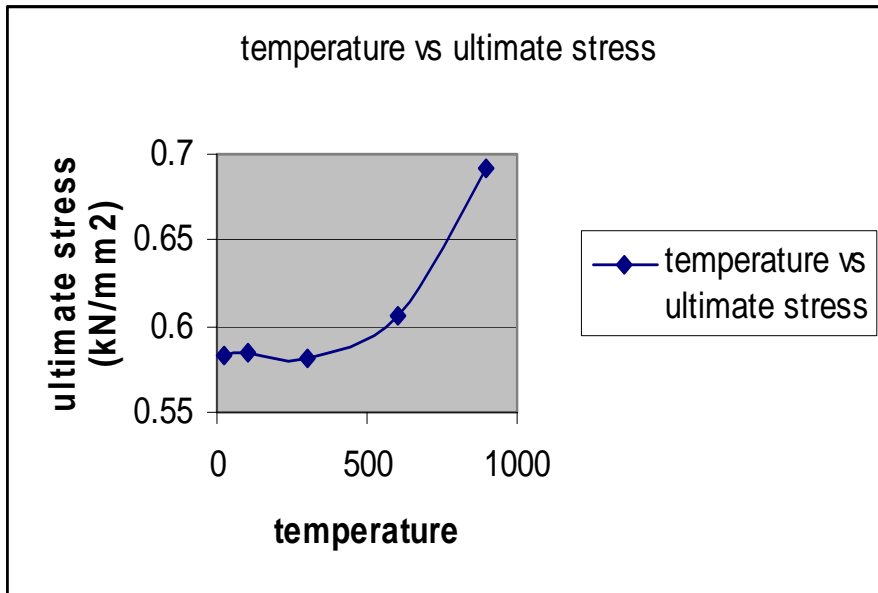
Fig 3.3: Temperature vs Ultimate stress

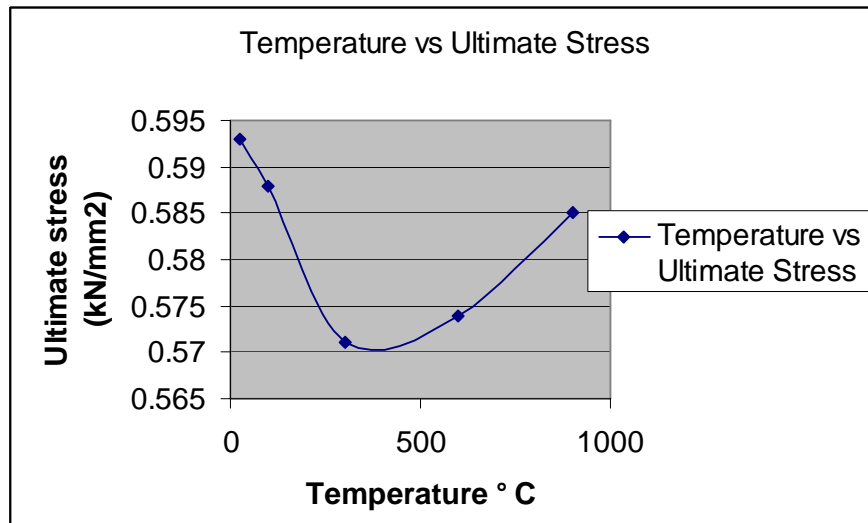
Fig 3.6: Temperature vs Ultimate stress

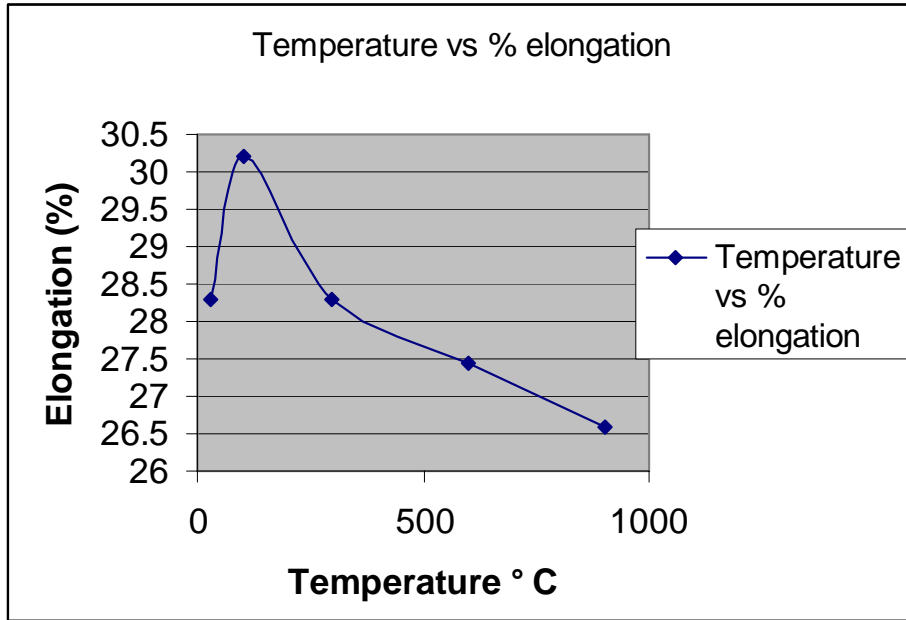
Fig 3.7: temperature vs elongation

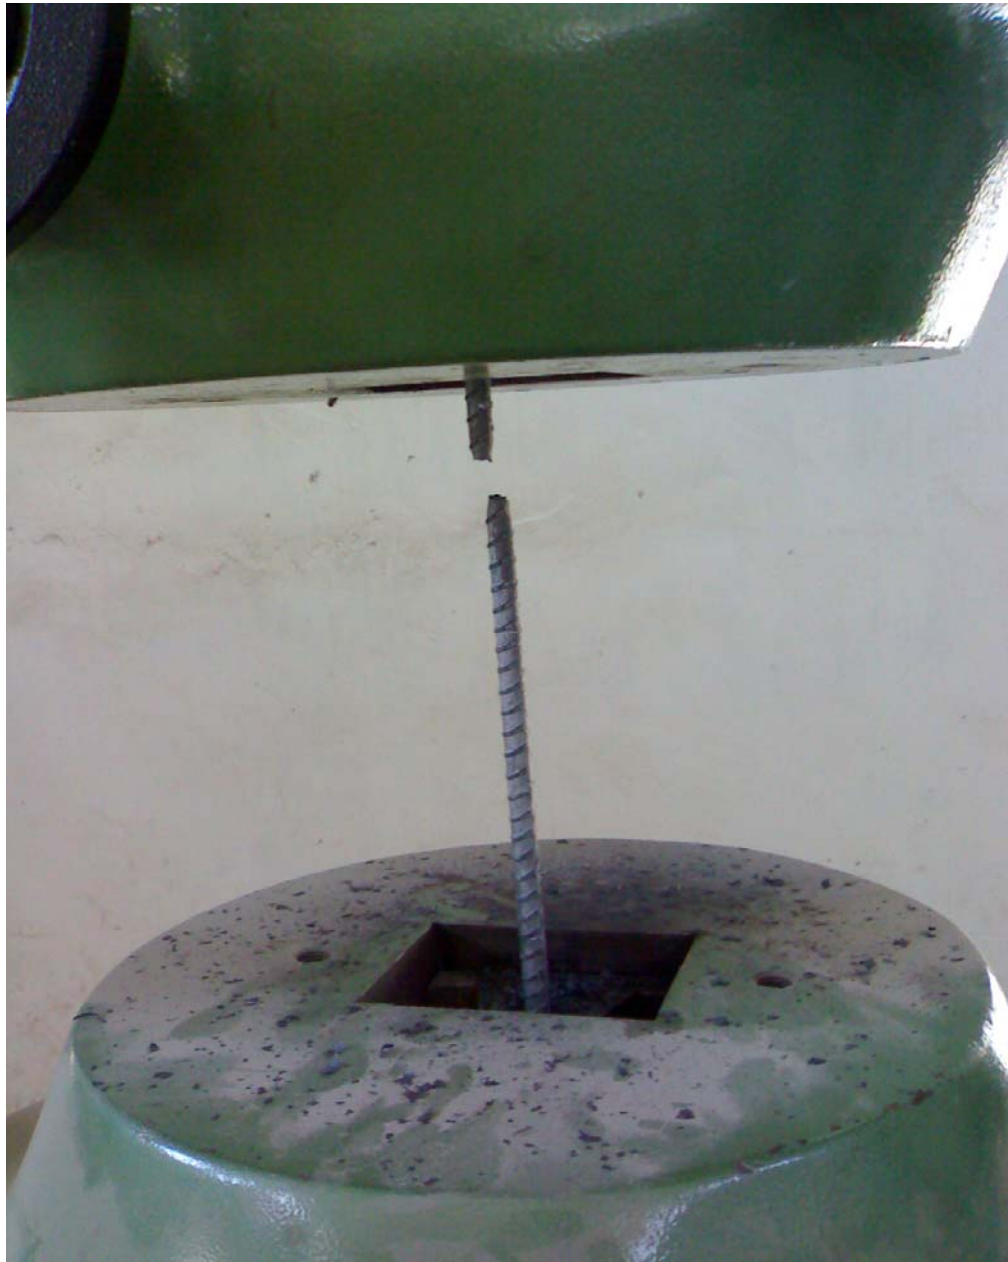
Specimen failed on UTM

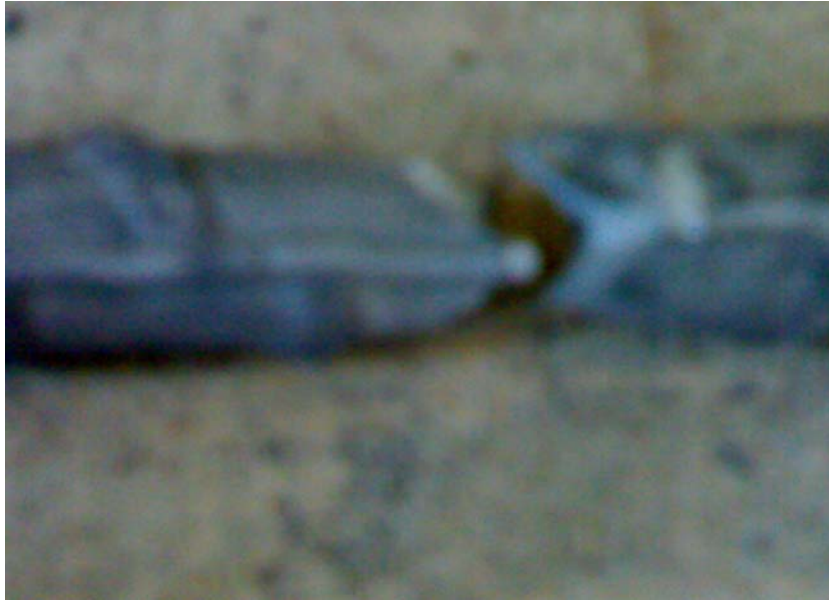
Failed specimen

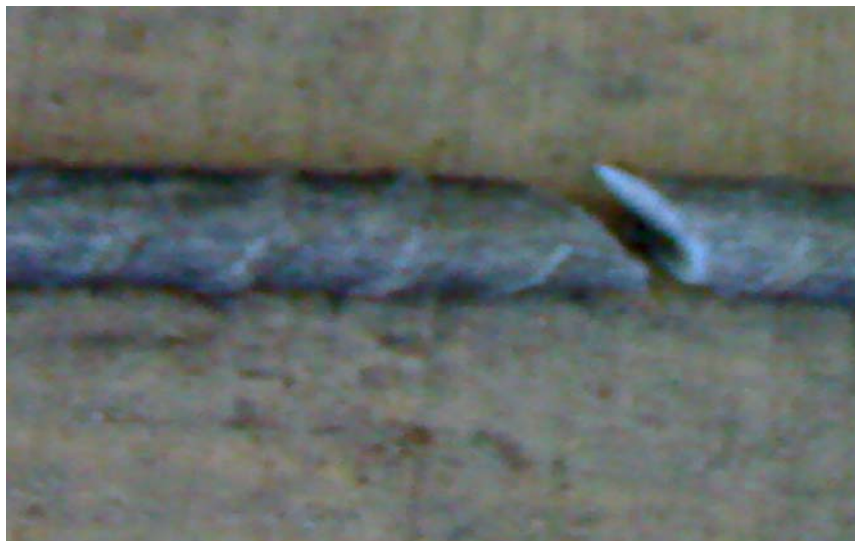
Shear failure of specimen
