# ENERGY SAVINGS IN BUILDING RESTORATION - AN APPLICATIVE CASE

Silvia Pennisi<sup>1</sup> & Gianluca Scaccianoce<sup>2</sup>

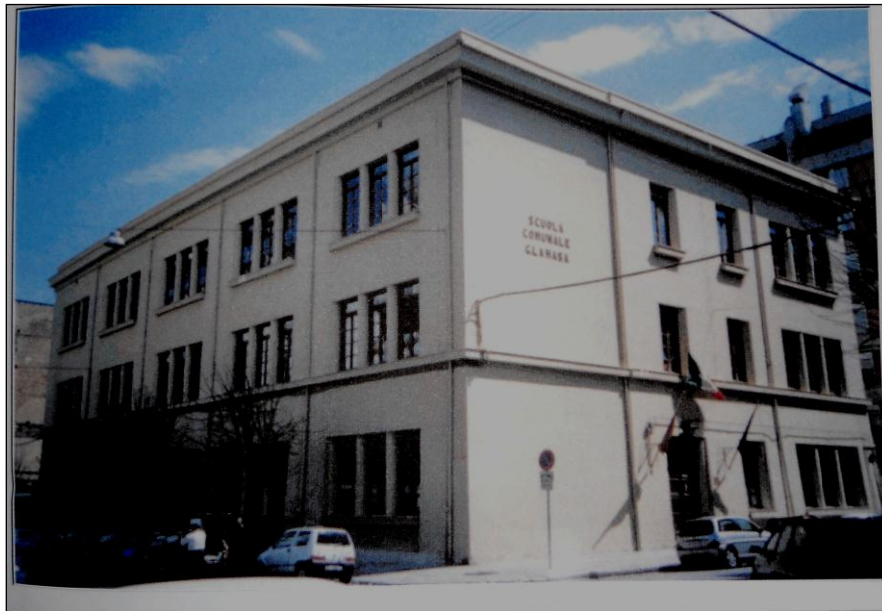
In the 1990, the school was refurbished and was checked the structural integrity of building (see Fig.7).

**Figure 7: Photography of the school façade in 1990.**

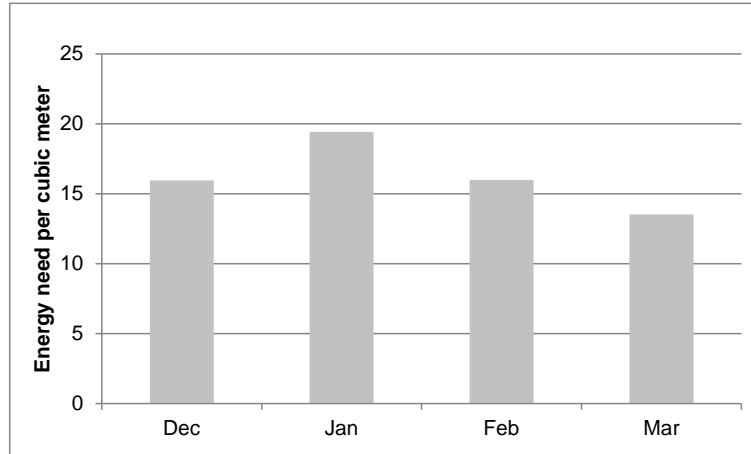
It is certainly more useful to know the energy need per cubic meter that, in this case, is equal to 64,9 MJ/m<sup>3</sup>. The Figure 10 shows the trend of the energy need per cubic meter during the heating season.

Figure 10: Percentage distribution of energy need for heating

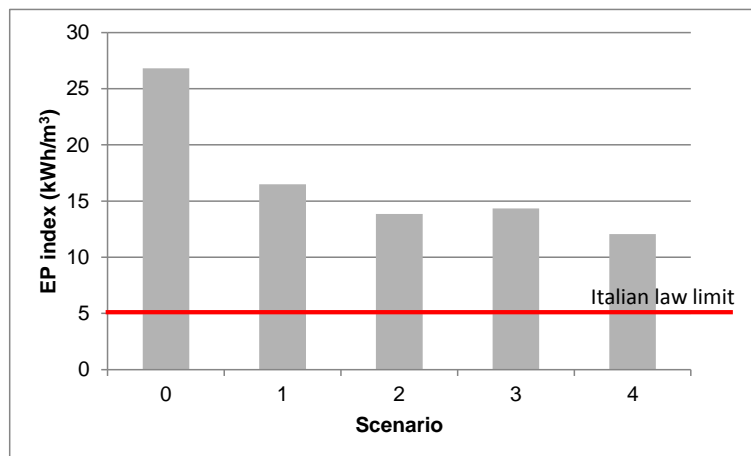
The proposed action scenarios influence considerably the energy consumption of building; in fact, these actions reduce the energy consumption between 38.5% to 55.1%. However, none of these actions is able to cut down the energy consumption so much so that the Energy Performance index goes below the law limit value (see Fig. 11).

Figure 11: Graph of the EP index of various scenarios.

The scenarios 2 and 4 are necessary to achieve the level of insulation required by Italian law “D.Lgs 192/05” (ITALIAN DECREE n.192, 2005), but both of them are not economically viable even unacceptable (payback times are longer than the useful life of interventions); on the contrary, the scenarios 1 and 3 are economically viable.

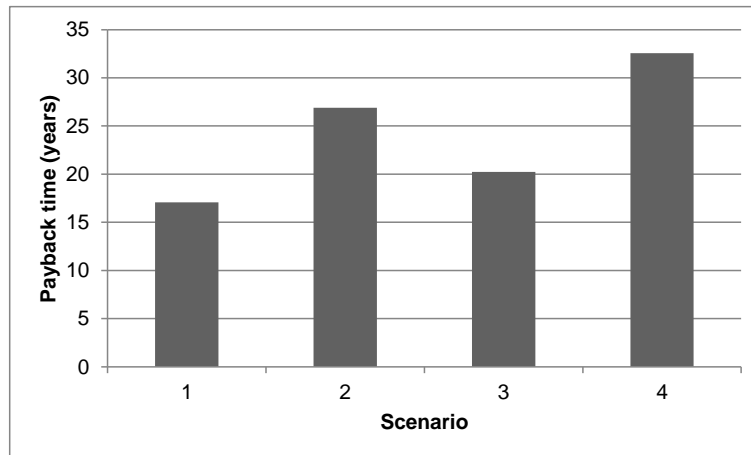
With regard to financial statement analysis, the payback times of action scenarios are assessed in order to evaluate the profit of each scenario (see Fig. 12).

**Figure 12: Graph of the payback time of various scenarios.**
