EXPERIMENTAL INVESTIGATION ON A GEOCONTAINER SUBMERGED REEF

B. CAMMAROTO⁽¹⁾, C. FARACI⁽¹⁾, G.B. FERRERI⁽²⁾, E. FOTI⁽³⁾

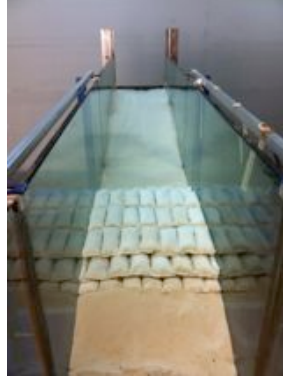
Figure 2 Picture of the geocontainer submerged reef model that was adopted in the present experimental campaign.

The submerged reef was built with geotextile sandbags. Models of sandbags were made with a 1:50 model to prototype scale ratio (Figure 2).

Each GSC was realized by making first: the geotextile casing, which was left open by one for the filling operations. It was then filled with sand characterized by a mean grain size $d_{50} = 1.4$ mm sand and finally the last side was closed, making sure to verify the size of the model. Each GSC weighted 320 g at a model scale. 80 GSC were made and the model of the submerged reef was built as shown in Figure 2. Table 1 shows the geometric characteristics of the structure, respectively, at a prototype scale and at a model scale. More exactly, the length of the bags in the direction of the wave motion is indicated with l_c , while the width of the bags in the transverse direction is indicated with b_c and the height of the bags with h_c .

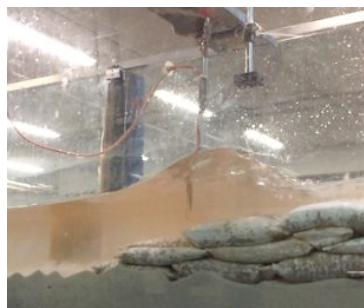
Figure 5 Test with coloured ink.

To study the wave-structure interaction, colored ink was also spilled in the channel with a needle (Figure 5). The needle was positioned 3 cm offshore from the GSC and 2.5 cm below the still water level. The test was done with a wave of $H_i = 3$ cm and $T = 1$ sec at a model scale. The ink showed the classic elliptical particles of fluid profile under the wave crest and the overall movement of the water flow, pushed by the wave, towards the reef structure. Under these conditions the ink is transported by the wave in the offshore direction for about $2/3T$ and for about $1/3T$ in the onshore direction. Clearly the time is subject to the error of the operator. This information shows that for this wave condition close to the reef the flow becomes asymmetric. The ink showed also that the water seeping under the bags exerts an upward thrust on the GSC, exactly when the crest of the wave passes, causing instability and accumulation of sand in the gaps of the structure.

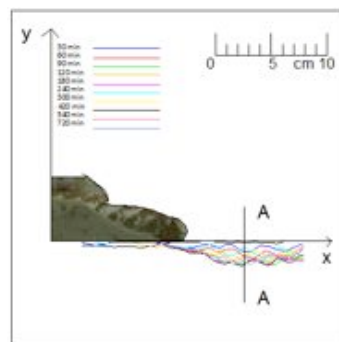
Figure 6 Beach profiles at the toe of the structure: a) Regular wave $H_s = 3.6$ cm b) Random wave $H_s = 1.8$ cm c) Regular wave $H_s = 4.6$ cm.

Beach profiles were plotted for all three tests after 30 min, 60 min, 90min, 120 min, 180 min, 240 min, 300 min, 420 min, 540 min, 720 min from the beginning (Figure 6). Then, the scour at the reef toe was also measured (Figure 7). In the test001 (Figure 6 a)) initially the material is transported offshore and determines a scour at the toe of the reef (t=0-90min), after that it accumulates near the reef (t=90-420 min), and then it reaches the maximum scour at the end of the test, i.e. after 12 hours. In the case of random wave test002 (Figure 6 b))the scour reaches its maximum value at 540 min and then it basically remains constant until the end of the test. In this case it is also visible that the sand reaches an equilibrium profile that is maintained till the end of the test. The scour causes serious problems of instability of the structure. In the case of random waves scour takes place since the beginning of the test (30 min.) (Figure 6 b)). In test003 the scour at the reef toe was also measured (Figure 6 c). During the tests initially the material accumulates near the reef (t=0-180 min), after that it is transported offshore and determines a scour at the toe of the reef. The maximum scour is reached at the end of the test, i.e. after 12 hours. In both the cases of regular waves test001 and test003, the scour at the toe occurs after a longer time, but it is more severe (Figure 6 a) and c)). The results are synthesized in Figure 7, where the scour evolution, made non dimensional with the maxim scour, is reported.

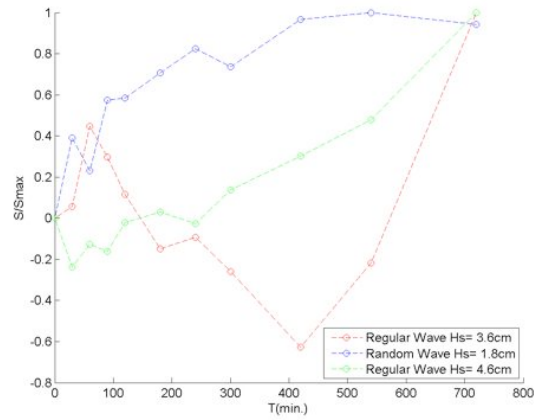
Figure 7 Non dimensional scour evolution.

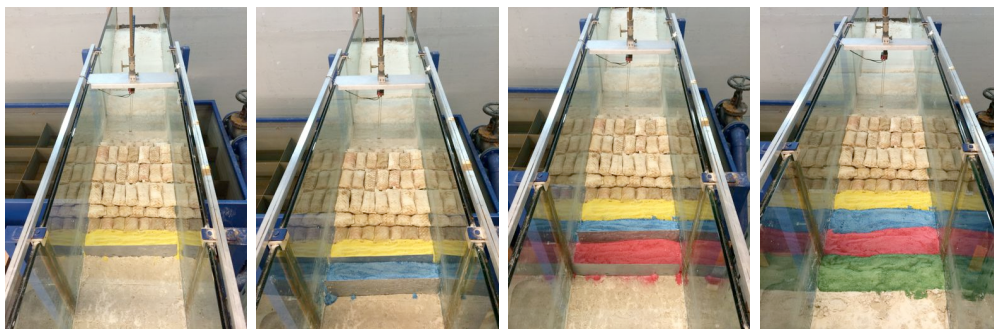
Figure 8 Installation of coloured sand

As said before, in the test003 the upper 3 cms of sand were replaced with colored sand. Once colored, the sand was prepared in strips of a width of about 5 cm in yellow, blue, red and green. To prevent the mixing of different color sand, during the tests a separator plate was used, as shown in Figure 8.

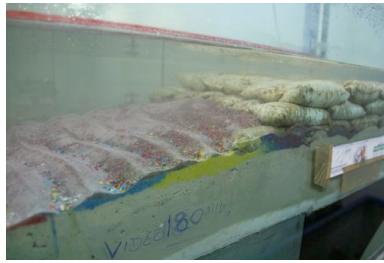
Figure 9 The red and the blue sand overcame the yellow layer (t=003min).

The test003 more clearly illustrates the sediment transport processes. After the first three hours of experiment, the amount of sediment entrained in the barrier is significantly higher than the outgoing amount (almost absent). After 180 minutes, the red and the blue sand overcame the yellow sand and after some time they led to an accumulation inside the reef. (Figure 9) The green sand was mainly transported offshore towards the wave maker and only in a small part towards the other three colored layers. Moreover the first row of geotextile bags was completely submerged by the sand, while the second row was partly covered by sand. This may affect the response of the barrier to the wave: the beach slope changed leading to an anticipation of the wave breaking. Moreover the permeability of the structure completely differed from the initial one, as the sand occupied almost all the space between bags.

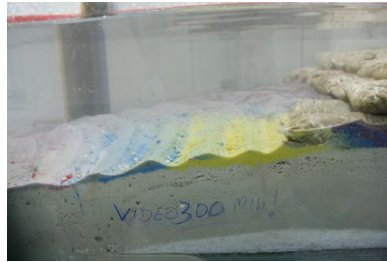
Figure 10 The model at t=300min.

After the first three hours the yellow sand (Figure 10), which was completely submerged by red and blue sand, (t=300min) is now visible, because the material that was accumulated over it and over the first and second rows of bags was transported in part towards the interior of the barrier, up to determine small accumulations over the structure itself (beach side) (Figure 11a), and partly offshore (Figure 11b). This is clearly a beneficial effect in response to coastal erosion in on-shore side.
