THE DIAGNOSIS OF ROAD SURFACE DISTRESSES THROUGH IMAGE-BASED MODELING TECHNIQUES. EXPERIMENTAL SURVEY ON LABORATORY-RUTTED SAMPLES.Laura Inzerillo^{1,2}, Gaetano Di Mino^{2,3}, Francesco Di Paola^{1,2}, Silvia Noto^{2,3}¹Department of Architecture, University of Palermo, Palermo, Italy²Euro-Mediterranean Institute of Science and Technology (IEMEST), Palermo, Italy³Department of Civil, Environment, Aerospace, of Materials Engineering, University of Palermo, Palermo, Italy**CORRESPONDENCE:**

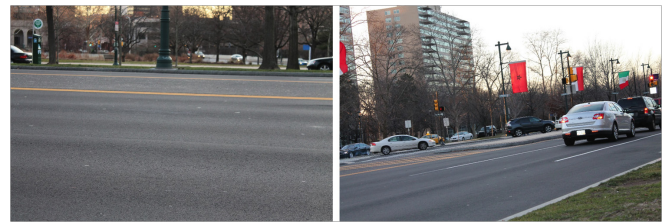
Fig. 1. Full scale rut depth: depression in the wheel path.

Rutting is a phenomena consisting of a gradual dip in the road surface, more or less localized; namely a depression in the wheel path (Fig. 1). It may also present with pavement uplift along the side of the rut.

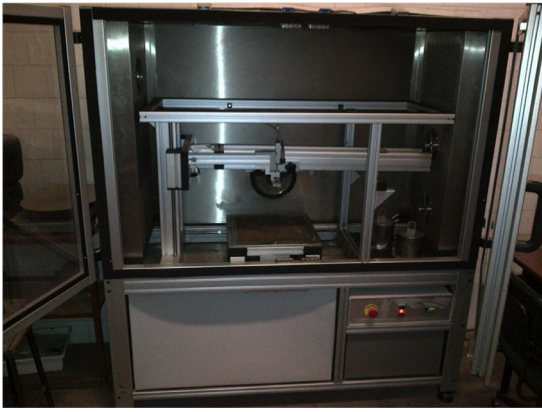
Fig. 2. Wheel Tracker Machine used in DICAM's laboratory.

In the end, the slab was tested for rutting behavior [UNI EN 12697-22] by means of a Wheel Tracker Machine (WTM). The final rut depth was 9.1 mm.
