SHORT REPORT

Analyzing the 27 July 2021 rainfall-induced catastrophic landslide event in the Kutupalong Rohingya Camp in Cox's Bazar, Bangladesh

A. S. M. Maksud Kamal¹, Farhad Hossain², Bayes Ahmed^{3*}

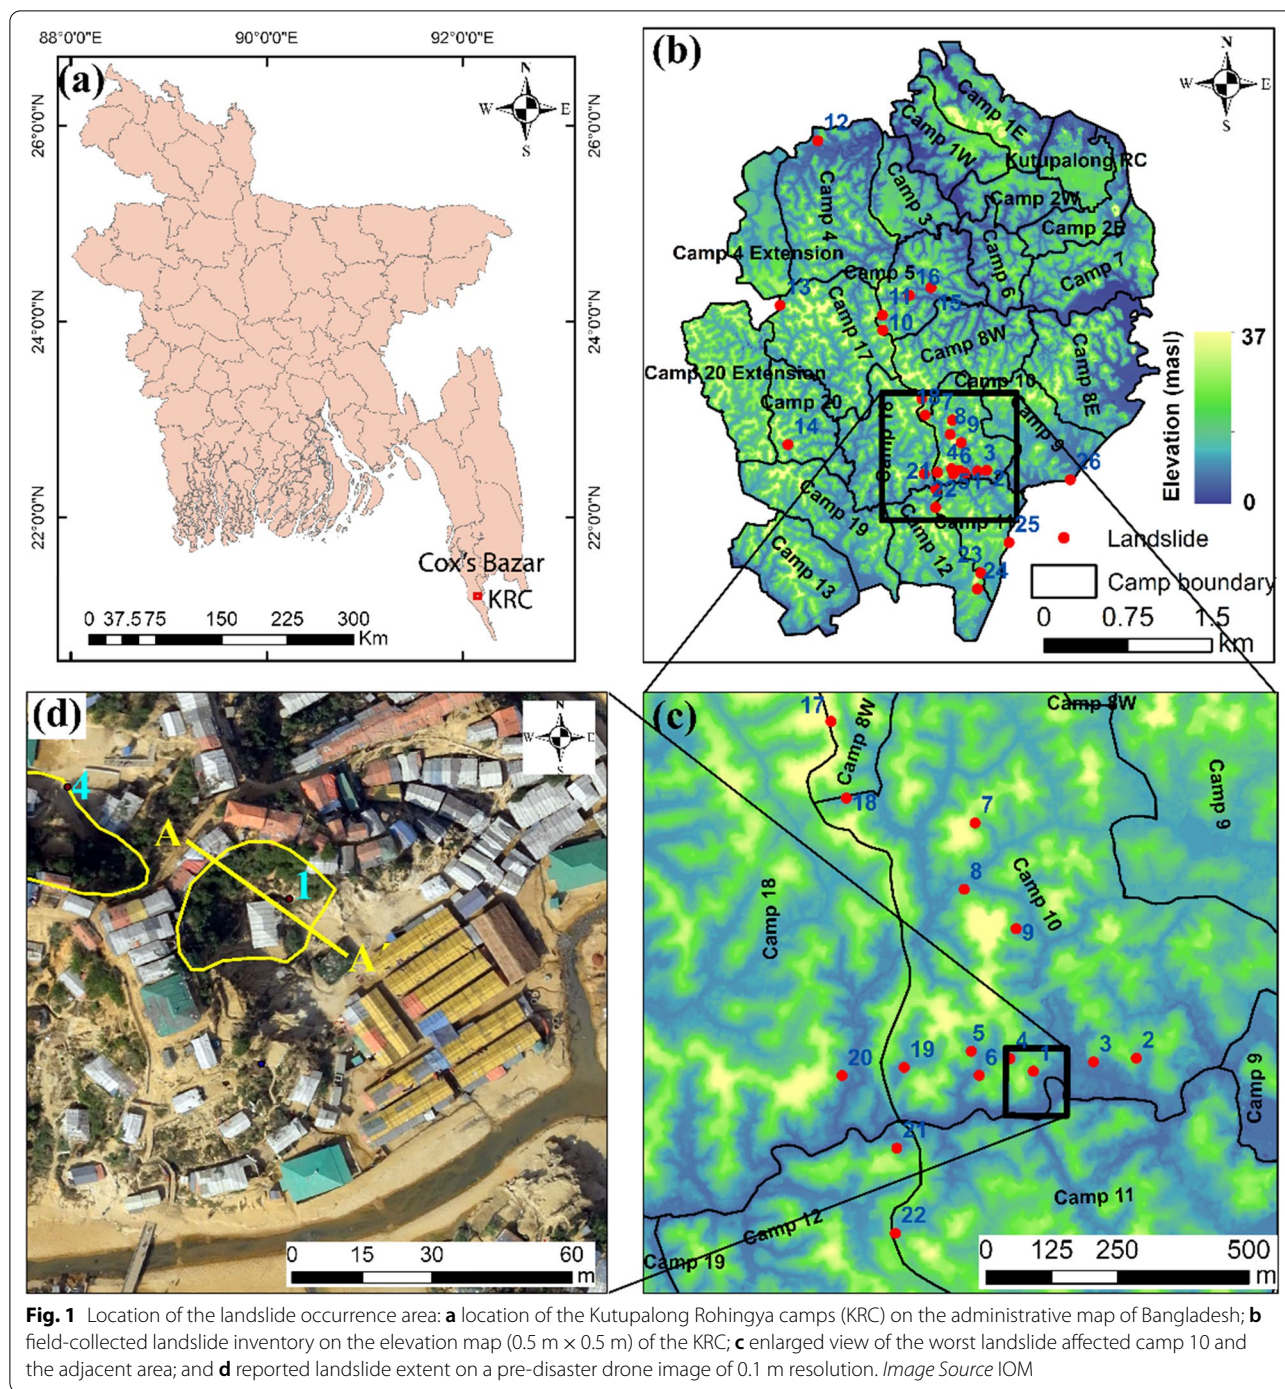
District (CBD), Bangladesh (Fig. 1). Approximately 257 landslides or slope failures were also reported in the KRC area (IOM 2021). The landslides washed away a large volume of slope materials, including temporary make-shift shelters for the refugees and other critical facilities inside the camps. In this study, twenty-six landslides were mapped in detail during the fieldwork (Fig. 1b). Among these landslides, two separate landslides incidents in camp 10 caused the death of 5 Rohingya people. One of these landslides has been critically discussed in this report because most of the landslides have similar characteristics and mechanisms. The reported landslide incidents occurred at 21° 11' 12.14" N, 92° 09' 15.20" E coordinate following a 7-day consistent rainfall of about 300 mm on 27 July 2021 at approximately 10:00 pm

Fig. 7 a and b landslide features and damages, and c schematic profile of the landslide slope along the A-A' line shown in Fig. 1c

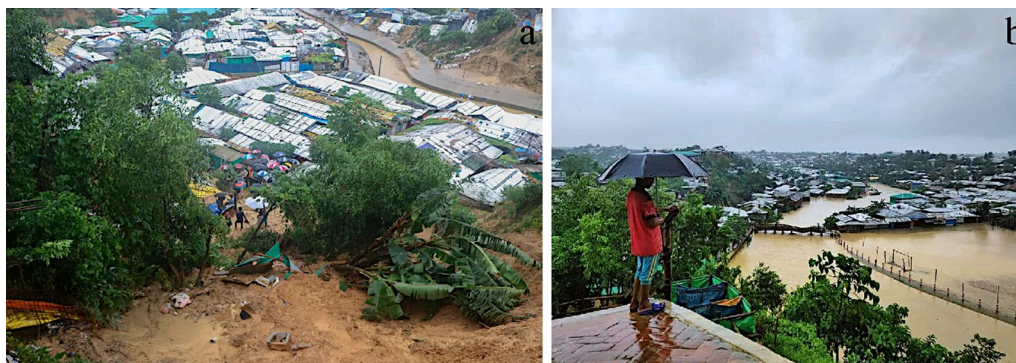
Fig. 2 **a** Landslide scar, uprooted trees, and houses built on the slope base, and **b** extreme flooding due to intense rainfall in the Kutupalong Rohingya camp. *Source* The authors, fieldwork, 2021

(GMT +6.00). The extreme rainfall events also caused widespread flash-flooding in the KRC valley (Fig. 2).

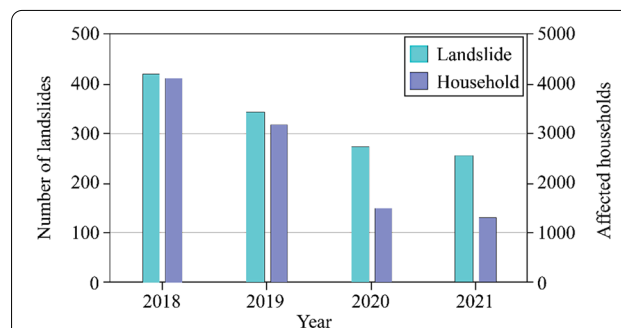
Fig. 3 Yearly occurrence of landslides and affected households in the Kutupalong Rohingya camp. *Data Source* IOM 2021

located in the Ukhia sub-district and were once covered with dense hilly forests. However, after the Rohingya settlement, extensive deforestation and unplanned slope cuts occurred (Ahmed 2021; Braun et al. 2019; Quader et al. 2021). Which immediately resulted in 422 landslides in 2018 that affected 4150 households (Fig. 3). Before the Rohingya settlement, large-scale landslide occurrences were not reported from the KRC area, although it is located in a treacherous terrain (Ahmed 2021). The households in the KRC were made of non-reinforced materials, which could not sustain landslides. After that, during the rainy season (June–September), landslides, associated casualties, and property loss have been regularly reported in the KRC. However, landslide frequency has been reduced in recent years due to the local authorities and NGOs taking slope stabilization and afforestation measures. For example, in 2021, landslide incidents were significantly reduced, and only about 257 landslides were reported inside the Rohingya camps, resulting in 5 fatalities and 1300 household damage (Fig. 3).

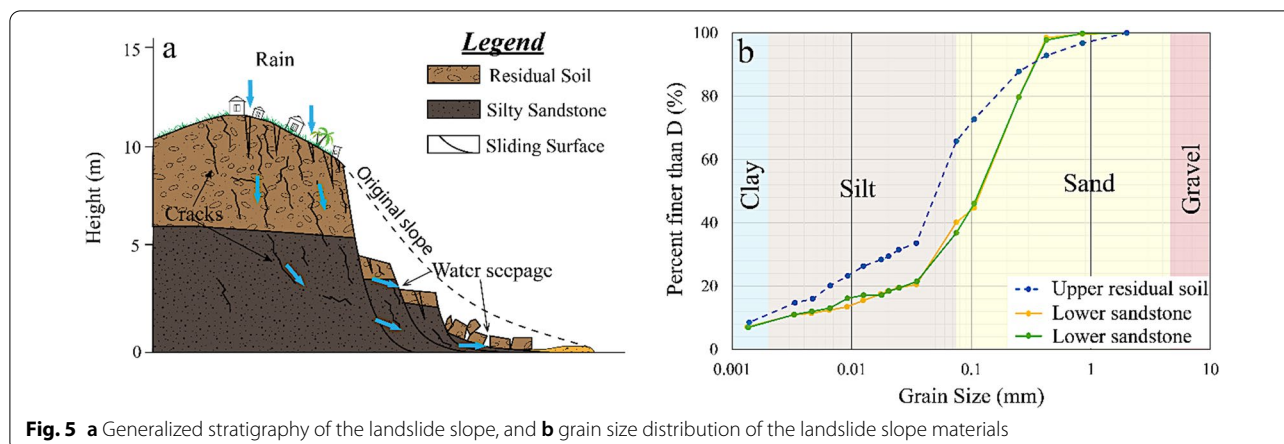
The study area is part of the Chittagong-Tripura fold belt (CTFB), consisting of numerous anticlines and synclines. Geologically, the KRC is made of Dupi Tila sandstone, Girujan clay, and Topham sandstone formations. The lithologies are loosely consolidated and sand-silt rich. Flat top, low rounded hillocks and broad valleys are the main geomorphological features present in this area. The surface elevation ranges from 0 to 37 m and is highly undulating. The hills and valleys were vegetated with tropical plants. The KRC area was previously protected, and only community forestry activities were permitted. However, since the influx of Rohingyas in 2017, they set up their shelters by cutting the hilltops and slopes and razing the forest for fuel. This environmental degradation caused an increase in rainwater infiltration in the subsurface. Stratigraphically the sliding slopes were composed of two layers—upper residual soil, predominantly clayey to silty and lower sandstone, mostly silty to sandy. The slumping prominent landslide was observed in the KRC. Still mudflow sometimes occurred after intense rainfall (Fig. 5a). The grain size distribution of the samples collected from landslide sites showed that more than 50% sand and silt were present in the upper and lower sandstone units.

However, the upper soil was more fine-grained than the lower sandstone (Fig. 5b).

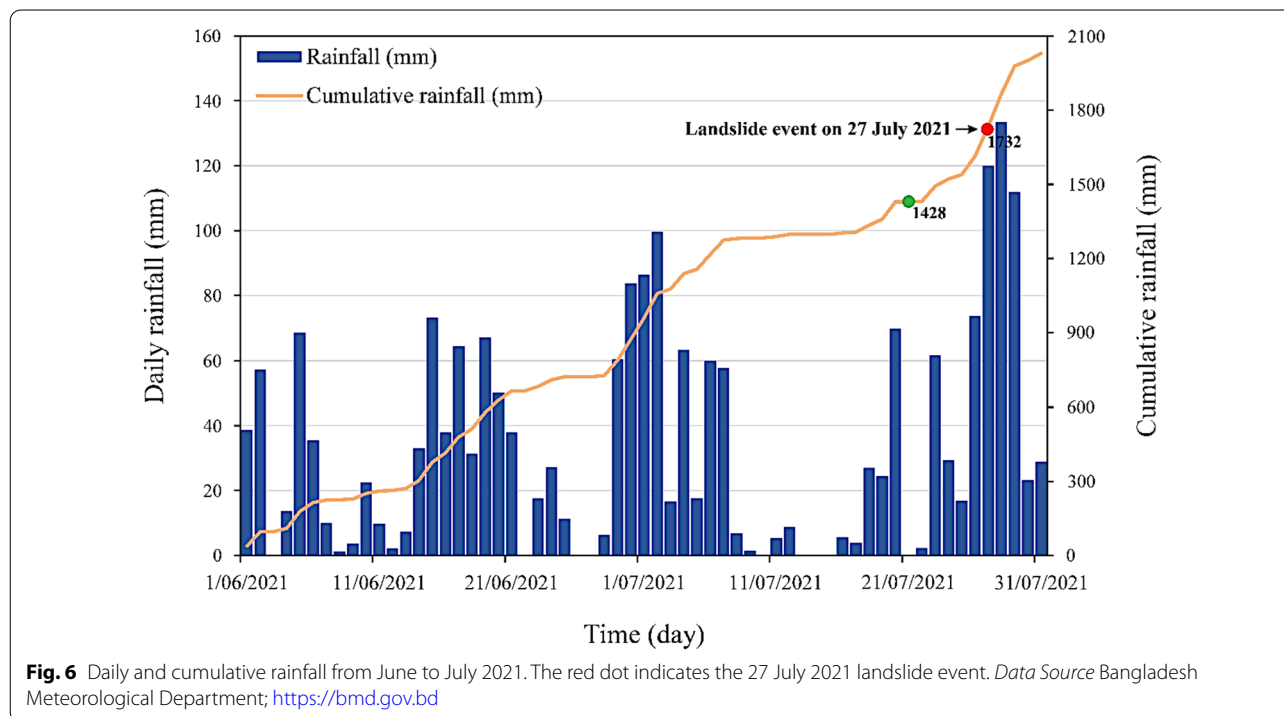
The region’s tropical monsoon climate is characterized by a very wet monsoon season from June to September. The average annual rainfall of Bangladesh is about 2500 mm, but the south-eastern region, where the study area (Fig. 1) is located, observes around 4000 mm of rainfall every year (Shahid 2011). Torrential rainfall in the monsoon is the primary triggering factor of landslides in the CHD region (Ahmed 2021). Figure 6 shows the recorded rainfall in Cox’s Bazar station from June to July

2021. The rainfall data analysis indicates that continuous rainfall occurs from the onset of June. Seven days before the landslide event of 27 July 2021, a continuous rainfall accumulation of about 300 mm was observed. The three-day antecedent rainfall amount was about 200 mm. Approximately 24 h prior to the landslide event, the cumulative rainfall had already accumulated more than 120 mm. Such extreme rainfall in this region can induce catastrophic landslide and flooding events (Fig. 2). The current threshold value for landslide occurrence is 300 mm and 200 mm for antecedent rainfall for 3-days and 1-day, respectively (Ali et al. 2018). During this event, antecedent rainfall for 3-days and 1-day was less

than the optimum. However, other factors such as hill cutting, overburden load and long-term (60 days) continuous rainfall from 01 June 2021 influenced the landslide occurrence.

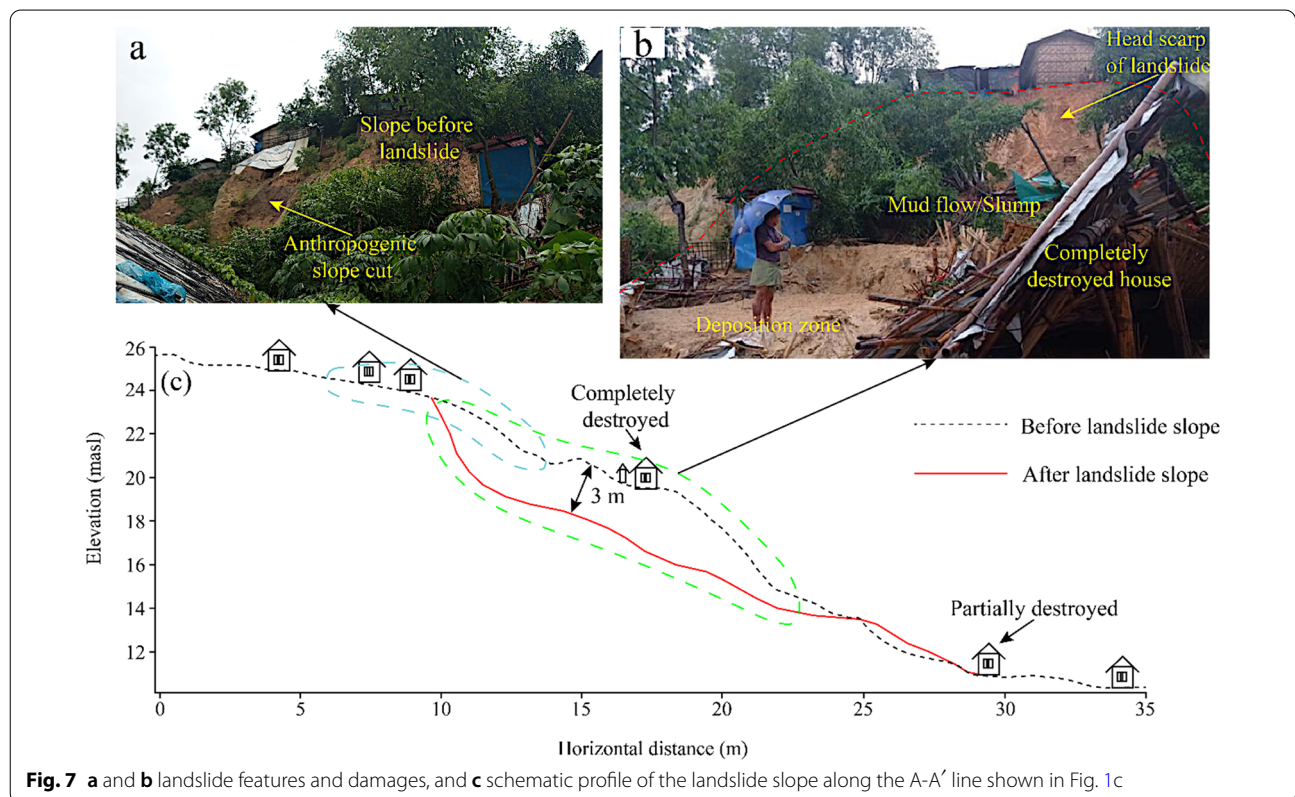
The reported landslide that occurred on 27 July 2021 in the KRC has been characterized as mudflow type. The slope materials were washed away with rainwater and composed more than 50% of sandy to silty-sized particles. The elevation of the landslide initiation and deposition zones were 25 m and 12 m above sea level, respectively. The longest path of the mudflow was about 33 m, and the width of 31 m. The area and volume of materials dislodged were about 612 m² and 2450 m³, respectively. The depth of the mudflow was about 3 to 4 m (Fig. 7). The leading cause of the landslide was torrential rainfall that quickly infiltrated through the upper

soil layer. The water reaching the lower sandstone layer effectively reduced the sliding resistance of the sandstone layer and flowed downslope.

The anthropogenic interventions in the form of forest raze and hazardously modified/cut hill slopes for constructing highly dense fragile shelters made of bamboo and corrugated iron sheet increased the infiltration rate and reduced the shear strength of the slopes. This phenomenon caused rainwater to flow along a channelized zone, facilitating landslides. The large-scale construction and rapid downslope movement of slope materials washed away the houses built on the dangerous hill slope and uprooted several trees. In addition, the dislodged materials deposited in the downslope caused partial damage to some other houses built on the slope toe (Fig. 7b, c). All the further landslides mapped during the fieldwork had identical morphologies and types and had almost similar characteristics as the reported landslide.

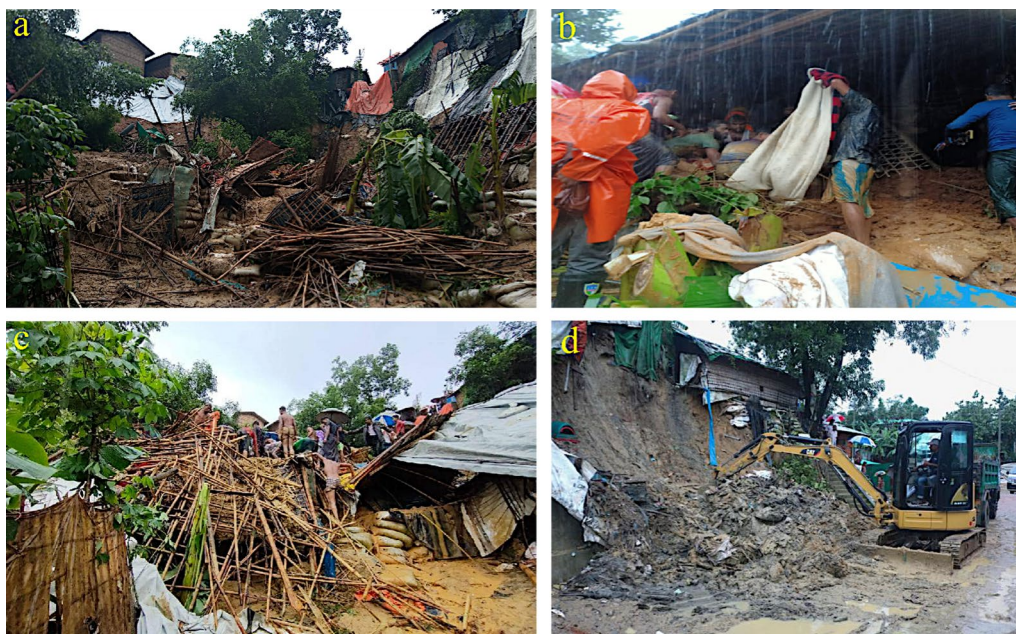
five people, including two children. The intense rainfall-induced landslide and flooding events damaged 5000 shelters and displaced 25,000 Rohingyas (ISCG 2021). Different aid organizations working under the supervision of the Refugee Relief and Repatriation Commission (RRRC) immediately engaged in the rescue operations. The details about the rescue operations are shown in Fig. 8a–d, although the activities were hampered because of continuous rainfall and extreme hilly flash-flooding in the entire region. In addition, the poor road connectivity (landslides blocked some major roads connecting the camps with the city center) and flood inundation disrupted the rescue effort.

Nevertheless, the rescue team evacuated 5000 residents to a safe place and admitted injured persons to the nearest hospital. The highly rapid mudflow with tremendous kinetic energy also uprooted several trees. It damaged some utility and critical infrastructures such as latrines, tube wells, and drainage lines on the hill slope.

Fig. 8 a Mud and garbage deposited on the slope base, b and c emergency rescue operations by the local people and volunteers, and d cleaning of the site and road by an excavator. Source The authors, fieldwork, August 2021
