Geomorphic effects of natural flood management woody dams in upland streams

One popular Natural Flood Management (NFM) technique involves the construction of channel-spanning woody dams in low-order streams that maintain a clearance height above base flows. While extensive research has examined the geomorphic effects of natural wood accumulations, little has been documented of NFM woody dams, which are structurally distinct from natural accumulations and may produce different patterns of erosion and deposition. This consideration is crucial because changes in physical habitat characteristics have implications for flood management objectives as well as ecosystem structure and functioning. This study adopted a Before-After Control-Impact (BACI) design to assess the geomorphic effects of NFM woody dams in the upper River Cover catchment, United Kingdom. One baseline survey prior to and three monitoring surveys up to 2 years following dam construction were conducted. Structure-from-Motion (SfM) photogrammetry was employed to capture topographic change, supplemented by bathymetric surveys. Results highlight that where the dams remained secure in place, they promoted in-stream habitat d

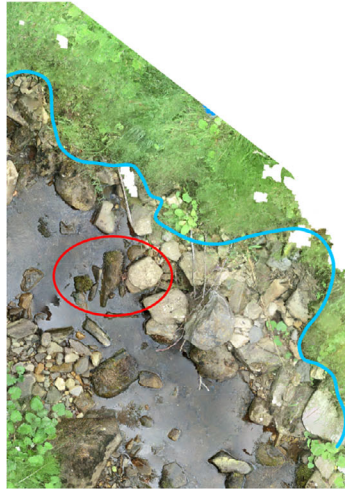
FIGURE 5 Major geomorphic changes along West Gill (the control tributary). Blue lines show bank positions recorded during the baseline survey in July 2018 [Color figure can be viewed at wileyonlinelibrary.com]

the left bank (1.3 m^3) was first observed in DoD 1 and further observed in DoD 3 (Figures 4b and 5a,b: clear retreat of the bank from its original position marked in blue). The average channel width at this site increased by 0.05 m (2.5%) over the study period. The middle control reach (West Gill 2) also experienced pronounced bank erosion during the study period. In DoD 2, the right bank near the upstream end of the study reach and the left bank near the middle of the study reach both experienced some erosion (0.38 m^3 in each area). The right bank recovered in DoD 3 following deposition. In contrast, the left bank continued to retreat after more erosion (0.17 m^3 ; Figure 5c,d). The middle part of the study reach, therefore, became approximately 0.5 m wider at the end of the study period.

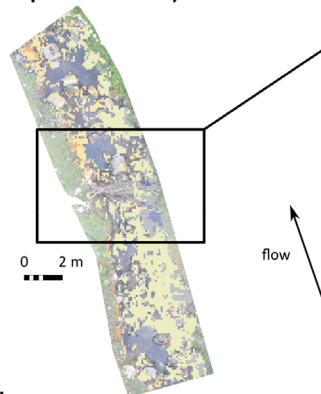
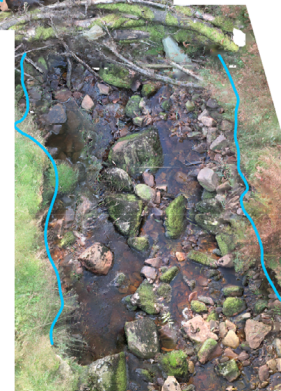
2nd dam on Downs Gill

FIGURE 6 Major geomorphic changes at the monitored dams on Downs Gill. Blue lines in (b) show bank positions recorded during the baseline survey in July 2018 [Color figure can be viewed at wileyonlinelibrary.com]

Bank erosion was also associated with the NFM woody dams. For instance, at the second dam on Downs Gill, flows were concentrated to the left side of the channel, resulting in the erosion of the left bank within the 3 m immediately downstream of the dam after October 2018 (1 month after dam installation; 0.20 m^3 eroded in DoD 2; 0.17 m^3 eroded in DoD 3; Figure 6b). At the seventh dam on Downs Gill, some localised bank erosion caused by water flowing around the dam was observed in May 2019. This was particularly evident in September 2020, where an accumulation of gravel-sized alluvium was observed on the left bank, at the original location of the dam (Figure 6g: red arrow). Similarly, localised erosion of the right bank was observed at the original location of the third dam on Fall Gill (Figure 7b), which was displaced in DoD 2. Meanwhile, the slightly-rotated fourth dam on Fall Gill diverted water into the left bank and led to the localised erosion observed in DoD 2 (Figure 7f). Finally, the seventh dam on Fall Gill was pushed a few metres downstream by high flows, and it caused erosion of the right bank through abrasion (Figure 7k,l).

In contrast, much greater and more persistent storage was observed at the two dams on Downs Gill, which had smaller clearance heights (0.30 and 0.24 m respectively) than the dams on Fall Gill (0.33–0.52 m; Figure 8). Immediately upstream of the second dam on Downs Gill, some gravels (0.02 m^3) started to accumulate near the right bank after October 2018, clogging the gap between the dam and the stream bed. Deposition along the right bank extended further upstream in DoD 3 (a total of 2.87 m^3 along the entire reach; Figures 4a and 6a). Since upstream sedimentation diverted flow to the left side of the channel, deposition was also predominant on the right side immediately downstream of the dam, resulting in the

accumulation at the toe of the right bank (0.32 m^3 deposited; Figure 6b). Overall, the channel appeared to have shifted 0.2 m laterally towards the left.

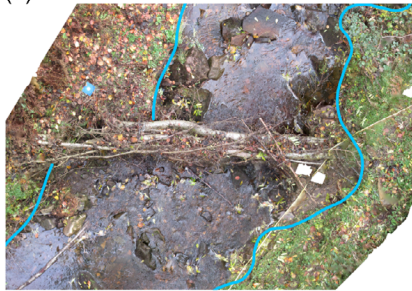
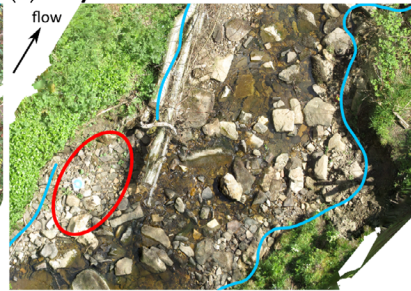
3rd dam on Fall Gill

FIGURE 7 Major geomorphic changes at the monitored dams on Fall Gill. Blue lines show bank positions recorded during the baseline survey in July 2018 [Color figure can be viewed at wileyonlinelibrary.com]

The monitored dams on Fall Gill stored only negligible amounts of sediments. Some gravels accumulated in the area enclosed by the left bank and the displaced third dam on Fall Gill (Figure 7b: red circle), but the volume was small (0.14 m^3). Reach-wide aggradation along the tributary occurred in DoD 2 (Figure 7d), but the deposits were transported by high flows in DoD 3 (Figure 7e,i) even when most of the dams remained in place, suggesting that the dams on Fall Gill generally had low sediment retention ability.

It is notable that two of the six dams monitored (i.e., the seventh dam on Downs Gill and the third dam on Fall Gill) had been completely displaced. Furthermore, the fourth dam on Fall Gill had been rotated clockwise by 30°, and the seventh dam had been pushed 0.4 m downstream. As described earlier, the latter two continued to exert geomorphic influence on the channel. However, the former two also served some geomorphic functions. Between May 2018 and May 2019, the outer bank of the bend downstream of the seventh dam on Downs Gill was gradually eroded, but the displaced dam protected it from further erosion in September 2020 (Figure 6d-f). The displaced third dam on Fall Gill allowed the left bank to develop towards the thalweg, resulting in a channel width 0.2 m narrower than the baseline condition (Figure 7b,c).

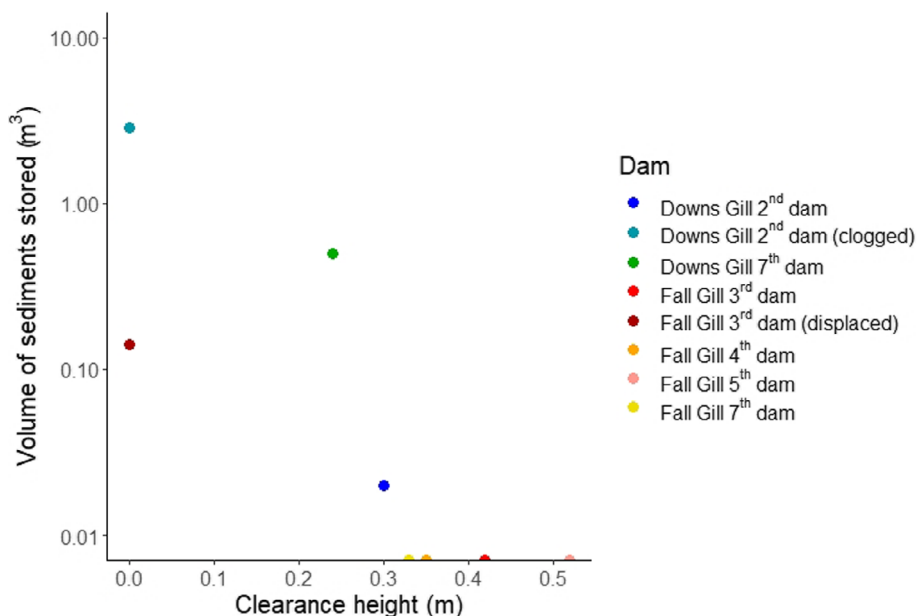
FIGURE 8 Maximum volume of sediments stored (m^3) as a function of dam clearance height (m) measured in October 2018. The second dam on Downs Gill and the third dam on Fall Gill are shown twice as their clearance heights had changed after being clogged and displaced respectively [Color figure can be viewed at wileyonlinelibrary.com]

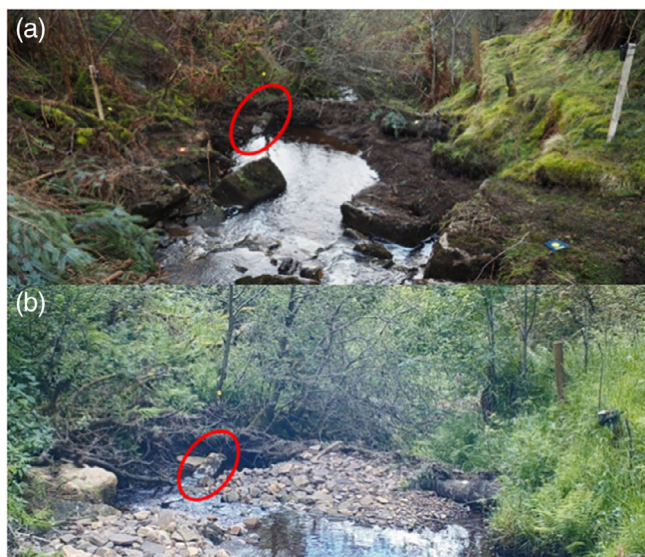
FIGURE 9 Clasts piling up against the most upstream dam on Fall Gill; as captured by a hand-held camera on February 21, 2019 (upper) and a time-lapse camera on June 21, 2019 (lower); both facing downstream; red circles indicate a reference boulder that had remained stationary [Color figure can be viewed at wileyonlinelibrary.com]
